# Presentation to NTSB Members

NTSB Accident File: DCA14MP002

Location: East Harlem – Manhattan, New York

# Summary of City's position

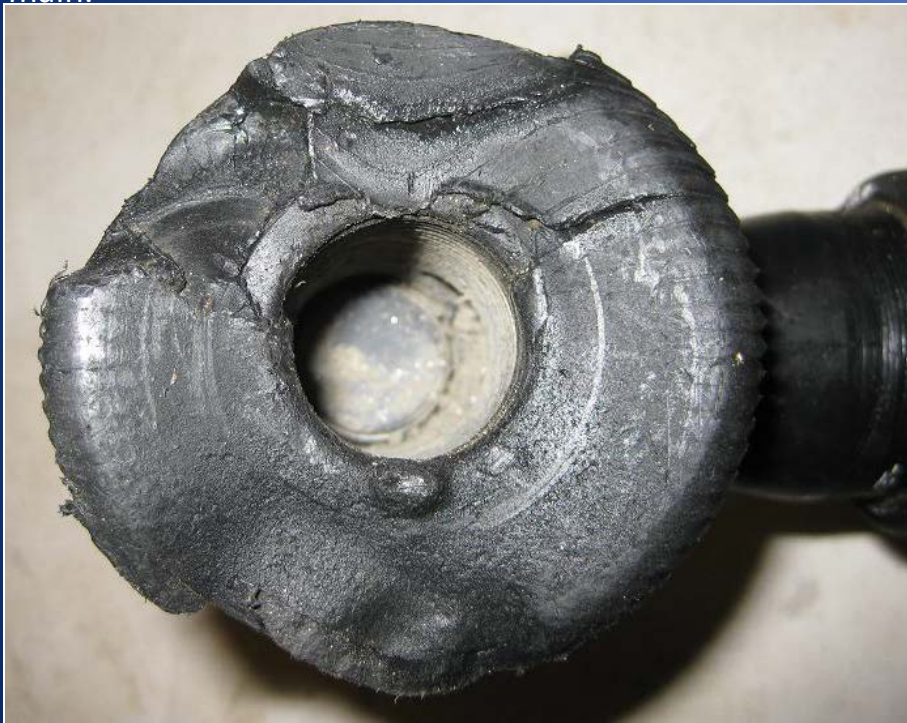
Tapping Tee Surface

“With the tee insufficiently fused onto the main, any slight force would have knocked the tee from the main...This substantial leak would suggest that the tee was almost completely removed from the main prior to any excavation...The lab has determined that the probable cause for the leakage of the sample was the cold fuse present between the 6” PE main and the Central Plastics Tapping Tee. . . it is likely that the leak originated at the cold fuse. This cold fuse was the result of poor preparation and poor installation of the tapping tee onto the main.”

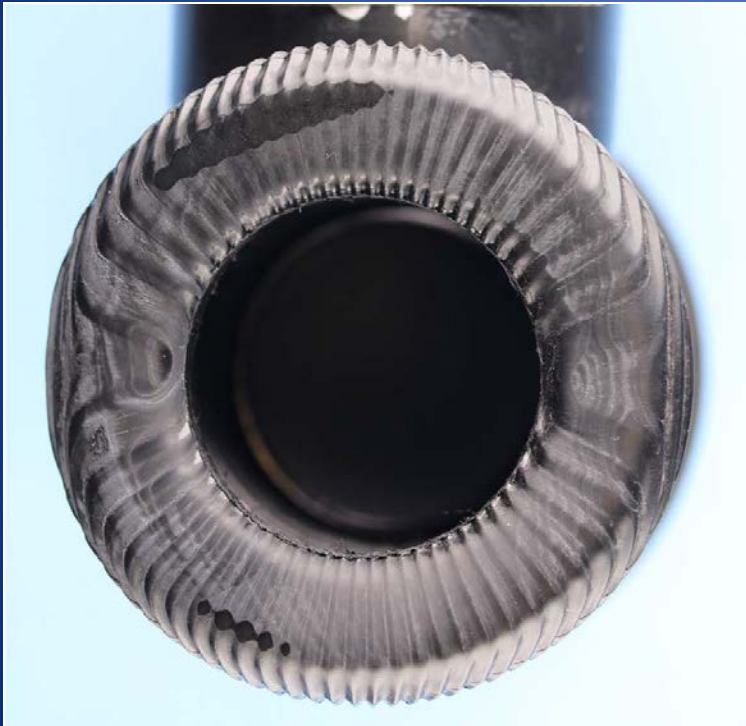
Tapping Tee Surface

NTSB noted of the intentionally contaminated exemplar: “The radial pattern fanned out (apart from each other) at the north and south positions, similar to the radial pattern that was found on one portion of the fractured saddle fusion joint from the accident site.”

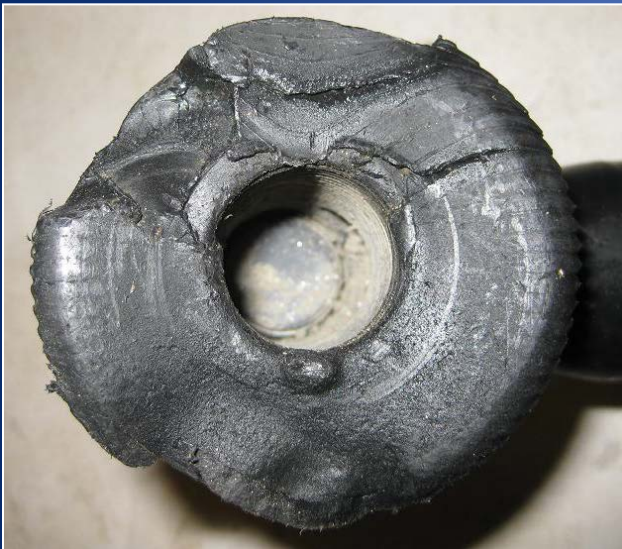
ConEd Report

The images below compare the appearance of tapping tee surfaces after joint separation for a cold fusion joint (Con Edison report) and a contaminated joint (NTSB test) with the appearance of the accident tapping tee that was in front of 1642 Park Avenue.

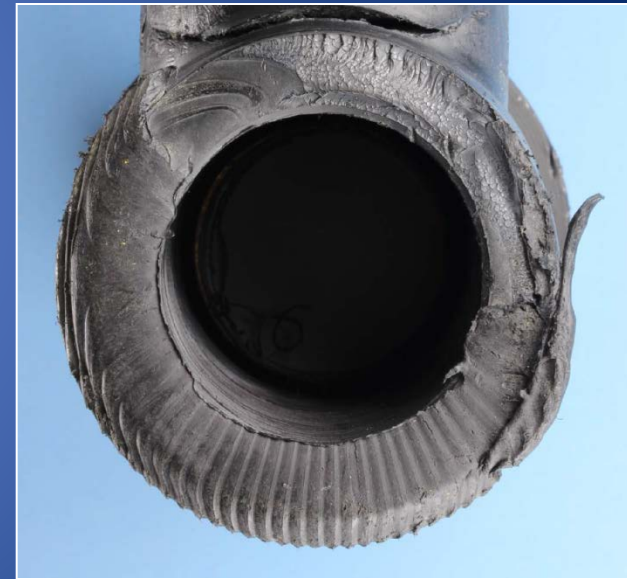
1642 Park Ave.

- Con Edison's own Section Manager in charge of its gas development lab, Joseph Madia, confirmed in his NTSB interview that radial marks or "serrated edges" on the fracture surfaces of failed fusion joints are a telltale sign of improper or "cold fusion." Such radial marks were found on the failed 1642 Park Avenue saddle fusion joint.
- Identical radial marks were found on the fracture surfaces of other improperly fused saddle fusion joints:
  - Failed Con Edison saddle fusion joint in Hawthorne, New York, confirmed by Con Edison Gas Development Laboratory Failure Analysis Report GT-11-029, dated Feb. 15, 2011.
  - Exemplar saddle fusion joint intentionally contaminated by NTSB with a mold-release agent (Materials Laboratory Factual Report Nos. 14-069 and 14-070).

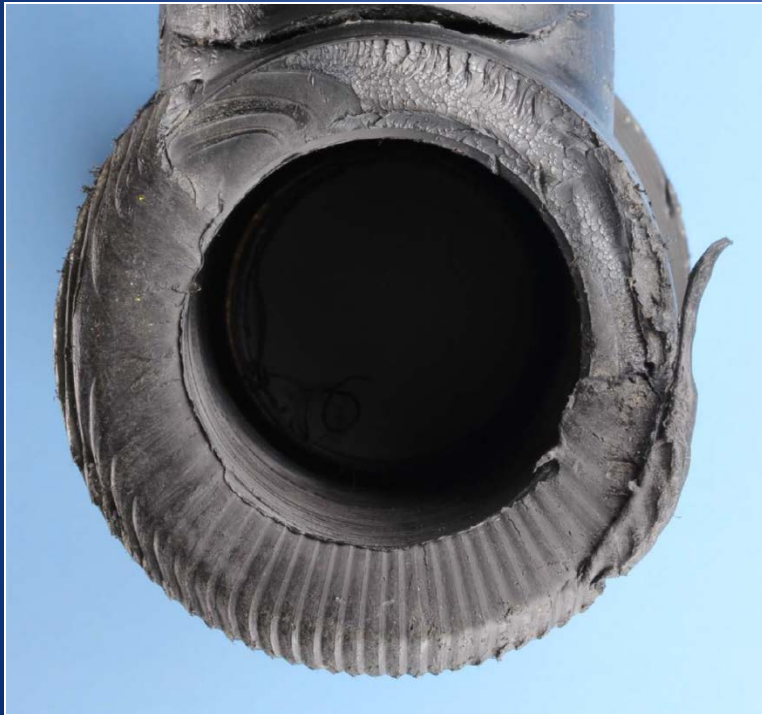
Tapping Tee Surface

- The Con Edison installer who fused the joint was not certified at the time for this type of installation.
- Nearly half (150 of the 360-degree circular joint) was incompletely and inadequately fused.
- The saddle fusion joint was improperly fused during Con Edison's installation of the service tee connection to the gas main in December 2011.
- Radial marks on the subject saddle fusion joint are telltale signs of improper or "cold fusion," as confirmed by Con Edison and NTSB lab reports, as well as NTSB interview testimony by the head of Con Edison's gas development laboratory.
- Con Edison acknowledged in its report of a similar failed fusion joint in Hawthorne, NY, that "any slight force" could separate the improperly fused joint.
- Separation of the improperly fused portion of the joint occurred, allowing gas to escape, fueling the explosion.

The images below are of the tapping tee surface and PE gas main surface of the separated fusion joint that was in front of 1642 Park Avenue.

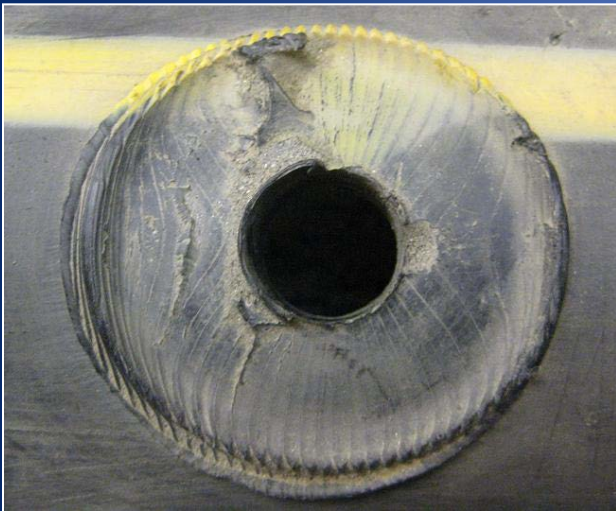
Con Edison report

The images below compare the appearance of HDPE gas main surfaces after joint separation for a cold fusion joint (Con Edison report) and a contaminated joint (NTSB test) with the appearance of the accident saddle fusion joint on the gas main that was in front of 1642 Park Avenue.
