NATIONAL TRANSPORTATION SAFETY BOARD

METALLURGIST'S FACTUAL REPORT

Report No 94-34

Place : Provincetown, Massachusetts
Date : August 2, 1993
Vehicle : Piper PA-28-181, N2093
NTSB No. : NYC 93-F-A140
Investigator : Al Yurman (ASI-NYC)

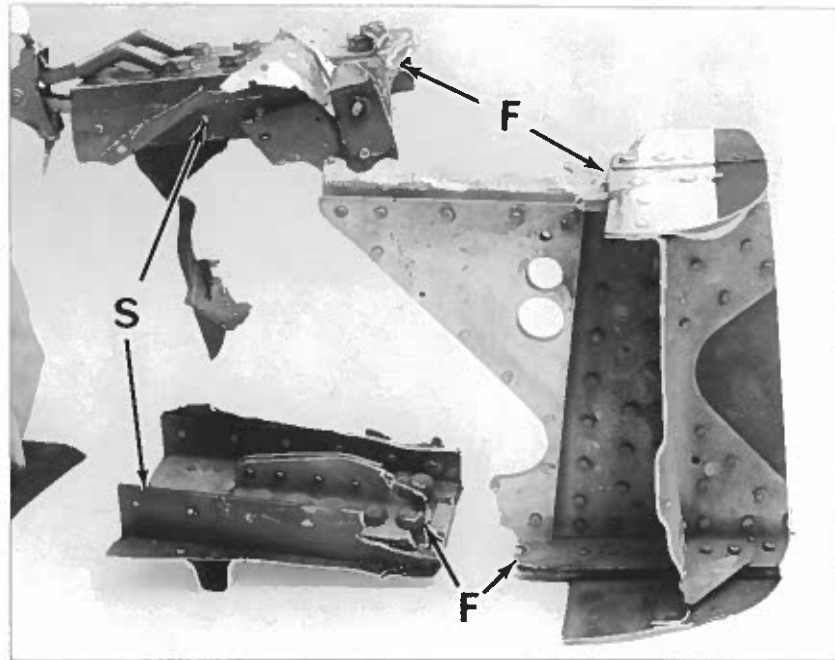
The right wing components included three pieces from the inboard end of the main spar. The main spar was fractured through both the upper and lower spar caps and through portions of the spar web. The spar pieces are shown in figure 1 displayed in their approximate original positions with the mating cap fractures denoted by arrows "F". Both spar caps were transversely fractured at positions near the outboard ends of the fuselage carry-through structure, denoted by arrows "S" in figure 1. A schematic of the wing spar and carry-through structure area is presented as figure 2 with the path of the spar separation depicted by the red section lines. The spar was a riveted assembly composed of extruded aluminum upper and lower spar caps with riveted aluminum sheet webbing and gussets. At the inboard ends, the spar caps are bolted to upper and lower "C" channels which act as the main wing to fuselage attachments and fuselage carry-through structure.

Figure 1: An overall view of the as-received right wing main spar structure with the mating spar cap fractures denoted by arrows "F". View looking forward.

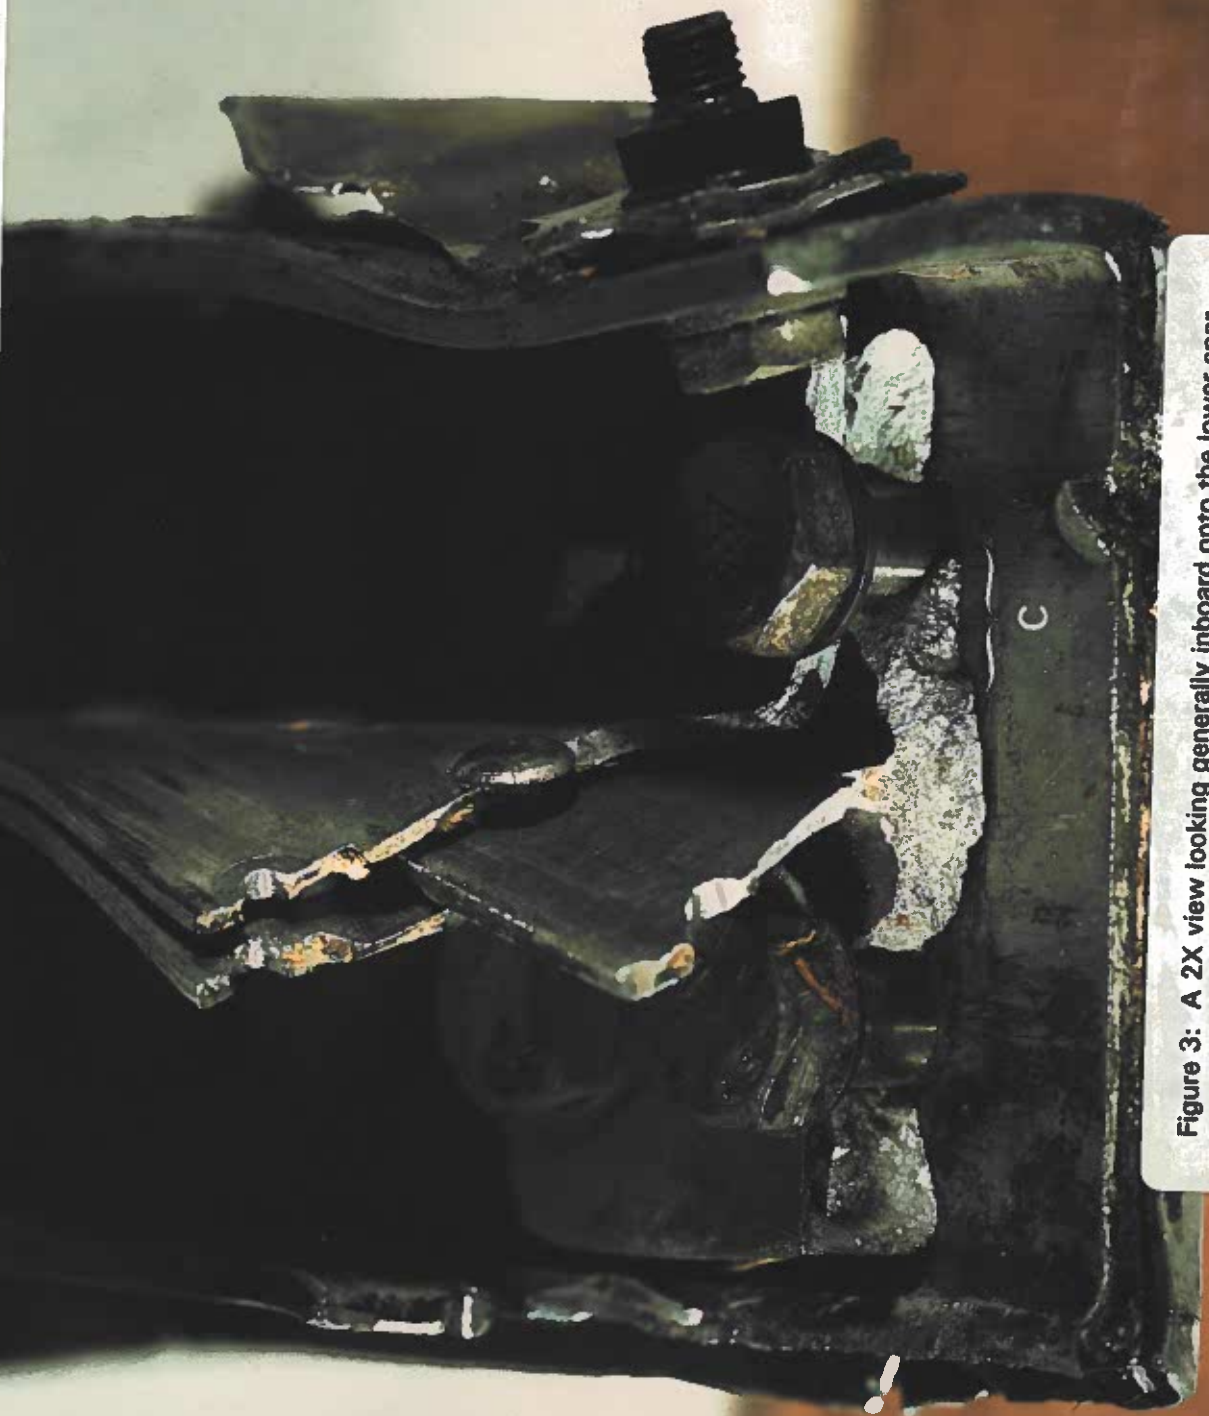
The upper spar cap was fractured just past the outboard end of the upper carry-through, while the lower cap fractured through the most outboard pair of bolts connecting the spar and carry-through, as shown in figure 3. Both spars appeared to exhibit upward bending outboard, however the transition to the upward wing dihedral occurs at this location and masks the amount of actual deformation. Magnified optical examinations of the upper spar cap and sheet metal fractures disclosed evidence typical of overstress separations with the upper cap fracture typical of upward bending of the wing. In contrast, indications of preexisting fatigue cracking was uncovered on the lower spar break.

The lower spar break had a small area of fatigue on the fracture surface near the forward bolt, see bracket "C" in figure 3. The fatigue zone was approximately 0.3 inches wide and had penetrated about 0.2 inches into the spar cap. The fatigue zone was slightly aft and outboard of the forward bolt hole but the fatigue extension had not penetrated the bore surface. The remainder of the lower spar fracture displayed surface features typical of an overstress separation. Closer optical examinations after disassembly of the structure established that the fatigue had initiated on the lower surface of the spar cap at a location approximately 0.073 inches from the edge of the bolt hole. The fatigue had progressed upward and aft away from the bolt hole. Scanning electron microscope (SEM) examination of the outboard fracture face, after it was cut from the remaining spar, uncovered two distinct fatigue origins in close proximity to each other on the surface of the spar in the areas denoted by arrows "O" in figure 4. Further viewing established that the fatigue progressed upward and aft generally avoiding the hole to the fatigue terminus, indicated by arrowheads in figure 4. Beyond the terminus, the fracture morphology was completely ductile dimples typical of an overstress fracture in ductile aluminum alloys.

Figure 3: A 2X view looking generally inboard onto the lower spar cap inboard fracture face. The area of fatigue is indicated by bracket "C". Note its proximity to the bolt.

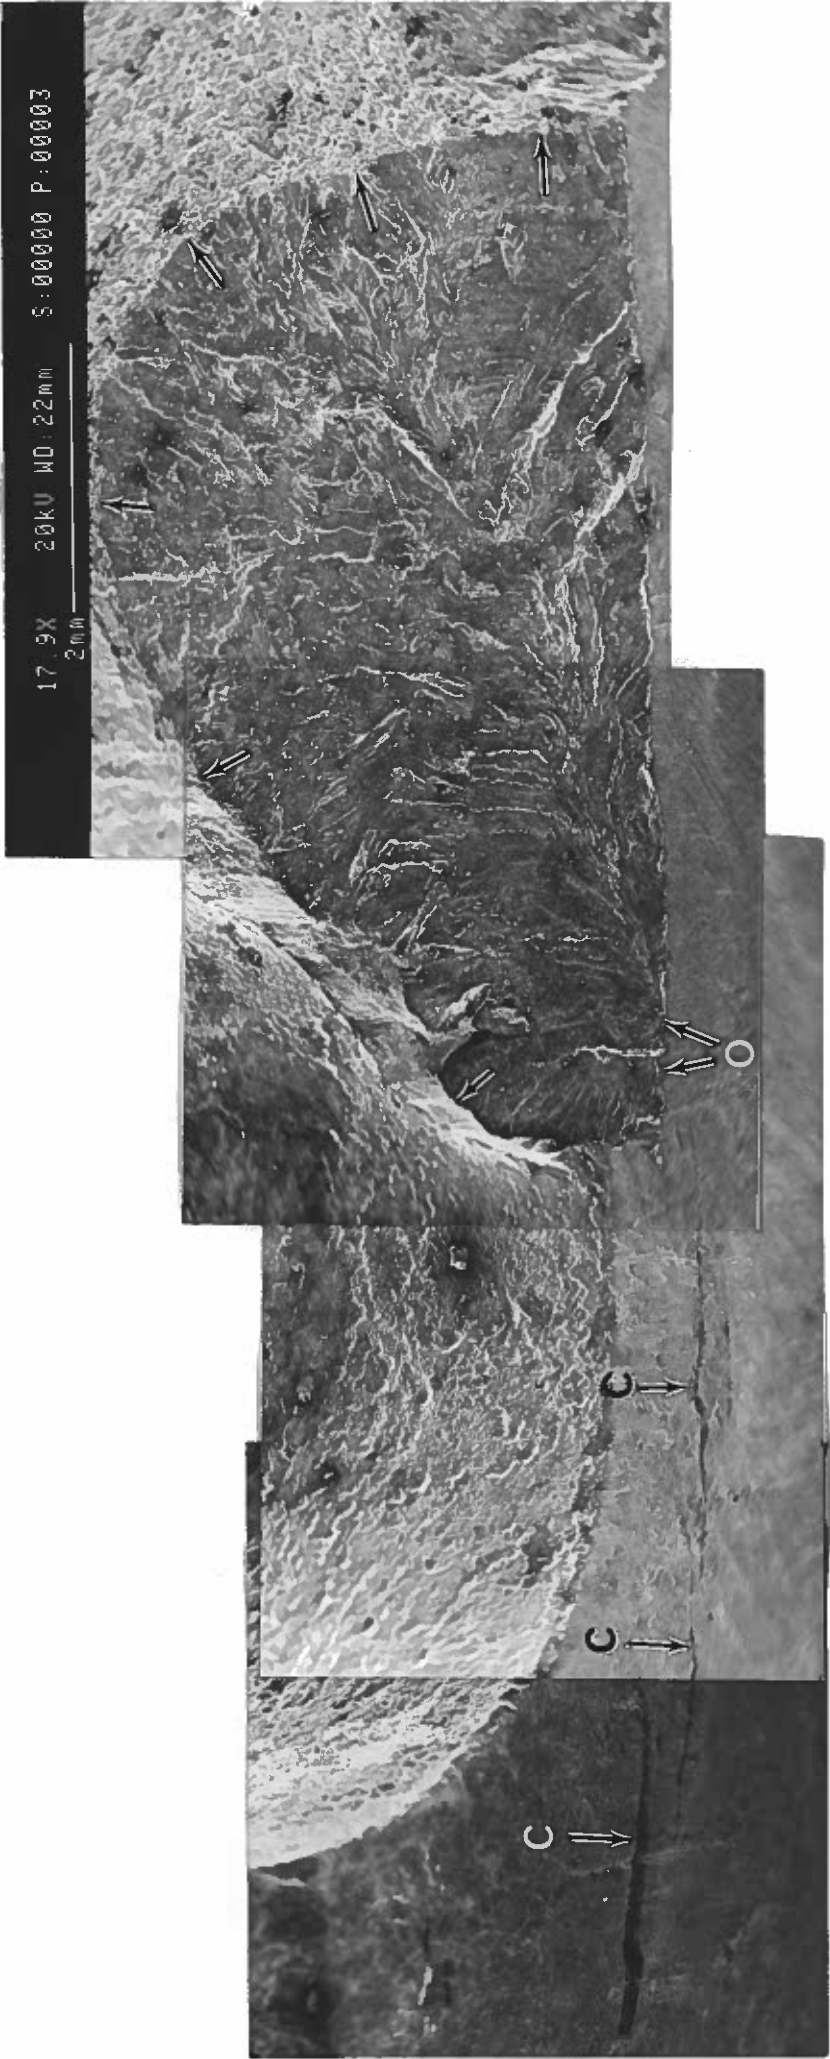
Figure 4: A SEM montage of the fatigue region and lower surface of the spar at 17.9X on the outboard fracture half. Fatigue origins are at arrows "o" with the fatigue terminus at the unlabeled arrows. View looking outboard and slightly up with aircraft forward at left.

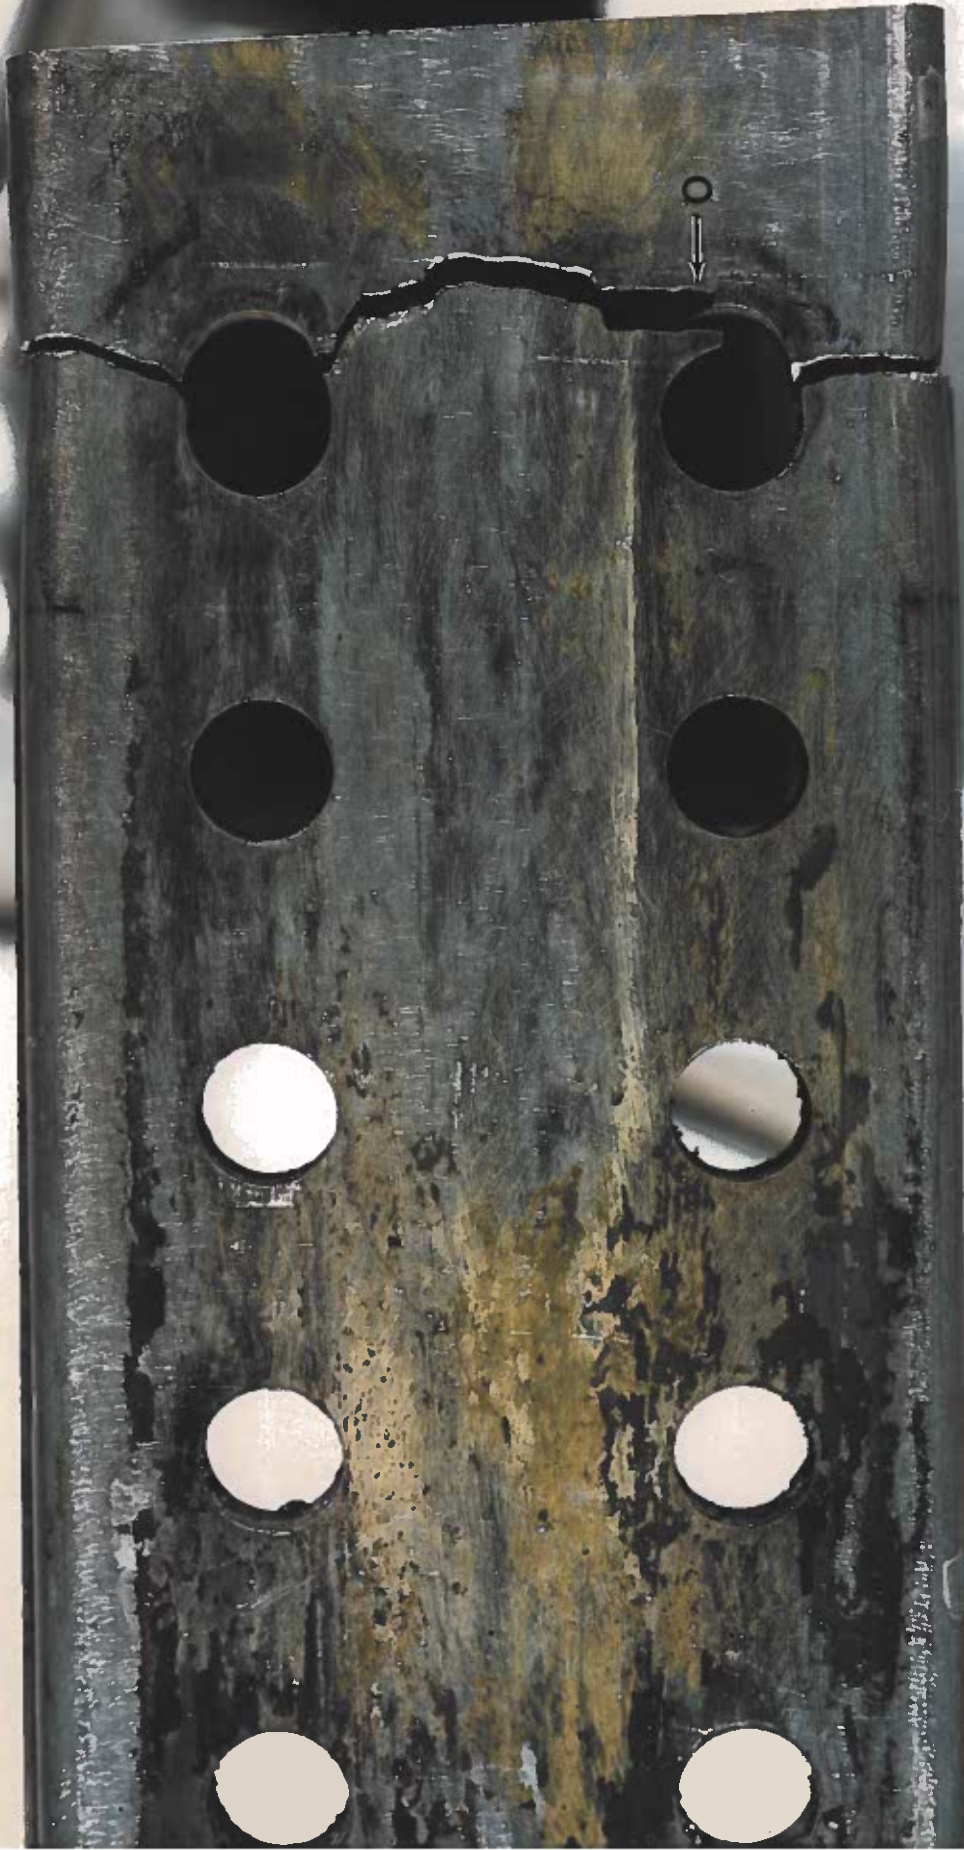
When removed from the carry-through channel, the lower surface of the spar was partially covered by green and yellow primer paint. Removal of loose paint by ultrasonic agitation in acetone uncovered many areas of randomly oriented surface scratches (see figure 5) as if the surface had been lightly sanded prior to assembly. As shown in the left view of figure 6, the fatigue origin, arrows "O", were located at the boundary of a faint polished area around the bolt hole (depicted by the dashed line). Light fretting and wear were also found immediately adjacent to the hole within this polished area. The wear area is indicated in figure 6 by the solid black line.

Figure 5: A 2X photograph showing the lower surface of the spar cap at the fracture and bolt location. Fatigue initiation location denoted by arrow "O".

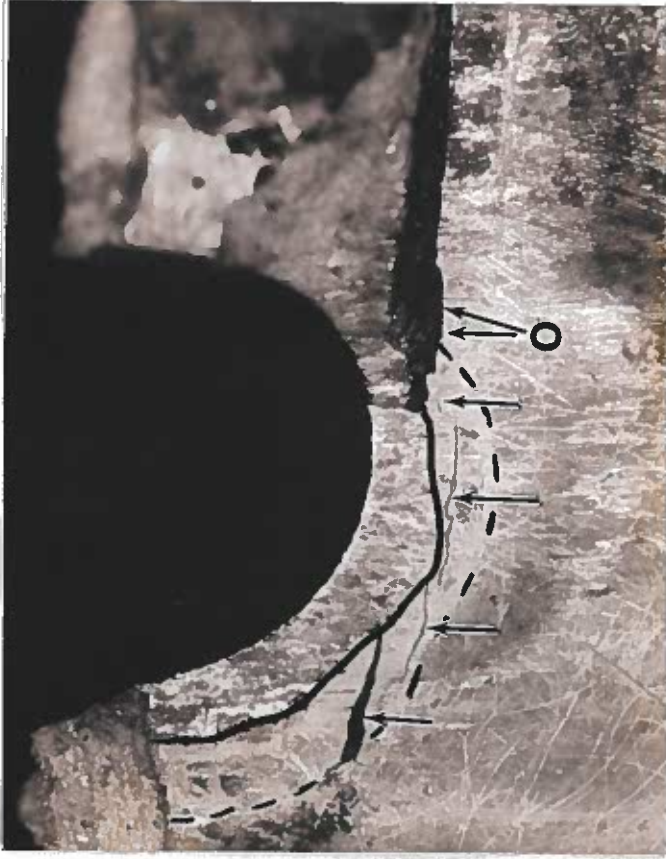
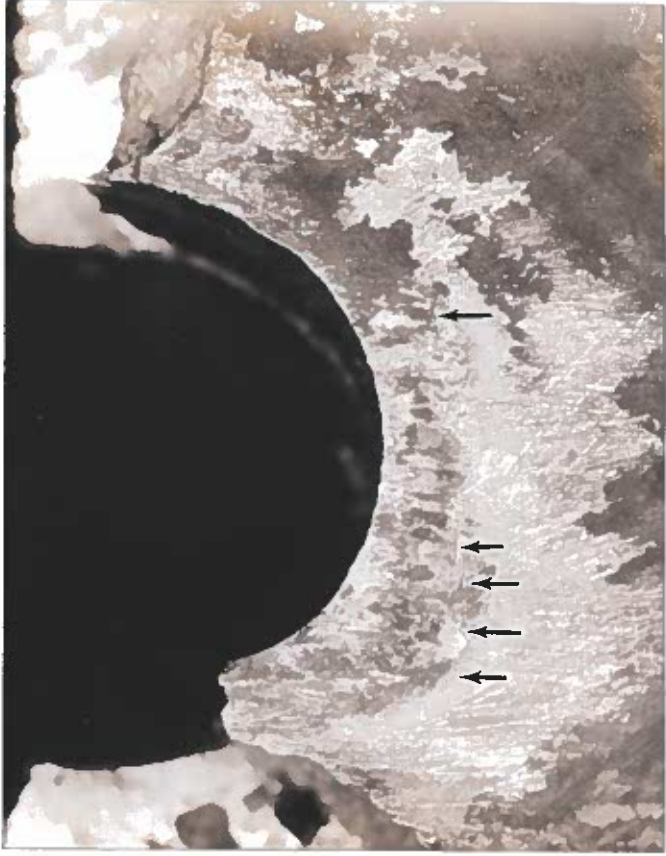
Several cracks, visible as irregular dark lines at the unlabeled arrows in figure 6, were present in the lower spar surface roughly paralleling the fatigue zone. Four cracks were located near the forward outboard hole and five smaller cracks were found near the aft bolt hole. The largest crack, at the forward hole measured 0.13 inches long.

Figure 6: 7.5X views of the lower spar cap surface adjacent to and outboard of the two outboard spar attachment bolts. The left view, of the forward bolt, shows the fatigue origin locations, arrows "o" and areas of polishing (dashed line) and fretting (solid line) surrounding the bolt hole. Unlabeled arrow in both views denote cracks. See also arrows "c" in figure 4.

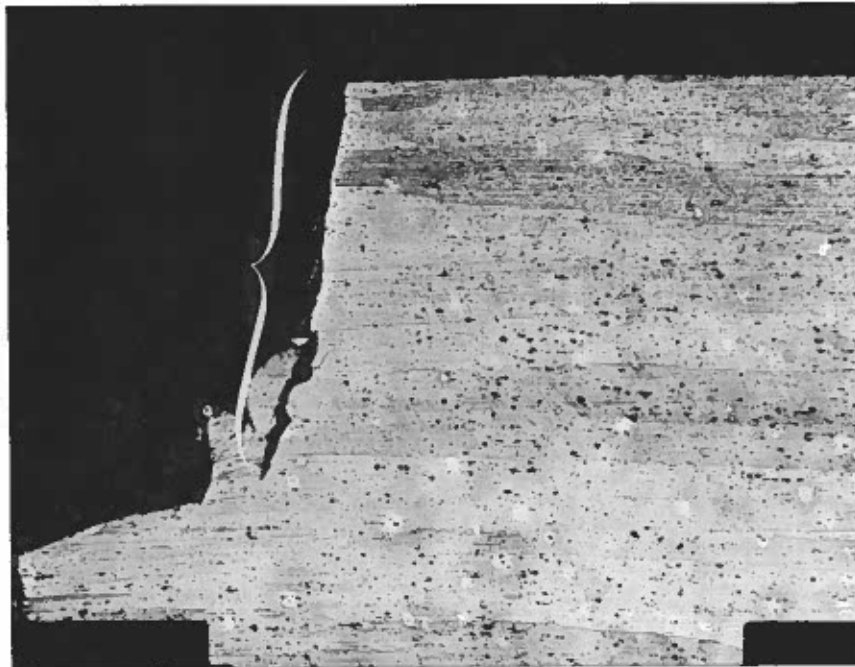
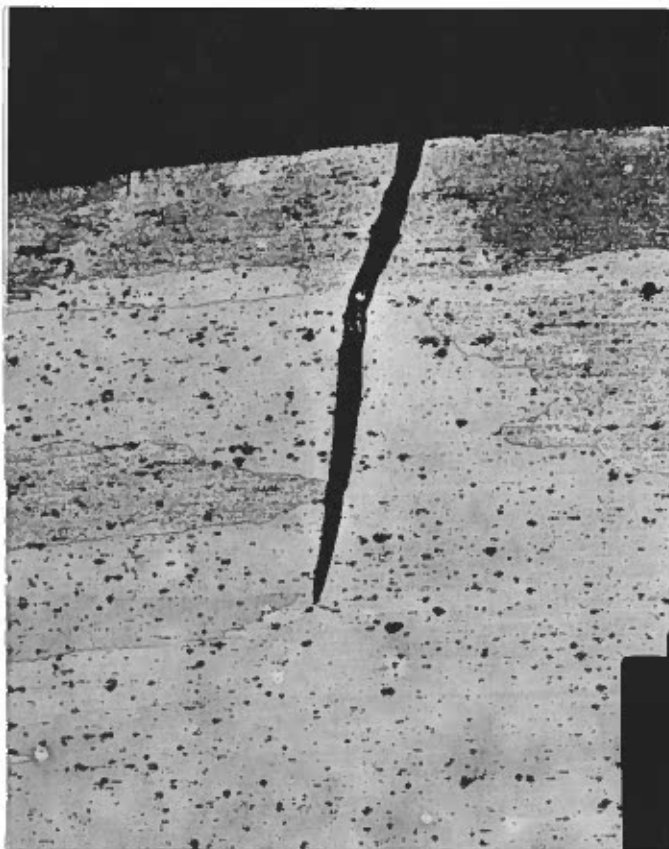
area and the crack both exhibited transgranular paths typical of fatigue progression through aluminum alloys, as shown in figure 7. The crack had only extended about 0.049 inches from the surface in this section.

Figure 7: Metallographic sections through the fatigue origin (top at 32X) and one of the cracks (left at 50X). Fatigue region denoted by bracket in upper view. Keller's Etch

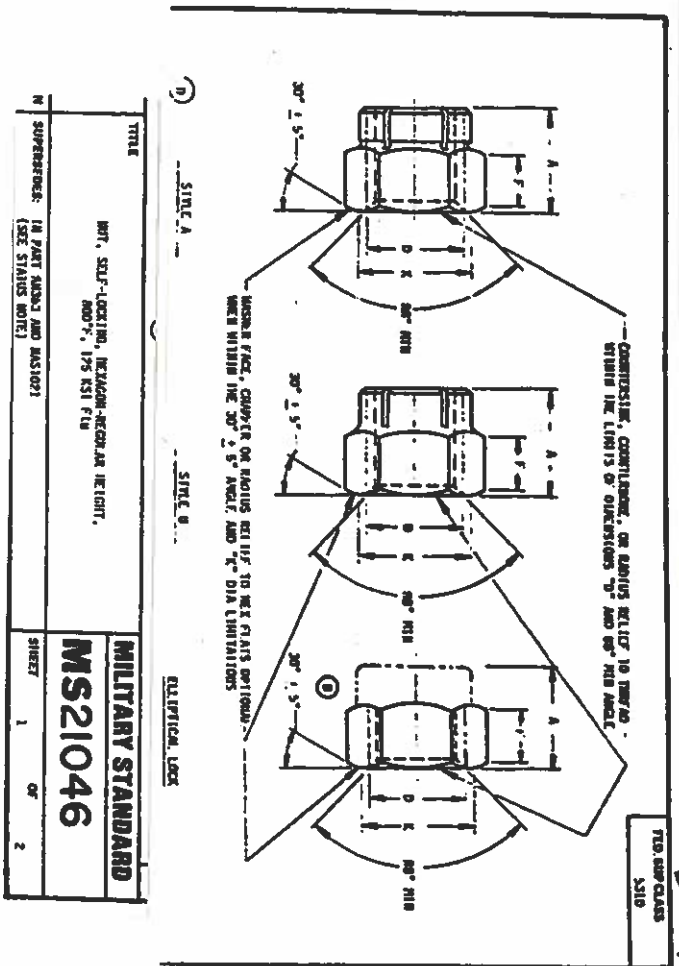
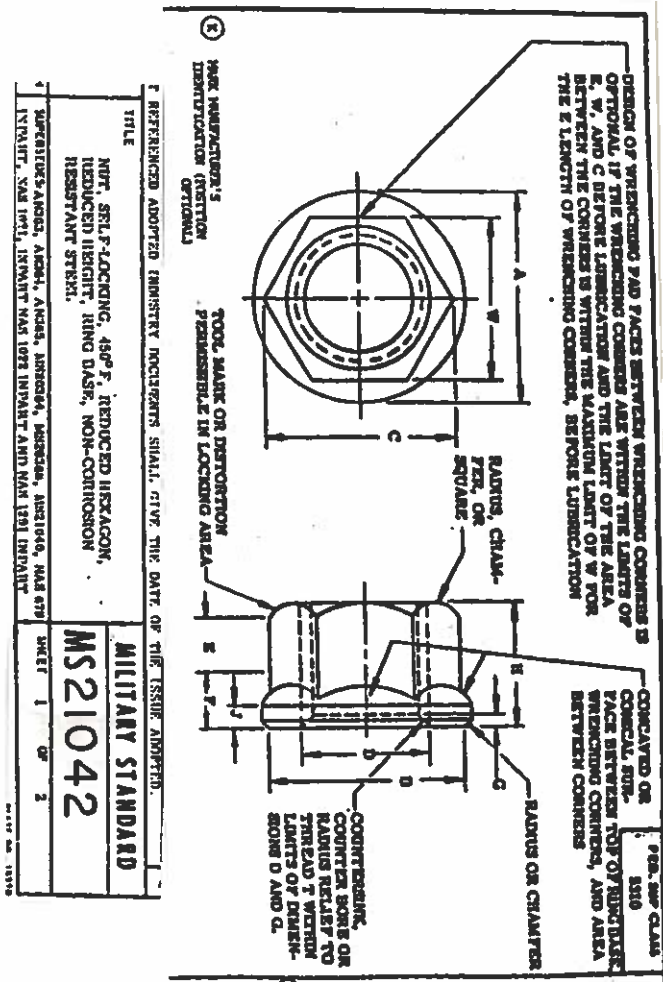
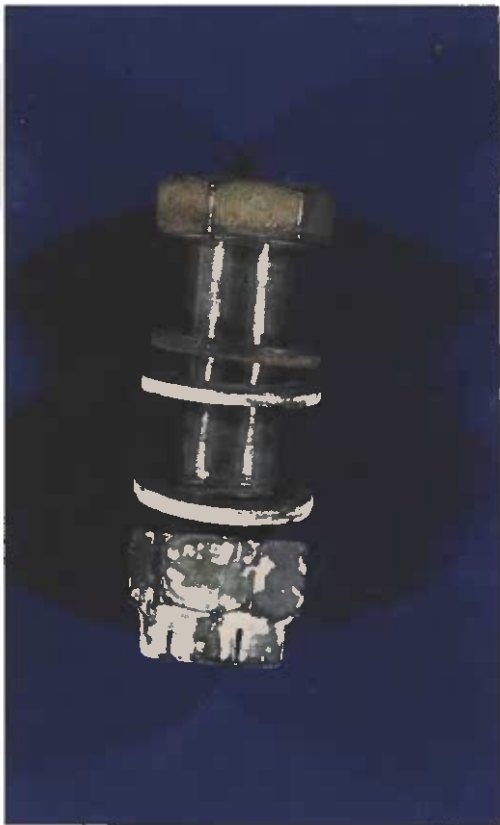
The PA-28-181 maintenance manual lists the fastener hardware to connect the wing spars to the fuselage carry-through structure. For the lower spar cap, AN176-13A⁴ or NAS464-P6-LA13⁵ bolts are to be installed with a combination of AN960-616⁶ and Piper 96352-3 washers and MS21042-6⁷ nuts. The placement order of the washers is also prescribed. Inspections during disassembly indicated that the washers on the received spar sections were in the prescribed order. The loosening torque for the ten lower spar cap to fuselage carry-through assembly bolts exceeded 300 inch-pounds except for the two at the fracture location where the nuts loosened at about 150 inch-pounds each. The maintenance manual lists the installation torque as 360 to 390 inch-pounds and also notes that the tightening torque is to be applied through the nuts on the lower spar cap and through the bolt heads on the upper spar cap. Rotational damaged to the under-nut washers indicated that the nuts were tightened on the received lower spar cap. The bolt heads were marked with an "X" in a triangle and the letters "CS". In accordance with MIL-HDBK-131A⁸, the triangle "X" marking denotes aircraft, close tolerance, alloy steel, machine bolts AN173 through AN186. The AN specification allows the bolt manufacturer to also place an identification mark on the head. Both the maintenance manual and Piper service letter No. 997 specify the use of MS21042 nuts on all of the main spar wing attachment bolts. MS21042 describes a self-locking ring based nut with a reduced hexagon and reduced height. The received nuts (see figure 8) were not marked with a part number or other identification and do not match this description in detail dimensions or style but rather appeared to more closely match one of the allowed configurations for a MS21046 nut.

Figure 8: A 1.5X view (left) of a typical main spar attachment bolts. Compare the nut to the MS illustrations above.

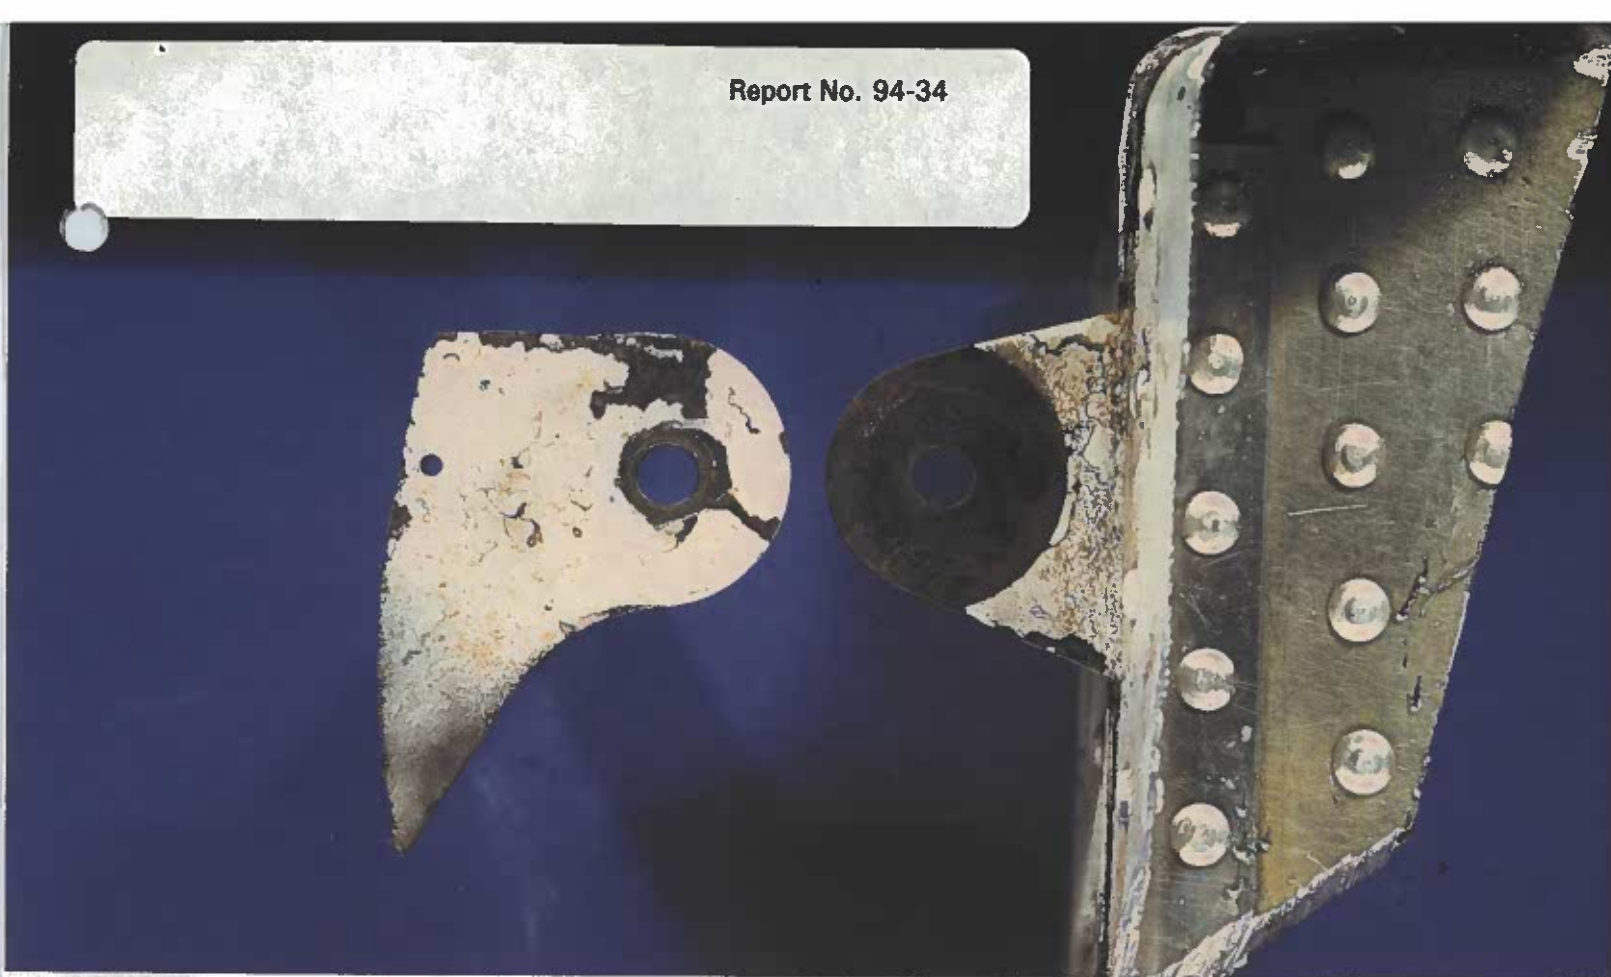
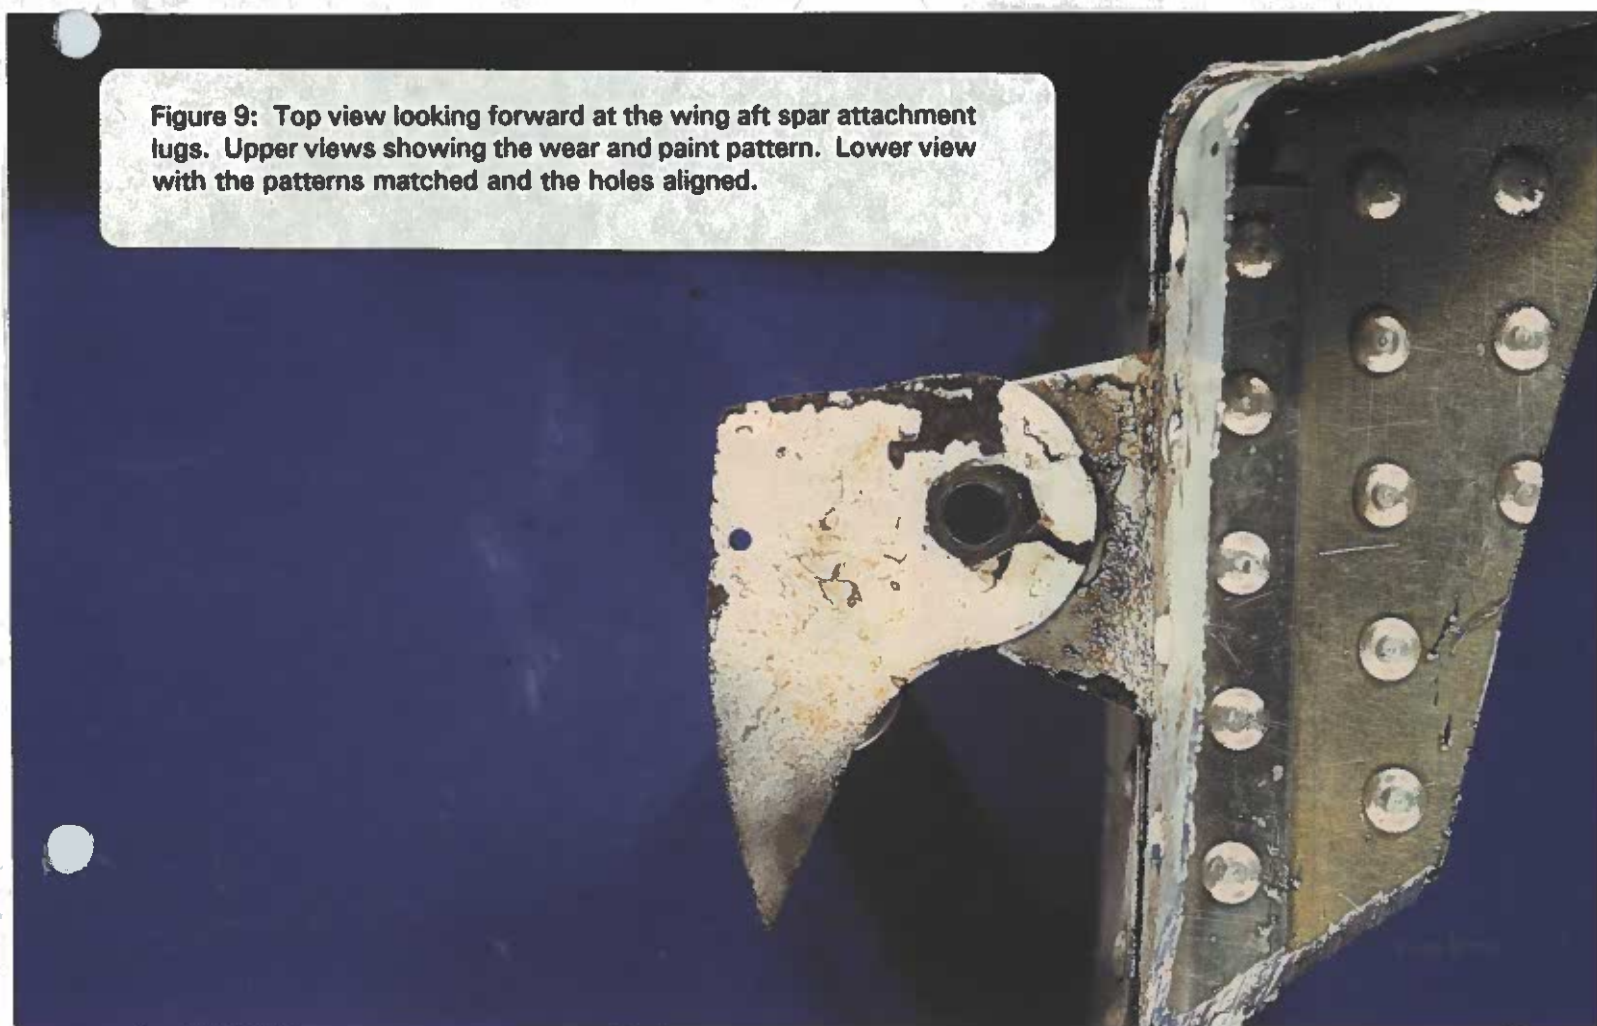
The fuselage and wing lugs of the wing aft attachment fitting were received cut from the aircraft structure. As shown in the upper view of figure 9, the lugs did not appear to be damaged. The Maintenance Manual shows that for this s/n aircraft, the two lugs are connected by an AN5-7A bolt through the holes in each fitting. The investigator was not lugs during assembly. Matching paint and wear patterns on the faying surfaces of each lug, as depicted in the lower view of figure 9, indicated that the lug surfaces had been in direct contact with each other with the bolt holes aligned. Visual inspections also showed that the holes were approximately round showing no appreciable deformation.

Figure 9: Top view looking forward at the wing aft spar attachment lugs. Upper views showing the wear and paint pattern. Lower view with the patterns matched and the holes aligned.
