Submission by the  
New York State Department of Public Service  
to the  
National Transportation Safety Board

Pipeline Accident  
East Harlem, Manhattan, NY

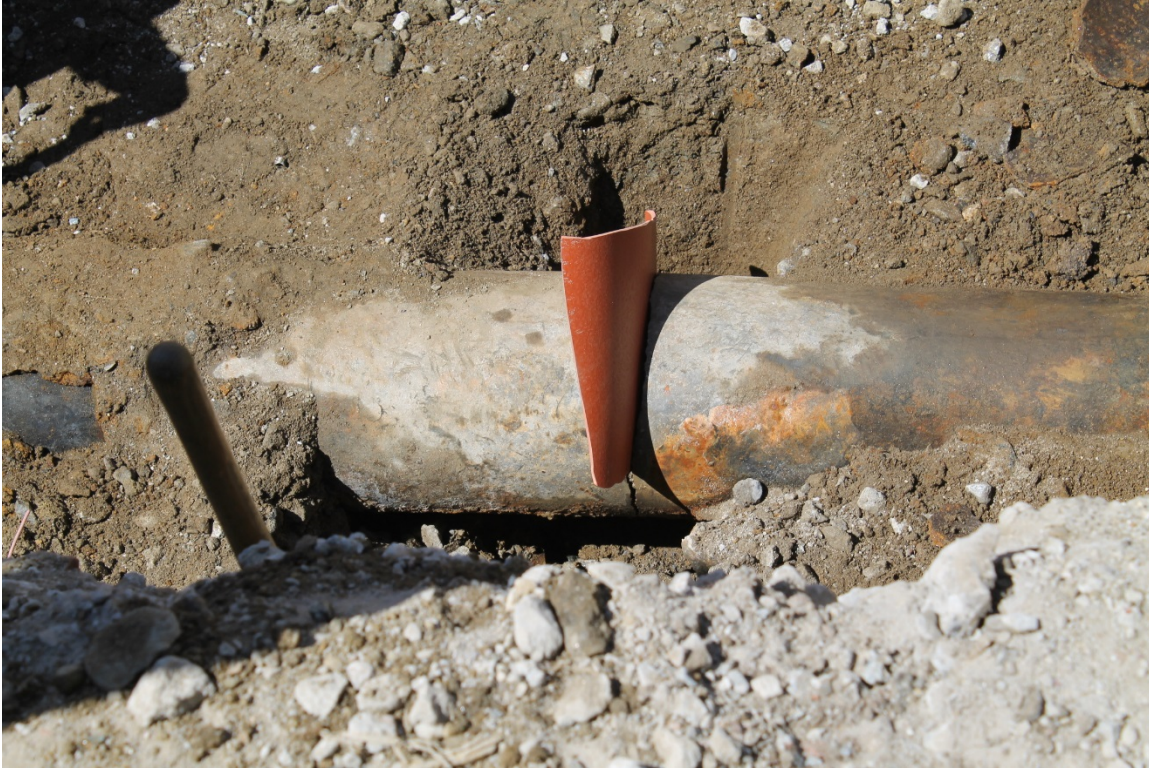
**Figure 1** – Crack in cast iron water pipe and iron oxide deposits down gradient of crack (right)

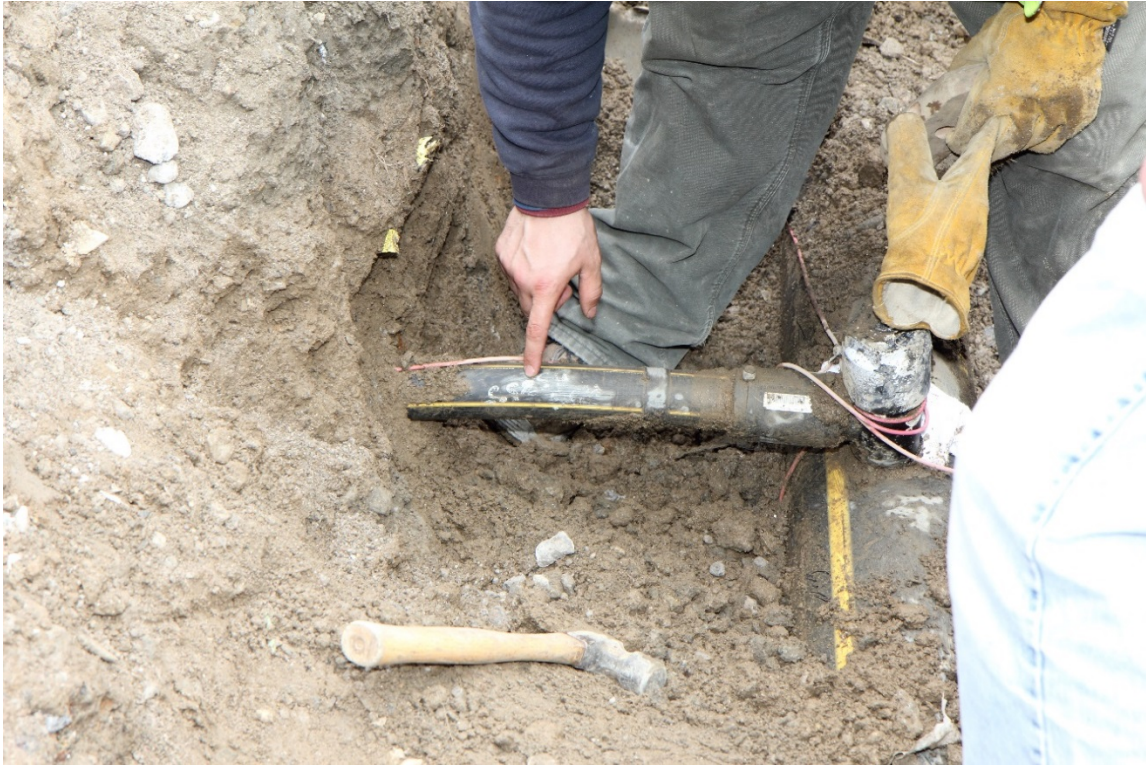
**Figure 2** – Bend in HDPE gas service pipe to 1642 Park Avenue due to sinking main

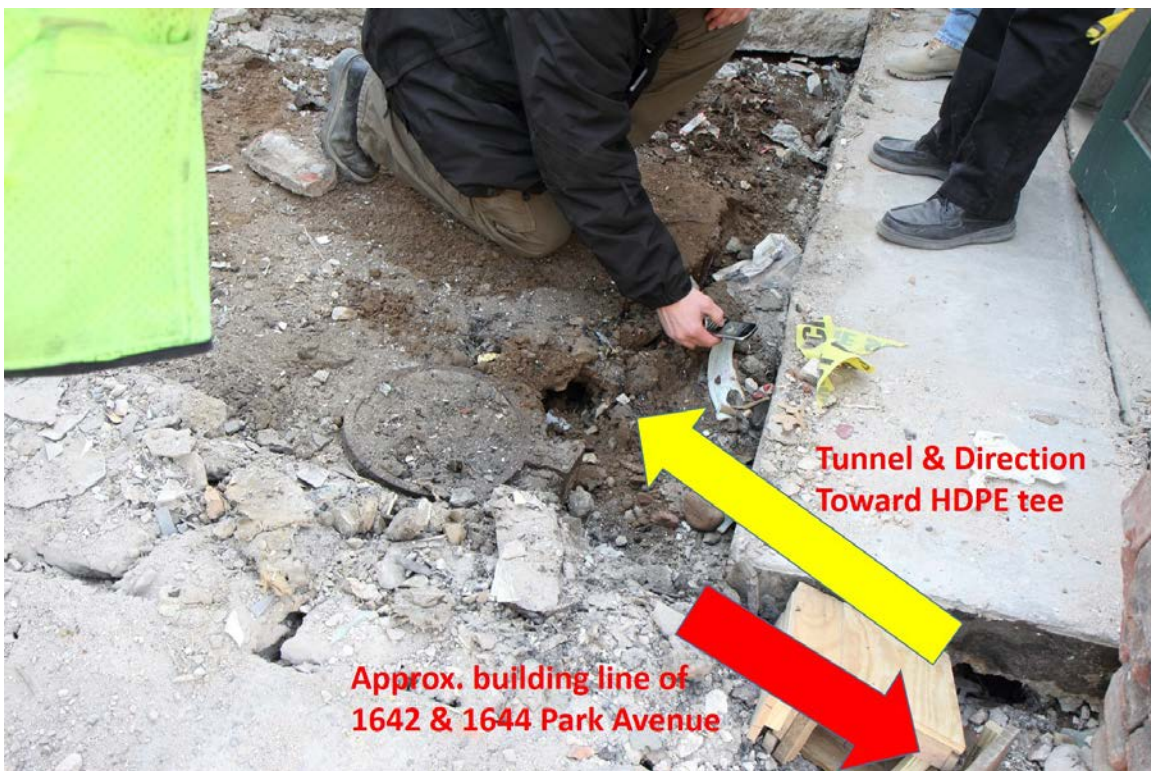
**Figure 3** – Charred concrete and tunnel under sidewalk in front of 1642 Park Avenue

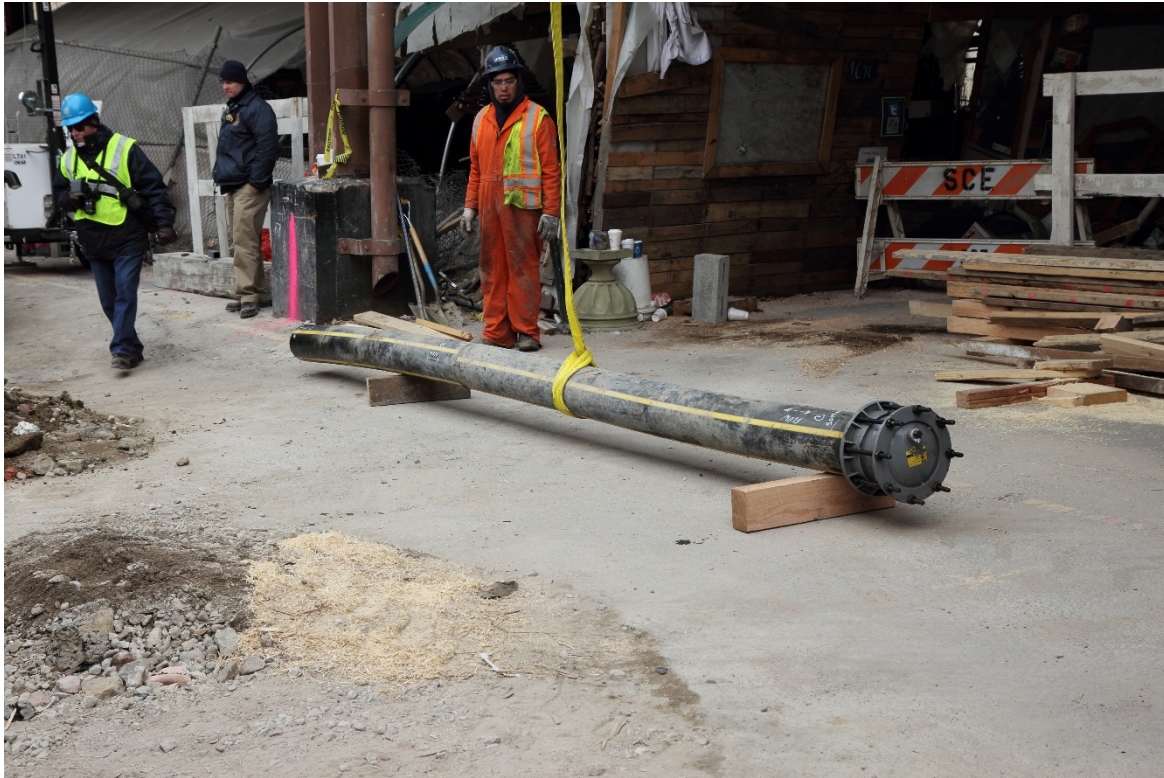
**Figure 4** – Permanent deformation of eight inch HDPE main due to loading from above and lack of support (voids) beneath the pipe

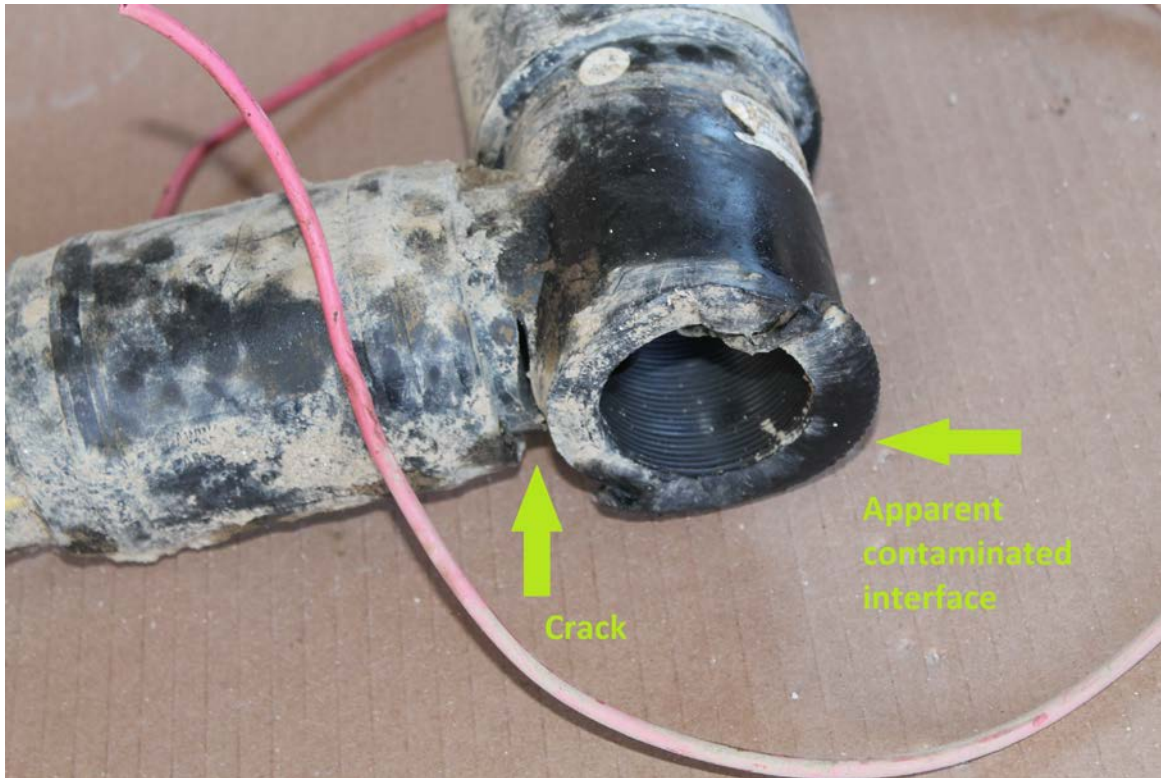
**Figure 5** – Crack in HDPE gas service tee and failed fusion joint
