NATIONAL TRANSPORTATION SAFETY BOARD
Office of Research and Engineering
Washington, D.C. 20594

Video Study

NTSB Case Number:
WPR22FA101

Location: Newport Beach, California
Date: February 19, 2022
Time: 1834 PST
Aircraft: MD 500N helicopter

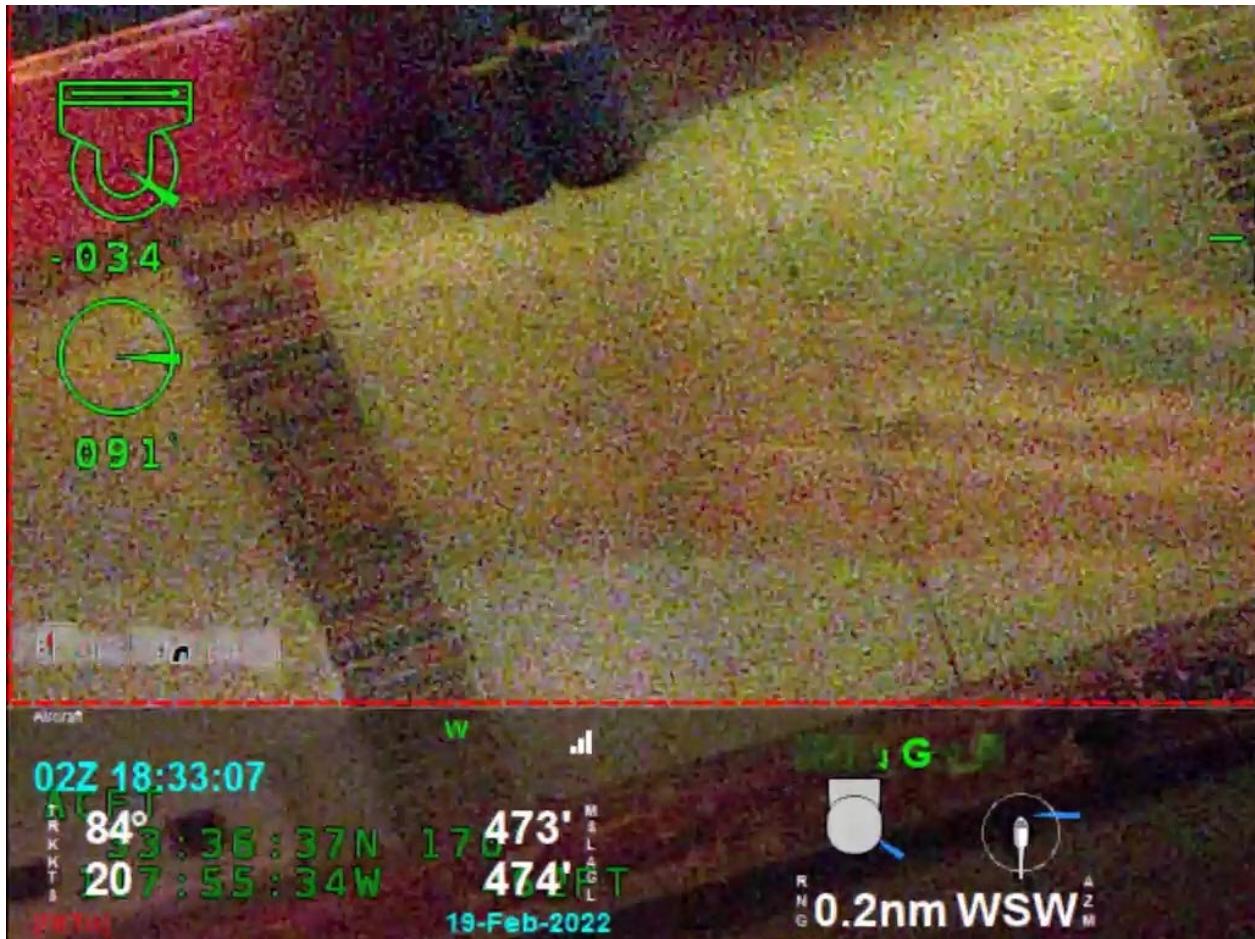
Figure 1. Frame from the Analyzed Video

The green icons in Figure 1 show the orientation of the camera with respect to the helicopter. It shows that the camera turret azimuth angle was 91° and the gimbal elevation angle was -34° . The video frame also displays the time when the image was acquired and the altitude of the helicopter.

Figure 1 shows that the azimuth angle of the camera is 91° with respect to the longitudinal axis of the helicopter. The sidewalk orientation with respect to the bottom of the video frame can be measured in the figure as 16° counterclockwise. A simplistic and incorrect estimate of the helicopter yaw angle with respect to the sidewalk is that it was oriented $91^\circ - 16^\circ = 75^\circ$ counterclockwise from the orientation when the helicopter nose points perpendicularly at the sidewalk. The 91° angle accounts for the yaw angle of the

The yaw angle of the camera with respect to the sidewalk would have been correct if the camera was looking straight down at the sidewalk. However, as can be seen in Figure 1, the elevation angle of the camera was -34° , i.e., the camera was looking at the sidewalk at an angle that was 34° relative to the horizontal plane. This made the width of the sidewalk in Figure 1 appear significantly narrower than what it would have been if the camera was looking straight down at the sidewalk. Consequently, the 16° angle measured in the figure is not the yaw angle between the camera and the sidewalk.

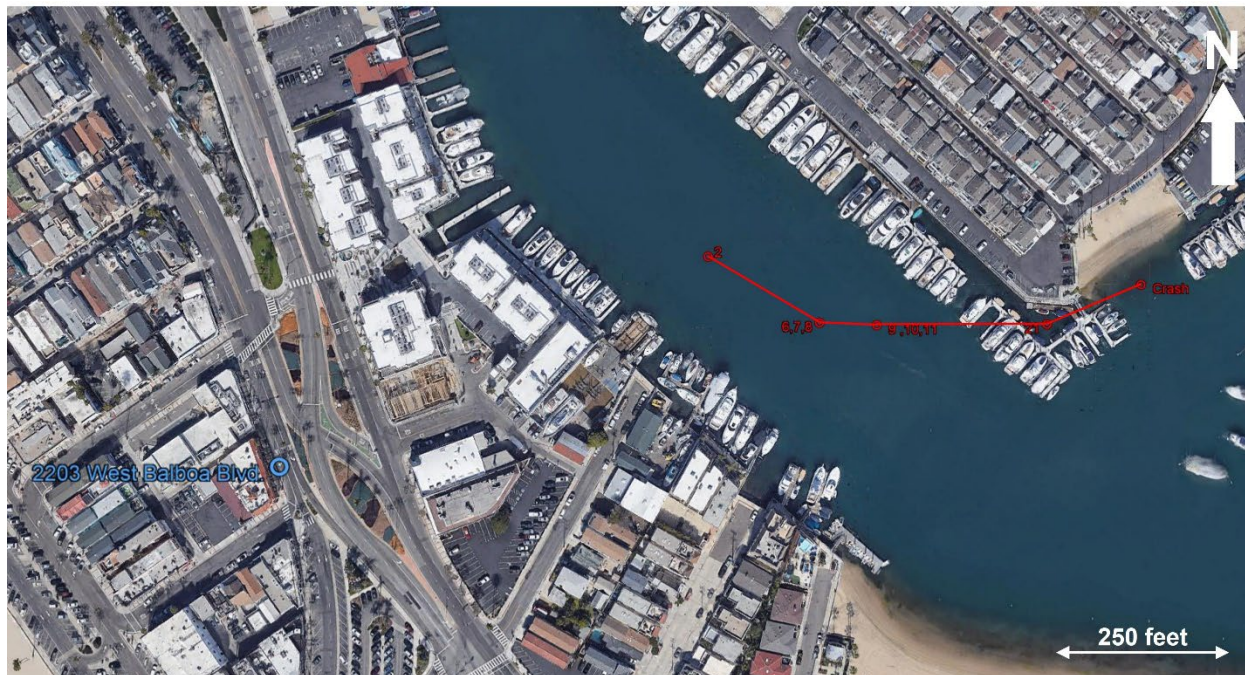
Figure 2. Aerial View of the Accident Area

Five locations are marked in red in Figure 2. The numbers near the red marks are the seconds past 18:33:00. Because of the low location resolution, the helicopter locations recorded on the video between 18:33:06 and 18:33:08 are unchanged and the recorded locations between 18:33:09 and 18:33:11 are unchanged. The helicopter was moving during these periods.

The image in Figure 1 is of the sidewalk at 2203 West Balboa Boulevard in Newport Beach, on the west side of the boulevard. That location is marked on the aerial view in Figure 2. The sidewalk was used as a reference for helicopter yaw angle and yaw rate estimation. When traveling south on West Balboa Boulevard, the heading is 160° , i.e., the direction is 160° clockwise from north.

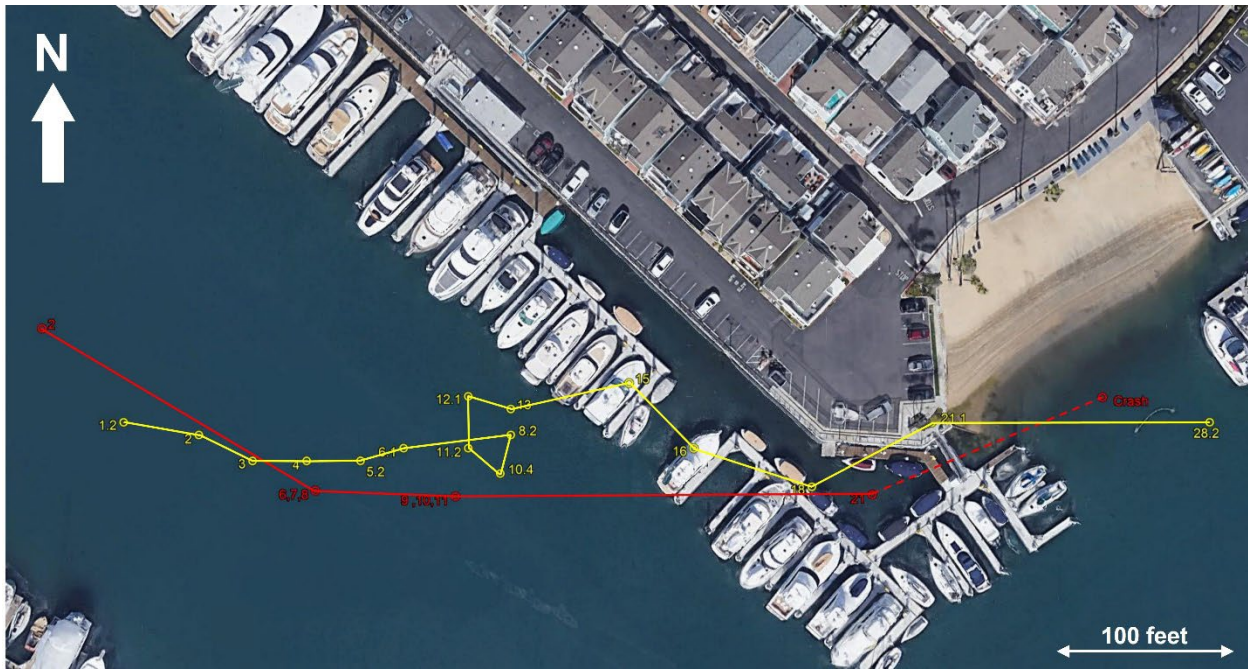
Figure 3. Helicopter Ground Track (red: based on video; yellow: based on ADS-B)

There was an ADS-B record available that had time resolution better than one second. Figure 3 shows in red the helicopter locations from Figure 2, that are based on the video, and in yellow some of the helicopter locations from the ADS-B data. The numbers along both ground tracks are the times expressed as seconds past 18:33:00.

The two ground tracks are based on different data sources and, therefore, the tracks do not coincide exactly. However, locations corresponding to the same times are closer than 150 feet from each other, indicating a good agreement between the two sources of data.

The ADS-B ground track shown in yellow in Figure 3 shows an approximate 360° clockwise circular path between ADS-B time 18:33:8.2 and ADS-B time 18:33:13. The helicopter location stayed within a circle with a 50-foot diameter during this maneuver. It is likely that this maneuver and the sudden increase of the helicopter yaw rate point to the same transition from stable flight to the high yaw rate spin that ended in water impact.

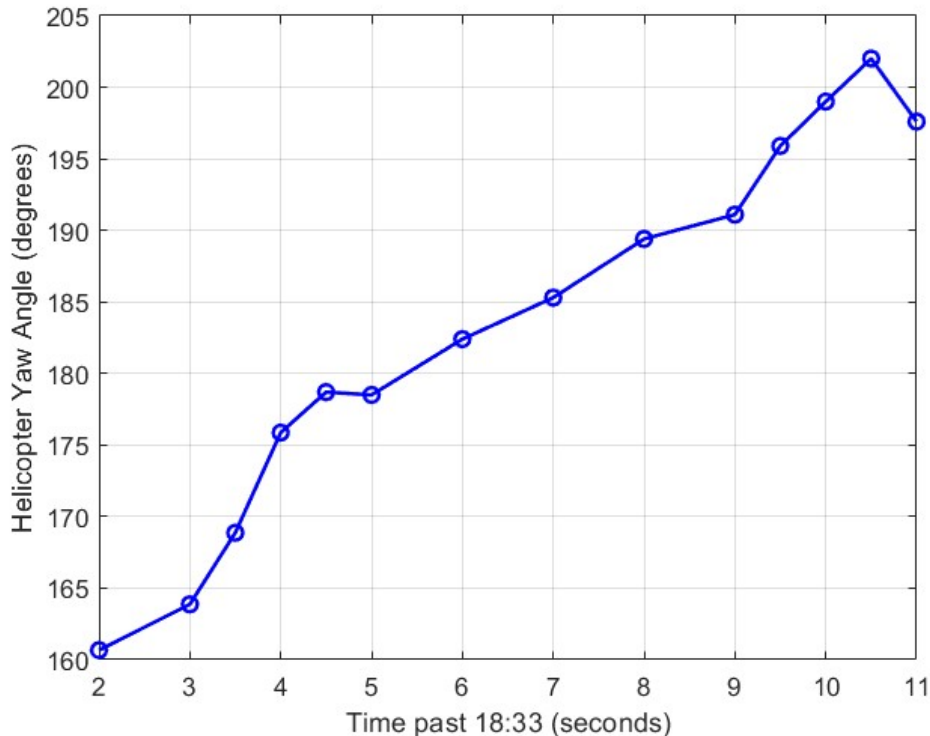
Figure 4. Estimated Helicopter Yaw Angle (clockwise from north)

Figure 4 shows the estimated helicopter yaw angle measured clockwise with respect to north at 14 times between 18:33:02 and 18:33:11. Figure 5 shows the estimated helicopter yaw rate. The yaw rate was computed by dividing the yaw angle difference by the time difference between pairs of adjacent data points. Because the yaw rate was estimated over short time periods, the accuracy of the data points in Figure 5 is ± 2 degrees/second.

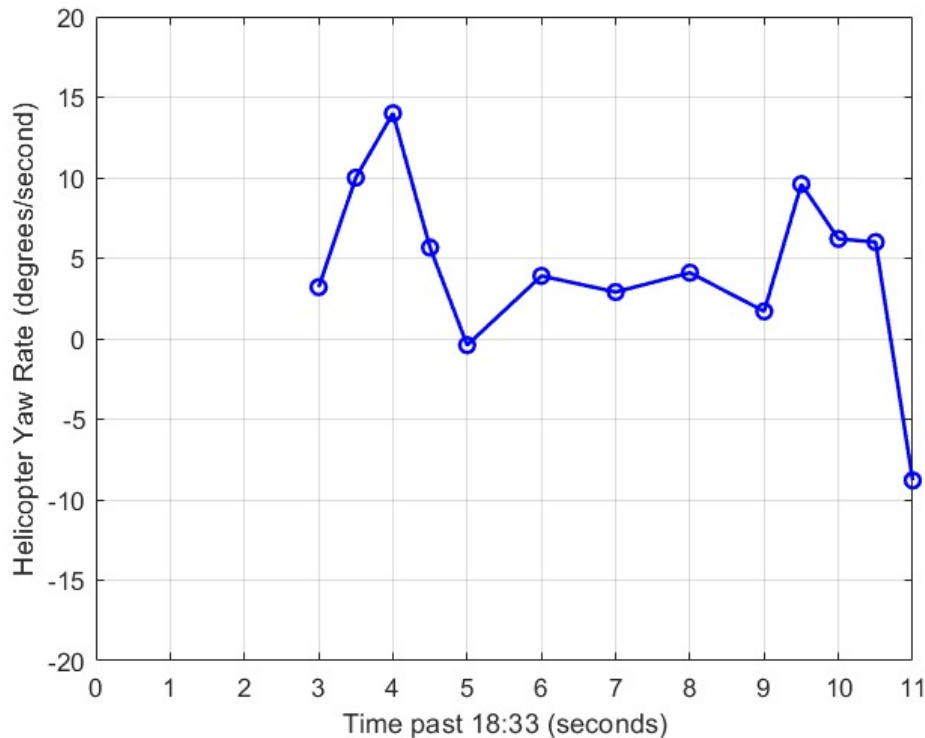
Figure 5. Estimated Helicopter Yaw Rate

The estimated yaw rate of the helicopter shown in Figure 5 can be combined with the estimate of helicopter yaw rate based on the camera yaw angle with respect to the helicopter shown in Figure 6. Figure 5 shows that the estimated helicopter yaw rate between time 18:33:05 and time 18:33:10.5 was in the range between 0° and 10°, indicating a small right yaw. Figure 6 shows that past time 18:33:12 the helicopter was already in a high-rate right yaw indicated by the high negative yaw rate of the camera. At time 18:33:13.5, the helicopter was already yawing at the high rate of above 130 degrees/second that stayed approximately constant until water impact. This indicates that the helicopter transitioned from a stable controlled flight to an unstable right yaw in less than three seconds.

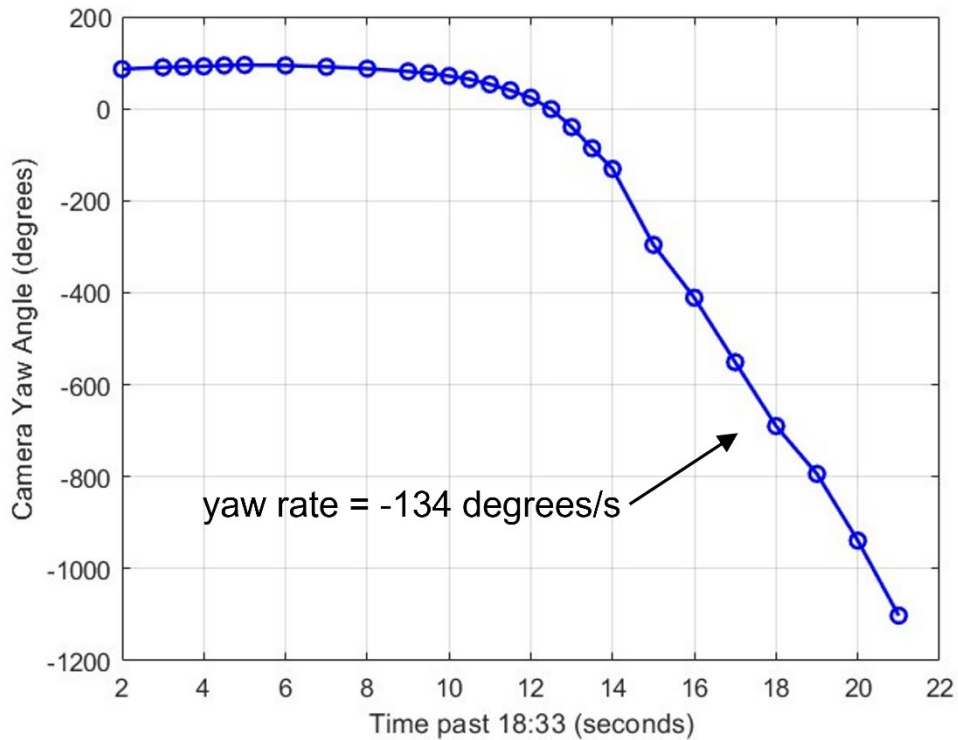
Figure 6. Camera Yaw Angle with Respect to Helicopter

Figure 6 shows the camera yaw angle with respect to the helicopter, as it was read off video frames. Past time 18:33:12, the angle is increasing rapidly. It is assumed that

the camera was rotating counterclockwise as it was attempting to keep pointing at 2203 West Balboa Boulevard while the helicopter was rotating clockwise. Therefore, the estimated yaw rate of the helicopter during the last six seconds of flight was about +134 degrees/second.
