Product Evaluation Report

Vessel Name: *Capt. Kirby Dupuis*

Engine Model: *3512*

Serial #: *TTF00289*

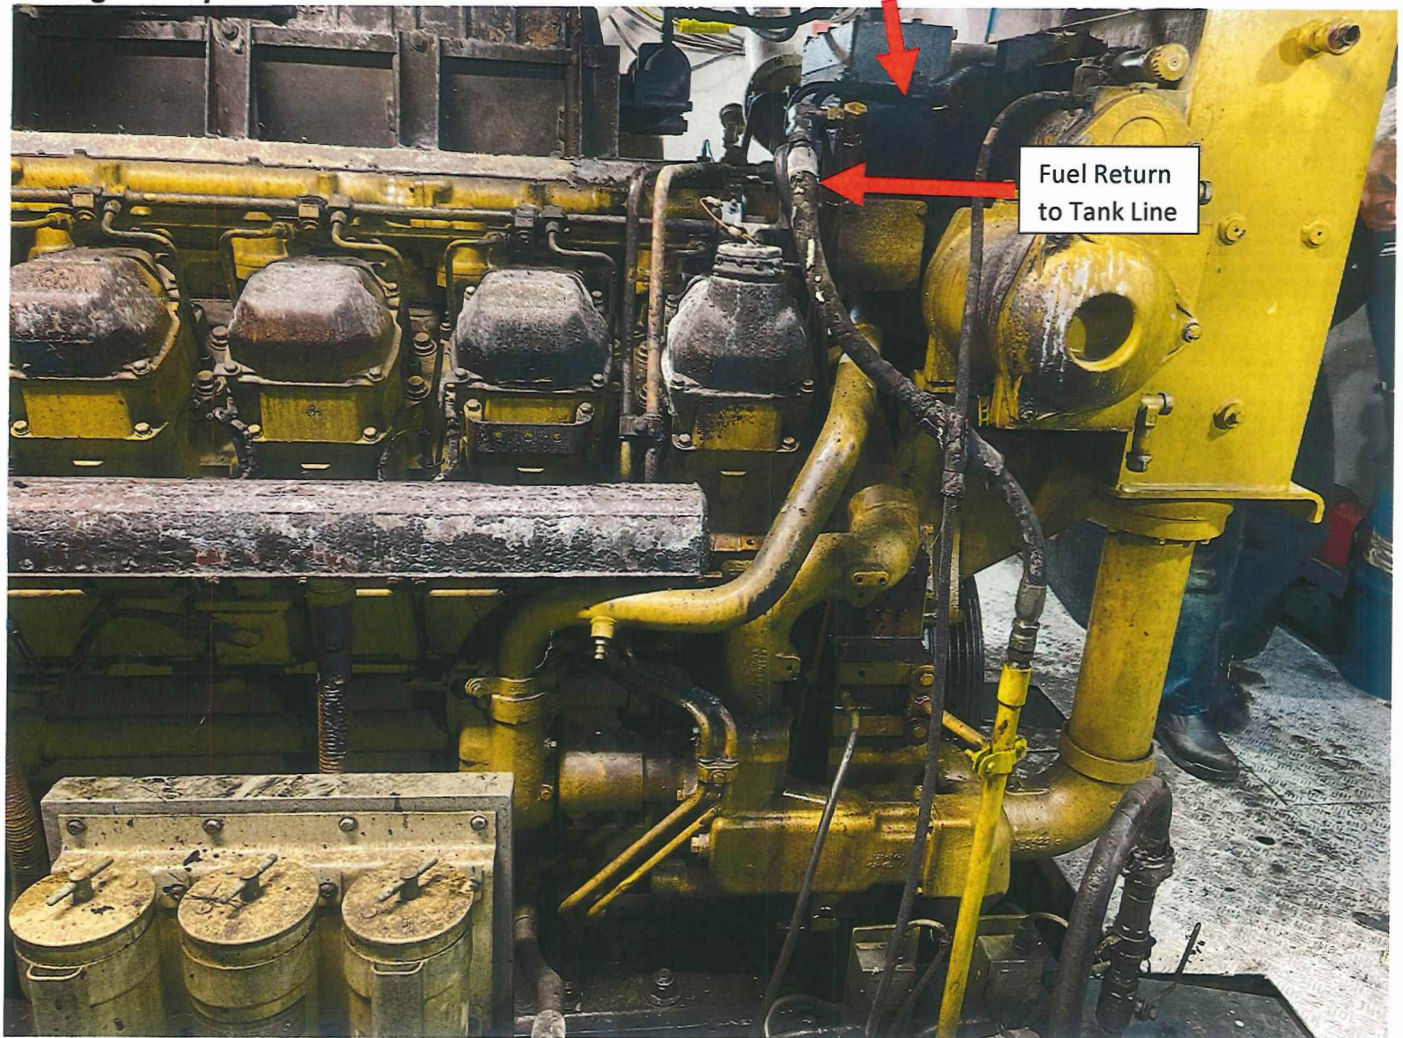
Picture below is the port main engine (TTF00289). Notice (top, red arrow) black and dark coloration of engine parts at the rear, center of the oil filter housing and water temperature regulator housing area. The valve covers and aftercooler also have evidence that the paint has been discolored or burned. The fuel return hose is still intact and tight with no evidence of leakage or rupture.

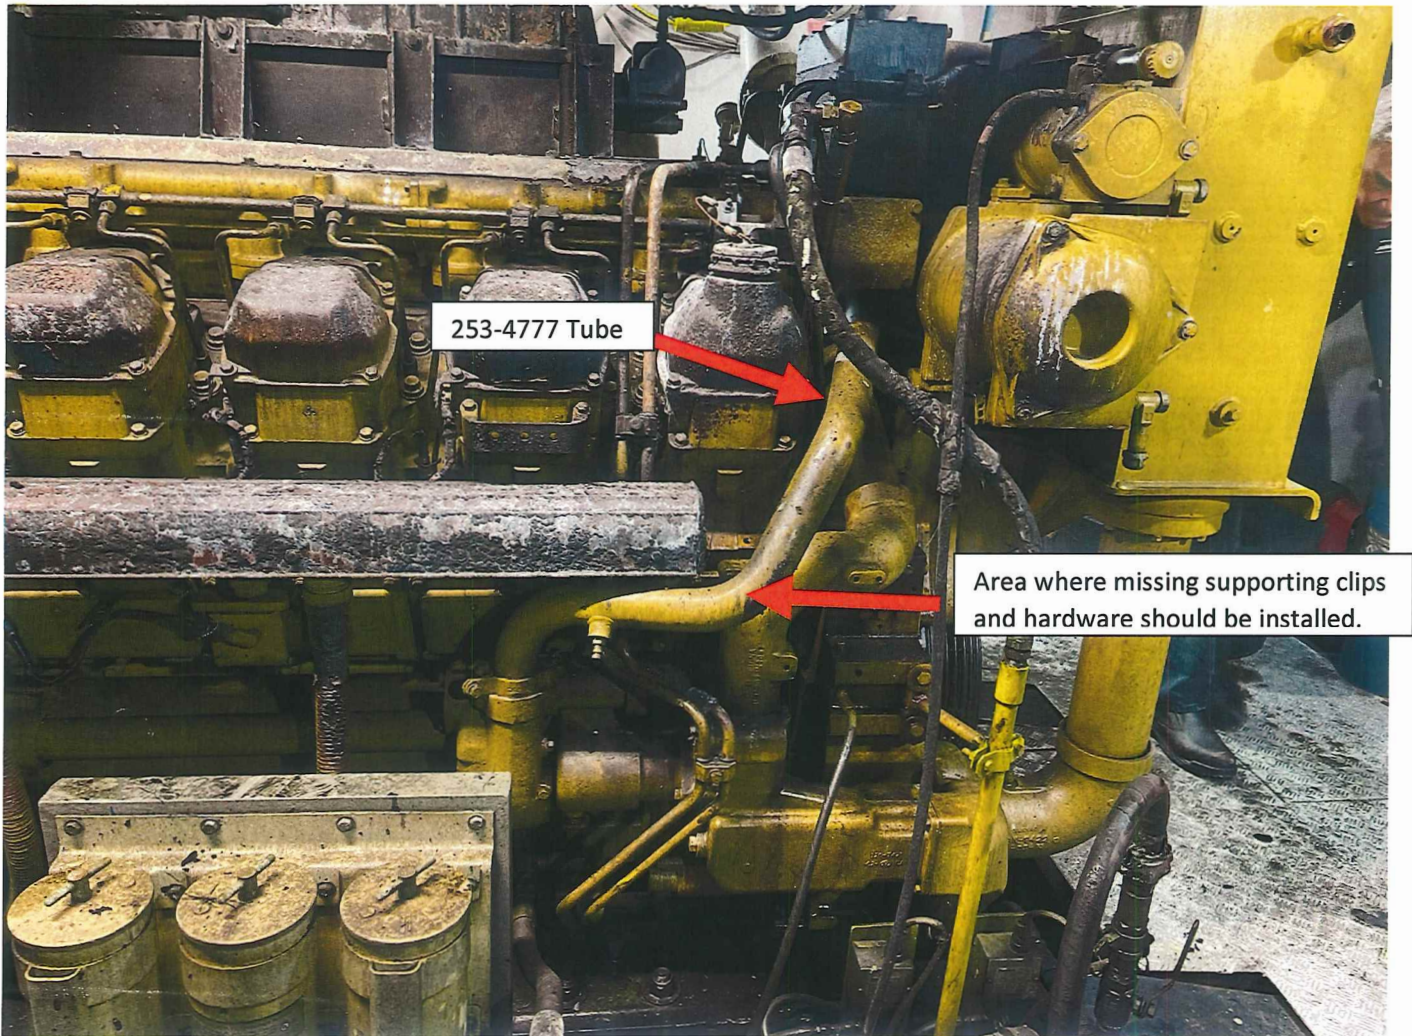
During visual inspection of the engine, it was noticed that there was a piece of a seal-o-ring on top of the front cover. We determined that we should remove the 253-4777 Tube. The lower section of this tube is connected to the oil cooler and the upper part of the tube connects to the rear of the oil filter housing. It was noticed that some of the supporting clips and mounting hardware for the 253-4777 tube was missing from the engine. We also discovered that the 8N1991 retaining ring that should be installed in the upper joint area where this tube connects to the oil filter housing was missing from the joint.

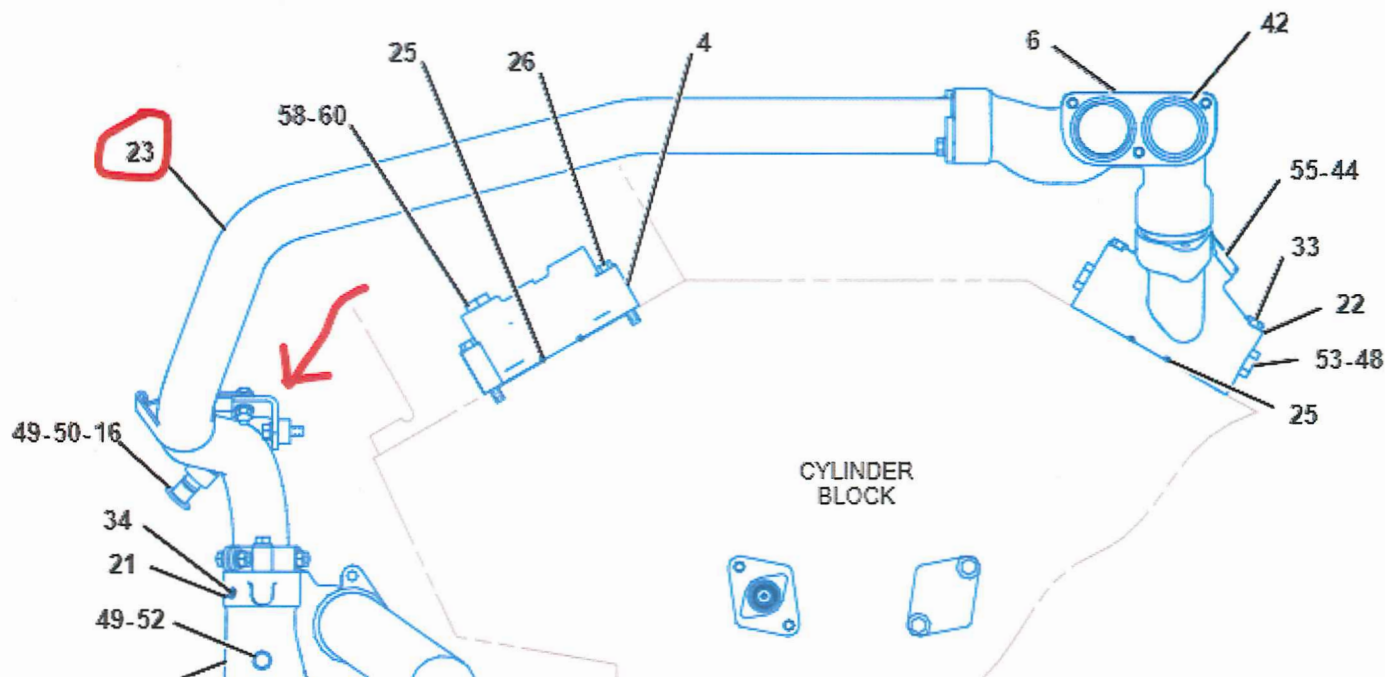
Below is a diagram of the parts breakdown of the 242-6277 oil lines group. #23 is the 253-4777 Tube. The red arrow points to the supporting clips and hardware that were not on the tube when we inspected the engine.

The 253-2477 tube was not properly secured to the engine because of the missing 8N1991 retaining ring at the upper joint along with some supporting clips and hardware which should have been installed around the midsection of the pipe. The bolt hole that is used to hold the pipe supporting clips on the side of the engine, has a broken bolt in it.

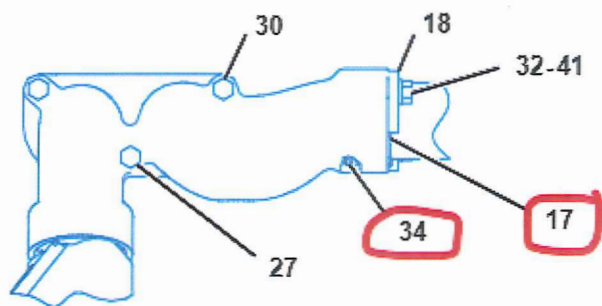
Below is a view of the upper joint area where the 253-4777 tube attaches to the rear of the oil filter housing. During removal of the tube, it was discovered that the #17-8N1991 retaining ring was not present in the joint. #34 is the 109-3232 seal-o-ring in it's proper location when the tube is installed into the 4W4313 adapter.

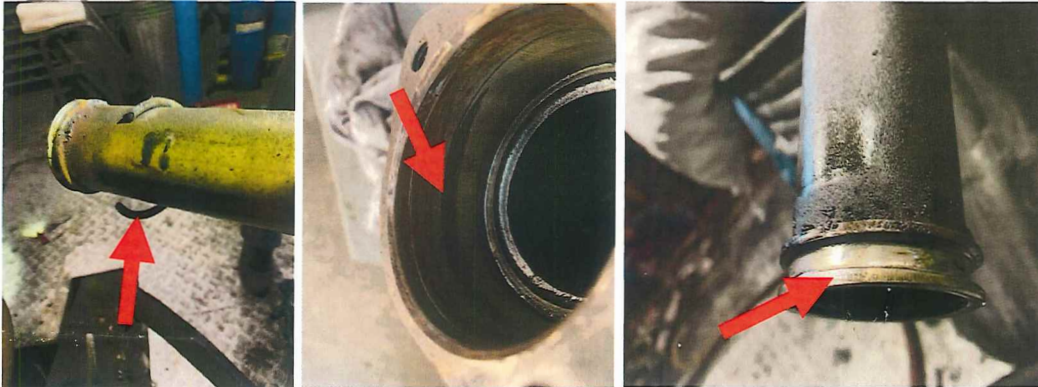
Below, left. Once the tube was removed, it was discovered that the 109-2332 seal-o-ring was cut. Center picture is the 4W4313 adapter. The adapter is bolted to the rear of the oil filter housing. When properly assembled, the 253-4777 tube with the 109-2332 seal-o-ring is installed into the adapter. Once the tube and seal are properly installed in the adapter, a 8N1991 retaining ring plus clips and hardware are needed to properly seat the pipe all the way into the adapter. Before disassembly, we could see that the 8N1991 retaining ring was not present. Center picture shows wear on the interior of the adapter. Right, shows wear to the seal-o-ring groove lip of the 253-4777 pipe.

It is undetermined as to how the seal was cut into 2 pieces. Normally, when we see a seal cut in this manner, it is cut during installation of the pipe. If cut during installation, a major oil leak would appear shortly after any repair. The wear seen on the pipe and the adapter along with the missing retainer ring and supporting clips and hardware, could all have been contributing factors to the failure of the seal-o-ring.

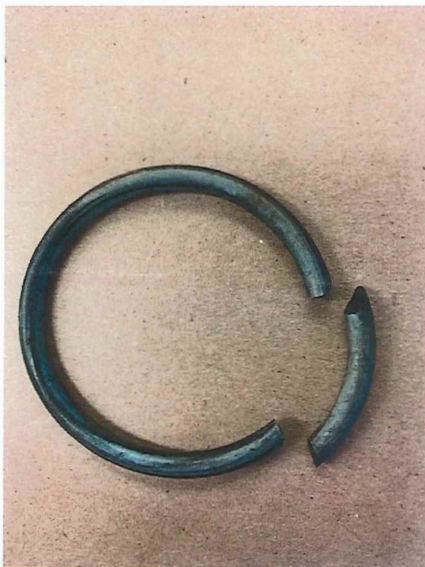
Below are both pieces of the 109-2332 seal-o-ring. The smaller piece was found on top of the front cover. The front cover is directly below the upper joint area where the tube is attached to the oil filter housing. The seal-o-ring doesn't show any flat area's that would indicate that this seal has a high amount of running hours on it.

Road signs leads us to believe that the oil leak seems to have been coming from the seal joint area where the 253-4777 pipe-4W4313 adapter joint is located at the rear of the oil filter housing. Once we removed the tube, we discovered the 109-2332 seal-o-ring was found to be in 2 pieces. The damaged 109-2332 seal-o-ring is the cause of the oil leak and subsequent fire. The damaged seal-o-ring allowed oil to leak from the joint.

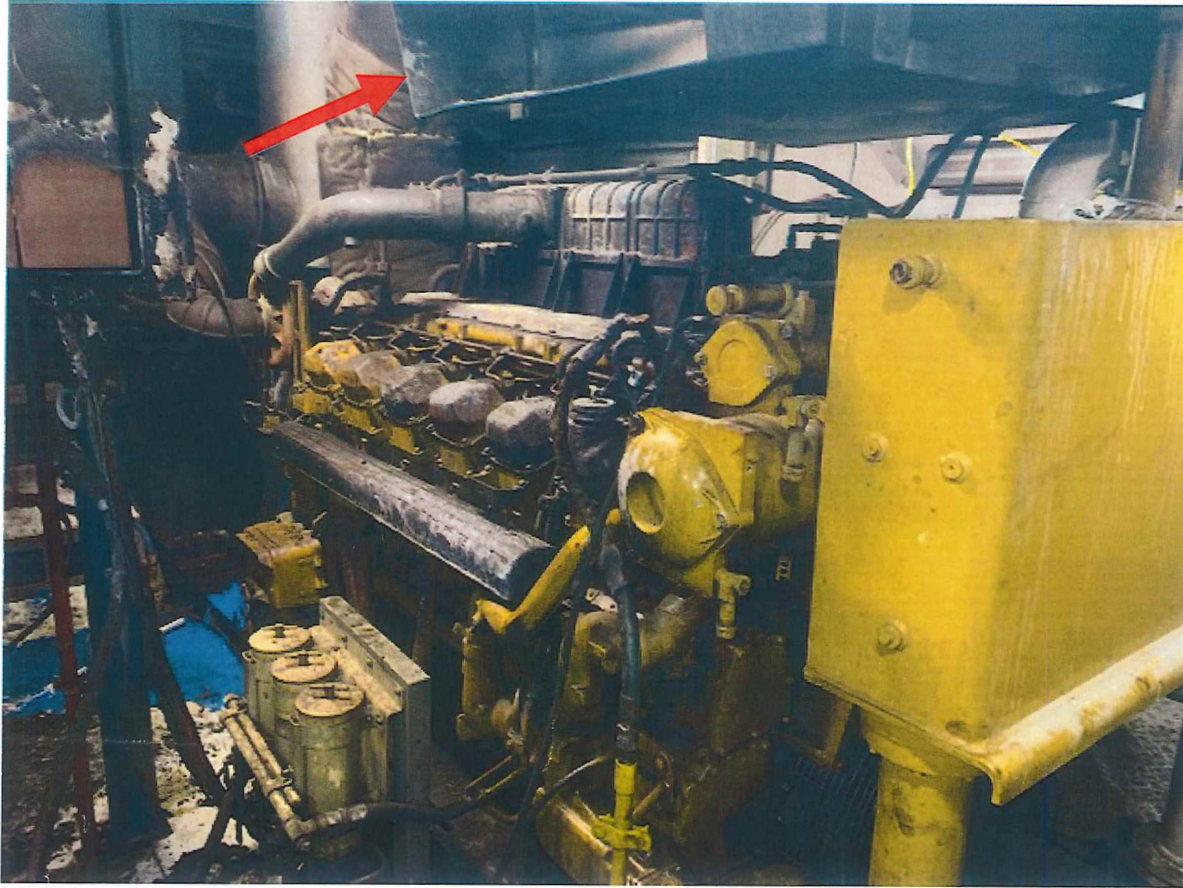
There is a large ventilation duct just above the area of the fire. The ventilation air duct, directs the incoming ventilation air onto the port engine and also across the engine room (Right to left in picture) from the port to the stbd. engine.

The cause of the engine room fire on the Capt. Kirby Dupuis was a severe oil leak. As the oil began to leak, oil sprayed or dripped onto the exhaust manifold near the #1 cylinder. Once the oil got on the exhaust manifold, the oil ignited, causing the fire. Ventilating air from the air duct above the engine supplied the fire with oxygen and blew the fire across the engine room damaging the stbd. main engine.
