National Transportation Safety Board

Response to Petition for Reconsideration

April 17, 2023

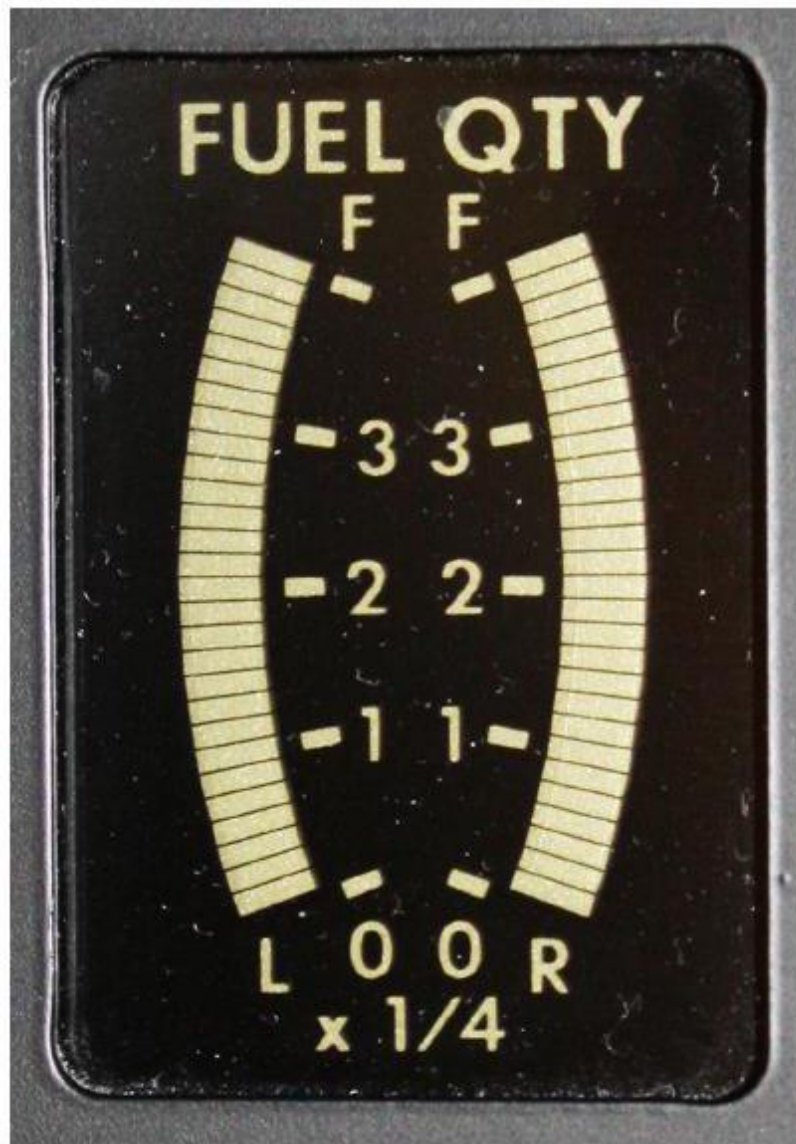
Further, the investigation found that, as fuel boost pumps cycled, a left-wing-heavy fuel imbalance developed. Fuel quantity for the left and right tanks is indicated in the cockpit by a liquid crystal display (LCD) that shows each tank's capacity in 28 segments (or bars), each of which represents about 7.17 gallons or 48.3 lbs of fuel, representing a total of about 201 gallons or 1,352 lbs of usable fuel per tank (NTSB 2011a, 12-13) (see figure 1).

Figure 1. Fuel quantity indicator (NTSB 2011a, 13).

The AFM contained a limitation specifying that the maximum fuel imbalance for the airplane was 26.4 gallons (178 lbs), which would be indicated by three LCD segments. The AFM provided an emergency procedure stating that, in the event fuel balance within the limitation cannot be maintained, the pilot should land the airplane as soon as practical. The investigation determined that the accident pilot likely recognized the fuel imbalance sometime between about 1 hour 21 minutes and 1 hour 32 minutes into the flight but did not divert to land the airplane as soon as practical after his attempt to correct it was unsuccessful. The pilot instead continued the flight (as the fuel imbalance continued to worsen) past numerous suitable

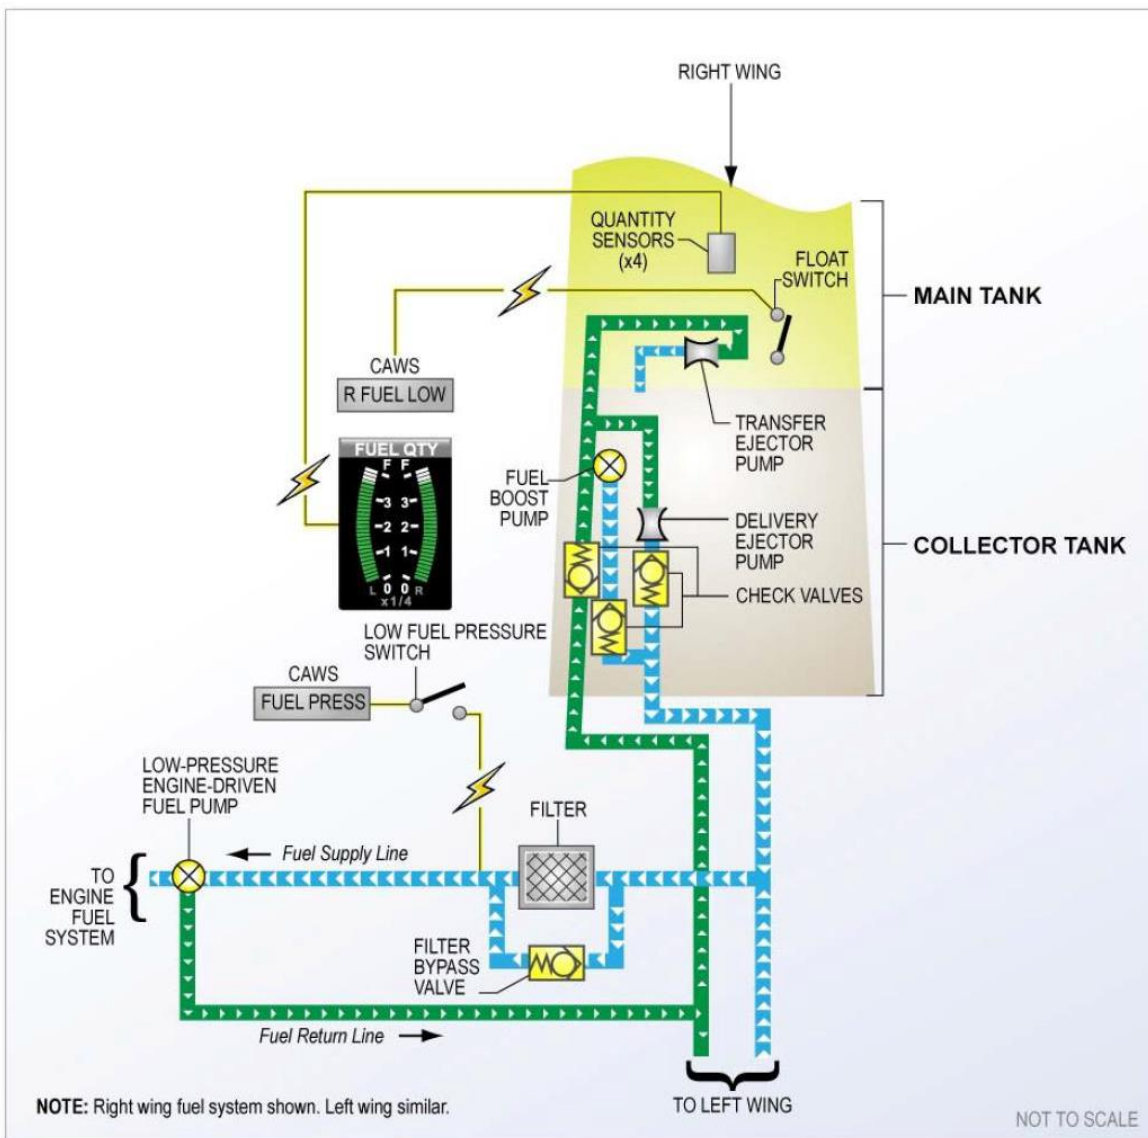
As described in the AFM for the accident airplane (and the NTSB’s report), during normal operations, fuel is transferred from the fuel tanks to the engine by a motive flow jet pump system that includes a low-pressure engine-driven fuel pump. The motive flow of fuel generated by the low-pressure, engine-driven fuel pump powers both the transfer ejector pumps (which transfer fuel from the aft portion of each main tank to its respective collector tank) and the delivery ejector pumps (which transfer fuel from each collector tank to a common manifold) (NTSB 2011a, 11-12; NTSB 2011d, 7) (see figure 3).

Figure 3. Pilatus PC-12 fuel system (NTSB 2017a, 11).

During abnormal flight operations, such as when a low fuel pressure condition is sensed, the fuel boost pumps provide redundancy by activating automatically to restore adequate fuel pressure to supply the engine with fuel; after fuel system pressure is restored, the fuel boost pumps run for another 10 seconds before turning off (NTSB 2011a, 12).

Thus, based on the fuel system design, it was not possible that a mechanical failure of the left fuel boost pump could have created the low fuel pressure condition sensed during the accident flight, as claimed in proposed new finding 3.

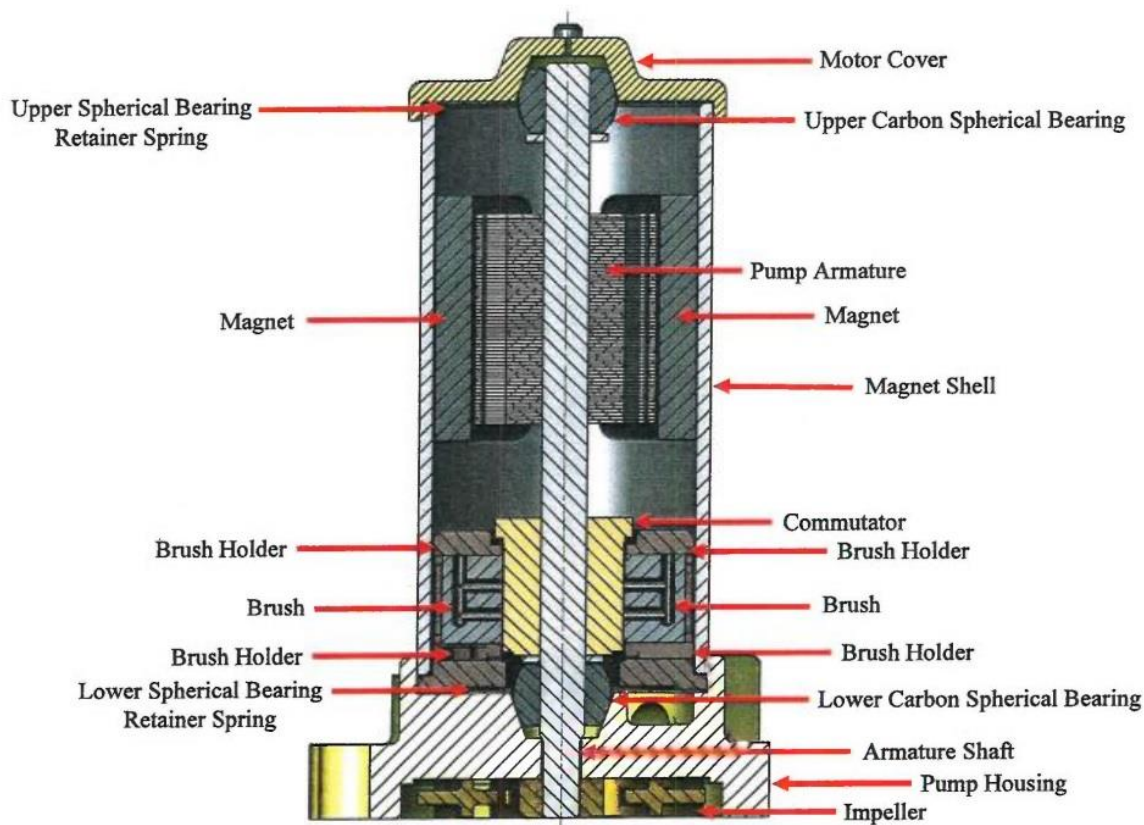
As part of our review of the petition’s claims, we have considered the analysis of the factual evidence provided by the petitioners’ experts, as well as the analysis provided by Pilatus and Crane Company (the manufacturer of the fuel boost pumps). The petition included a labeled diagram of the left fuel boost pump components (see figure 4).

Figure 4. Fuel boost pump components (Fraenkel et al. 2017c, Attachment 1).

We note that the NTSB's factual evidence from the recovered left fuel boost pump components revealed evidence that the impeller from the left fuel boost pump was rotating at the time of impact, consistent with pump operation (Pilatus 2017b, 3-4). Further, we note that the nonrotational contact damage and stationary impact marks on the pump housing described by the petition are secondary witness marks (which occurred as the armature shaft was ejected from the pump housing during the impact sequence) and that these marks lie on top of rotational smearing marks in the shaft bore (Pilatus 2017b, 4-5). The petition's examination of the left fuel boost pump commutator included the use of a coordinate measuring machine to obtain data to "reconstruct" the total indicated runout (TIR) of the commutator, which is the dimensional characterization of deviation from roundness of a rotating component when measured against a reference axis or datum. The evaluation determined that the derived commutator TIR was four times the limit specified for the pump and claims that the value "correlates directly with the runout measurement when the part left the factory" (Fraenkel et al. 2017a, 25).

We note that the actual TIR of the commutator recovered from the wreckage could not be measured directly due to the bent armature shaft (Crane 2017, 2). Also, the accident airplane's fuel boost pump was manufactured in 2001, sustained severe impact damage during the accident, and was stored for more than 3 years postaccident within bags of wreckage debris before the examination. Further, although the evaluation technique to "reconstruct" the TIR included the removal of data that corresponded with impact-affected surface areas, we find it unlikely that the results are reflective of the as-manufactured condition of the commutator. We note that large areas of data were subtracted during the evaluation process, with the "reconstructed" TIR value having been derived by subtracting the measurement for the lowest valley or dent in the commutator from the measurement of the highest peak (Crane 2017, 8).
