NATIONAL TRANSPORTATION SAFETY BOARD

ON SCENE OBSERVATIONS

WPR19FA123

Location: Kailua, Hawaii
Date: April 29, 2019
Aircraft: Robinson R44, Registration N808NV, Serial #0926
NTSB IIC: Samantha Link

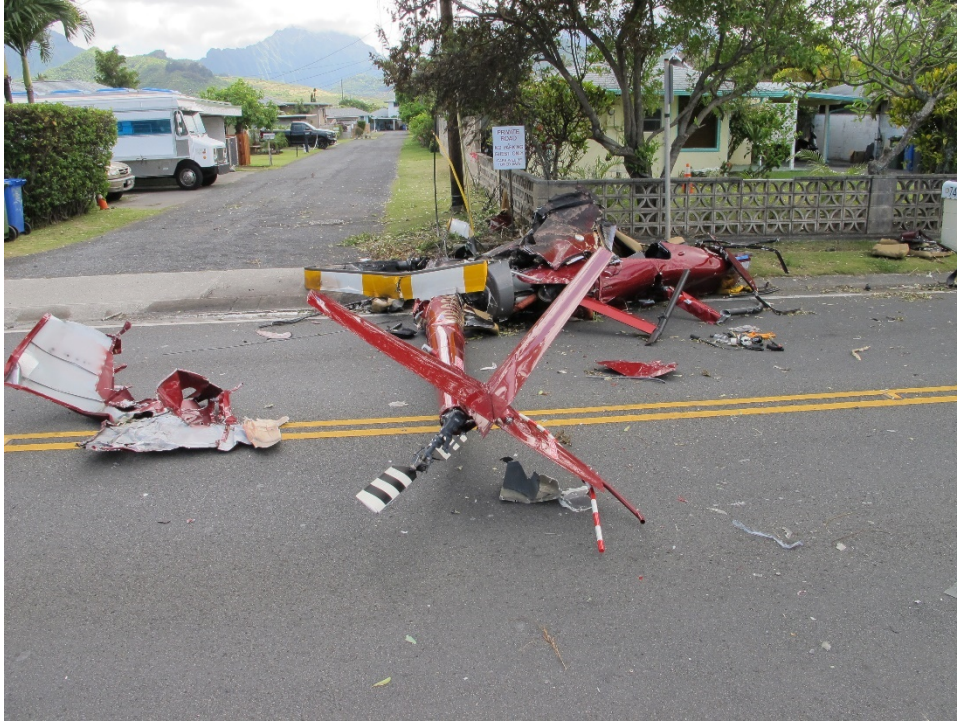
Figure 1: Overview

The wreckage came to rest in the residential town of Kailua, Hawaii. The debris field was about ¼ mile long and extended along a northerly heading. The first identified pieces of debris were a piece of plexiglass and carpet. Directly northeast, and slightly out of the main debris path, was

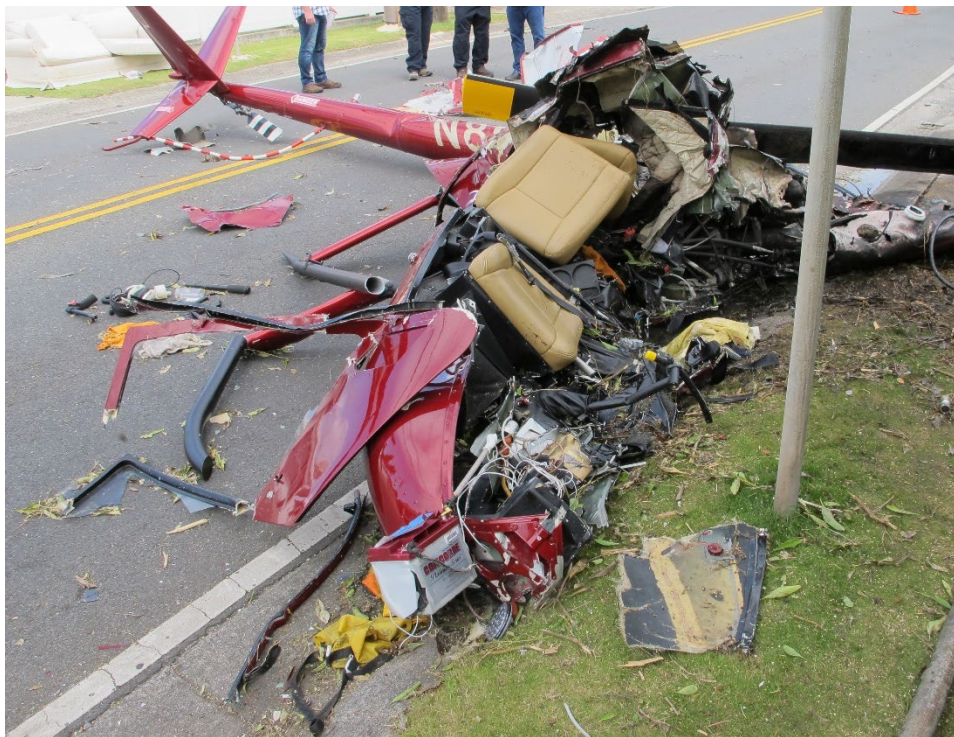
Figure 2: Cabin Area

The helicopter came to rest on its left side on the edge of a roadway. The cabin area was heavily fragmented and exhibited overall left side crushing throughout. A portion of the forward left side fuselage was not present at the main wreckage. The aft cabin, main rotor driveshaft and assembly, and engine exhibited post impact fire related damage. The main rotor blades remained attached to the main rotor hub and exhibited extensive damage. One main rotor blade was bent 90 degrees about midspan. The other main rotor blade was bent near the hub and about 1/3rd of the outboard tip was fracture separated and not present at the main wreckage.

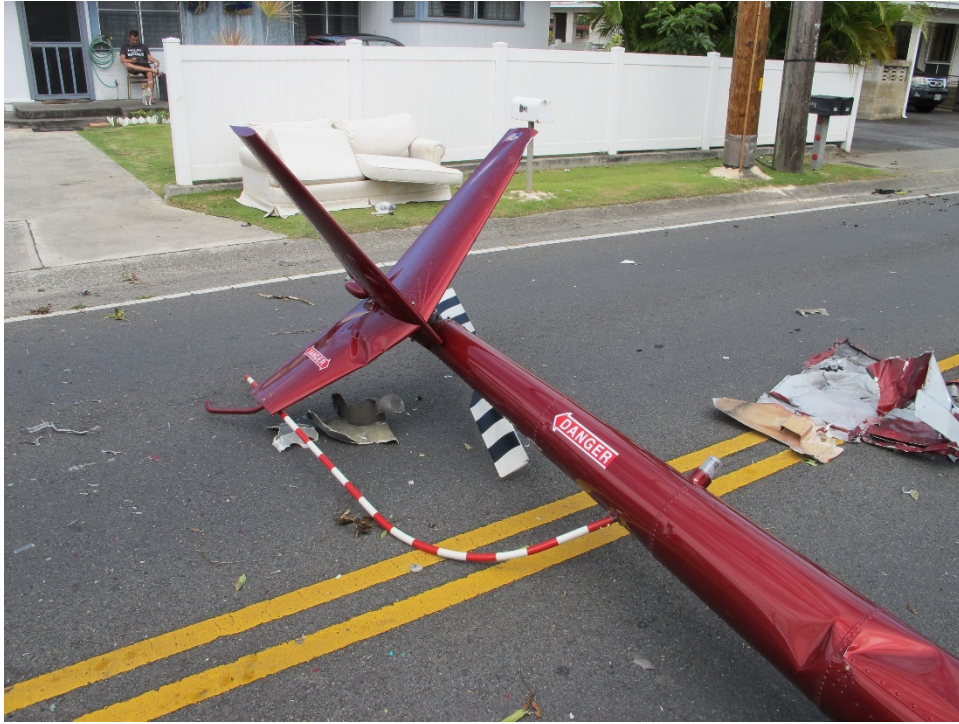
Figure 3: Tail section

The tailcone remained attached to the fuselage and came to rest at about a 90-degree angle from the fuselage. The forward portion of the tailcone exhibited areas of crush damage. The horizontal and vertical stabilizers were mostly intact and exhibited some crush damage. The tail skid tube was not damaged. The tail rotor assembly remained attached to the airframe and was relatively undamaged; the tail rotor blades exhibited limited impact related damage.

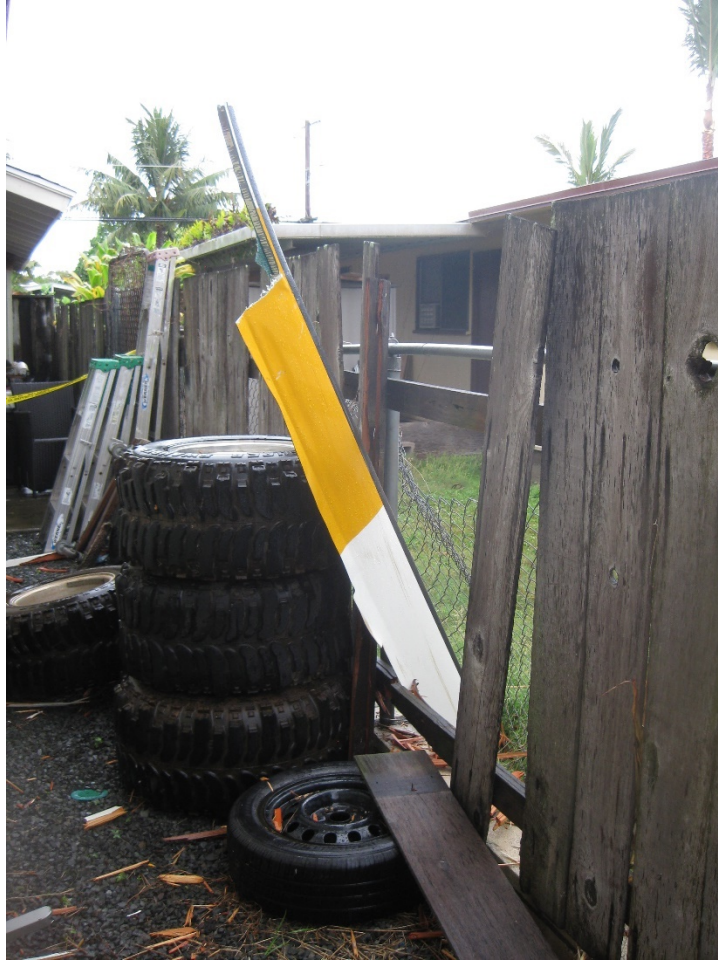
Figure 11: Portion of Main Rotor Blade

the outboard about 1/3rd of a main rotor blade, which came to rest in a residential fence. Following the first identified pieces of debris was a large area of scattered airframe and cockpit components. These items consisted of tinted and regular plexiglass, a battery cover, a small main rotor blade fragment, the forward left door post, a fragment of instrument console, left door hinge, altimeter pieces, and fire extinguisher. Continuing north from this large area were other items from the cabin area extending towards the main wreckage. These items included plexiglass fragments, the mixture control guard, a headset speaker, and ended with the main fuel tank. About 70 yards north of the fuel tank was the main wreckage, which was the end of the debris path. (See docket for Google Earth maps of the debris field).
