## **NATIONAL TRANSPORTATION SAFETY BOARD**

# **ON SCENE OBSERVATIONS**

**CEN21FA150**

Location: Berwyn, NE  
Date: March 6, 2021  
Aircraft: Aviat A-1B, Registration N166WW, Serial #2372  
NTSB IIC: Samantha Link

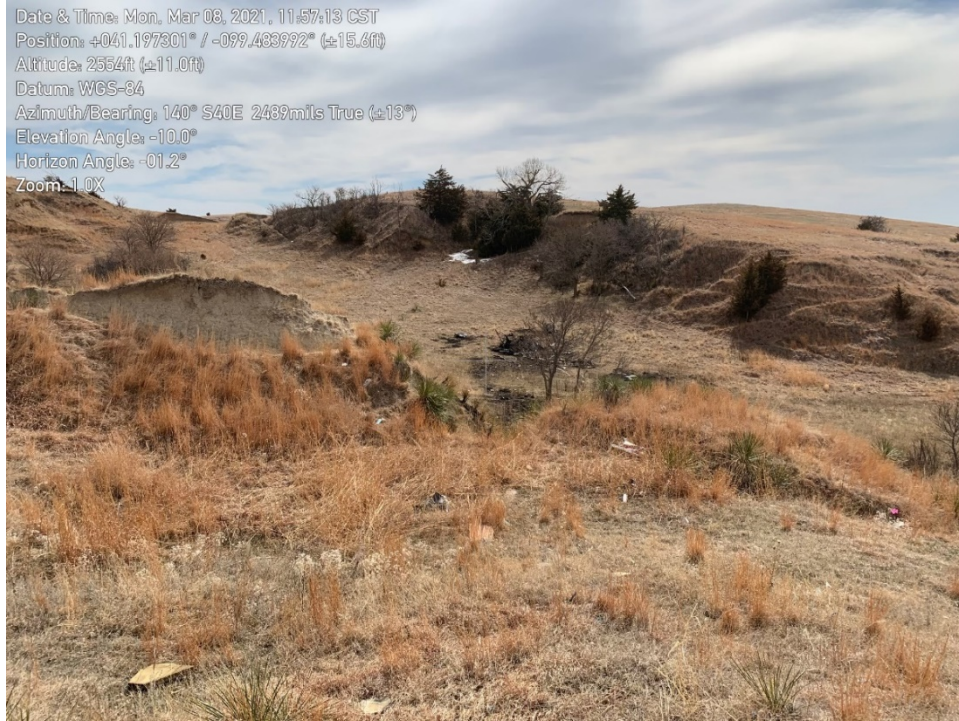
The airplane impacted a field perpendicular to a gully in a very rural area; the debris field was about 300 feet long. The first identified point of impact was a long narrow area of disturbed dirt, with the right wingtip nearby. Followed by two slash marks consistent with propeller blade slices, then a large area of disturbed dirt with propeller blade fragments. The main wreckage came to rest at the bottom of a gully, and the last piece of debris was the engine.

Figure 1: Overview of Accident Site

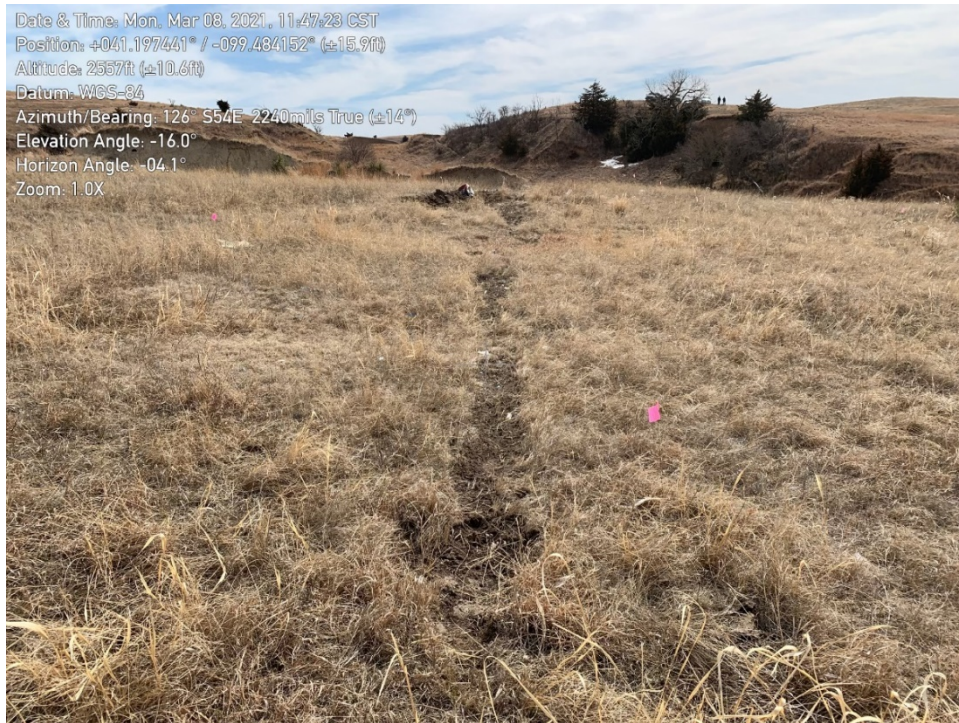
Figure 2: First Identified Point of Contact

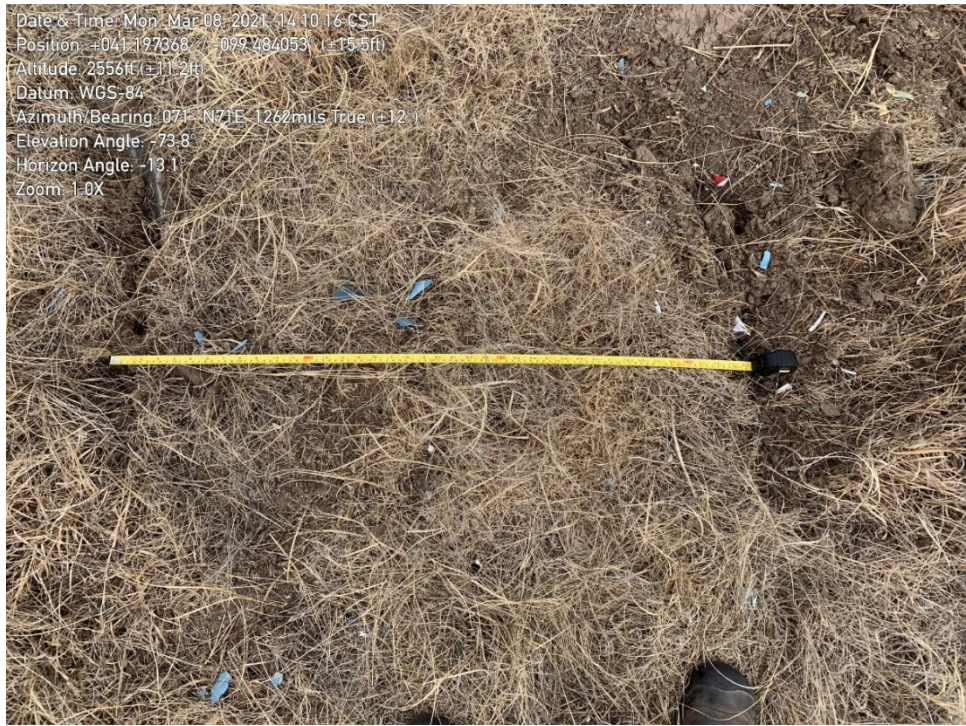
Figure 3: Propeller Strikes

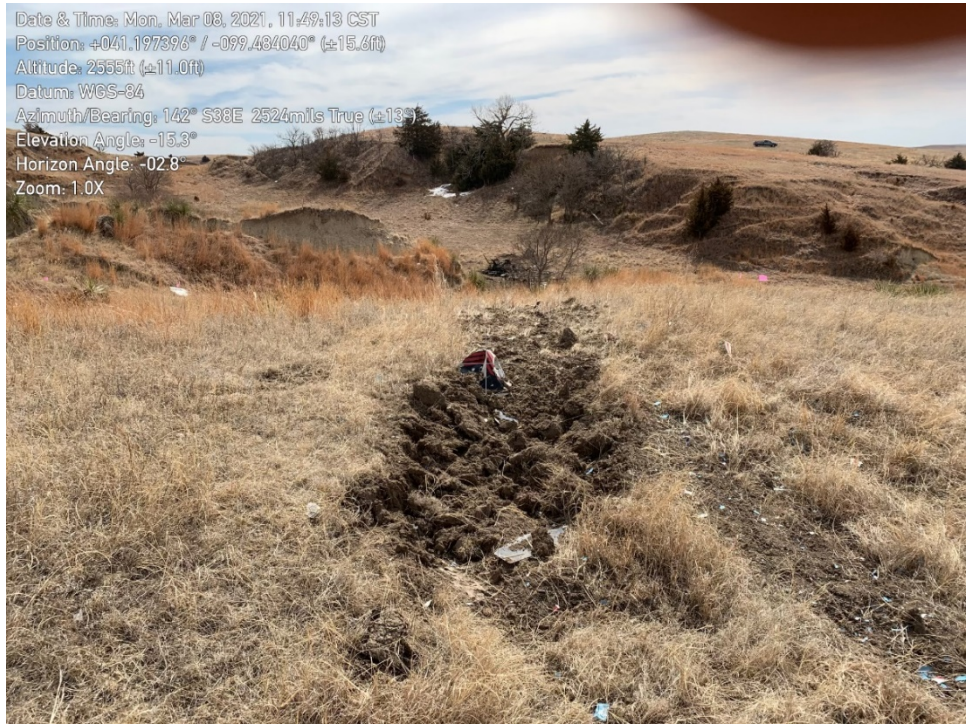
Figure 4: Large Area of Disturbed Dirt with Propeller Blade Fragments

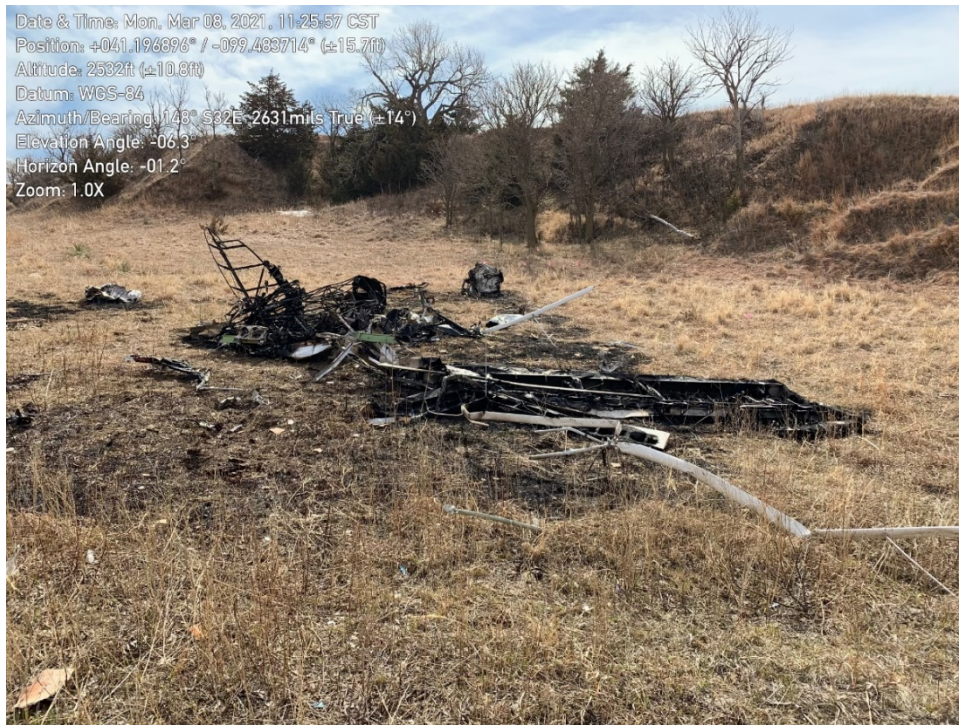
Figure 5: Main Wreckage

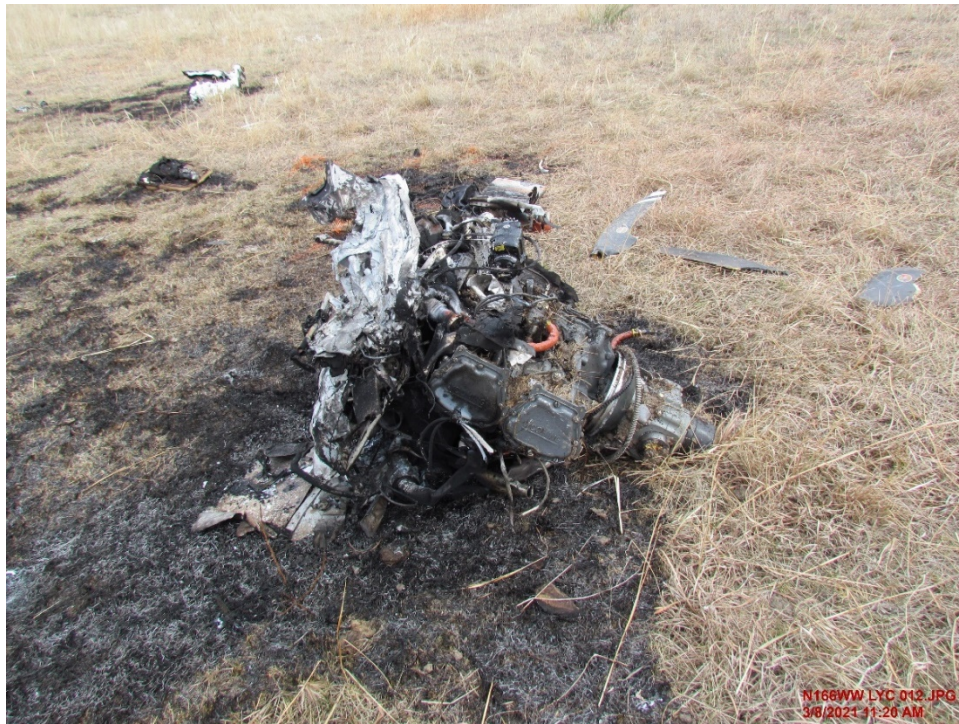
Figure 6: Engine

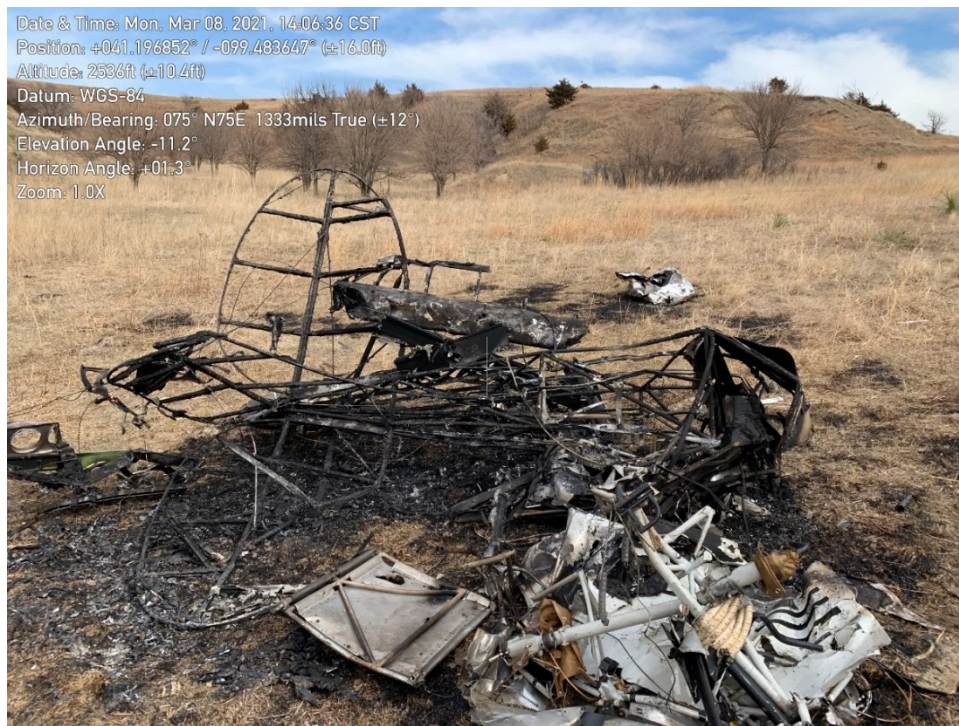
- The airframe came to rest in a ball and exhibited heavy thermal damage.
  - The fabric was completely gone and only the airplane's frame remained.
- Flight control continuity was established throughout the airframe.
  - The rudder controls within the cockpit were unidentifiable. They were located in an area of heavily melted material.
- The instrument panel was fragmented.
  - The instruments were fracture separated and heavily damaged.
- The main landing gear wheels were found separate from the main wreckage.

Figure 7: Aft Fuselage and Empennage

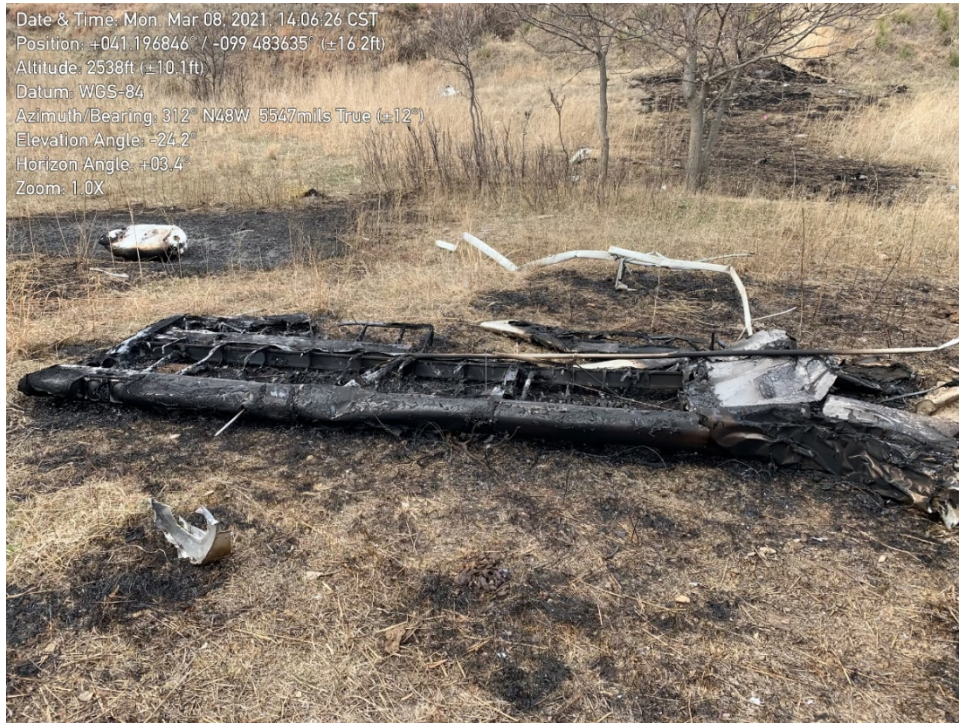
**Figure 8: Left Wing**

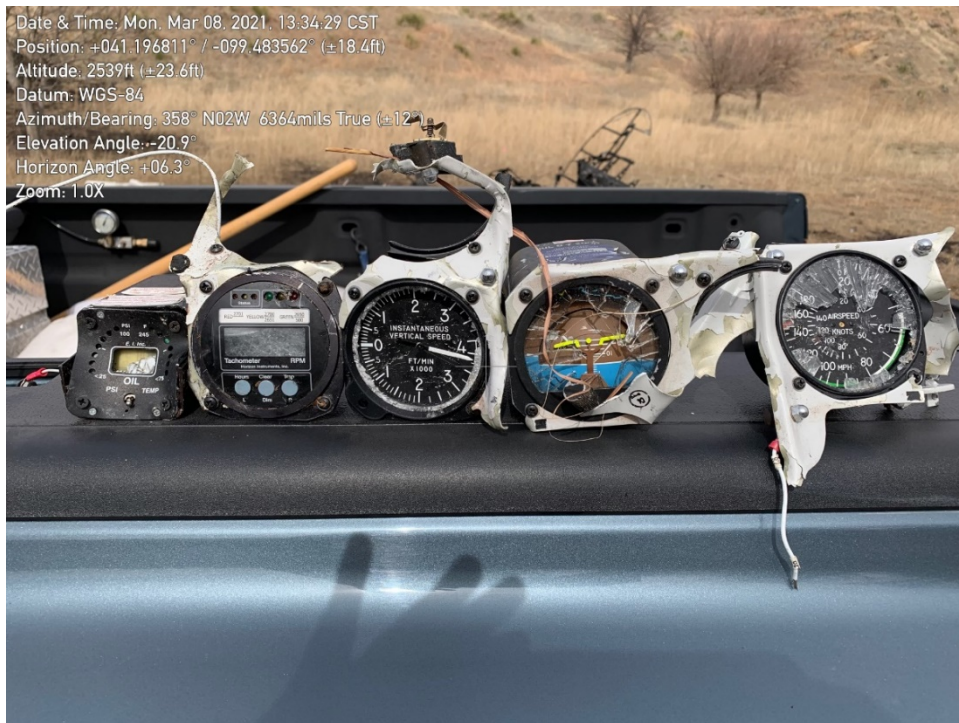
**Figure 9: Instruments**

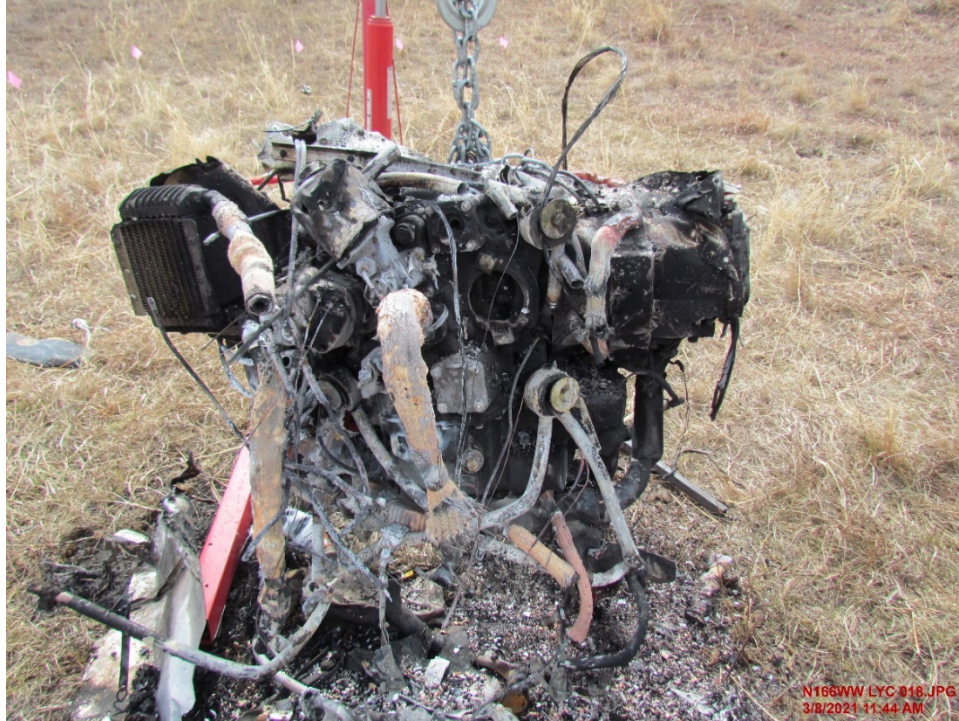
Figure 10: Accessory Section

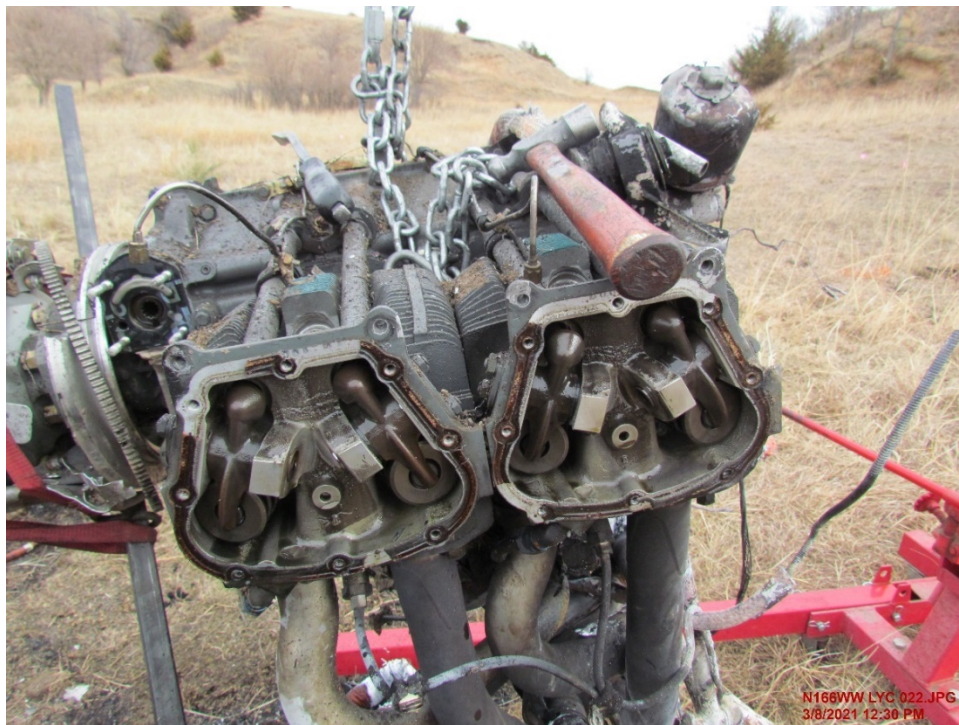
Figure 11: Left Side of Engine

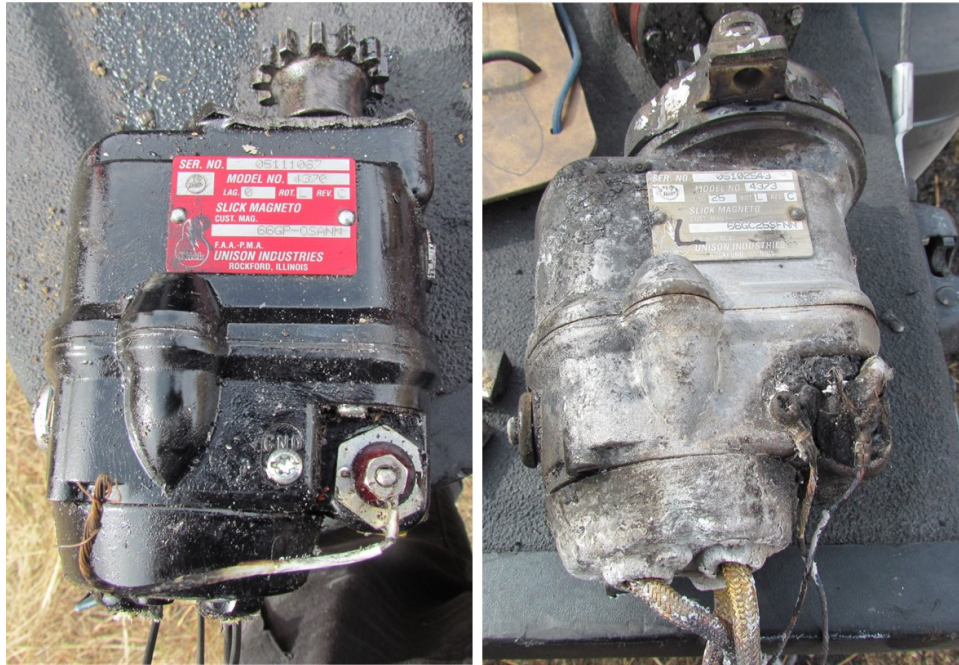
- The right magneto flange was fractured; however, the magneto was rotated with a drill.
  - Spark was obtained on all leads.
- The left magneto exhibited extensive thermal damage and was unable to be rotated.

Figure 12: Magnetos

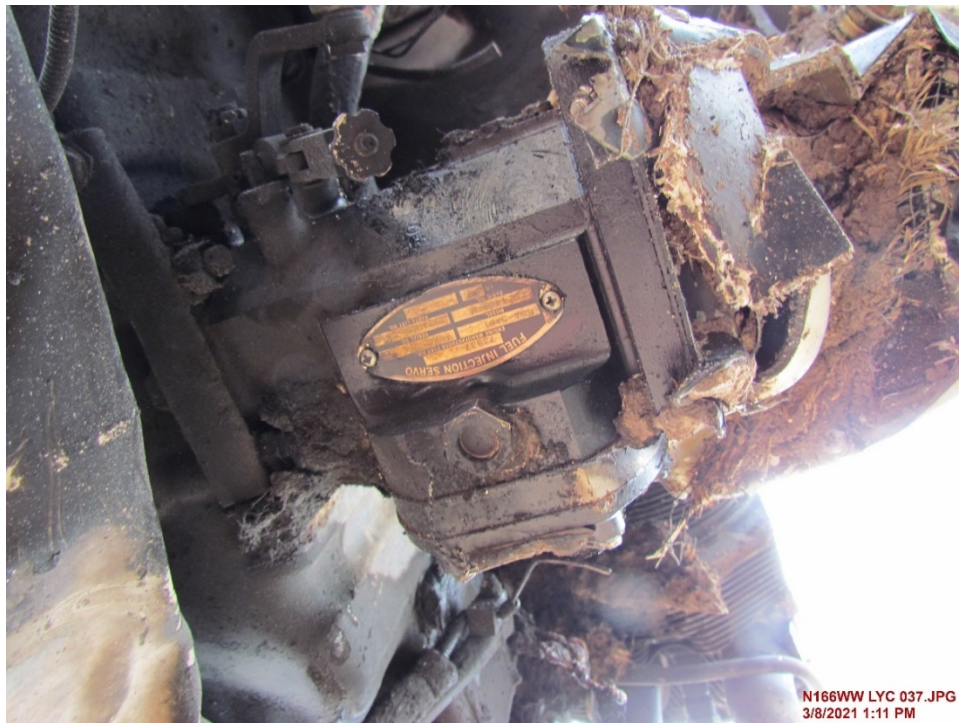
- It was unable to be rotated.
- The engine driven fuel pump was partially consumed by fire.
- The oil pickup screen was removed and clear of debris.
- The fuel servo remained attached to the oil sump.

Figure 13: Fuel Servo

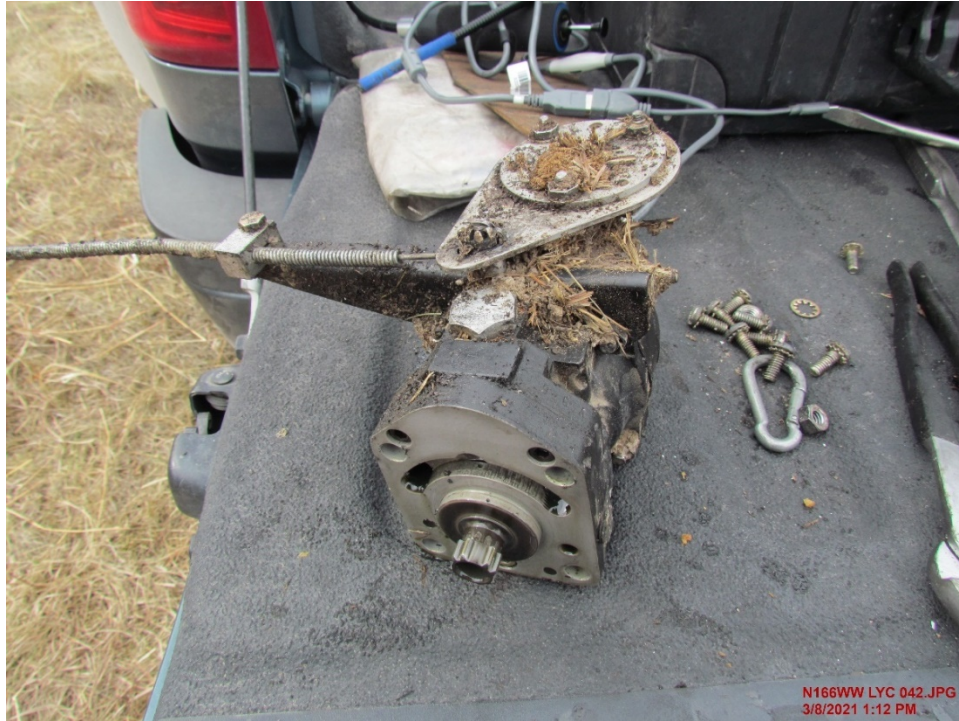
- The diaphragm remained intact, and fuel was found within the divider.
- The propeller governor rotated freely.
  - The screen was removed and clear of debris.

Figure 14: Propeller Governor

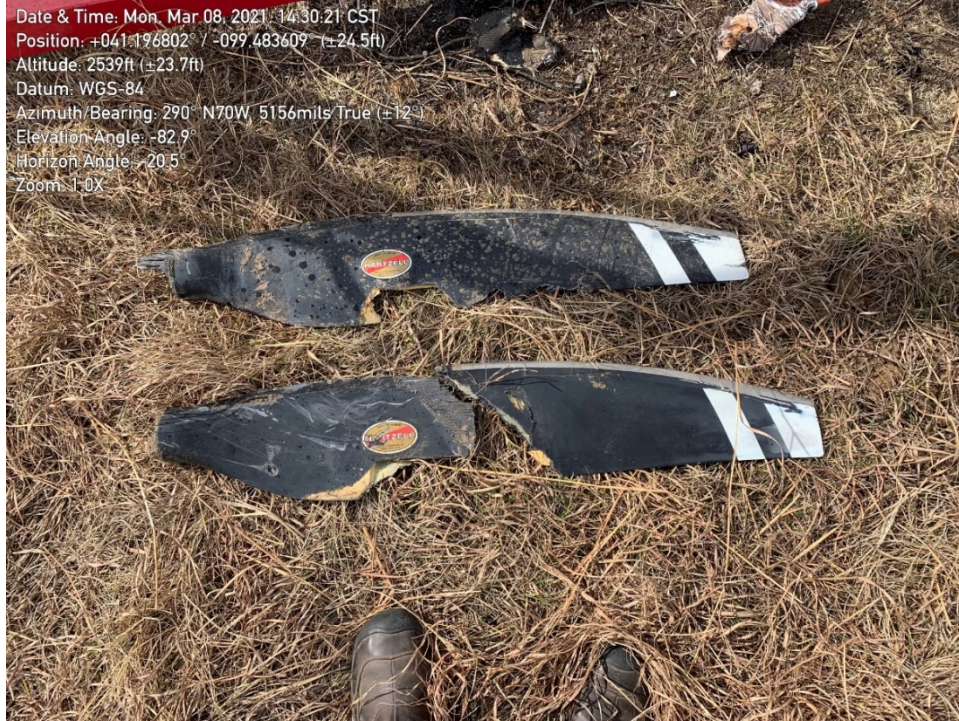
- Both composite propeller blades were fracture separated at the blade root, and one blade was also fractured midspan.
- Both blades exhibited chordwise scratching on both the face and chamber sides.
- Both blades exhibited gouges in the trailing edge slightly inboard from midspan.

Figure 15: Chamber side of Propeller Blades

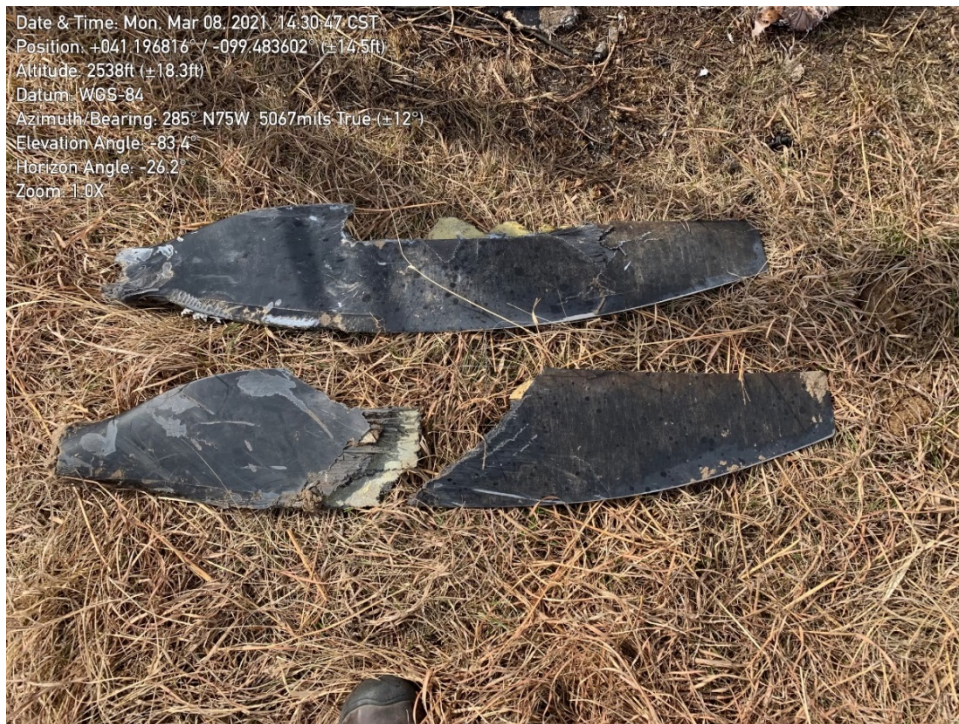
Figure 16: Face Side of Propeller Blades
