NATIONAL TRANSPORTATION SAFETY BOARD

On Scene Examination Summary

July 23, 2019
Skwentna, Alaska

NTSB Number: ANC19FA038
Location: Skwentna, Alaska
Date: March 6, 2019
Aircraft: Cessna 172 N7469A, S/N 29569, 1956
Engine: Continental Motors O-300A, S/N 15926-7-A-R

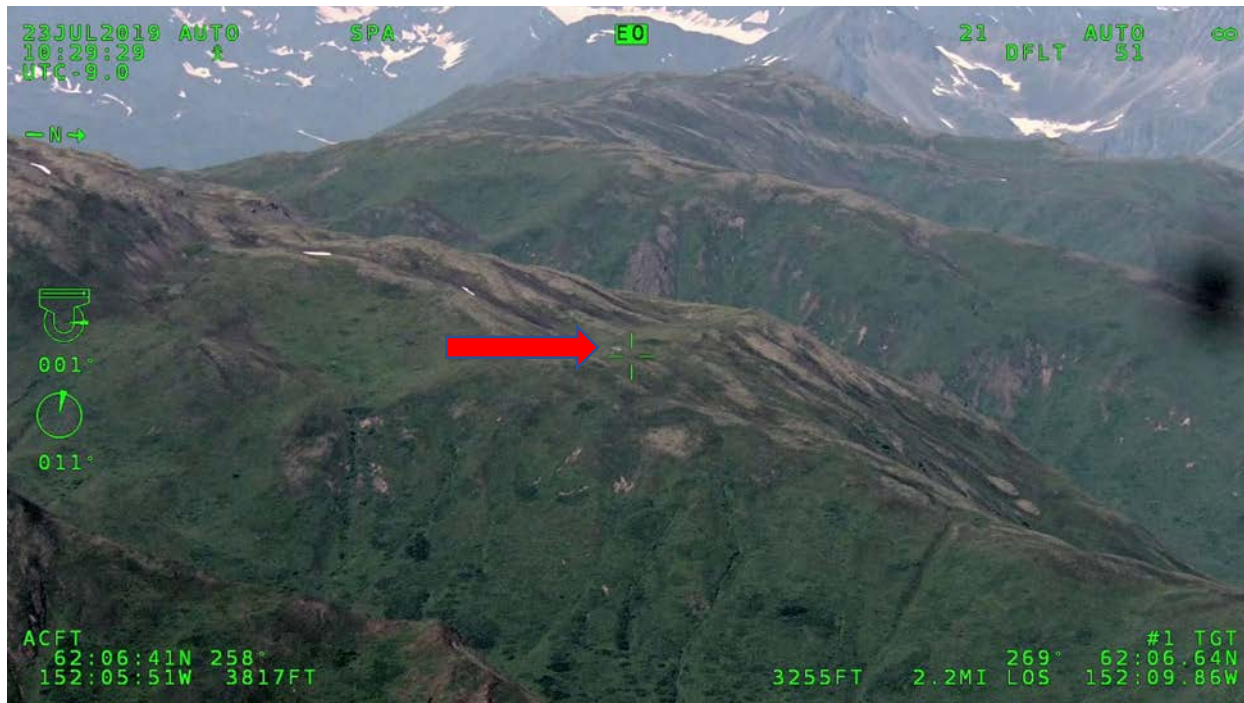
The wreckage was located by a helicopter pilot/guide on July 22, 2019 on Alaska state owned land. See figure 1. There was no insurance on the airplane and recovery efforts were not made. An Alaska State

Figure 1. N7469A at the accident scene on July 23, 2019. (courtesy of the Alaska State Troopers)

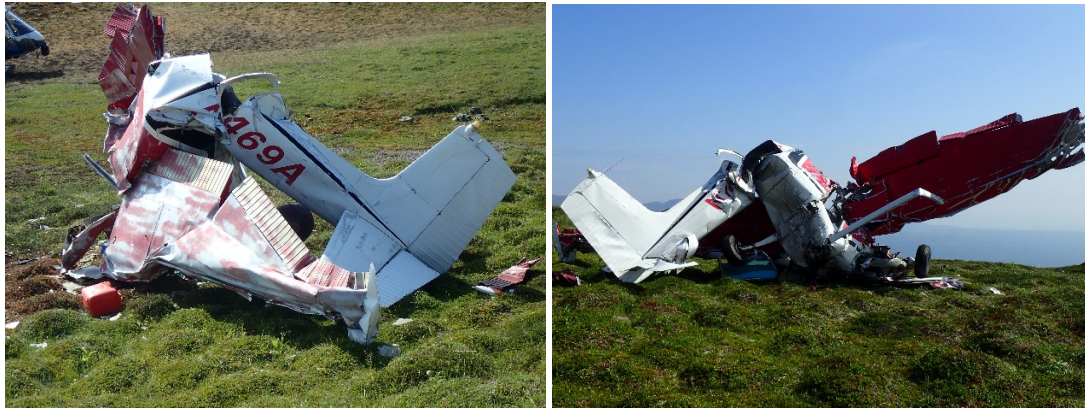
The airplane came to rest, after the seasonal snow melt, on an open grass covered ridge at an elevation of 3,241 ft heading 107° true. The fuselage was about 80° nose down leaning left 30°. All major components were present, and the debris was contained within a radius of 30 ft. The aft fuselage was twisted and displaced to the left with extensive buckling evident. The nose and engine section was displaced right and crushed into the ground. The wings remained partially attached with leading edge buckling across both wing spans. See figure 2.

Figure 2. Close up of the wreckage at the accident site.

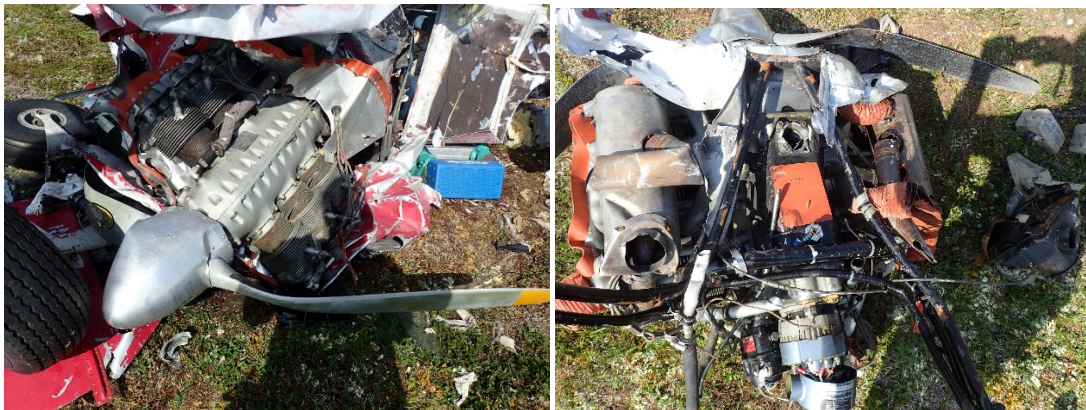
Figure 3. Continental O-300 engine and attached propeller upright (left) and bottom (right) at the accident scene.

The engine cowlings were separated from the fuselage and crushed under the wreckage. The engine mounts were fractured, and the engine was displaced almost 90° to the right of the fuselage heading. See figure 3. The case and cylinders were intact. The propeller remained attached to the engine and could be rotated within the confines of the ground. The ignition harness and spark plugs were secure in place. The magnetos were secure, and after removal, spark was evident at each terminal post when manually rotated. See figure 4. The rocker box covers were removed, and rocker arms were noted to move appropriately when the engine was manually rotated. See figure 5. The carburetor and airbox were separated from the bottom of the engine at the fractured mounting pad that indicated dull, dimpled overload fracture signatures. The throttle cable was attached to the throttle arm and the cable exhibited a separation about 1 ft from the carburetor. The throttle valve and controls were separated from the carburetor at the fractured base plate. The mixture control lever was attached, and the control cable was separated at the connector. The carburetor fuel inlet filter was removed and indicated no debris. The carburetor bowl had no fluids present and the float assembly and mixture needle were intact. See figure 6. The airbox inlet and filter

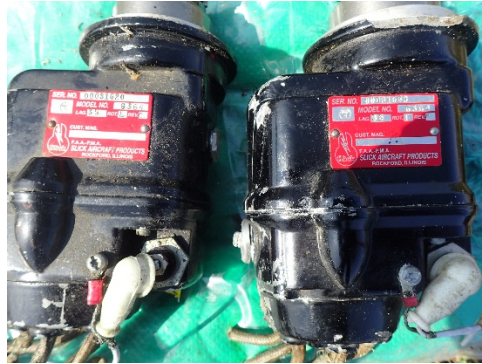
Figure 4. Left and right magnetos removed from the engine accessory drive.

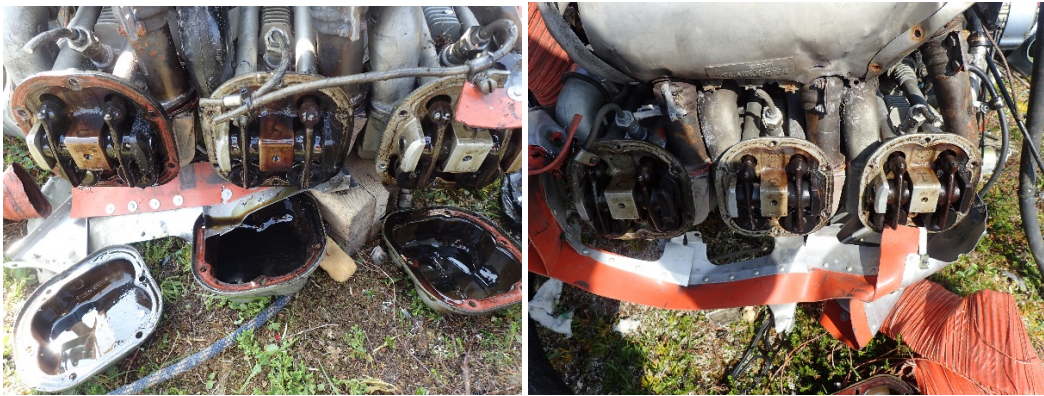
screen were clear of debris. The oil drain valve was fractured, and minimal oil was present in the sump. Oil was present in all of the rocker arm housings.

Figure 5. Rocker arm housings for cylinders 2, 4, and 6 (left) and 5, 3, and 1 (right).

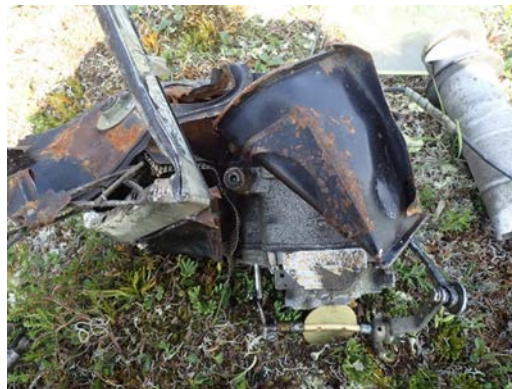
Figure 6. Carburetor and airbox at the accident scene.
