**NATIONAL TRANSPORTATION SAFETY BOARD
Office of Research and Engineering
Vehicle Recorder Division
Washington, D.C. 20594**

**GROUP CHAIRMAN'S FACTUAL REPORT OF
INVESTIGATION**

RRD19FR009

Onboard Image Recorder

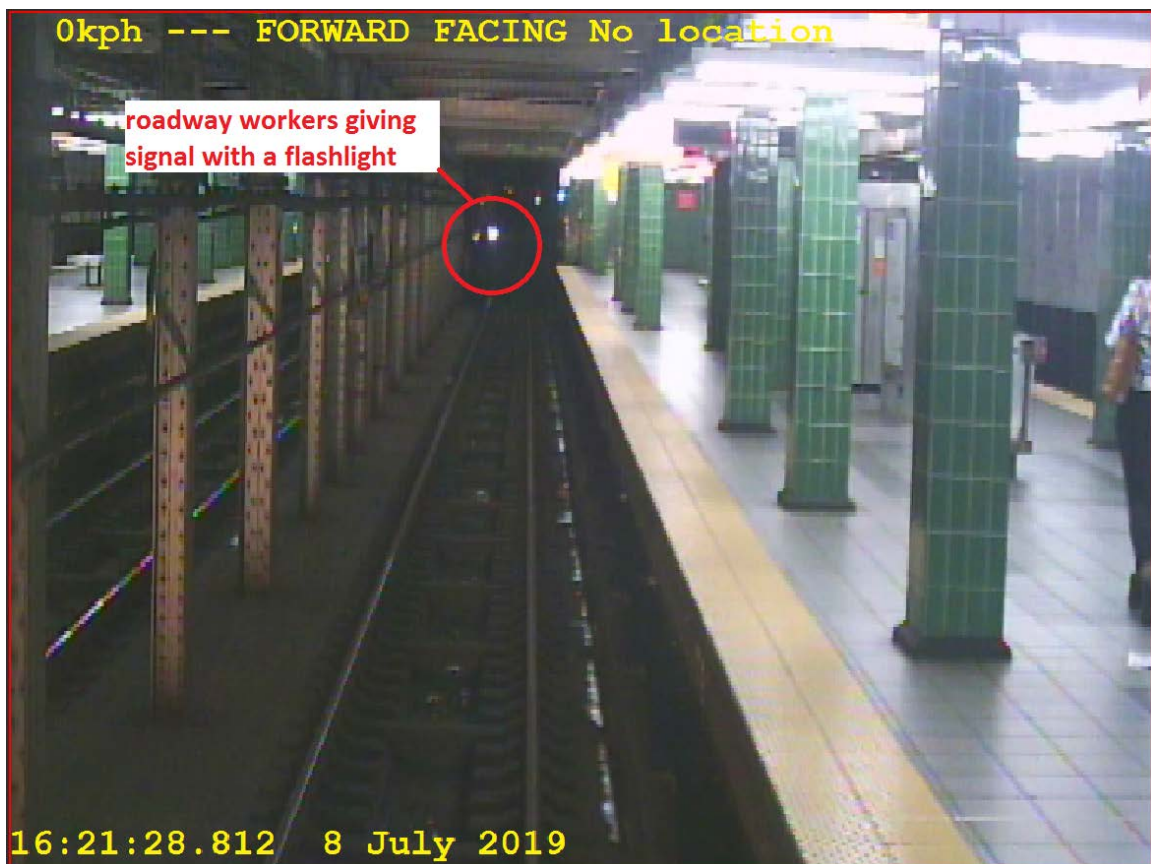
Figure 1: screenshot of the roadway workers giving a horizontal hand signal with a flashlight (time on the figure was 1 hour behind EDT).

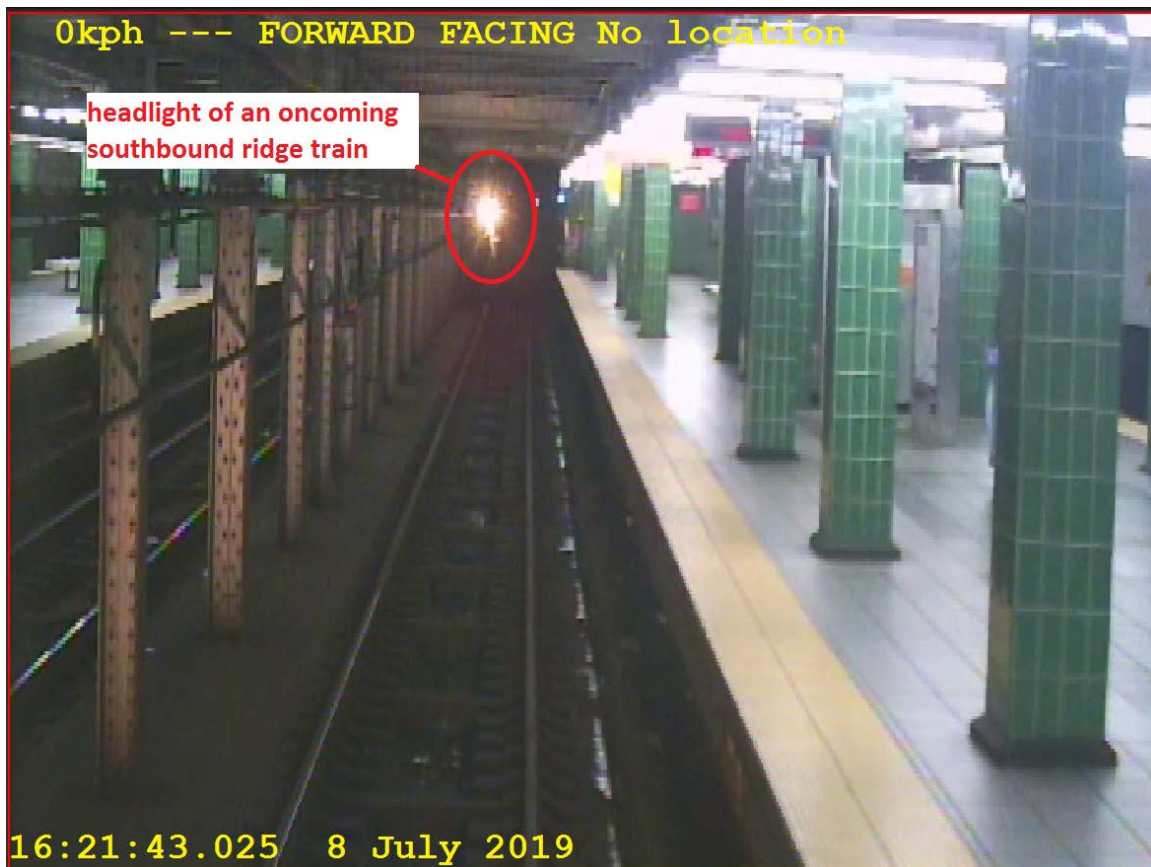
The operator began moving the train while he was still looking behind the train along the platform. Around the same time that the train began moving, the headlight of an oncoming southbound ridge train on track 2 came into view at 17:21:43. The headlight of the oncoming train was very bright. Figure 2 is a screenshot at this time.

Figure 2: the headlight of an oncoming southbound ridge train seen ahead of the striking train (time on the figure was 1 hour behind EDT).

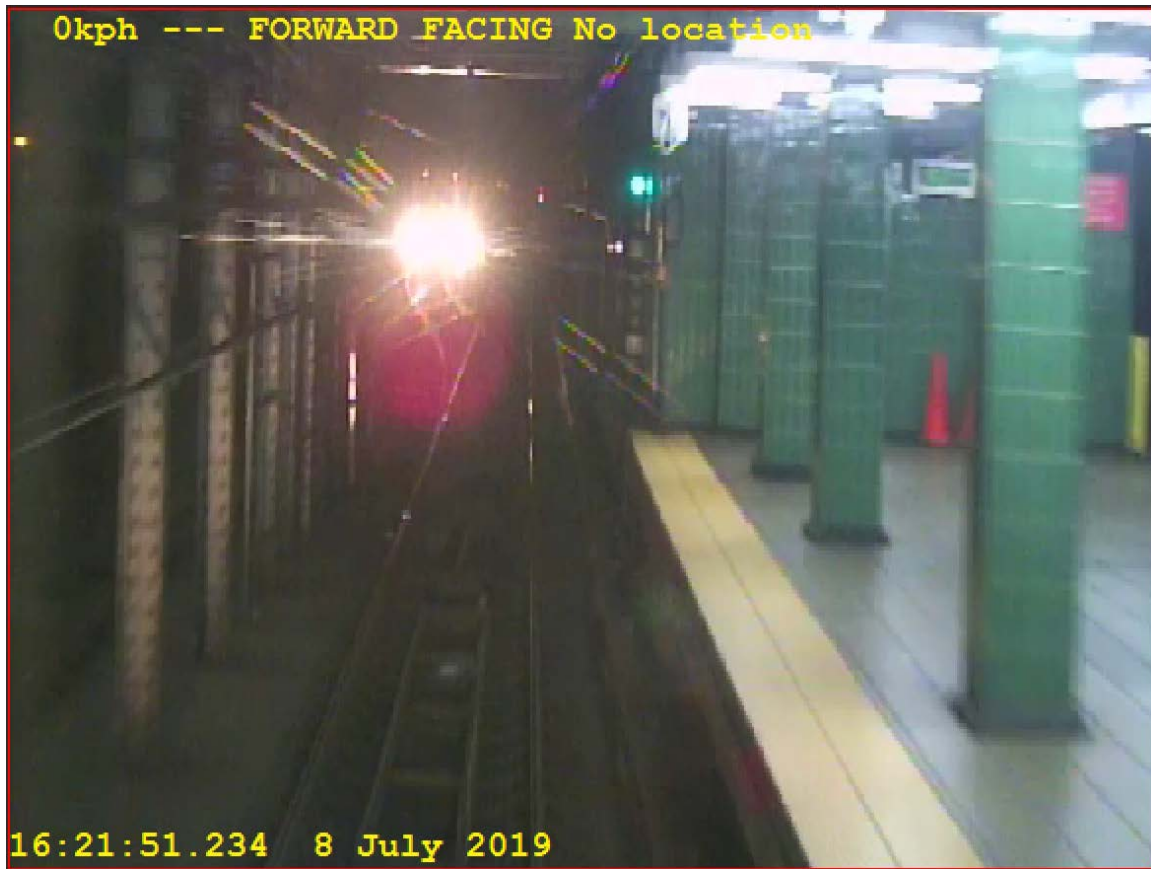
At 17:21:43, the roadway workers' signal appeared to cease¹. The striking train was moving forward. The oncoming train was still approaching with headlight on. At 17:21:47, the operator appeared to be looking forward. At this time, a quick horizontal hand signal was observed from a roadway worker. The operator then glanced backward again toward the platform as the train was accelerating away from the station. By 17:21:51, the operator was looking forward again, however, the oncoming train continued to approach with a bright headlight. Figure 3 is a

screenshot of this time. It was not obvious from the camera view that the roadway workers were visible.

Figure 3: screenshot at 17:21:51 (time on the figure was 1 hour behind EDT).

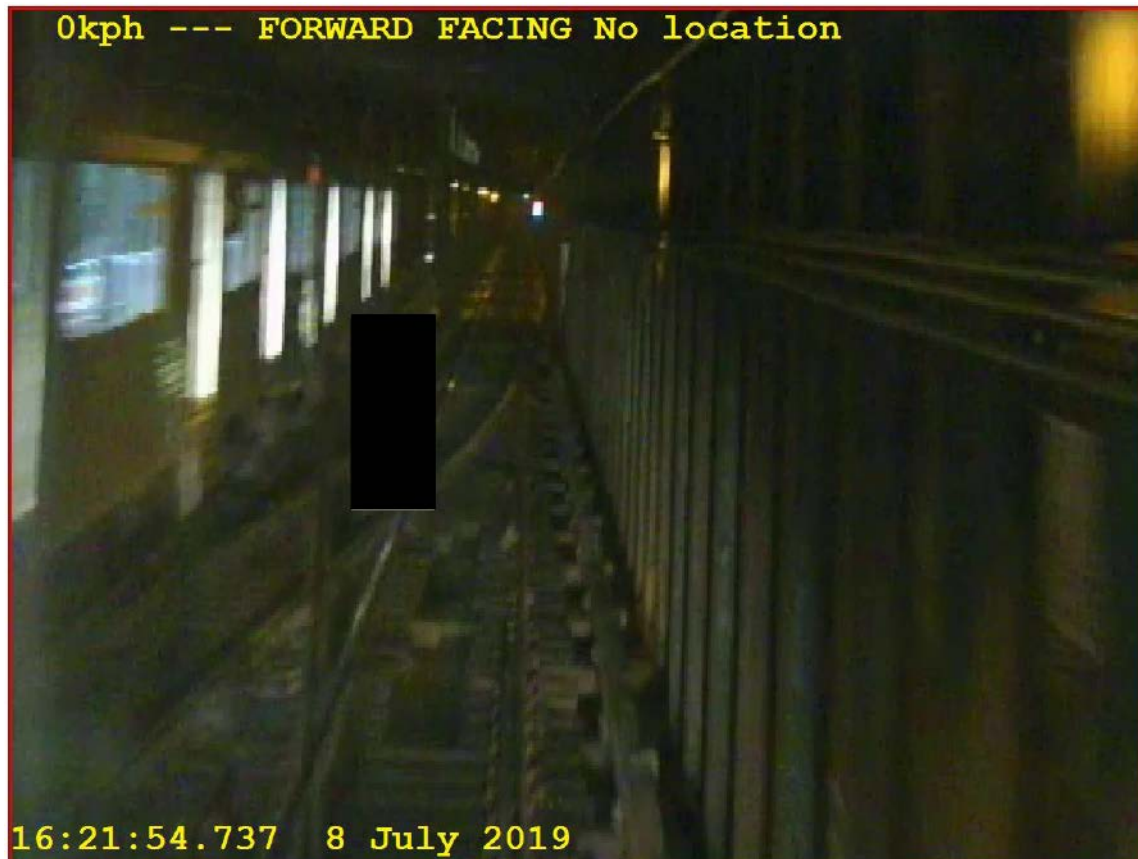
At 17:21:54, the oncoming train passed the striking train, and the roadway workers came into view. The watch man and inspector were standing side by side in the interlocking fouling track 3, facing track 2. The inspector was closer to the approaching train. The operator was looking forward at this time. The roadway workers appeared to be looking at the passing southbound train, not the striking train. Figure 4 is a redacted screenshot at this time.

Figure 4: redacted screenshot at 17:21:54 (time on the figure was 1 hour behind EDT).
