**NATIONAL TRANSPORTATION SAFETY BOARD**  
**Office of Research and Engineering**  
**Vehicle Recorder Division**  
**Washington, D.C. 20594**

**GROUP CHAIRMAN'S FACTUAL REPORT OF  
INVESTIGATION**

**RRD21LR005**

## **Onboard Image Recorder**

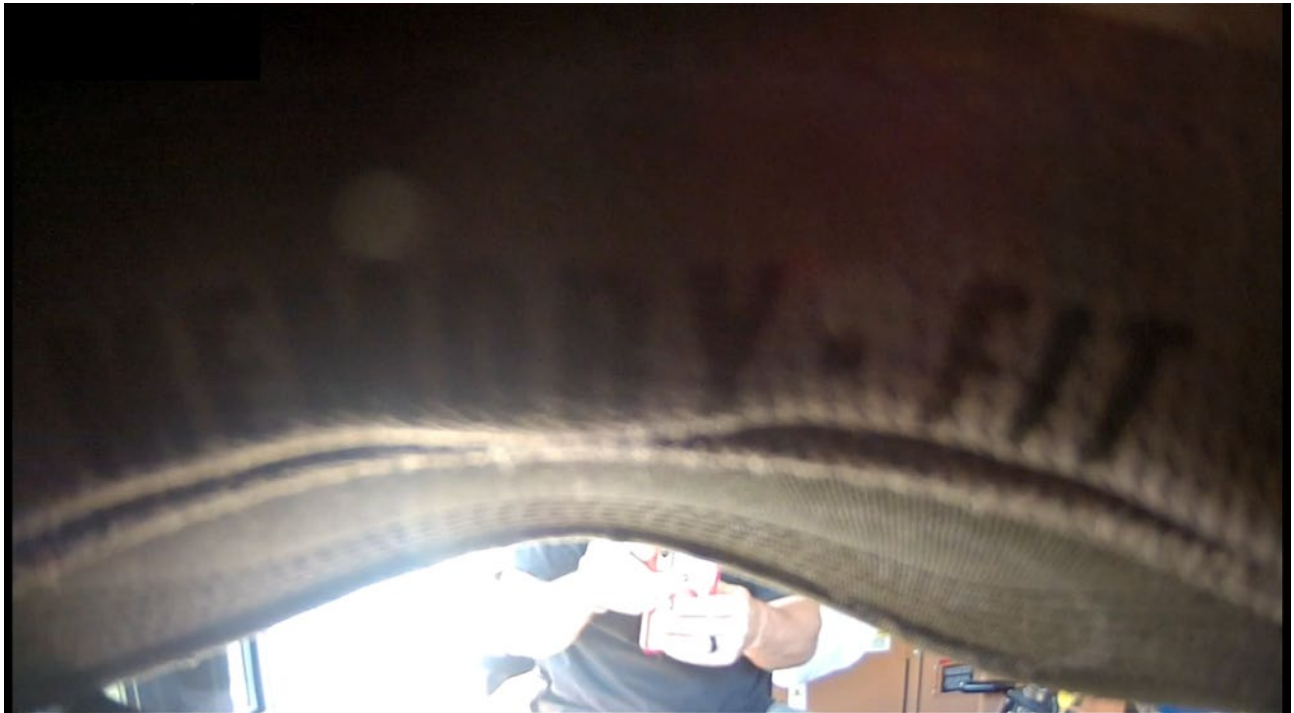
**Figure 3: Screenshot at 16:11.**

- 15:31 – 16:10** The engineer's eye and head motion were consistent with observing the locomotive's controls and the track ahead while vaping.
- 16:11** The engineer took off his cap and covered up the camera. Under the cap's brim, the area near the engineer's abdomen was still visible, while the cap covered most of the rest of the camera's view. The engineer was holding his cellphone and appeared to be manipulating the cellphone in a manner consistent with entering text. Figure 3 is a screenshot at this time.

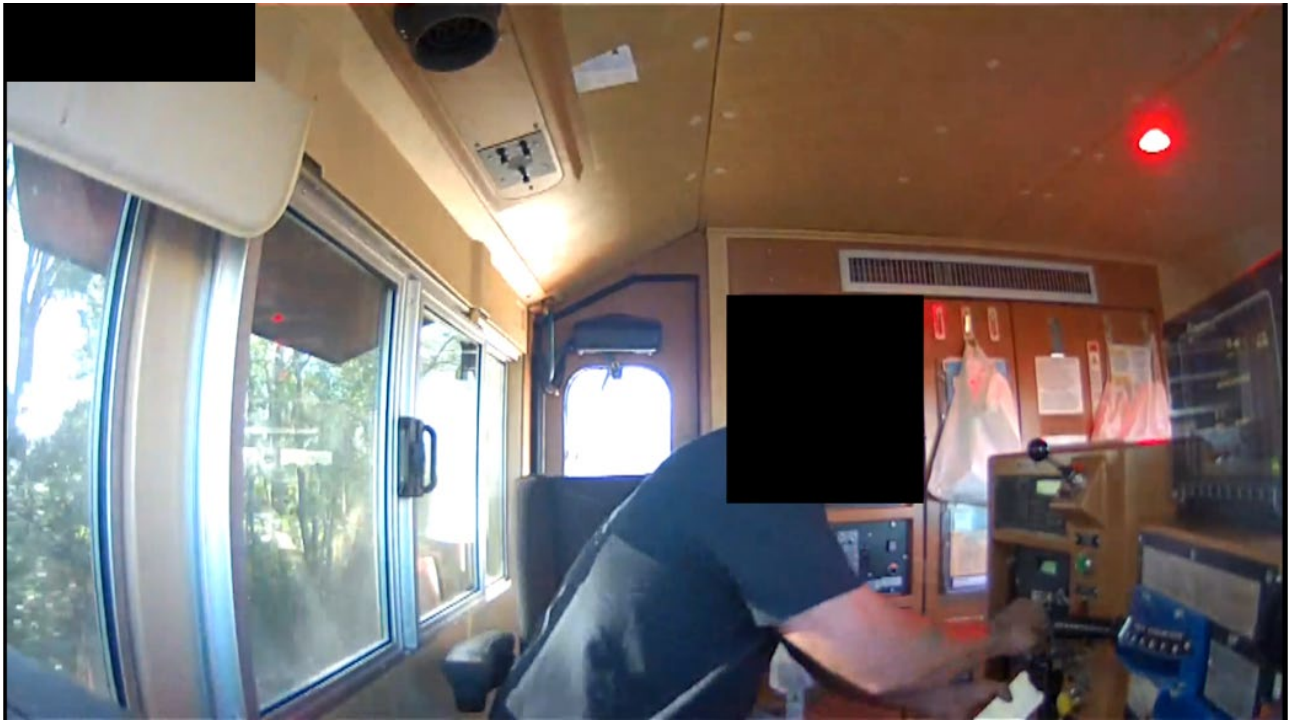
- 26:51** The engineer, while holding the cellphone on his left hand, fully applied the independent brake, then applied the automatic brake which was fully applied earlier by him upon impact. The engineer then stood and put the cellphone into his pocket. Figure 4 is a screenshot at this time. The engineer is redacted on the image.

**Figure 4: Screenshot at 26:51. The engineer re-applied the automatic brake while holding the cellphone on the left hand.**

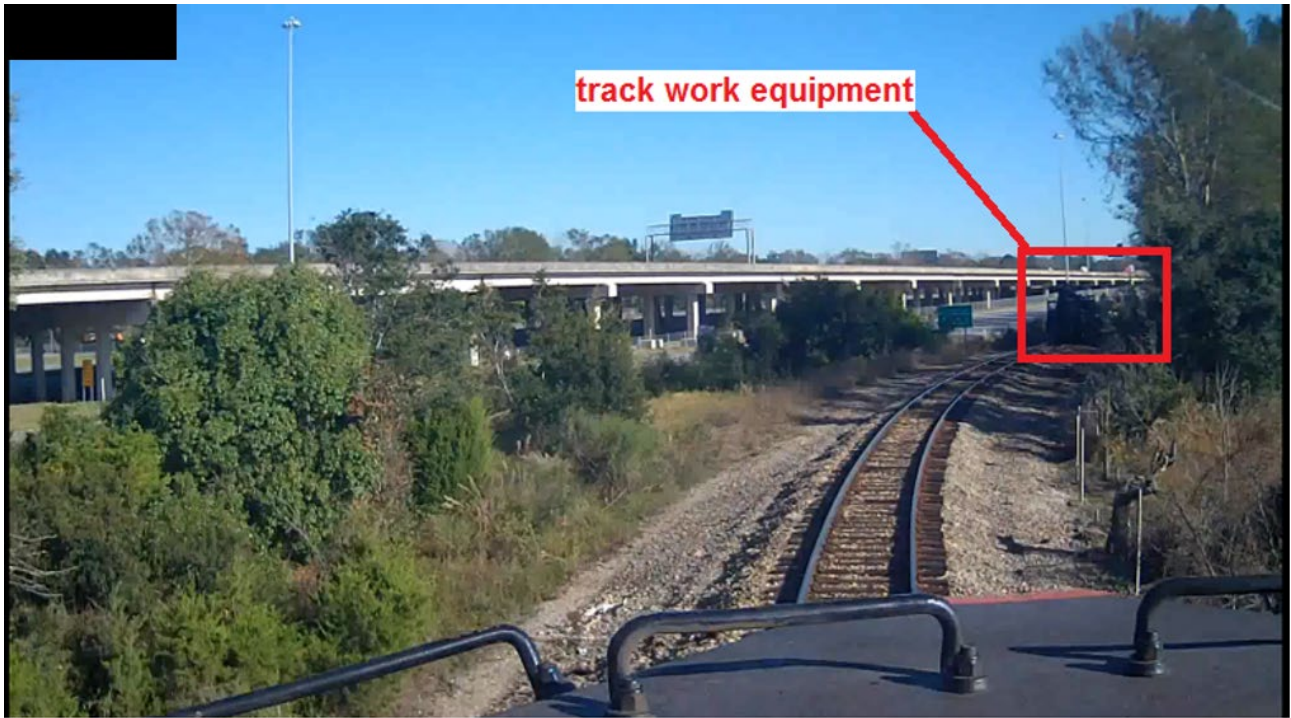
**Figure 5: Screenshot at 26:33.**

**26:33** Rail track work equipment became visible to the outward facing camera. Figure 5 is a screenshot at this time.

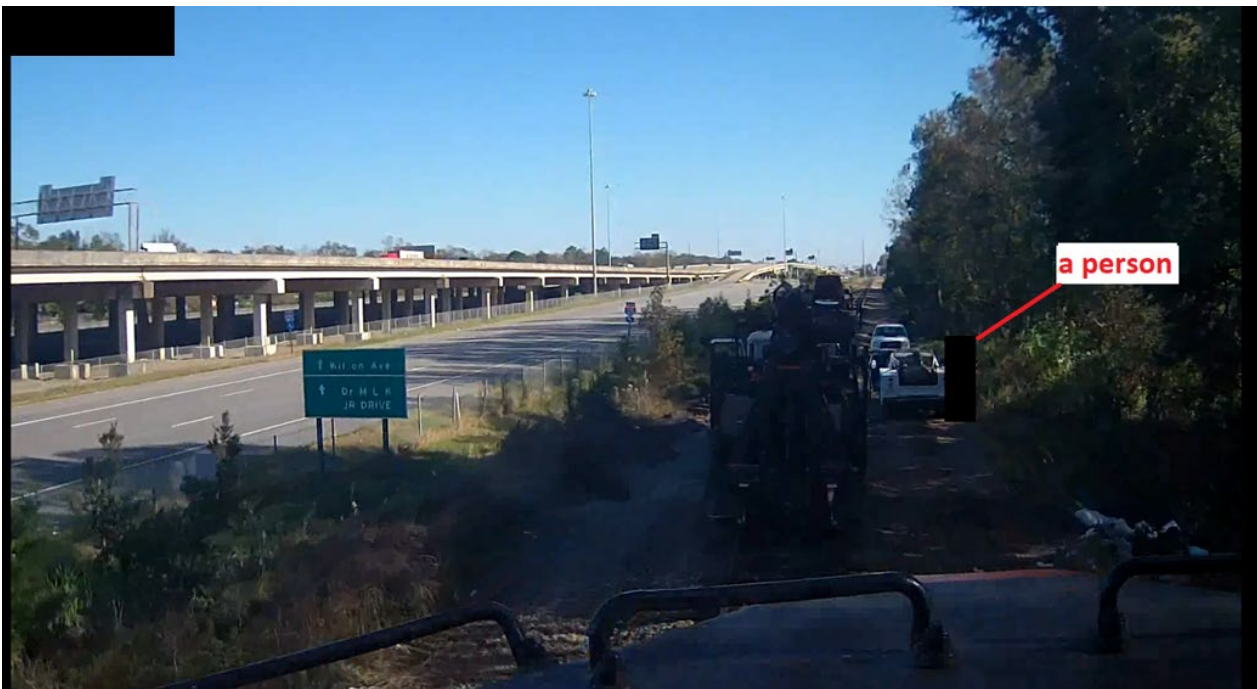
**Figure 6: Screenshot at 26:41.**

Just prior to the collision, as the train approaching, there was no advance warning sign visible. Figure 6 is a screenshot at this time. A person was visible standing next a truck on the right side of the rail track. The person is redacted on the image.
