National Transportation Safety Board

RRD22MR010

ONBOARD VIDEO RECORDER

Location: Mendon, Missouri
Date: June 27, 2022
Vehicle 1: Amtrak train No. 4
Vehicle 2: 2007 Kenworth dump truck

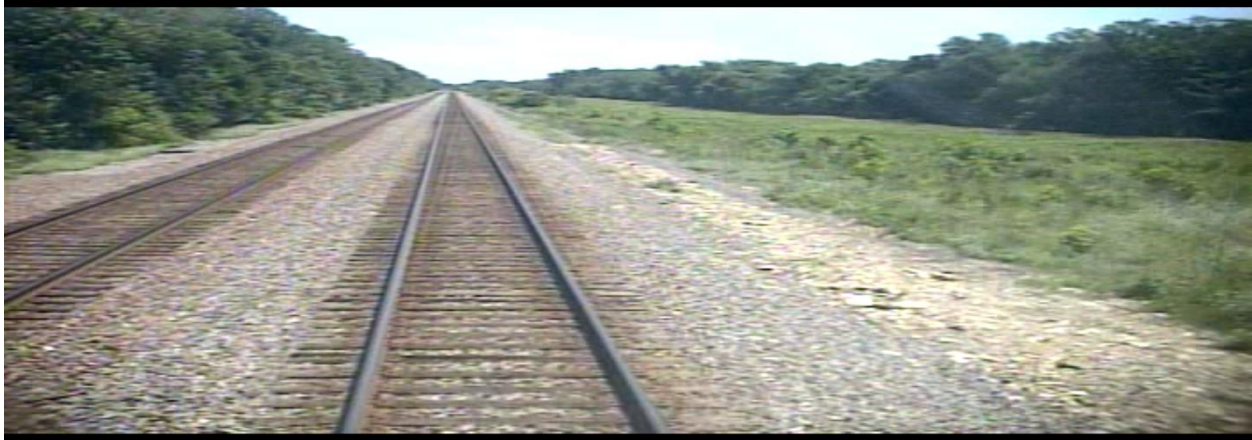
This video recorder was mounted on the locomotive of the Amtrak train No. 4 and facing forward. Figure 1 shows the field of view of the video recorder at the beginning of the recording. The file is not presented in its original aspect ratio and is instead represented in a widescreen format as per the playback software.

Figure 1. Field of view of the 11.04.59_11.14.59 AMTK 133.avi video file at the beginning of the recording. Note that the original aspect ratio of the recorded video was formatted in widescreen by playback software.

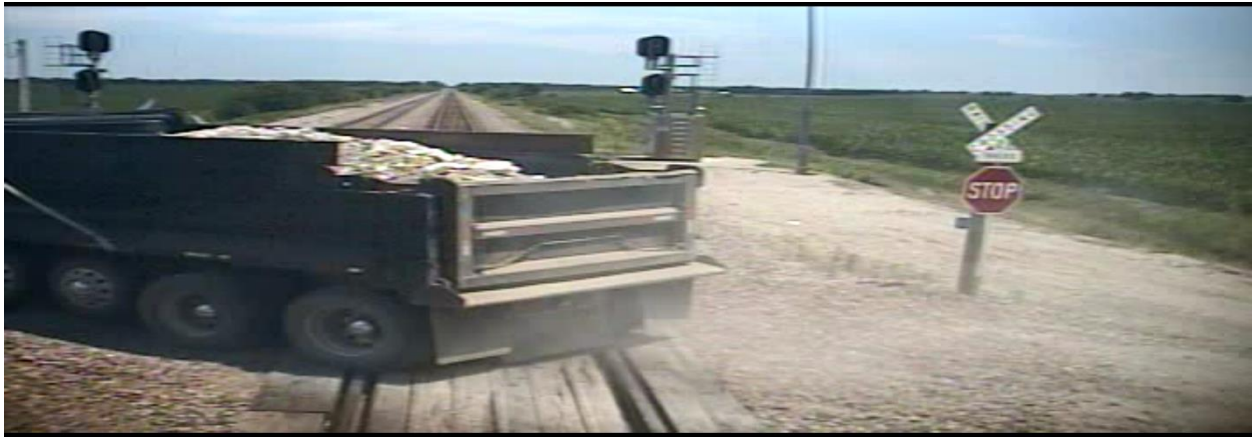
04:03 ~ 04:13 - A series of horns sounded. As the train was approaching an intersection, the 2007 Kenworth dump truck was travelling towards the intersection from the right side of the track. The dump truck did not stop at the intersection and continued moving forward onto the track.

04:14 - The impact occurred. Figure 2 shows a screenshot just prior to the impact. A stop sign was at the intersection before the dump truck moving forward onto the track (pictured to the right).

Figure 2. Screenshot just prior to the impact. Note that the original aspect ratio of the recorded video was formatted in widescreen by playback software.

04:15 ~ 04:31 - After the impact, the train shook and continued moving forward on the track. The train came to a stop at 04:31.

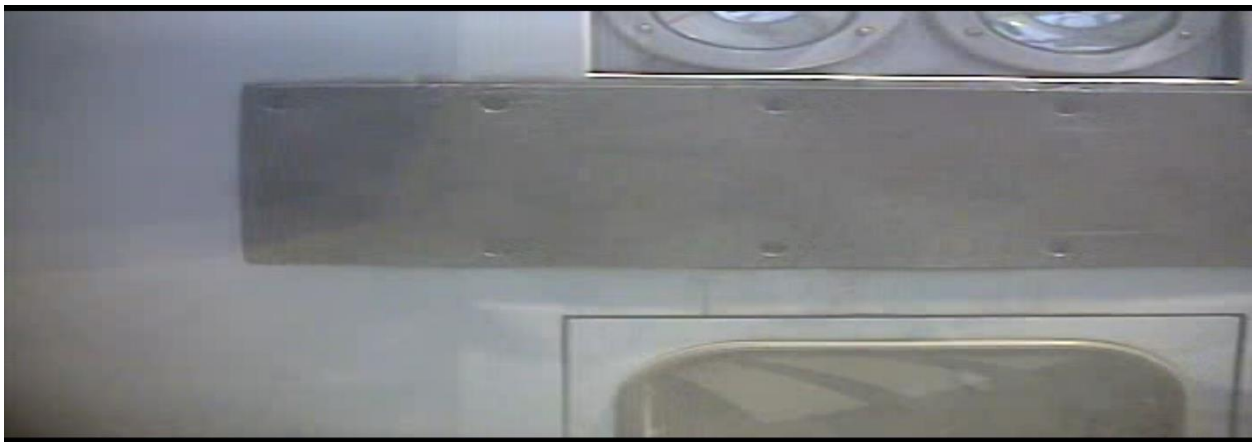
Figure 3 shows the field of view of this video recorder. For the entire recording, the field of view does not change but wobbles slightly until the impact. The field of view suggested the video recorder was mounted outside of a train car of the Amtrak train No. 4 and was facing the train car. The audio suggested the train was travelling on a track until the impact.

Figure 3. Field of view of the 09.40.20_09.50.20 AMTK 166.avi video file.

06:55 - The impact occurred. A loud impact sound was audible.

06:56 ~ 07:11 - The field of view shook. A dust cloud covered the field of view while some objects which seem to be little rocks were flying past.

07:14 - The field of view became stable, which suggested the train stopped moving.
