DCA22MA009

OPERATIONAL FACTORS/HUMAN PERFORMANCE

Attachment 23
Elevator Evaluation
November 2, 2022

ELEVATOR EVALUATON

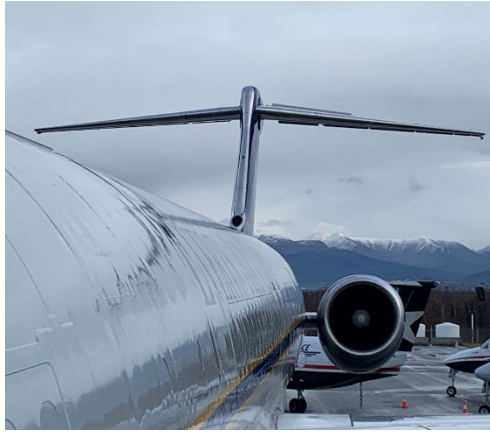
Figure 1. Elevator as viewed from airstairs at the main cabin entry door located on the left (captain's) side of the airplane.

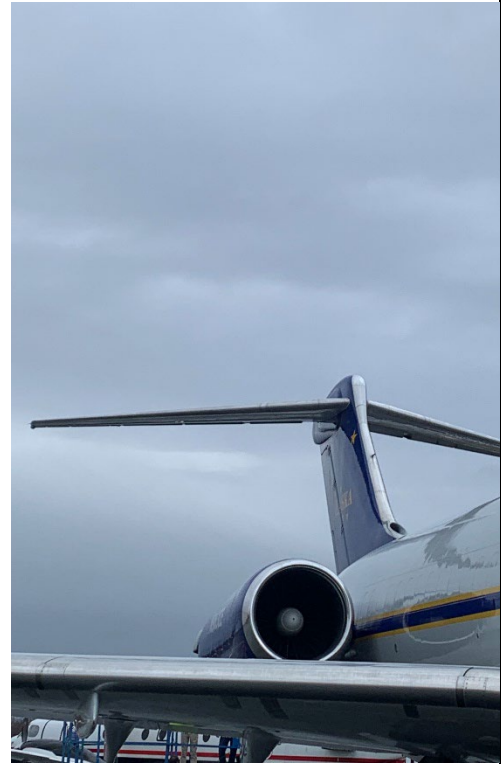
Figure 2. Elevator as viewed from the ground. As viewed in photograph left side of elevator (first officer side of aircraft) is in a faired position and the right side (captain's side) is trailing edge up.

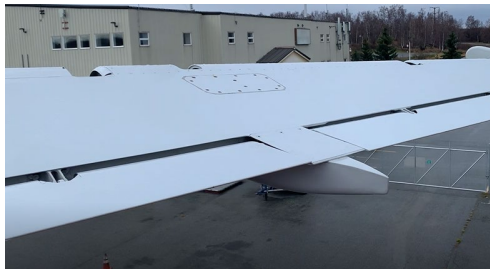
Figure 3. Elevator as viewed from elevated position in trailing edge down.

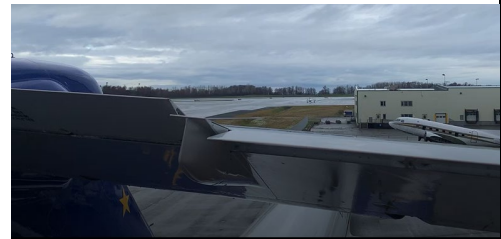
Figure 4. Elevator as viewed from an elevated position, in trailing edge up position.

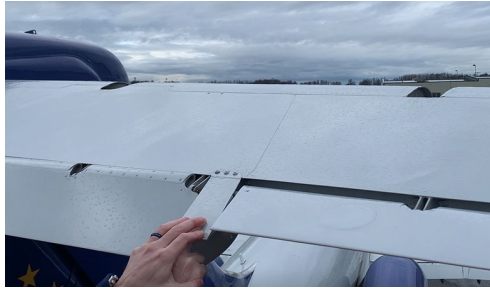
Notes: During the test, the director of operations for Everts applied downward pressure on the elevator to simulate a TED/jammed position. The elevator, when manual downward pressure was released, was observed to return to a faired or trailing edge up position. During the testing while manually applying downward pressure on the right elevator, the left elevator moved normally when the control column was moved in the cockpit. This was observed from the ground and an elevated position. The TED position was visible from the ground and an elevated position. The line pilot provided by Everts Air Cargo also stated that the position of the elevator would be easy to detect when walking to the plane in both daylight and nighttime (with the assistance of ramp lighting and/or flashlight) conditions. The investigative team and Everts line pilot observed the procedure to be clear and understandable and allowed the pilot to clearly discern if an elevator is jammed in the trailing edge down position. The line pilot noted that although he had never observed a TED position, the faired or trailing edge up position was easy to detect for him.

Figure 5. Elevator as viewed in trailing edge down from an elevated position aft of the aircraft looking forward, with manual downward pressure being applied during control column aft movement.

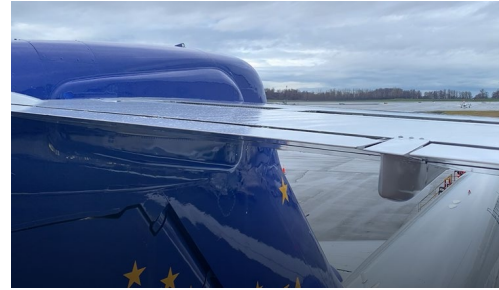
Figure 6. Elevator as viewed in faired position.

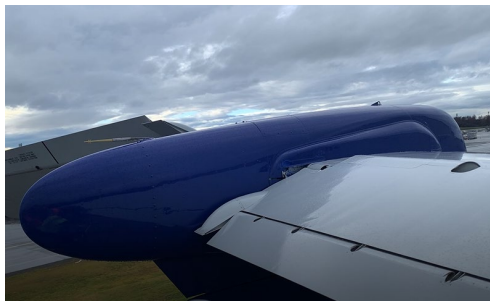
Figure 7. Elevator as viewed looking from aft of the airplane. The left side (in photo) elevator is in trailing edge up while manual pressure is being applied to the right side to remain in trailing edge down. The elevator was being moved to the aft position via the control column in the cockpit..

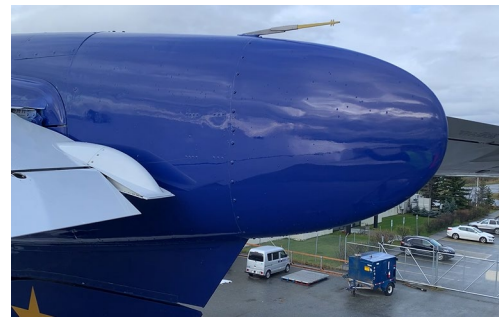
Figure 8. Elevator as viewed from the left side (captain side of airplane) with control column aft pressure being applied in the cockpit. In the photo manual downward pressure is being applied to the left side of the elevator to remain in trailing edge down.

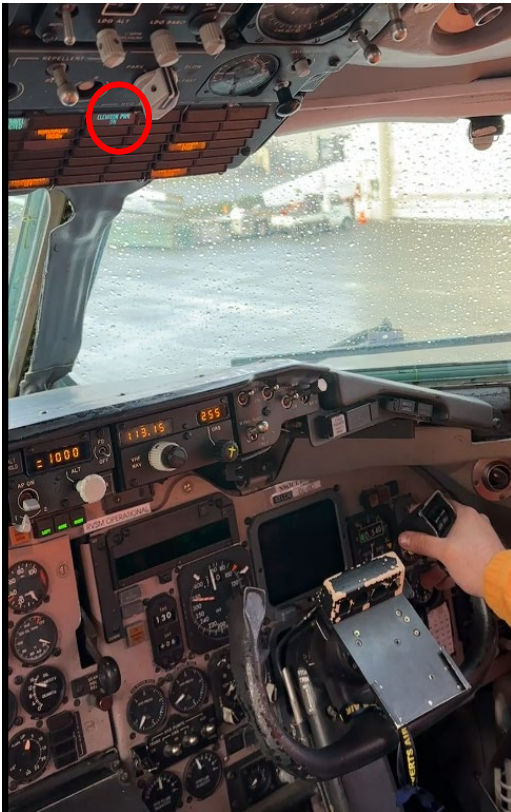
Figure 9. Elevator Power On blue overhead light (circled in red above) activation with control column in full forward position.

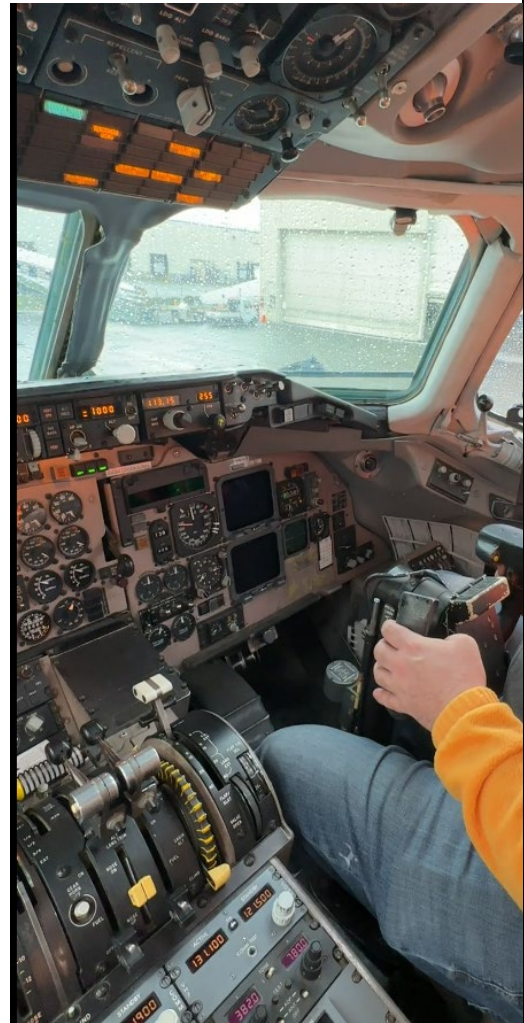
Figure 10. Control yoke in full aft position.

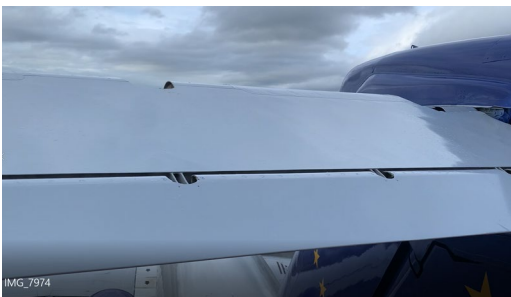
Figure 11. Left side (captain's side) elevator in trailing edge down with full forward control column.

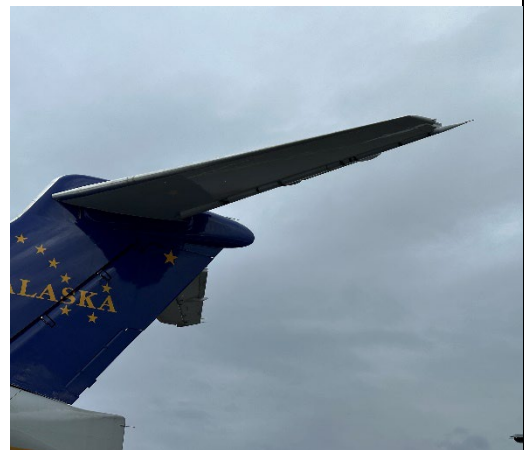
Figure 12. Left side (captain's side of airplane) elevator with full aft control column pressure.

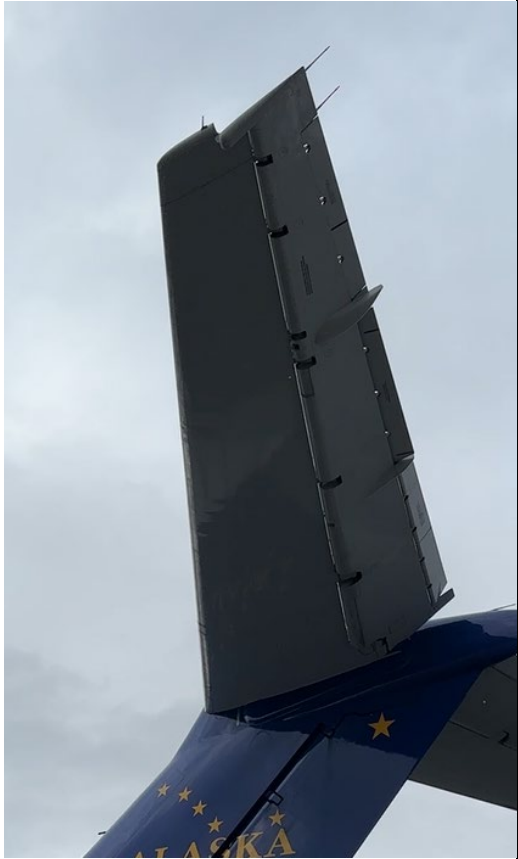
Figure 13. Left side (captain's side) elevator as viewed from the ground in the trailing edge up position.

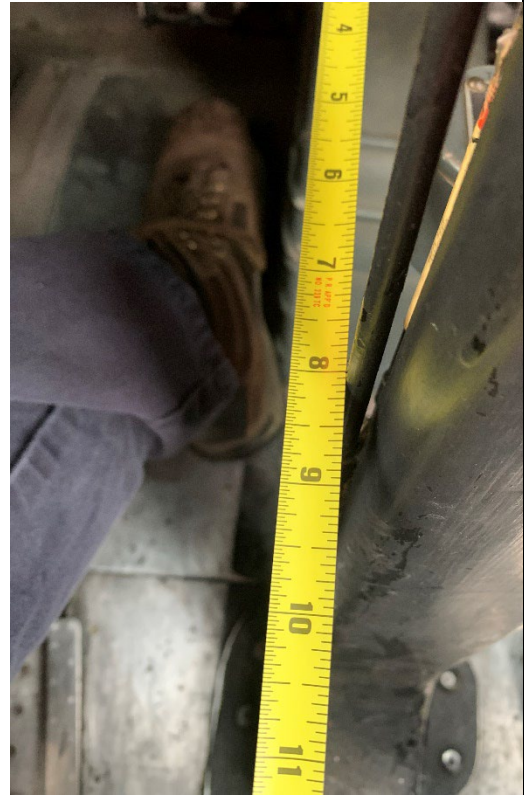
Figure 14. First Officer control column at rest location. The measurement from the footrest below the flight displays to the aft side of the control column (side facing FO seat). The measurement was 8.75 inches.

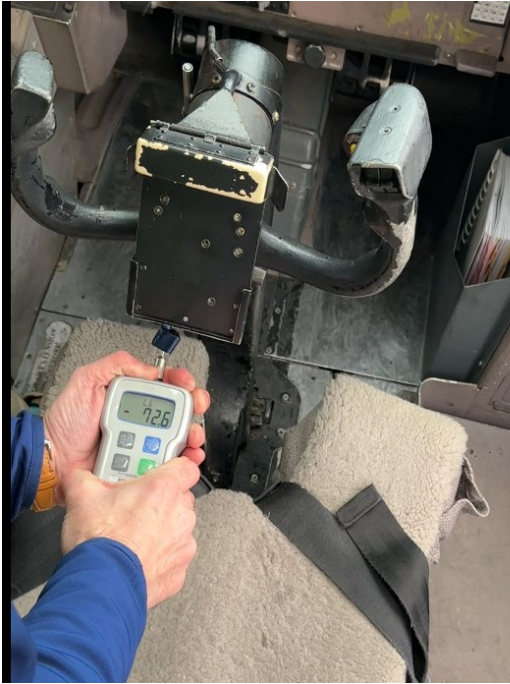
Figure 15: Full aft pressure applied during a normal non-jammed elevator flight control check.

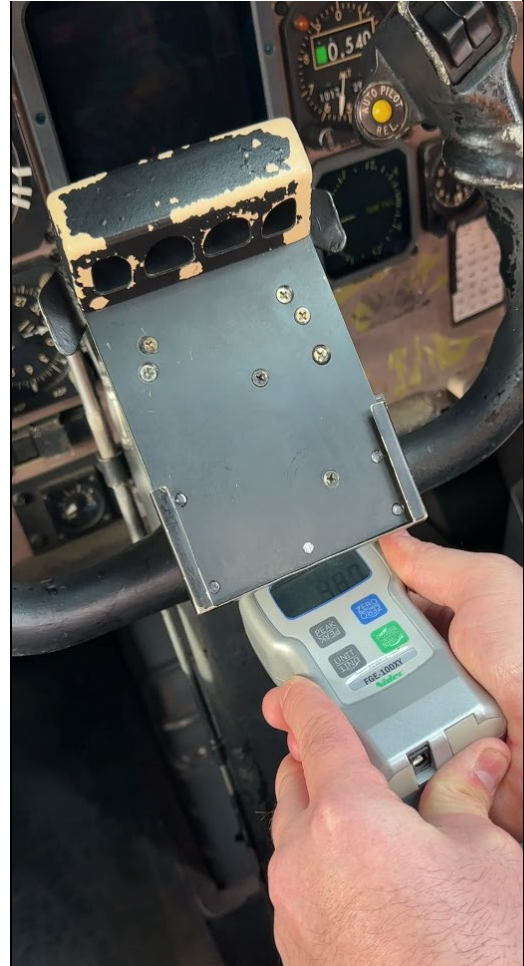
Figure 16: Full forward pressure applied during a normal non-jammed elevator flight control check.
