# National Transportation Safety Board

Edwardsville, Illinois  
March 11, 2022

## **PIPELINE OPERATIONS/INTEGRITY MANAGEMENT**

Group Chair's Factual Report  
Report Date: October 19, 2023

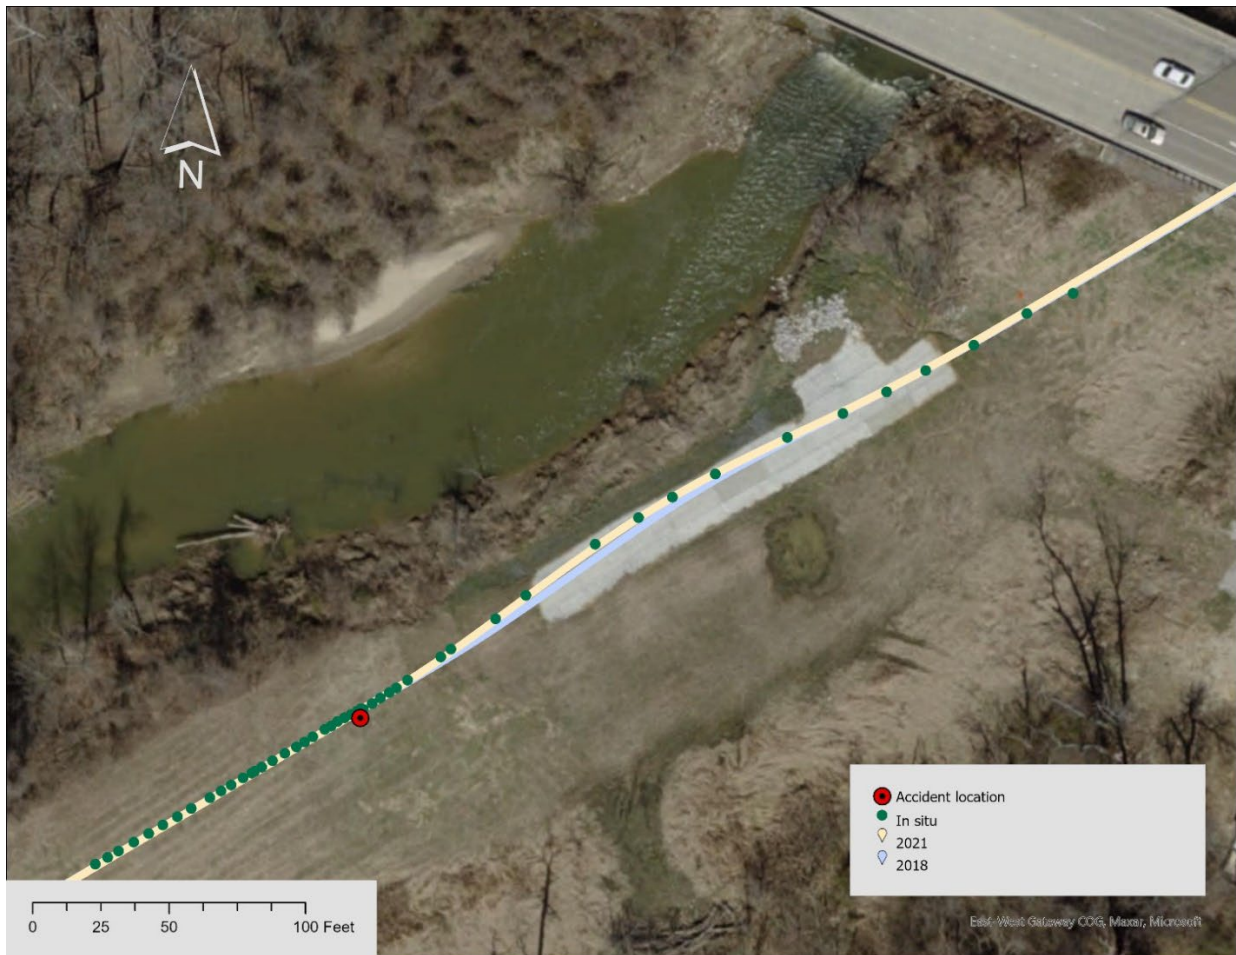
**Figure 4.** GPS survey locations compared to 2018 and 2021 IMU data with a red dot indicating the accident location.

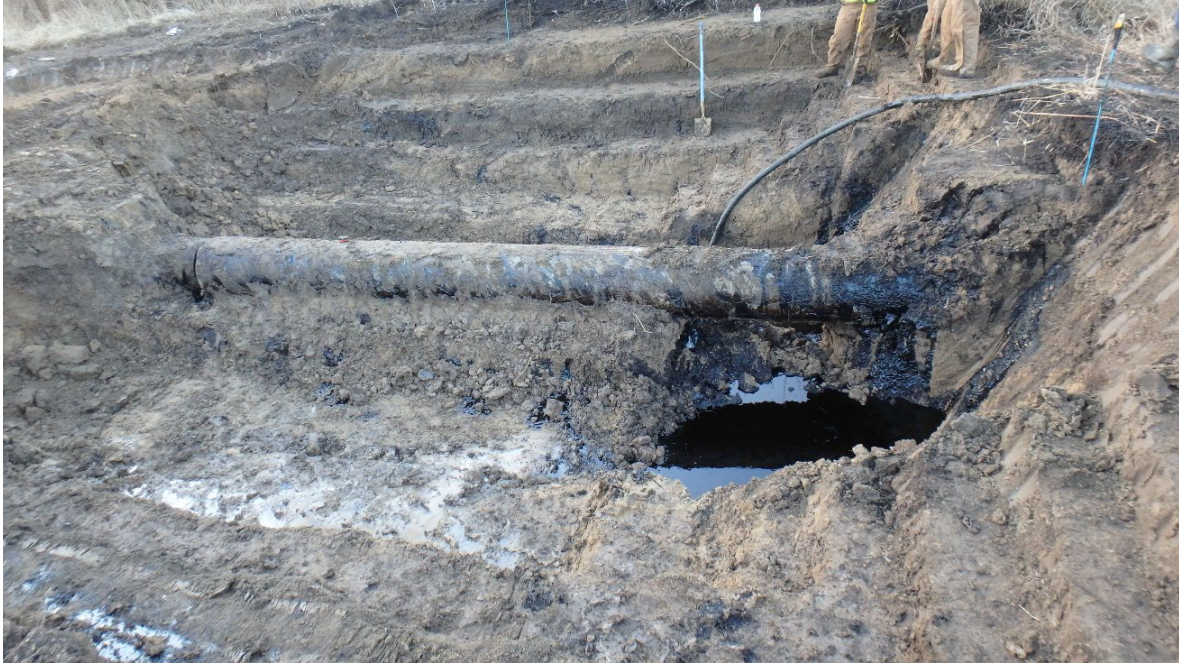
Figure 5. Woodpat pipeline point of failure. (March 12, 2022, 7:26 p.m.)

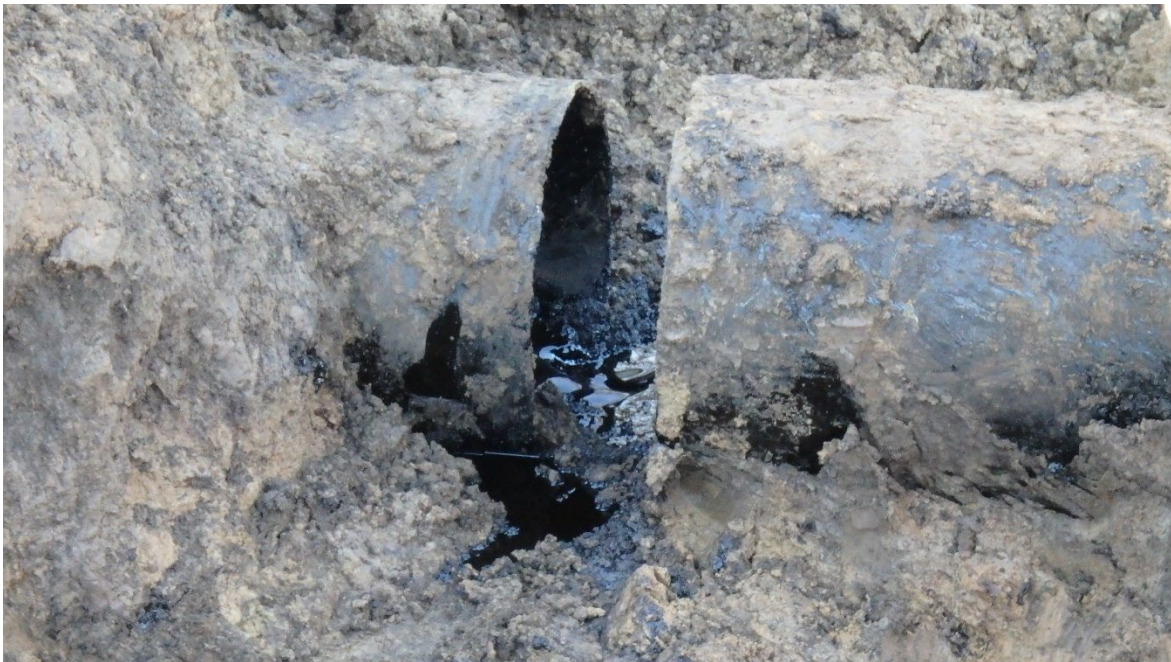
Figure 6. Close up of the Woodpat pipeline separated at the girth weld. (March 12, 2022, 7:00 p.m.)

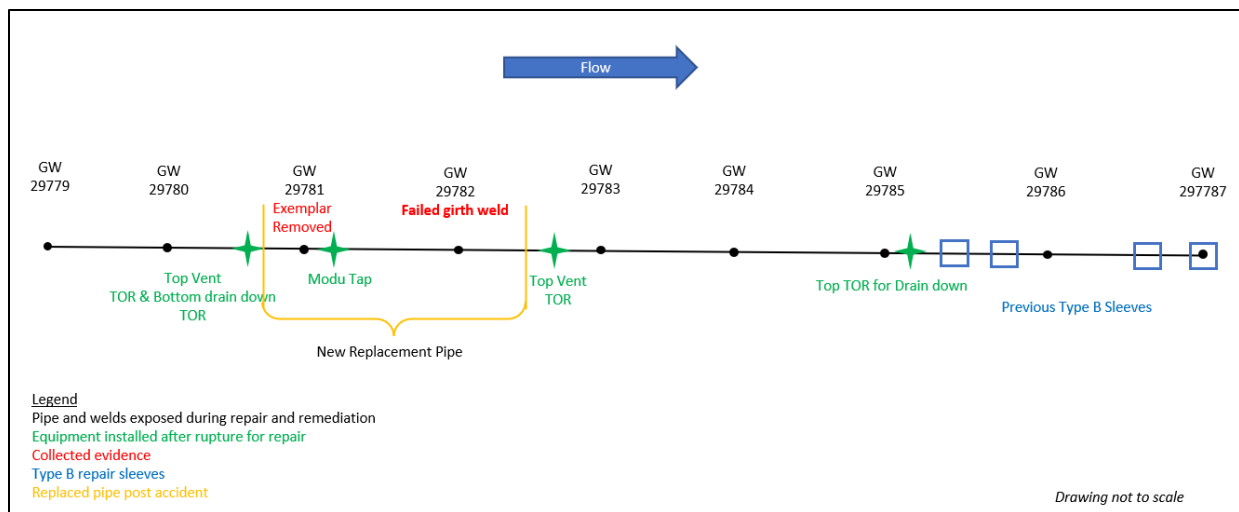
Following the accident, Marathon initiated numerous repairs and remediation activities. Figure 8 is a simplified process flow diagram showing the area of the rupture, from several girth welds upstream of the failed girth weld to several girth welds downstream. As part of the activities to repair and restart the pipeline, Marathon exposed from joint identification (ID) 29779 to 10 feet downstream of Joint ID 29787. Aside from the girth welds removed from Joint IDs 29781 and 29782 for metallurgical testing, all girth welds were non-destructively examined using ultrasonic phased arrays.<sup>34</sup>

**Figure 8.** Simplified flow diagram showing the girth welds upstream and downstream of the failure. (Source: PHMSA.)

After removing joint ID MAPL 29781, and approximately 10 feet of joints MAPL 29782 and 29780, Marathon installed approximately 60 feet of new pipe. This new

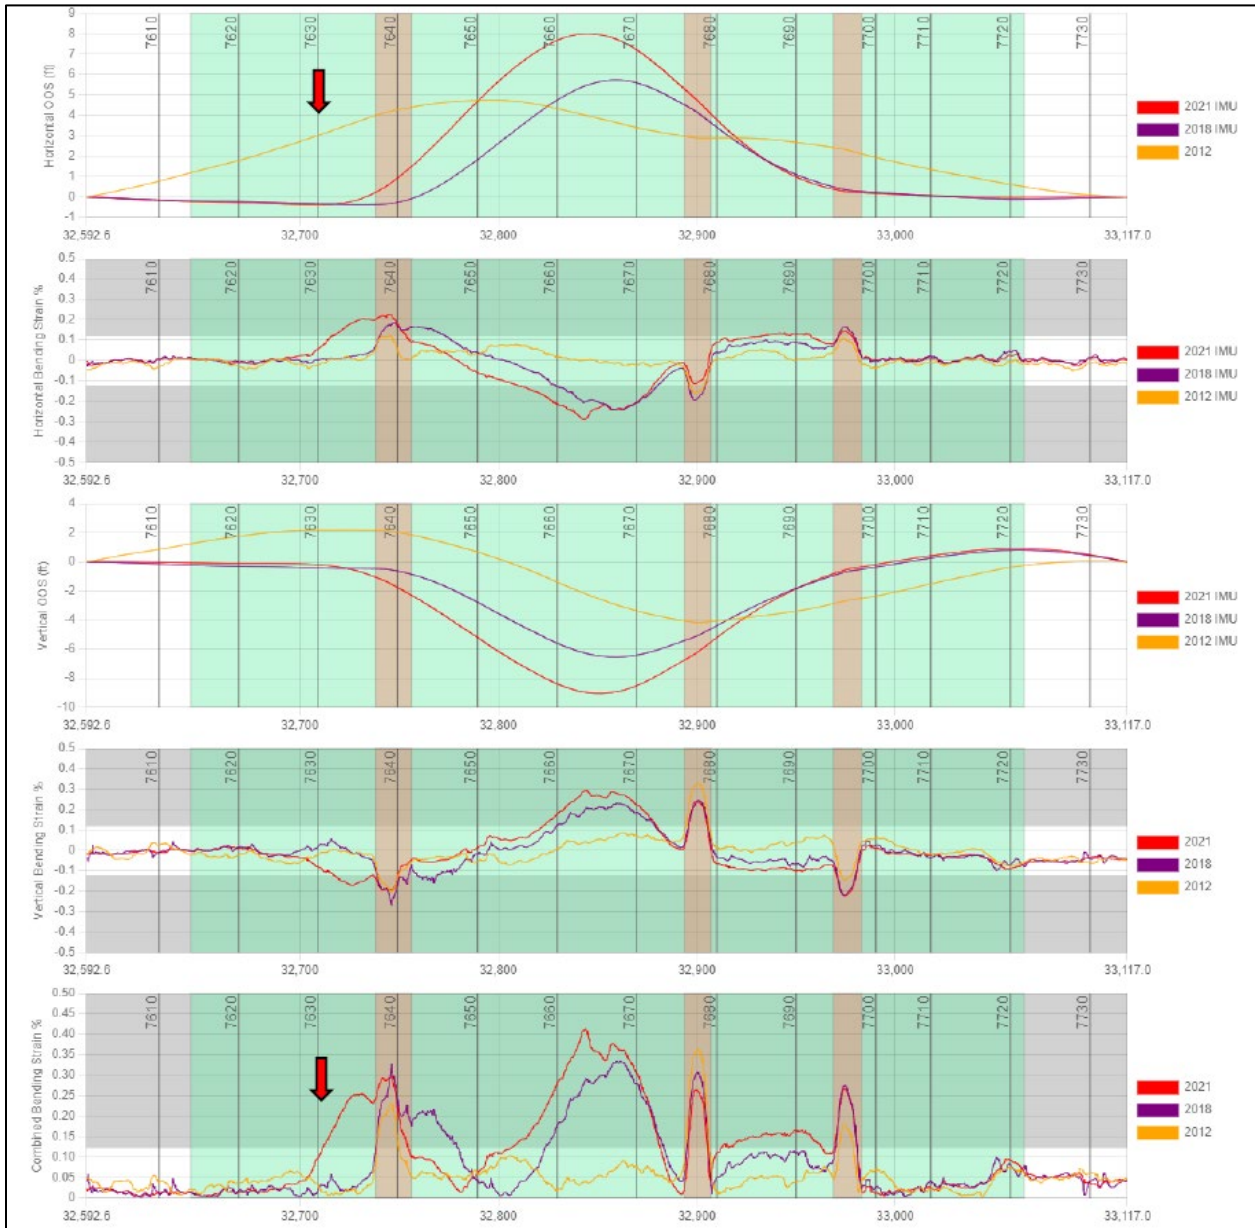
**Figure 9.** IMU data comparisons for 2012, 2018, and 2021. The red arrow indicates the failed girth weld #7630. (Source: ADV Integrity.)

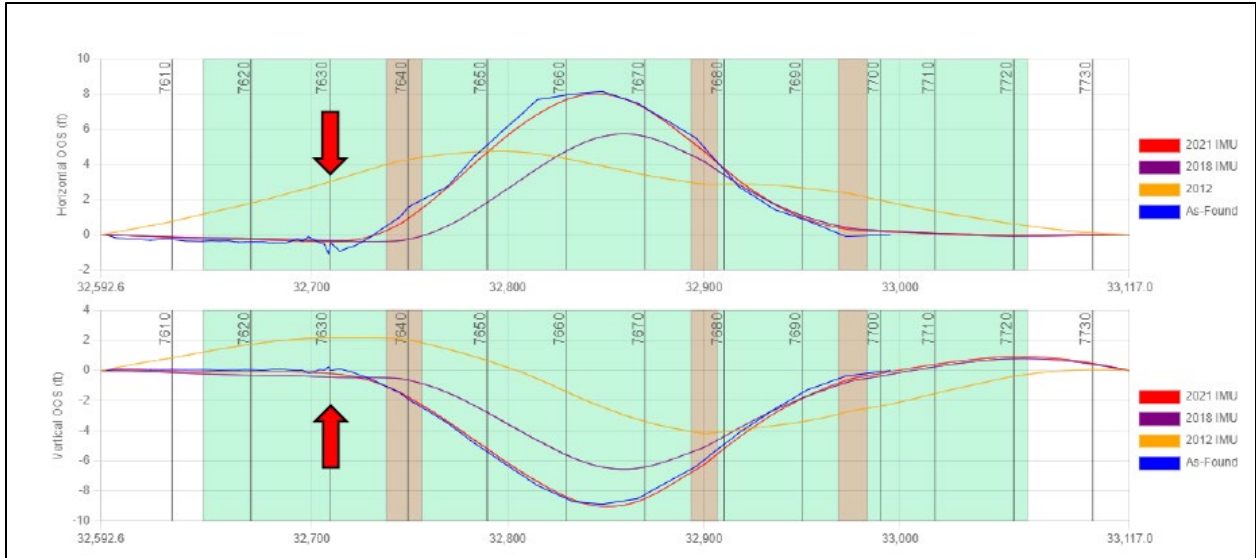
**Figure 10.** Comparison of out-of-straightness from data collected 2012, 2018, 2021, and post-incident. (Source: ADV Integrity.)

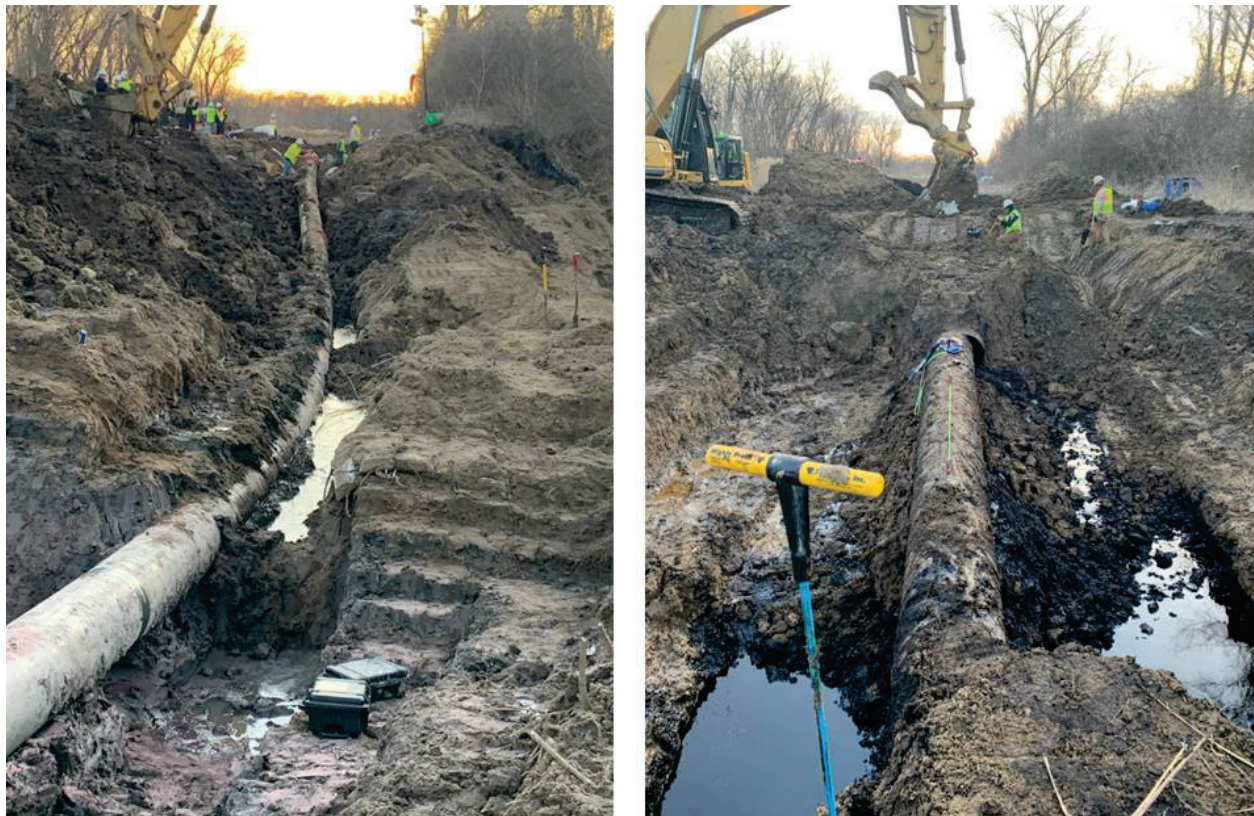
Figure 1.1: Failed Girth Weld During Excavation

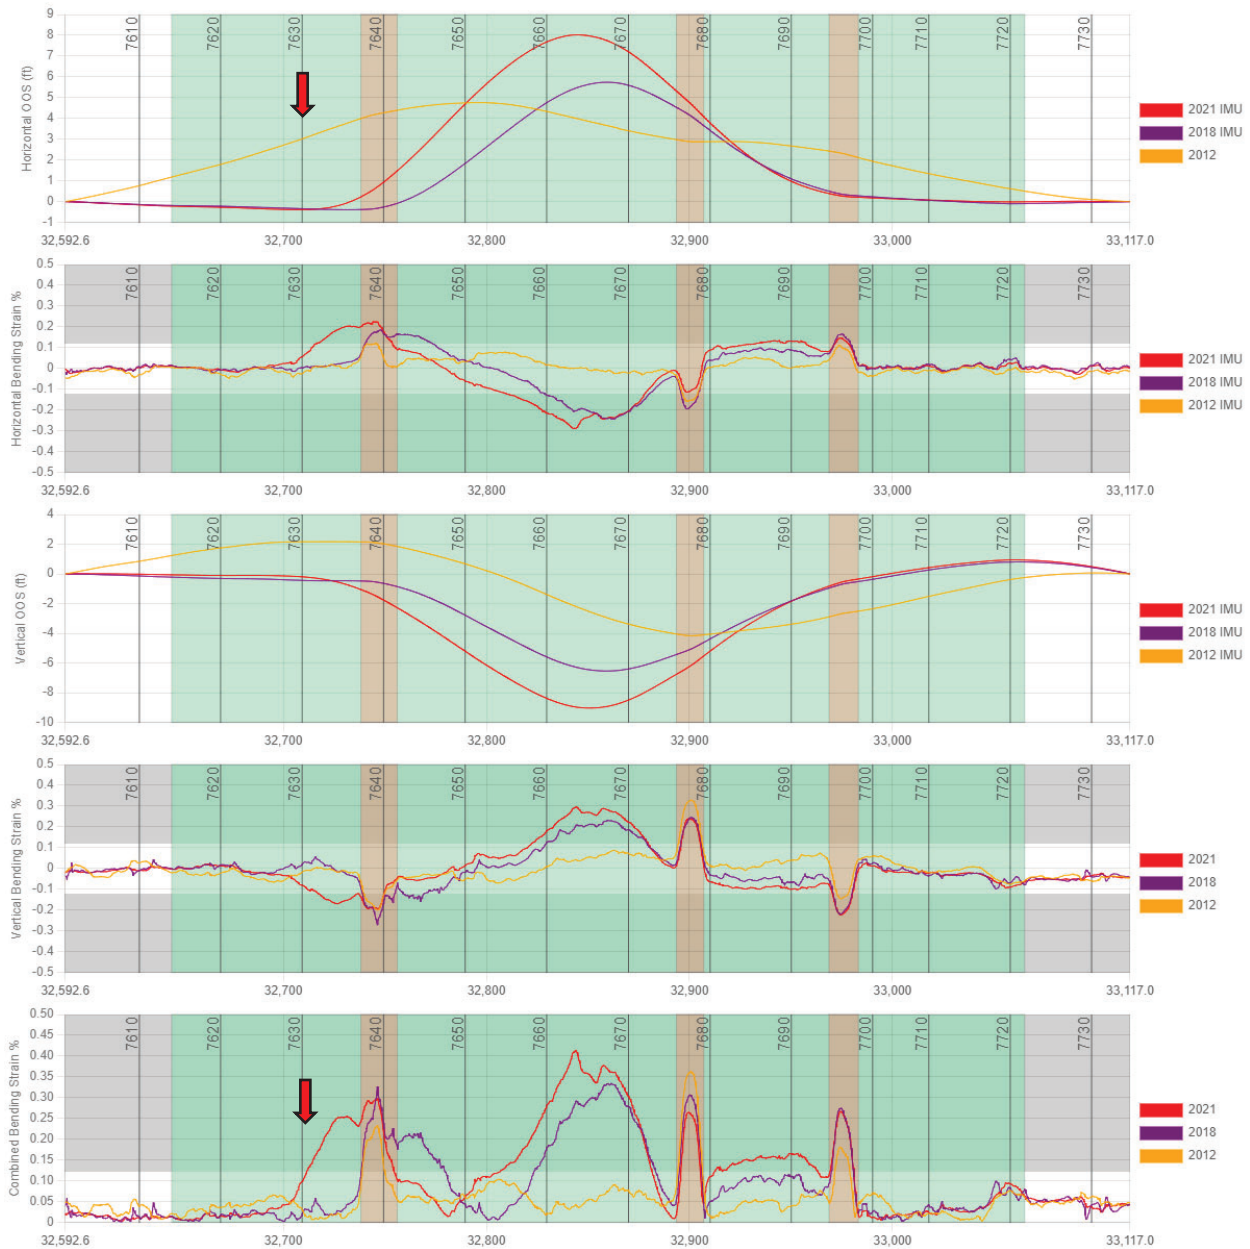
When comparing the strains in Figure 3.2, a clear progression in the horizontal, vertical, and combined strains is evident from 2012 to 2018 and from 2018 to 2021. This data confirms that the pipeline was experiencing external loads and being subjected to both horizontal and vertical movement in the time between 2012 and 2021.

**Figure 3.2: IMU Comparison for 2012, 2018, and 2021**

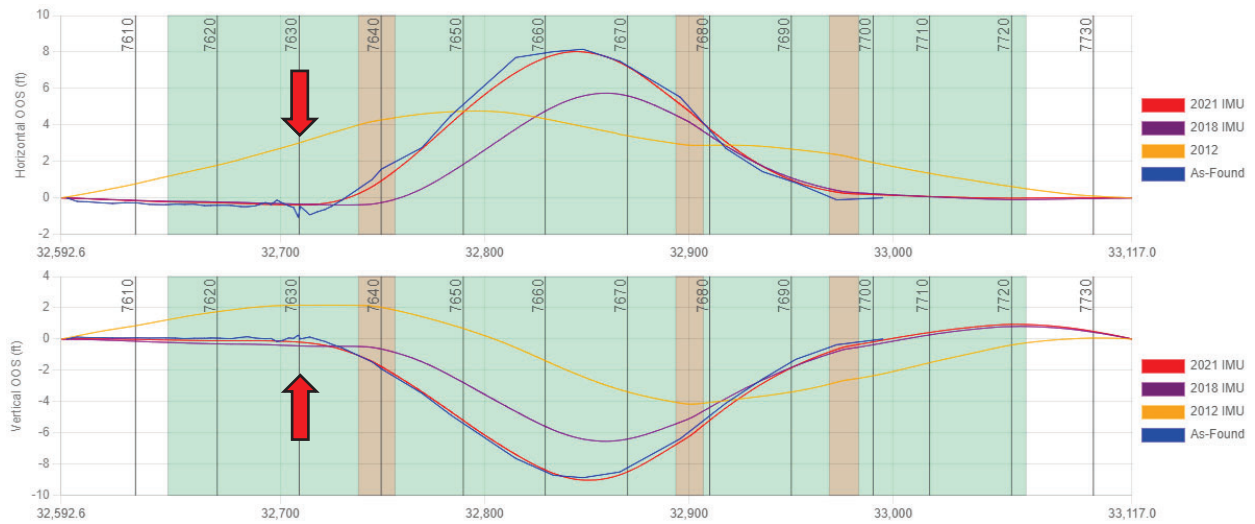
The information from the as-found survey was aligned and overlaid with the available IMU data sets. The comparison for the horizontal and vertical out-of-straightness profiles are shown in Figure 3.7. The survey information shows that the Woodpat pipeline exhibited slight additional movement after the 2021 survey with a total horizontal out-of-straightness of 8.2 feet. The vertical out-of-straightness did not show a measurable difference when compared to the 2021 IMU data set with a total vertical deviation of 9-feet.

Figure 3.7: As-Found Survey

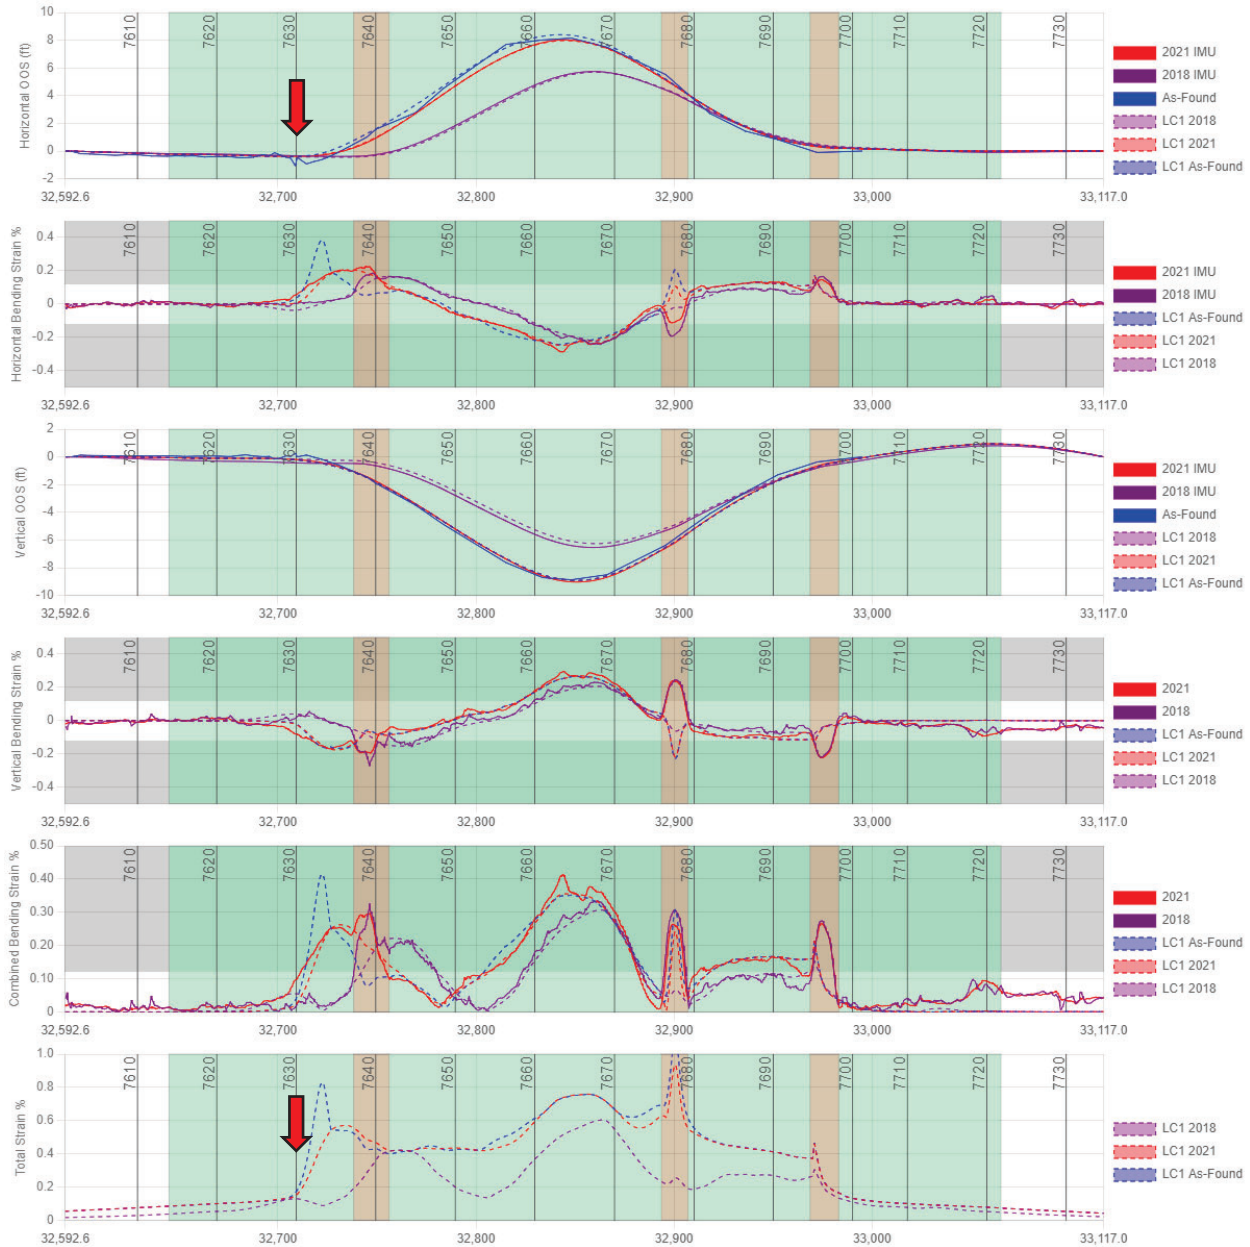
In summary, the comparison for Load Case 1 shows that the horizontal bending and total strains changed rapidly near the upstream flank of the landslide adjacent to the location of the failed girth weld. While the actual total strains are 0.18% at the location of the failed girth weld, the peak total strain occurs less than 10-feet away from the girth weld. Given the uncertainties with the precise position of the WoodPat pipeline prior to failure with respect to the landslide extents, it is possible that the strains were as high as 0.83% in the weld if the upstream flank of the landslide is shifted slightly upstream from where it is located based on the 2021 IMU data.

**Figure 5.2: Load Case 1, Upper Bound Undrained, Results Comparison**

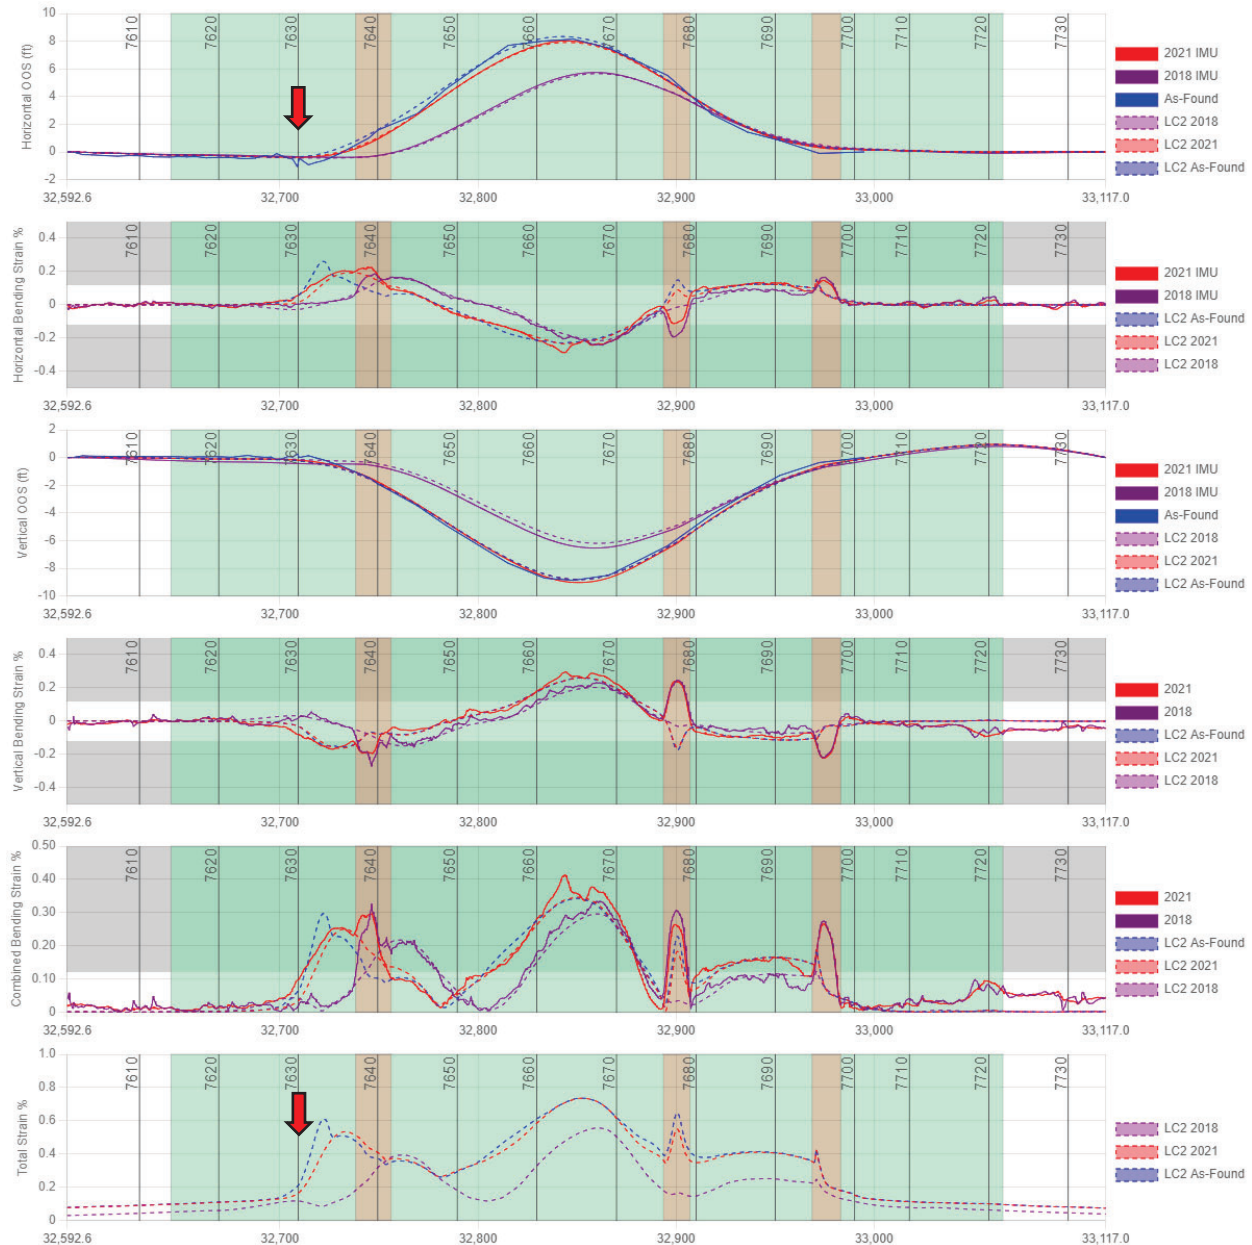
With respect to the out-of-straightness plots, the results from Load Case 2 are nearly identical to the results from Load Case 1. Both the horizontal and vertical out-of-straightness plots show excellent agreement with the 2018, 2021, and as-found data sets. However, the results do show differences in the horizontal, combined, and total strains. The sharp peak observed in Load Case 1 is more muted for Load Case 2 with lower overall strains near the upstream flank of the landslide. The horizontal bending strain near the upstream flank is 0.26% while the total strain is 0.61%. The strains are lower for Load Case 2 because the axial and bending resistance of the soil is weaker for the lower-bound load properties. The weaker properties delay the formation of the plastic hinge, but do not prevent its formation.

Figure 5.3: Load Case 2, Lower Bound Undrained, Results Comparison

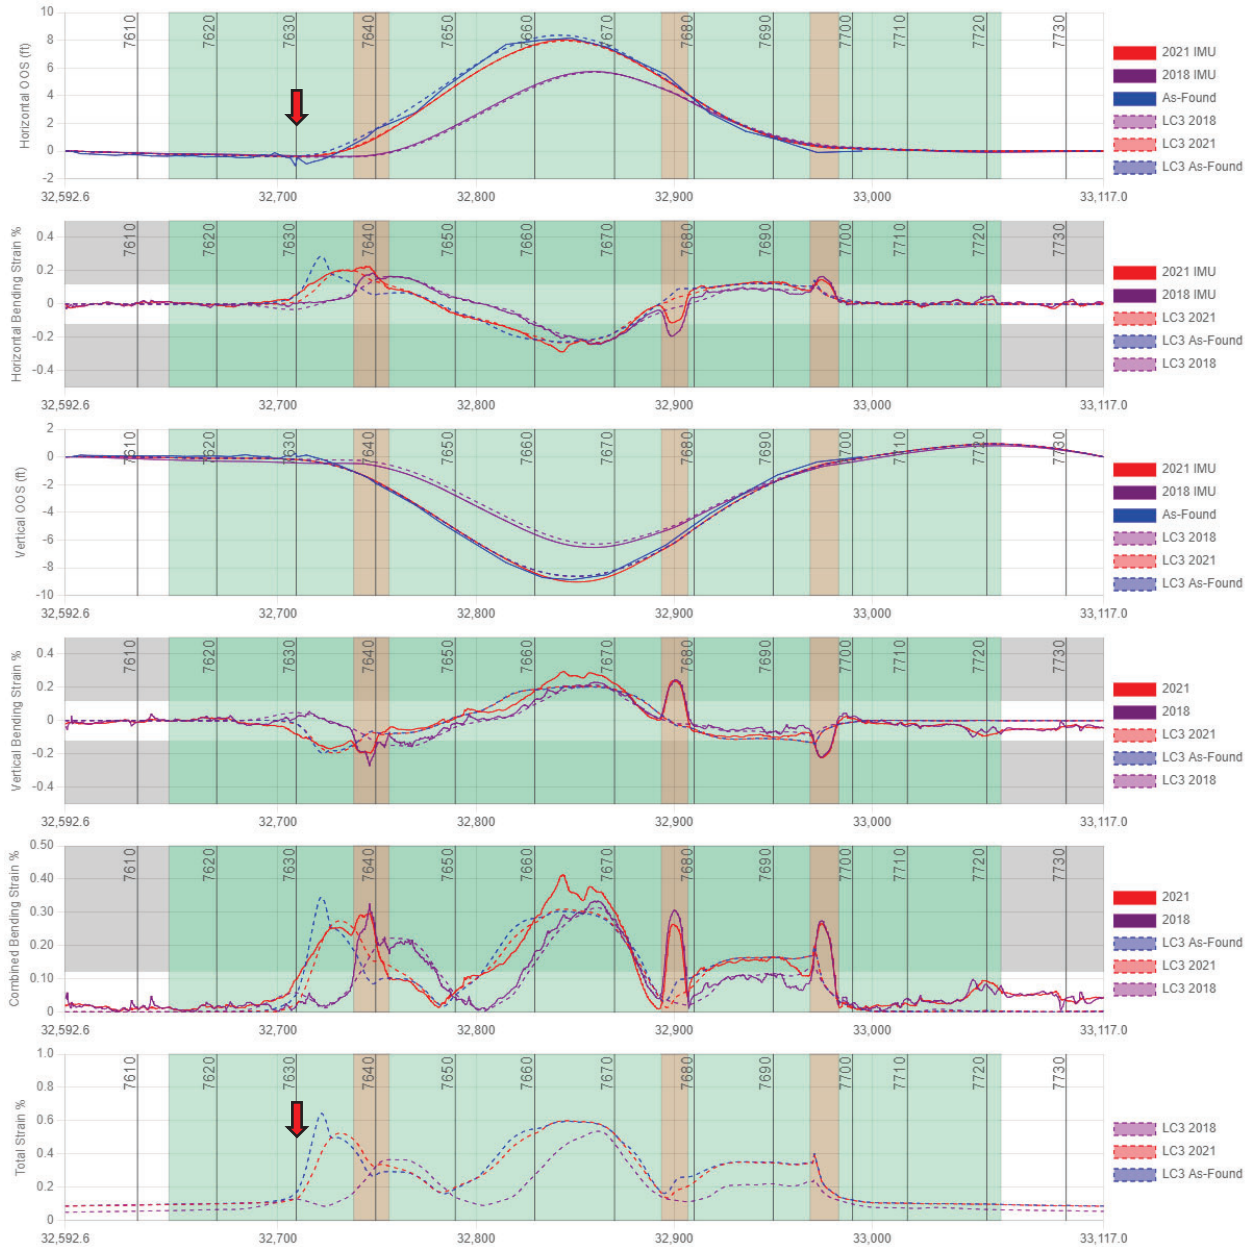
Regarding the strains, the results from Load Case 3 show similar results to Load Case 1. A localized peak in the strains is evident near the upstream flank of the landslide. The horizontal bending strain near the upstream flank is 0.29% while the total strain is 0.64%. These strains are slightly lower than the results for the upper bound undrained properties in Load Case 1.

Figure 5.4: Load Case 3, Upper Bound Drained, Results Comparison

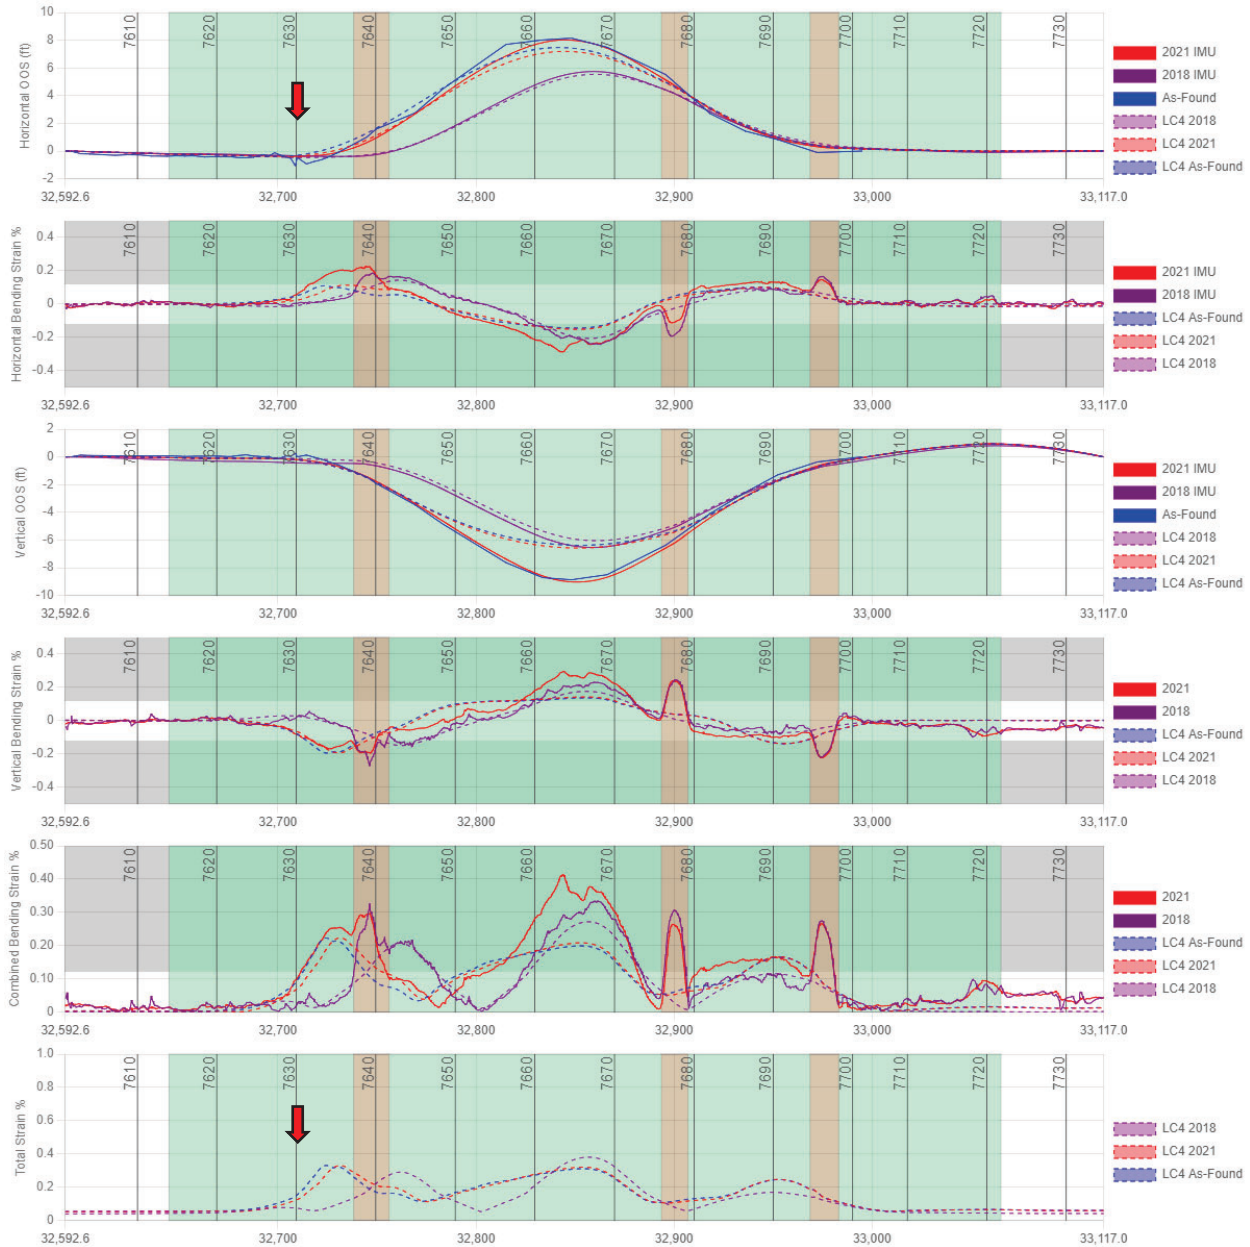
Regarding the strains, the results for Load Case 4 show significantly lower strains than the other load cases. The vertical and horizontal strains for the 2021 condition show poor agreement with the IMU data. While additional modifications to the soil properties may provide improvements to the comparison, it is unlikely that the vertical displacements will be able to be calibrated. These results indicate that the lower bound drained properties are not an accurate representation of the conditions observed at the failure location based on the 2021 IMU data and information collected at the time of failure. Therefore, the results from Load Case 4 were disregarded for future use.

Figure 5.5: Load Case 4, Lower Bound Drained, Results Comparison

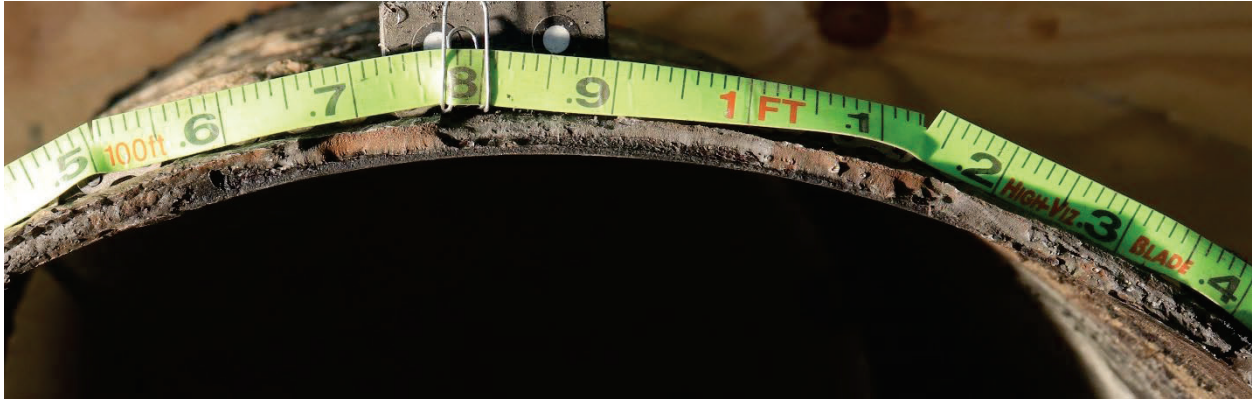
- Incomplete Penetration, 0.5-inch long, 4:15 to 4:21 o'clock orientation (24.5 inch to 25 inch)
  - Metallurgical depth 1.3 mm
- Incomplete Fusion, 0.5-inch long, 6:54 to 7:00 o'clock orientation (39.75 inch to 40.25 inch)
- Burn through, 0.25 inch long, 9:20 to 9:23 o'clock orientation (53.75 inch to 54 inch)

**Figure 1: Photograph of fracture surface. Numbered scale divisions are inches.**

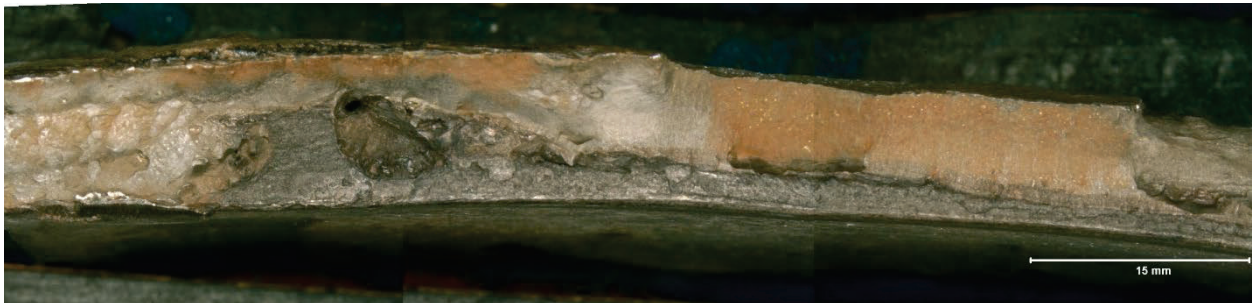
**Figure 2: Photograph of fracture surface.**

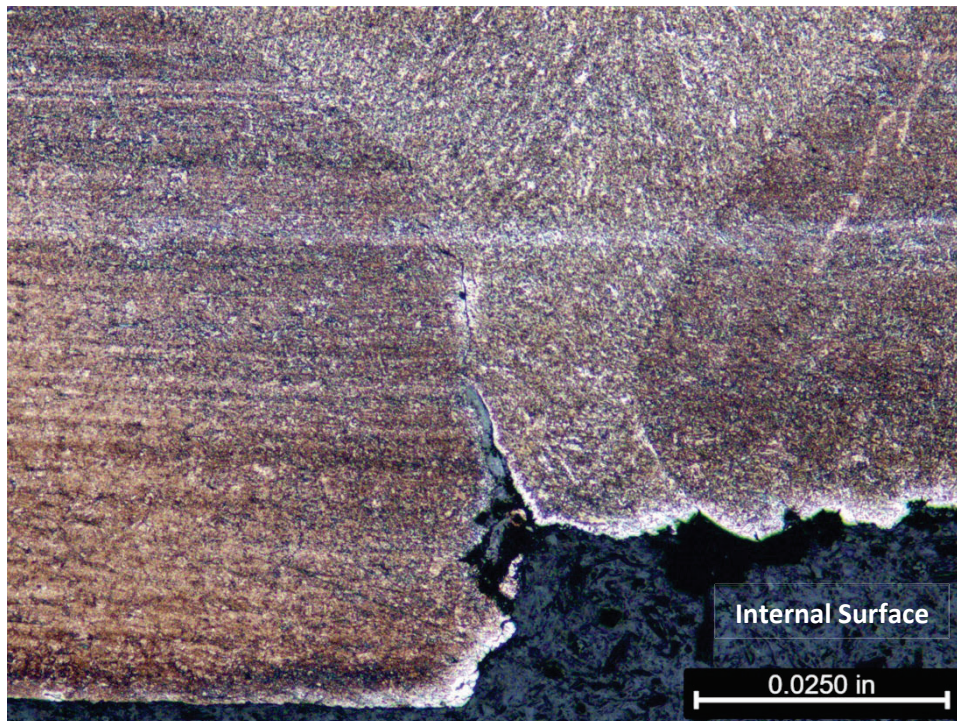
Figure 11: Photomicrograph of girth weld feature present along the internal surface of the 3:00 o'clock cross section. Etchant is 2% Nital; original mangification is 50x.
