NATIONAL TRANSPORTATION SAFETY BOARD

Group Chairman's Factual Report

OPERATIONAL FACTORS

CEN19MA190

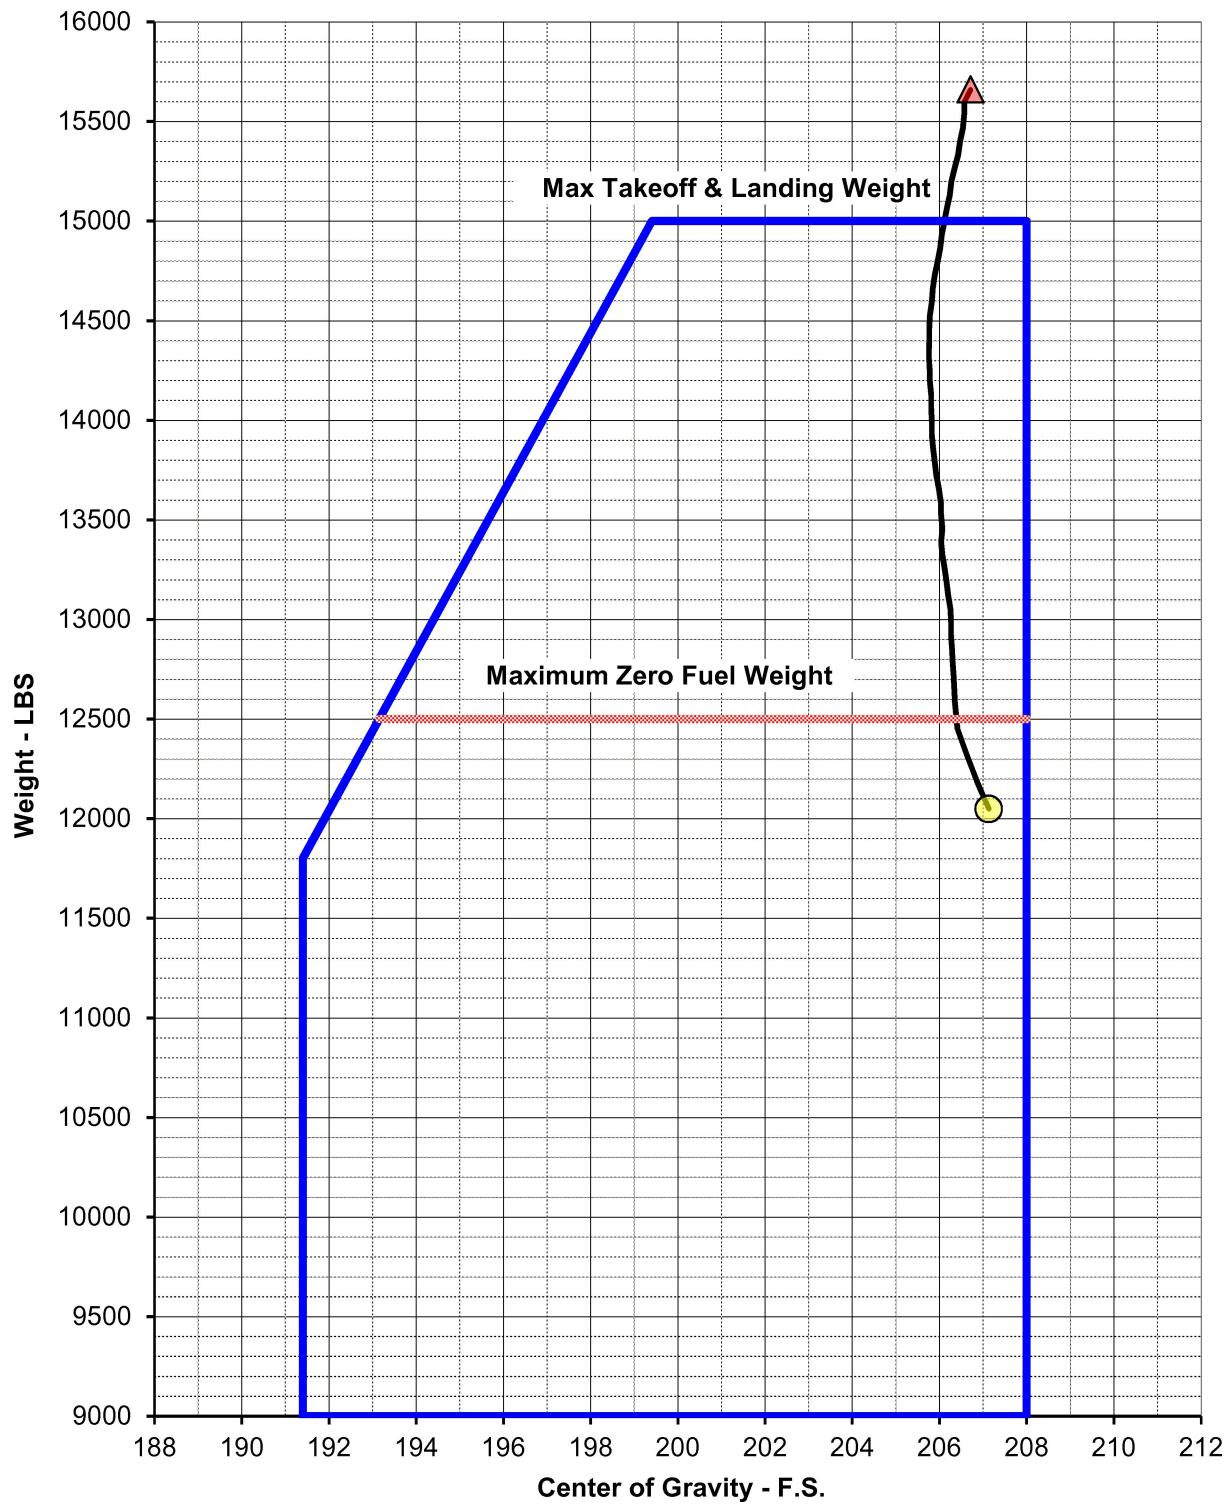
The maximum takeoff and landing weight for the accident airplane was 15,000 lbs. The estimated ramp weight prior to departure was 15,660 lbs. The computed center of gravity was 206.71 inches aft of datum (208.0 inches aft of datum was the aft limit).

Weight (lbs)	Arm (in)	Moment (in-lbs)
Zero Fuel Weight	12,049	207.13	2495831.15
Total Fuel Weight	3,611	205.32	741400.00
Ramp Weight	15,660	206.71	3237231.15
