## **EL PASO LINE 2000 CONVERSION**

## Response to NTSB Request from Kinder Morgan

SUBJECT: Line 2000 Hydrotest Ruptures

Hydrotesting Line 2000 during the months of August and September produced four ruptures at MPs 487.5, 493.1, 496.9, and 498.6. All of the ruptured pipe sections were submitted to the Metallurgy Lab for analysis. Although operational background information on this line is unavailable, the pipe is nominally a 30 inch OD, 0.303 inch wall thickness, X70, manufactured by Bergrohr.

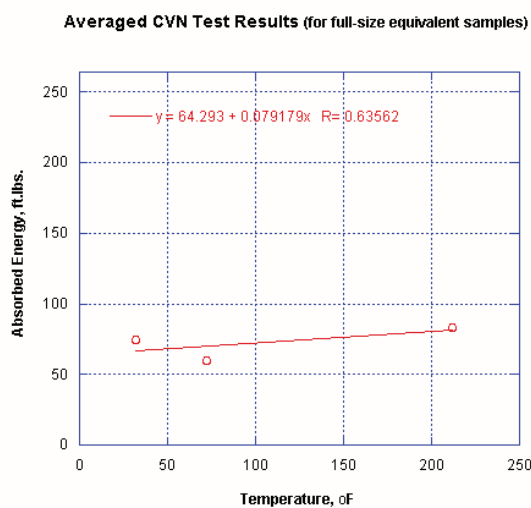
Figure 1. CVN test results for Line 2000 pipe material.

Figure 1 portrays the Charpy V-Notch test results for test temperatures up to 212°F. These results satisfy the API5L Supplementary Requirement 5 (SR5) for minimum shear area, while the absorbed energy values at 32°F averaged 75 ft-lb for a full size equivalent sample size. The chemical analysis results are listed under Table II.

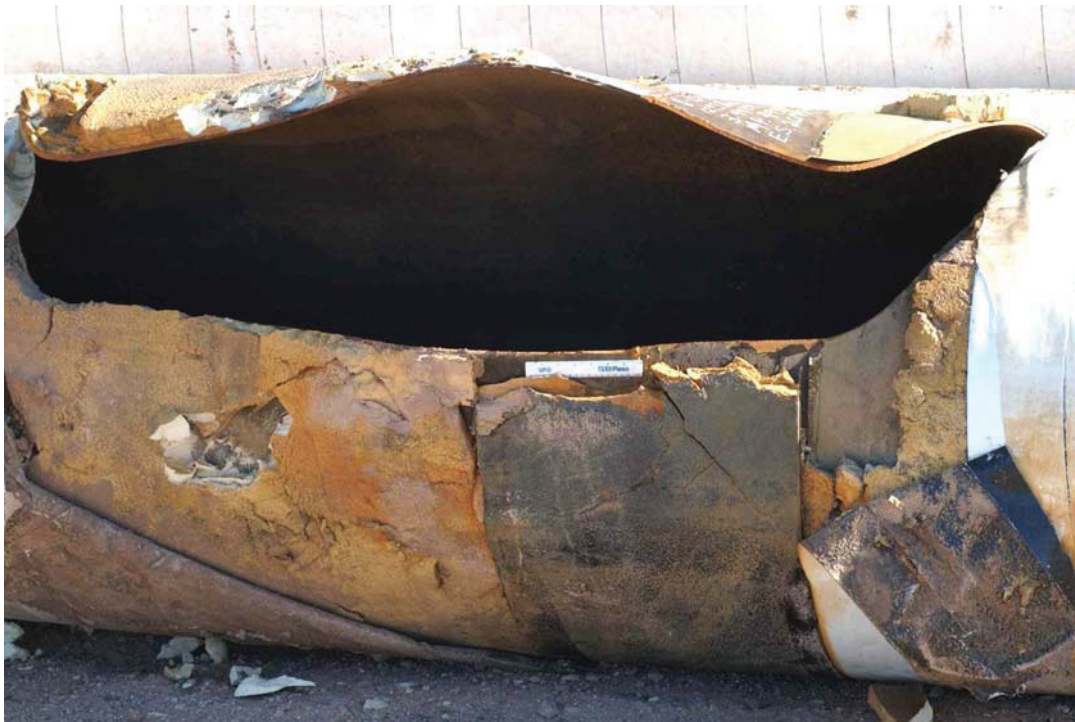
All four ruptures are primarily oriented axially with a significant portion of the rupture planes demonstrating shear fracture conditions. Photograph 1, showing the rupture at MP 493.1, is generally representative of the macroscopic fracture evidence observed at each of the other rupture sites. The predominance of the shear fracture zones confirms high fracture toughness of the pipe material, while the axial portions of the rupture interfaces signify coincidentally the presence of the rupture initiation sites in association with at least two conditional states: 1). The presence of pre-existing (original manufacturing) defects and 2). Corrosion enhanced wall thickness reduction. Details of the axial portions of each of these ruptures are shown in Photographs 2-6. The rupture at MP 487.5 is revealed in Photographs 2 and 3, which document a pre-existing defect condition in the form of an unbounded interface or part-wall defect and at least some portion of a lamination (see arrow locations in Photographs 2 and 3). The defect conditions representative of the MP 493.1 rupture are revealed in Photograph 4. These linear features are associated with inclusion chains and possibly center-line segregation,

Photograph 1. Representative documentation of the hydrotest rupture at MP 493.1.

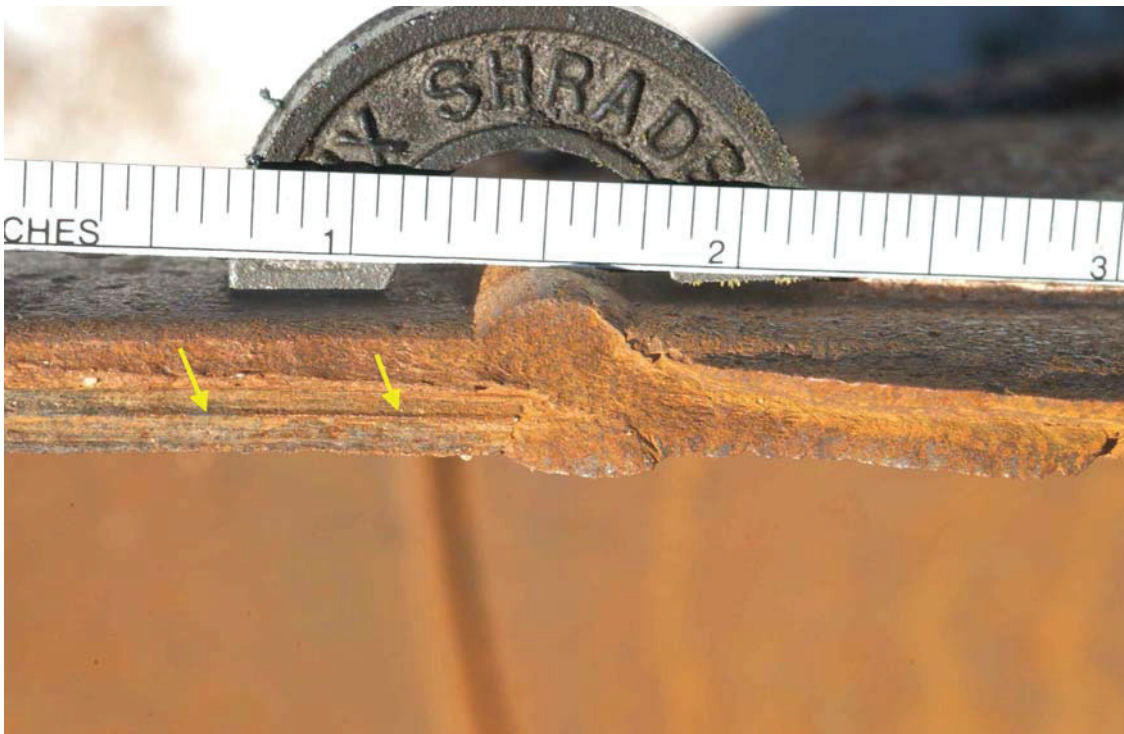
Photograph 2. A portion of the hydrotest rupture surface at MP 487.5 showing the part-wall defect (arrows).

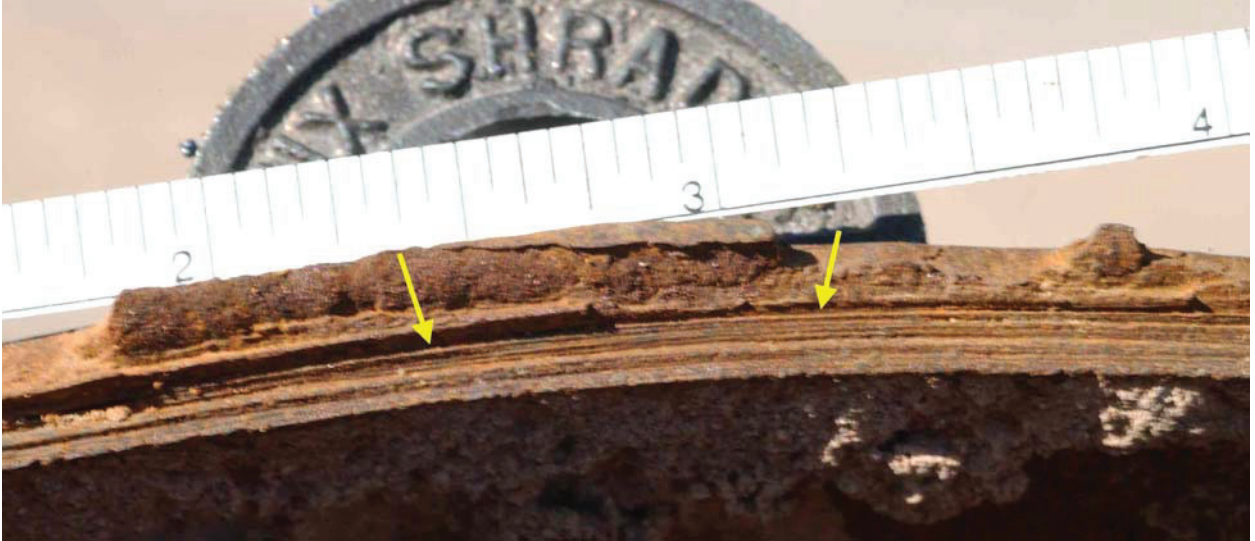
Photograph 3. Another portion of the hydrotest rupture surface at MP 487.5 showing more of the part-wall defect (arrows).

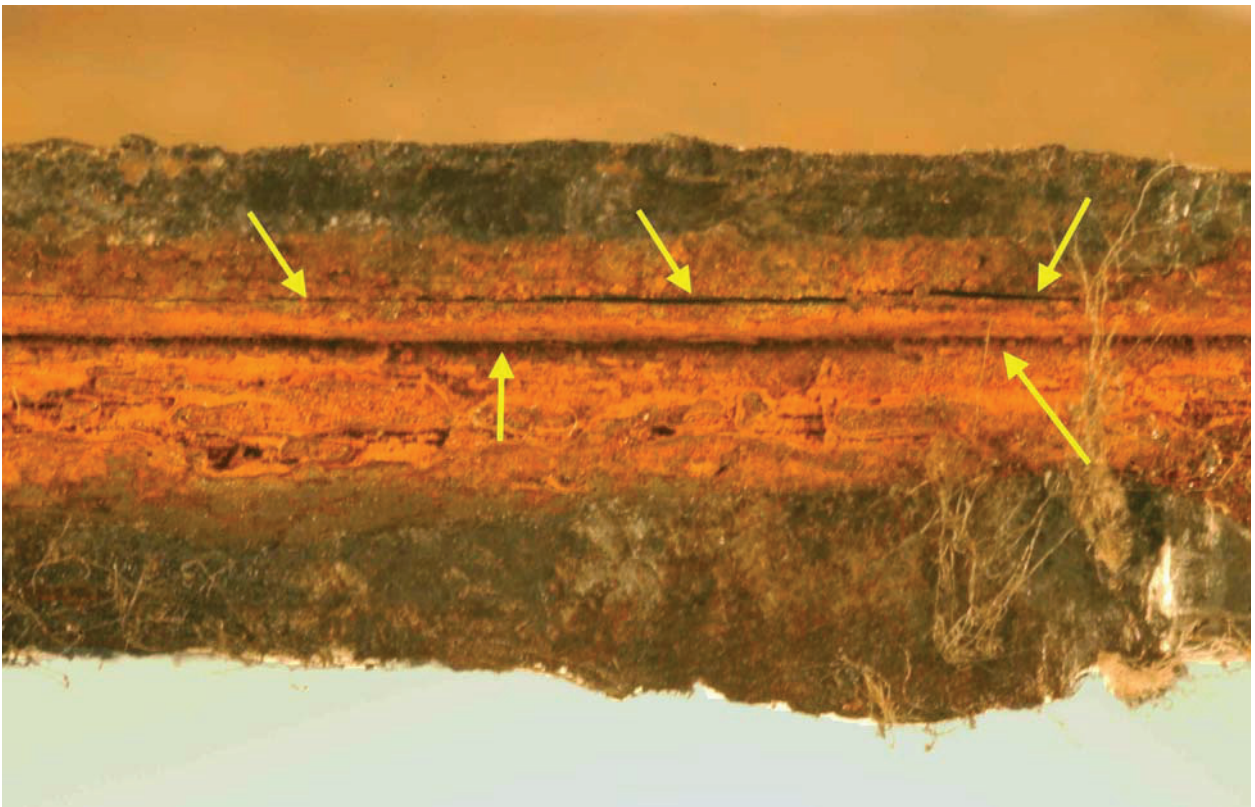
Photograph 4. A portion of the rupture surface at MP 493.1 showing the intersection of two laminations. Approximately 6X.

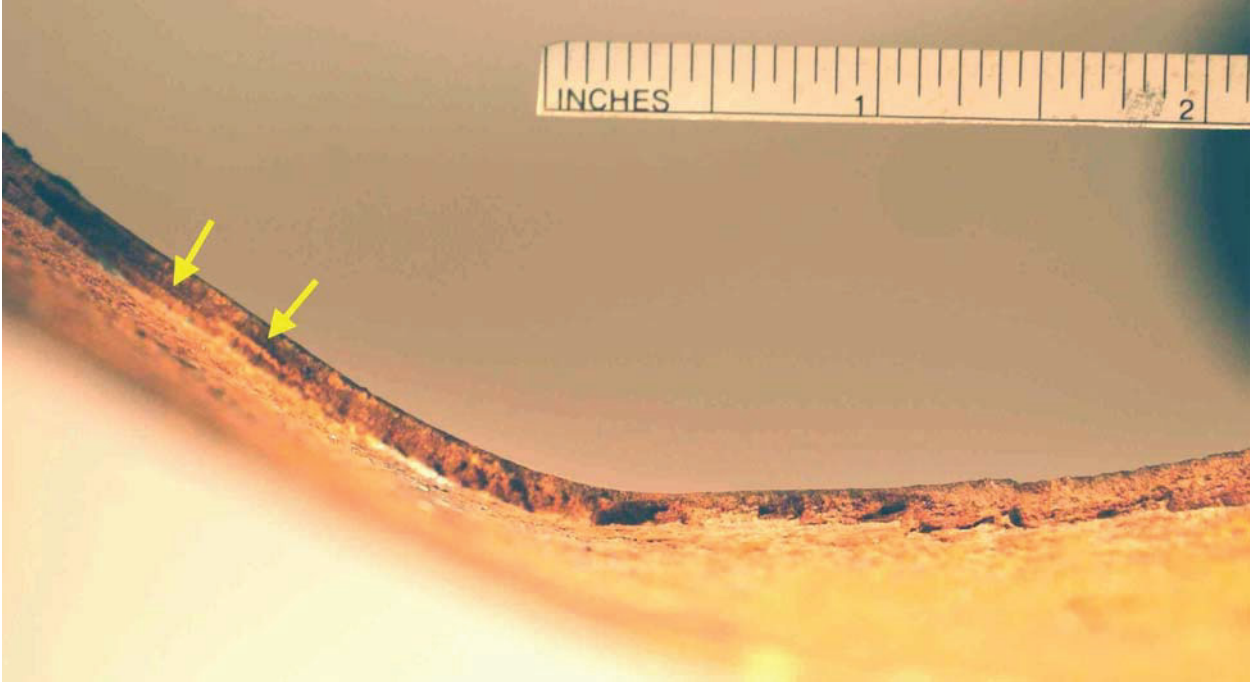
- RSTRENG analysis showed that the external corrosion damage observed at MP 496.9 had reduced the safe maximum operating pressure to 917 psig and projected a burst pressure of 1273 psig. The actual rupture pressure was slightly higher at 1303 psi.
- Since the hydrotests exposed the original manufacturing defect conditions, and recognizing that all remaining defects should be sub-critical in size, additional work on this line is not anticipated at this time.
- Due to the extent of OD corrosion observed at the MP 496.9 location, historical documentation of the CP history and related information should be examined for all piping downstream of former heating stations. The coating at this site may have been particularly effective in shielding the pipe, since it consisted of an inner tape coating, a polyurethane foam insulation layer, plus a heavy tape outer layer, possibly Polyken 956-30.

Photograph 5 shows a portion of the rupture interface for MP 496.9, which reveals significant wall loss (58.8%) due to external corrosion damage. The external coating system used on this portion of the piping was a multi-layer tape system with urethane foam insulation. Small lamination defects can also be observed in Photograph 5.

Photograph 5. A portion of the rupture surface at MP 496.9 showing significant wall loss due to external corrosion and a shallow lamination (see arrows).

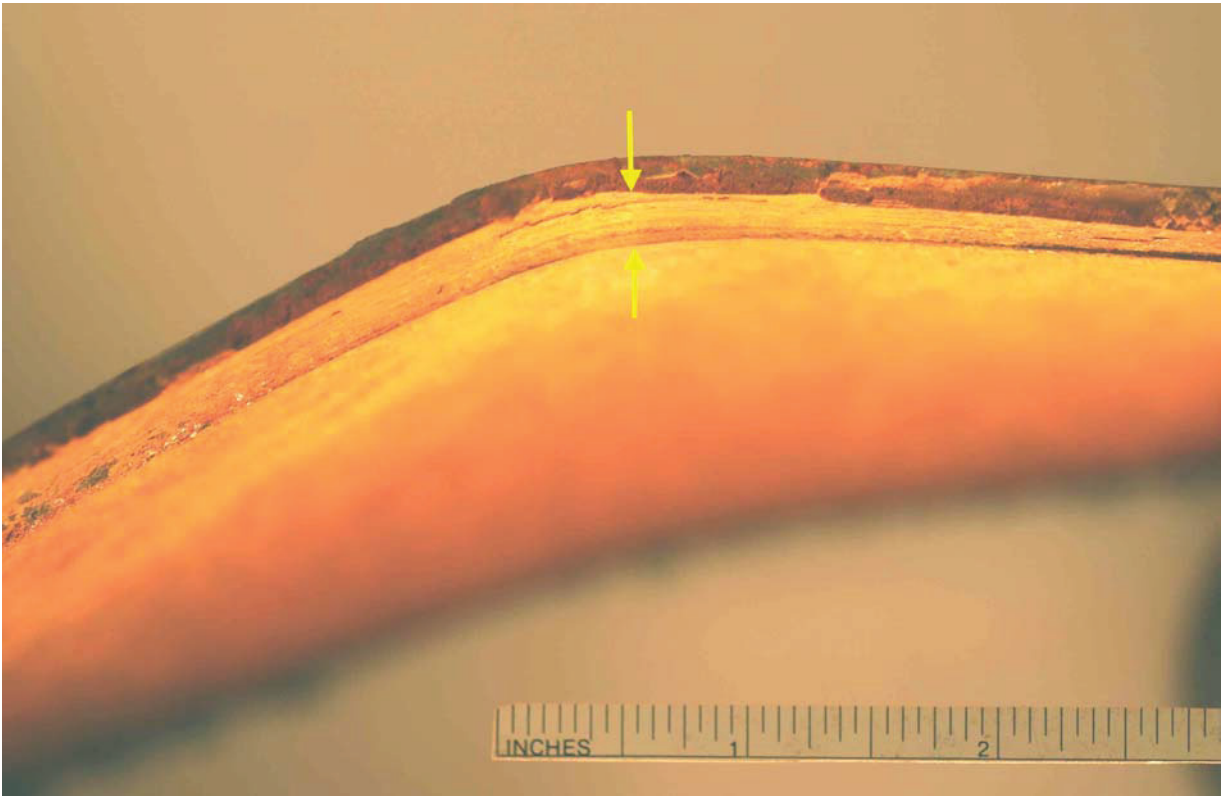
The rupture at MP 498.6 is shown in Photograph 6. The scalloped contour of this rupture interface is due to a lamination, which was approximately 0.7 inches wide. Since the dimensions of this lamination were measurable, fracture mechanics was utilized for this defect condition.

Photograph 6. A portion of the rupture surface at MP 498.6 showing exposure of the contained lamination (arrows).

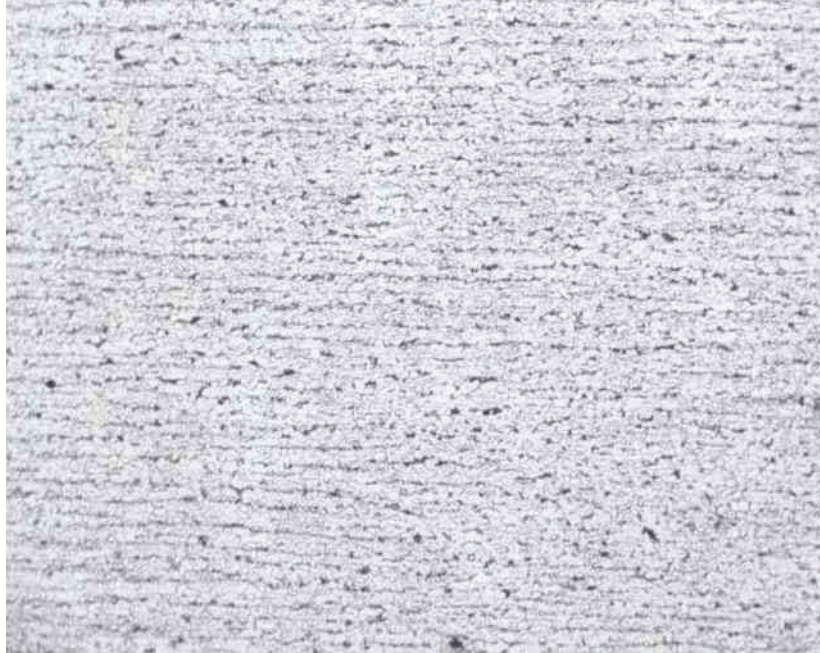
Transverse metallographic sections were prepared for three of the four failures, with each intersecting the approximate hydrotest rupture origins. Photographs 7 and 8 provide details of the general microstructural features representative of pipe comprising this Bergrohr production. The pipe material represents fine-grained steel, generally banded and alternating in very thin layers of ferrite (light) and carbides (dark). Fiberling of small inclusion clusters in linear arrays was also observed. The ASTM grain size equivalent for the ferritic grains is 10+, which serves to optimize strength and fracture toughness (see mechanical test results). The sectioning on the rupture at MP 487.5 documents the size and distribution of the inclusion clusters found intersecting this portion of the rupture interface. Photographs 9-11 show the inclusions in close proximity to the rupture interface. Since the original slabs that were rolled into plate as a precursor for pipe manufacturing were continuously cast, some portion of the inclusions are probably representative of center-line segregation. However, the general microstructural state is the same that was shown in Photographs 7 and 8.

Photograph 7. Representative microstructural features of the pipe steel at MP 487.5 with fine-grained, banded ferrite and pearlite. 100X. Nital reagent.

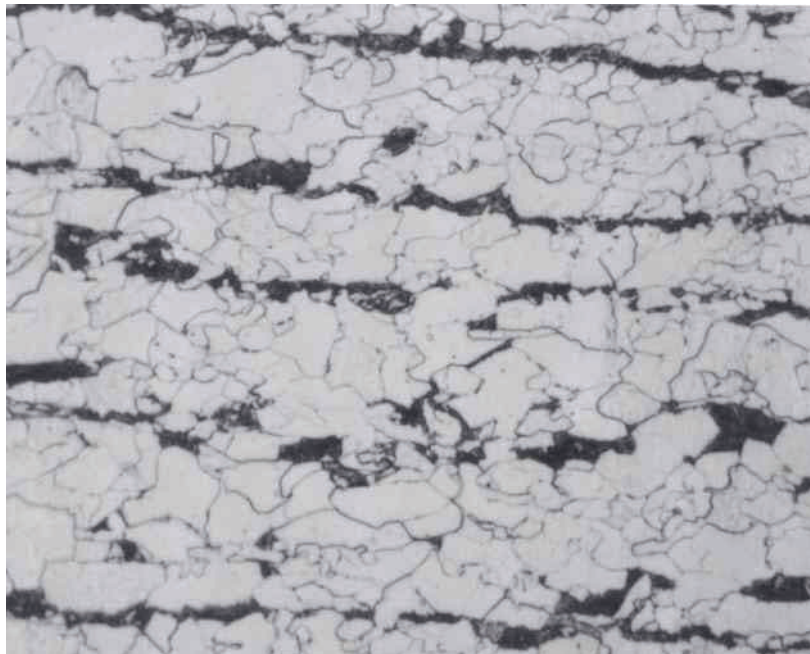
Photograph 8. A close-up of the microstructural features of the pipe steel with alternating layers of ferrite (light) and pearlite (dark). 800X. Nital reagent.

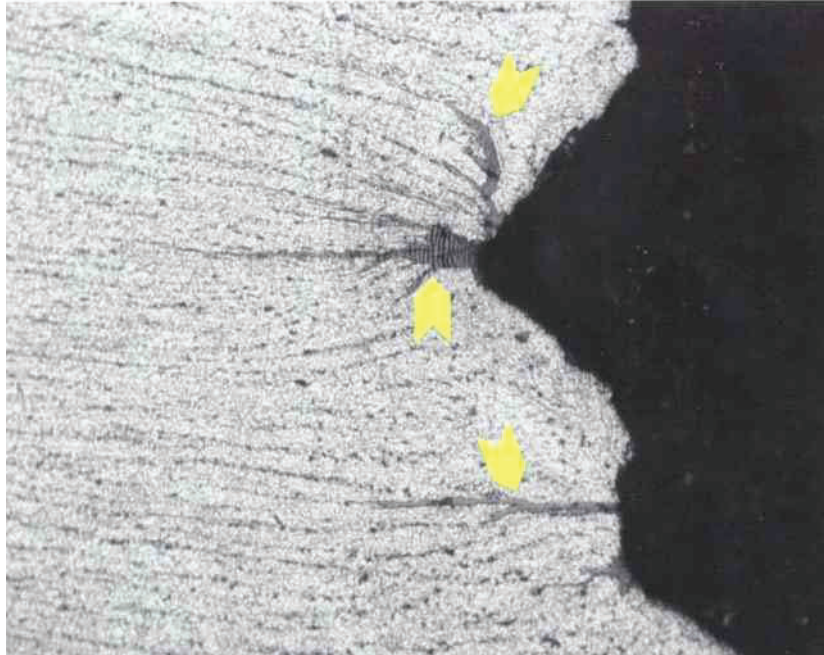
Photograph 9. Representative microstructural features of the pipe steel along the rupture interface at MP 487.5 showing the inclusion enrichment (arrows). 100X. Nital reagent.

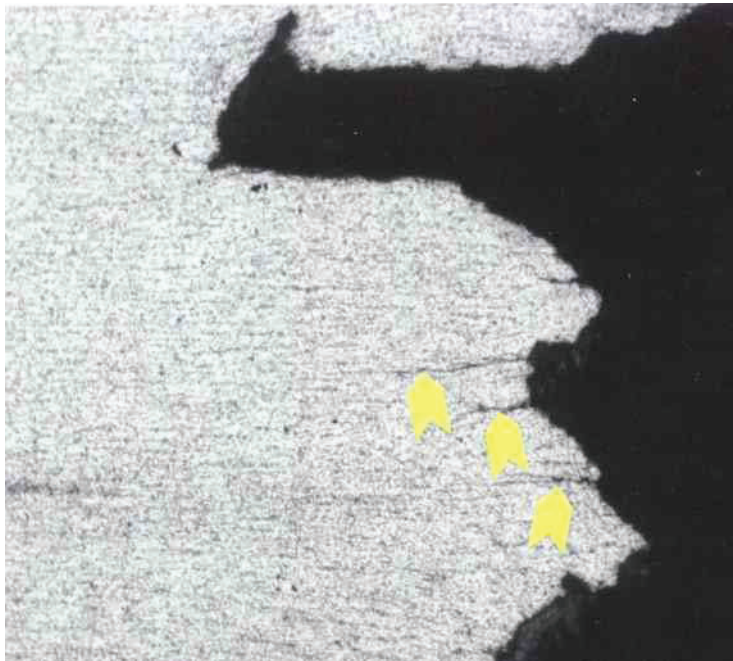
Photograph 10. More general view of the microstructural features of the pipe steel along the rupture interface at MP 487.5 showing the inclusion enrichment (arrows). 50X. Nital reagent.

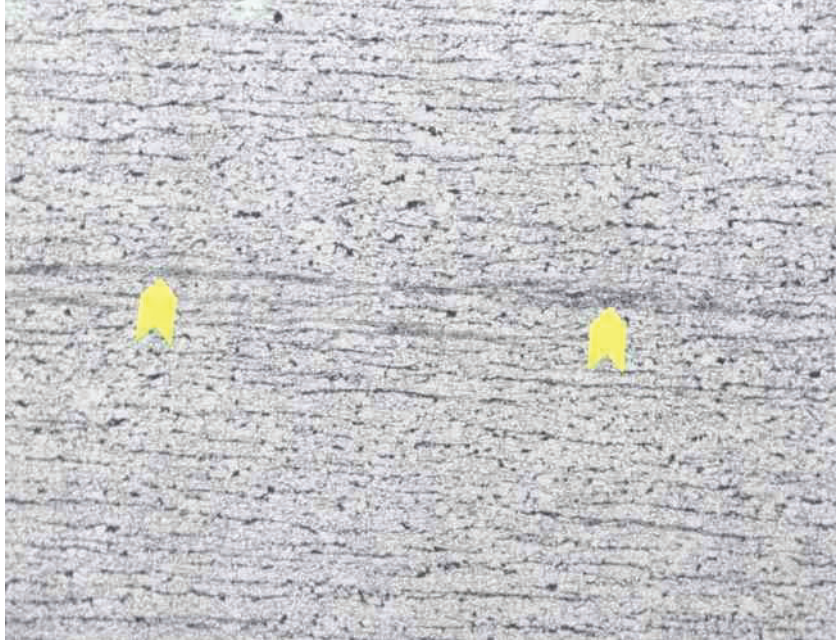
Photograph 11. Representative microstructural features of the pipe steel along the rupture interface at MP 487.5 showing some minor inclusion clusters (arrows). 100X. Nital reagent.

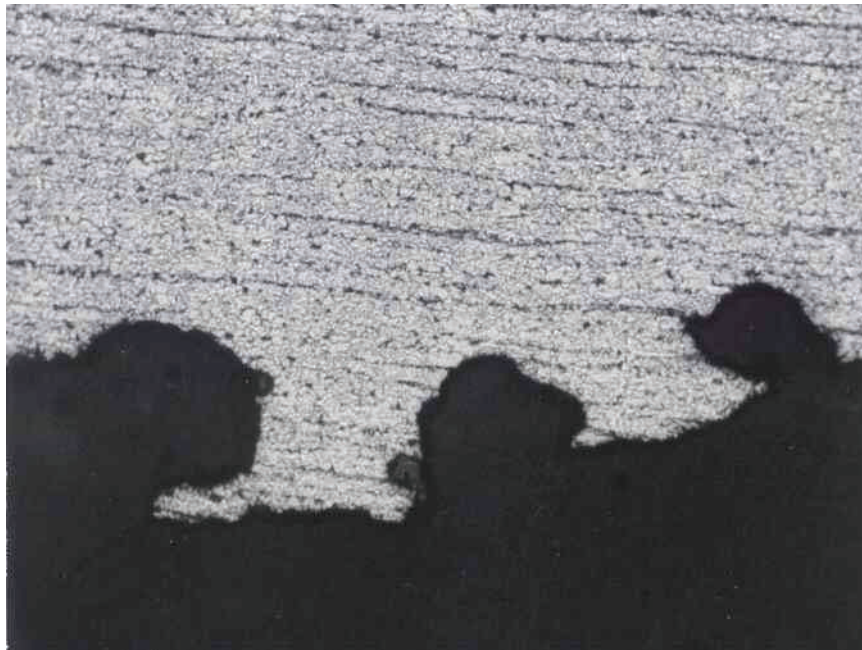
The remaining transverse metallographic section is shown in Photograph 12. As shown in this photograph, the corrosion is in the form of overlapping pits with some demonstration of preferential microstructural corrosion. This rupture site was the only site which demonstrated significant corrosion damage. UT wall thickness readings were performed from the ID-side of the pipe along an axial distance of six-feet adjacent to the rupture. The maximum pit depth was 0.055 inches, while the average pit depth was less at 0.034 inches. RSTRENG analysis for the B31G (Case 3) criterion demonstrated that the safe maximum pressure for this line would have been 917 psig.

Photograph 12. Representative microstructural features of the pipe steel at MP 496.9 OD surface corrosion in the form overlapping pits. 100X. Nital reagent.

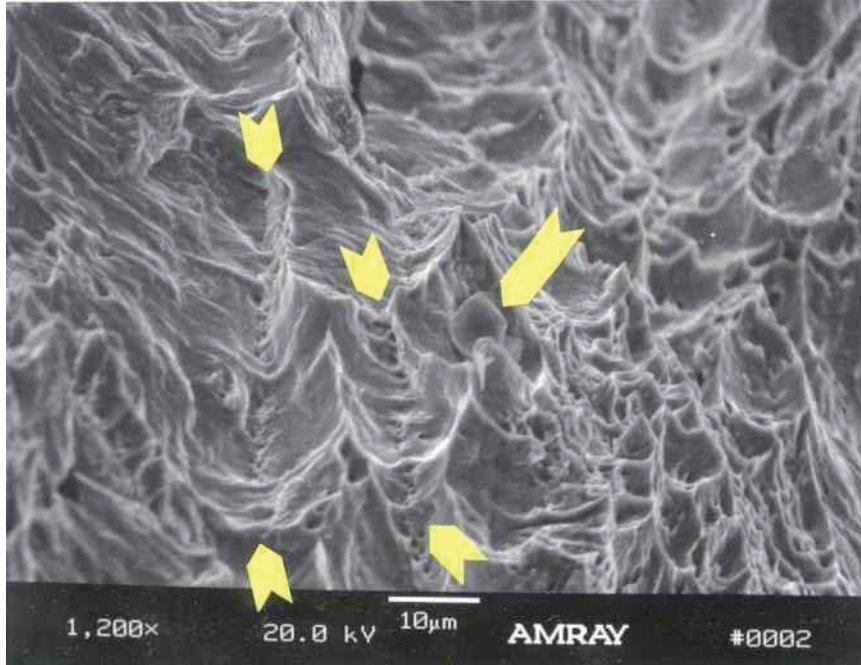
With the impact samples returned from METL, one of the samples was chosen at random and examined using the SEM/EDS system. All of the impact samples demonstrated high proportions of shear fracture evidence as well as mid-span delaminations. In order to understand the fracture characteristics of this pipe steel and the relevance of the fibering or inclusion clusters observed in the microstructural state, a SEM study of one of the fractured impact samples located numerous residual inclusions. One of the inclusions observed is referenced in Photograph 13, which was confirmed by EDS to be mostly a particle composed of calcium sulfide. Since CaO or burnt lime is added during steel production operations to aid in desulfurization, residual CaS dispersed within the steel indicates that the slag-off process was not fully effective. The linear morphology of these inclusion particles is further illustrated in Photograph 13 by noting the two “tracks” of former sites of inclusion particles. The balance of the fracture evidence confirms dimple rupture and shear fracture predominance.

Photograph 13. SEM fractograph showing a CaS particle (large arrow), two linear arrays of former inclusion sites (see smaller arrows), and shear fracture evidence. 1200X.
