# DR-105

## Kinder Morgan Immediate Response to MLV 38

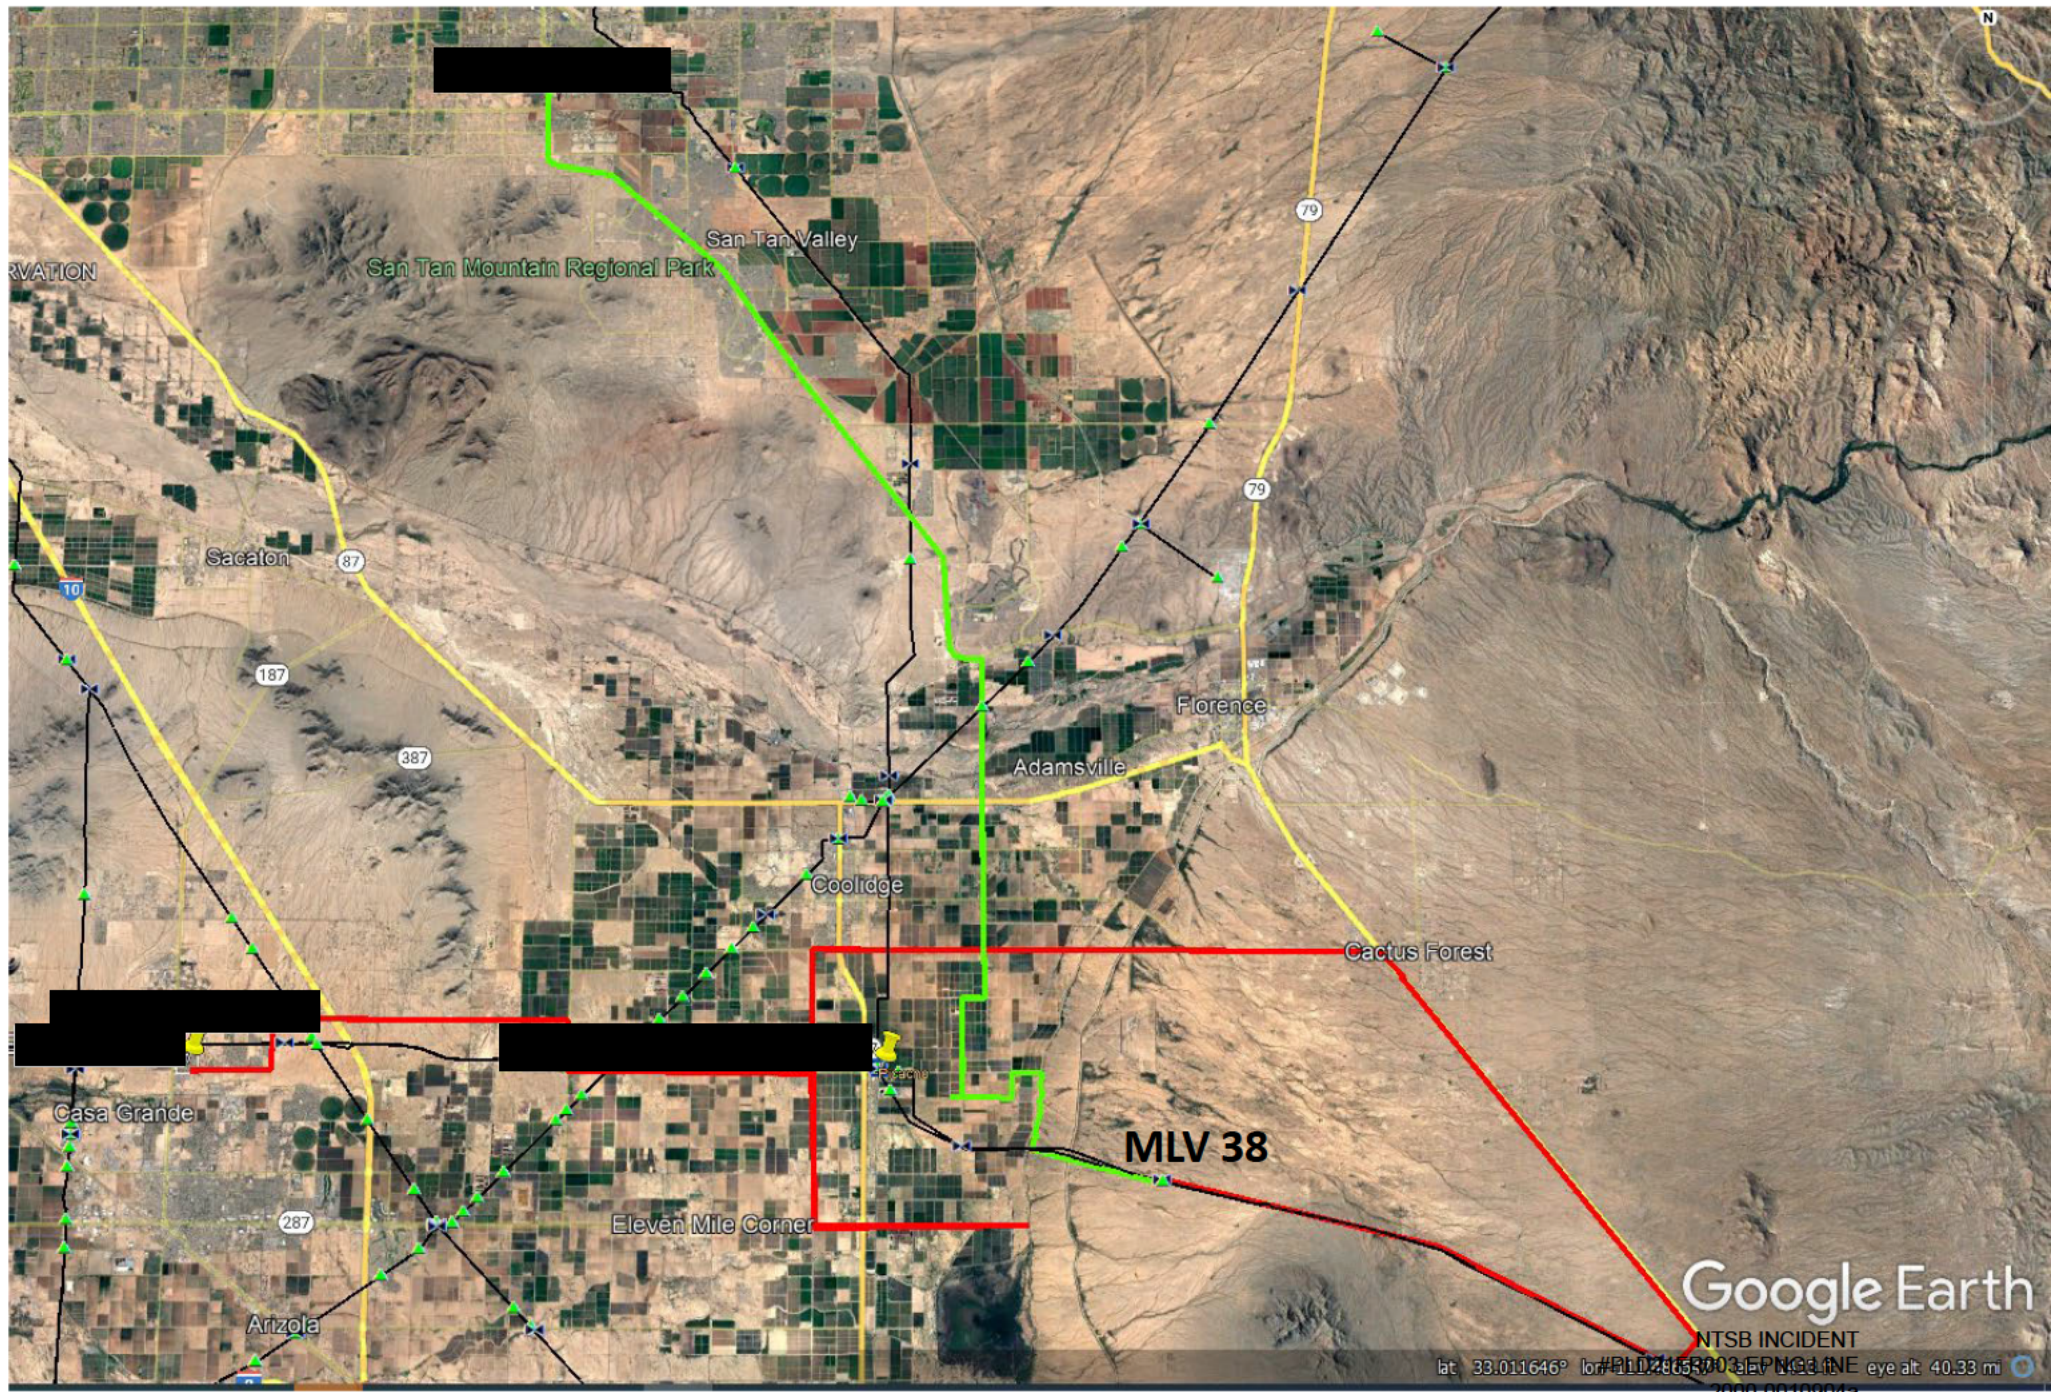
**Line Patroller's  
Route to MLV 38**

**Measurement  
Technician's  
Route to MLV 38**

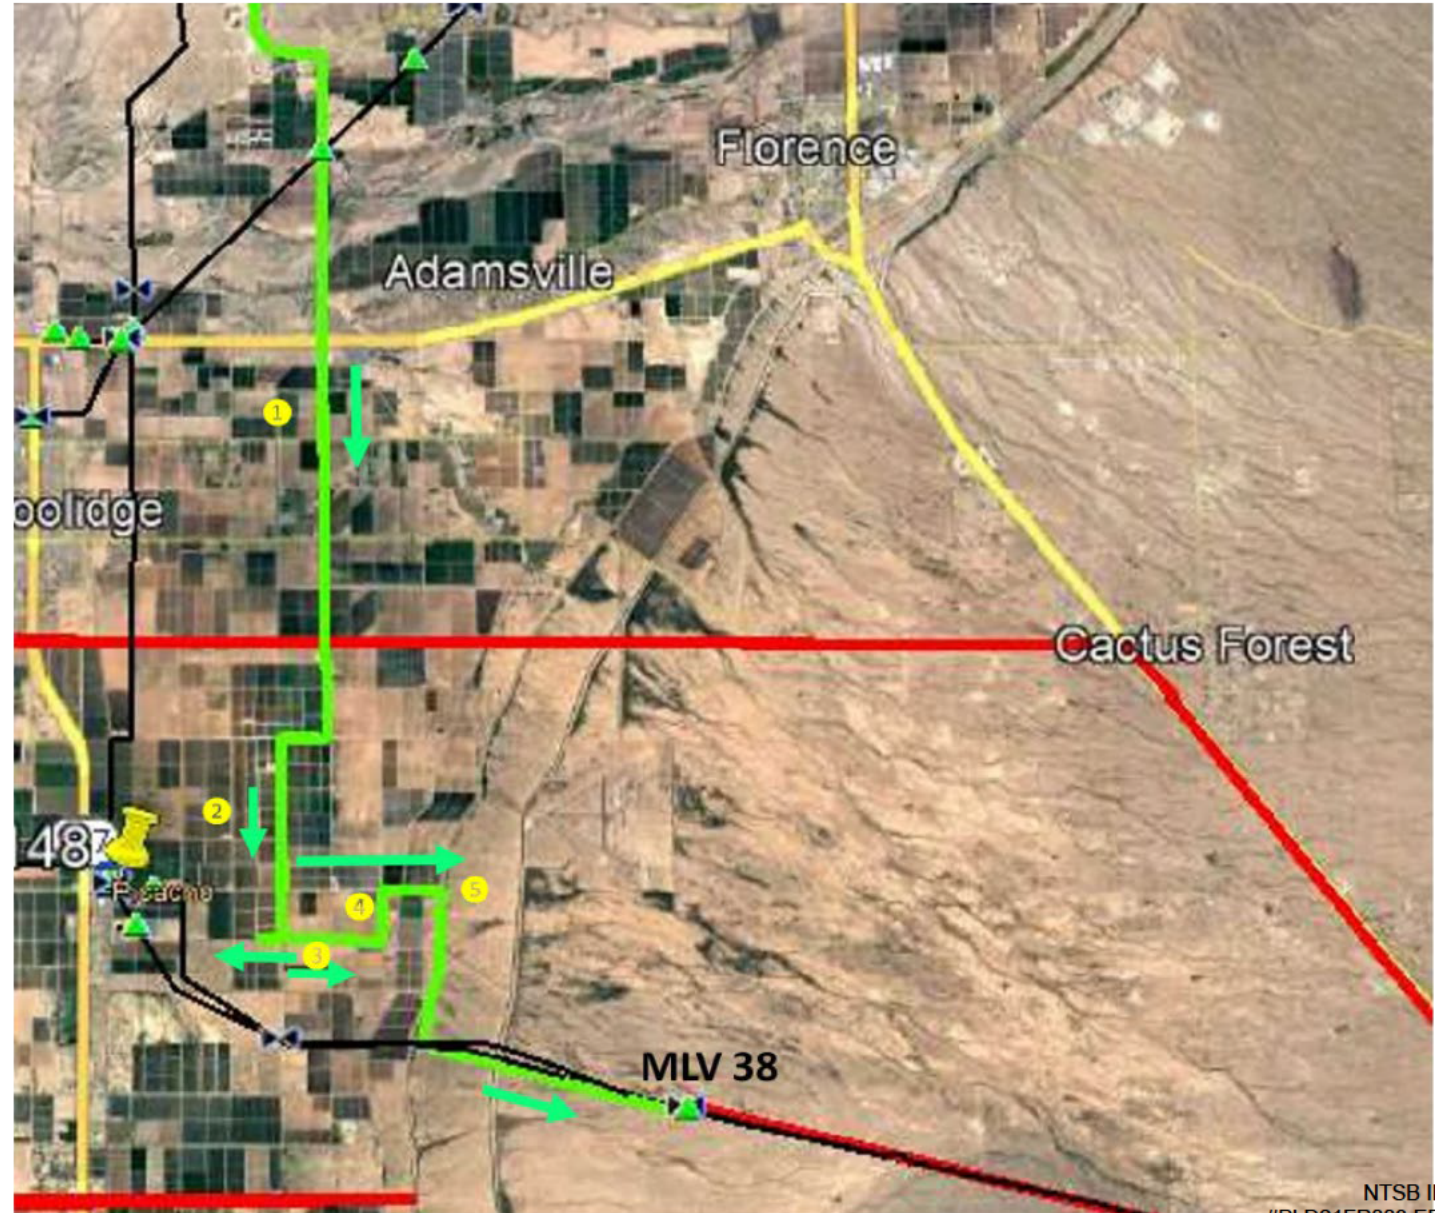
# Line Patroller's Route to MLV 38

- The unpaved path next to the irrigation canal to the [REDACTED] of MLV 38 was reported to be washed out and difficult to navigate, very slow going.
- LP had local knowledge that MT did not about unpaved farm and irrigation paths that allowed a more direct route from the [REDACTED] and did not require crossing the washed out canal bridge that blocked MT.
- LP's rate of progress on the secondary and washed out roads appears similar to MT's.

- LP came down [REDACTED] from the [REDACTED]
- [REDACTED] on [REDACTED]
- [REDACTED] on [REDACTED]
- [REDACTED] on [REDACTED]
- [REDACTED] on a farm/irrigation path
- He heard they were having trouble getting to MLV 38
- He U-turned and headed [REDACTED] to [REDACTED]
- [REDACTED] on [REDACTED]
- [REDACTED] on [REDACTED]
- [REDACTED] to an unpaved irrigation path
- [REDACTED] on an unpaved irrigation path to pipeline ROW
- [REDACTED] to MLV 38 along the ROW

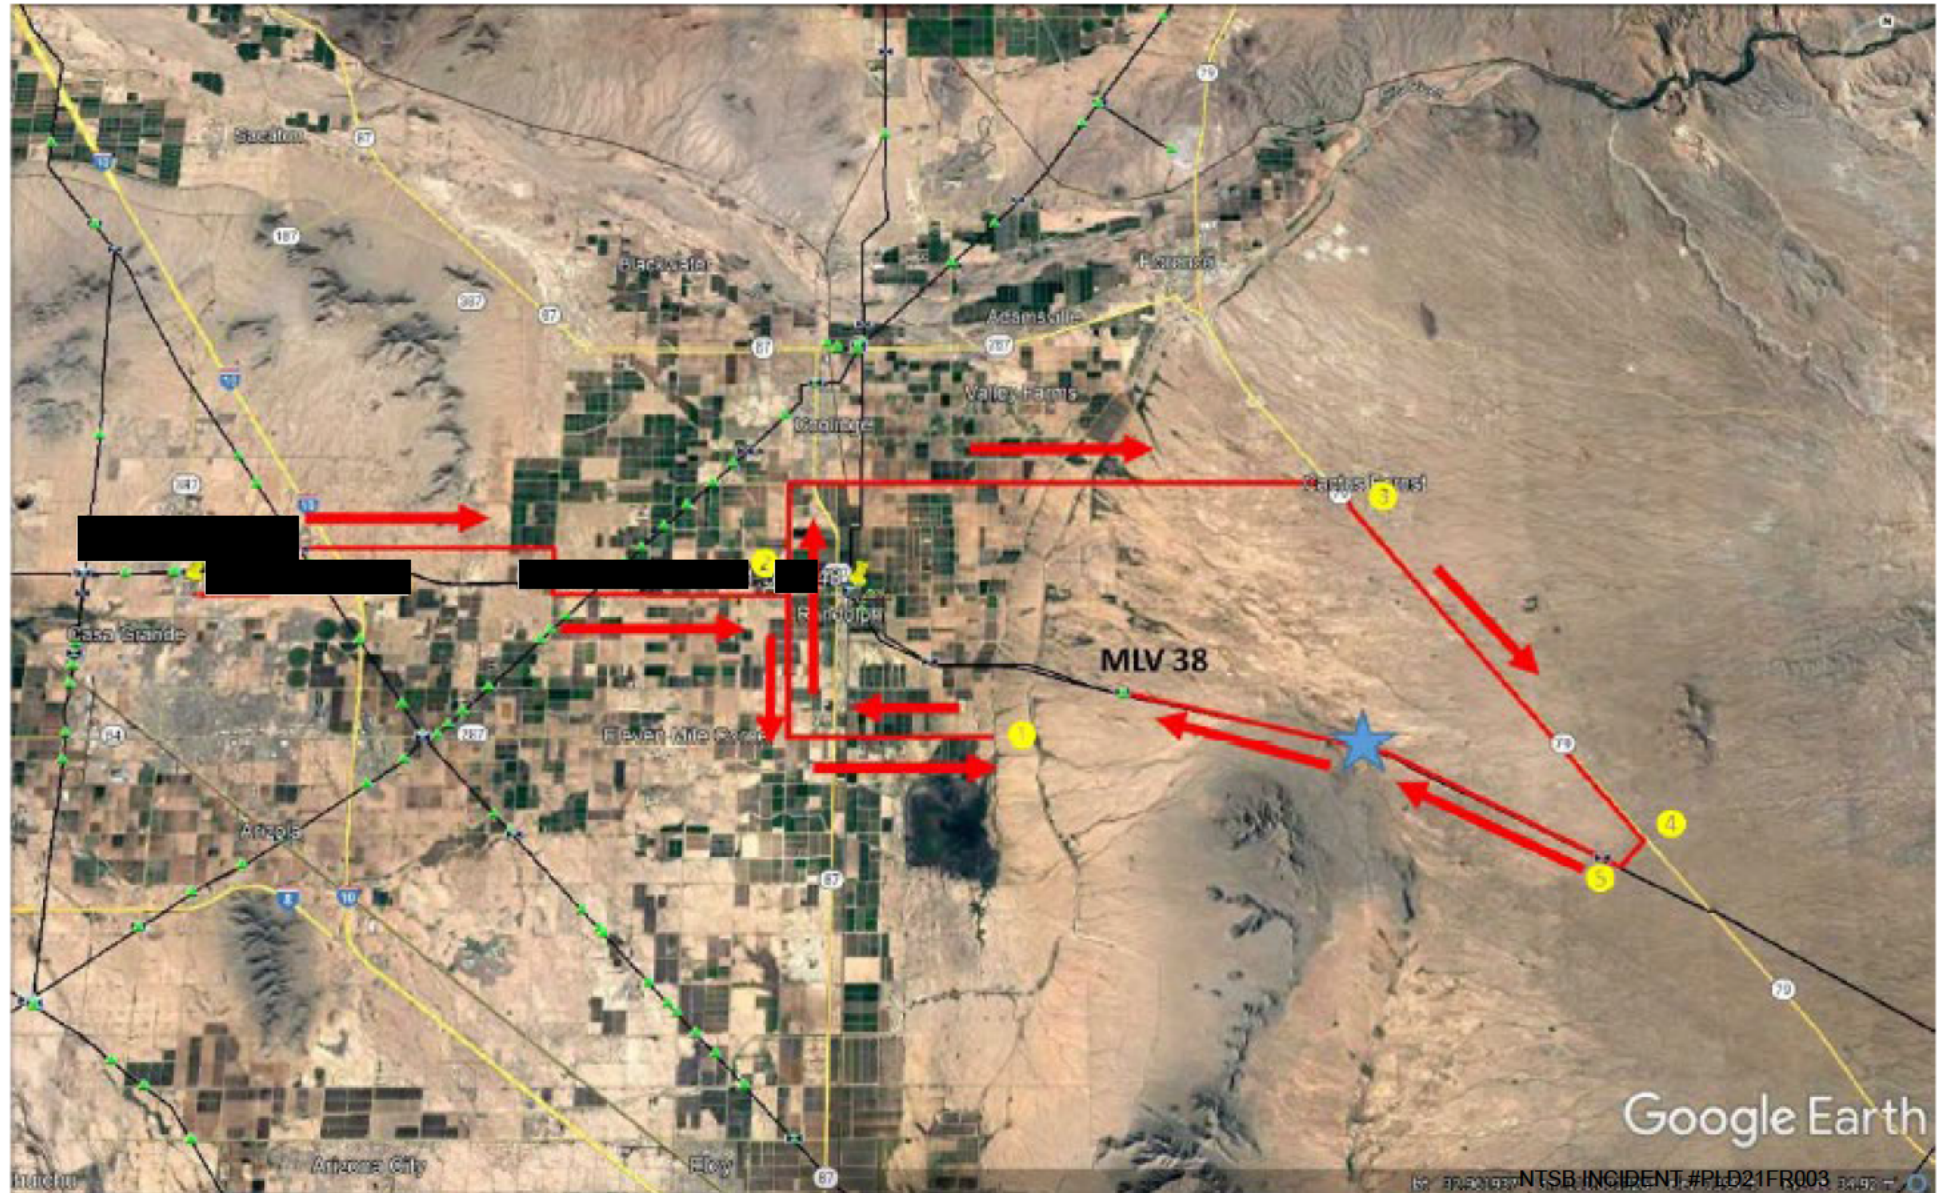
# Measurement Technician's Route to MLV 38

- Paved with the exception of the last few miles across [REDACTED] towards MLV 38 to the washed out canal bridge, and the final 9.3 miles of easement road.
- Pipeline easement road was badly washed out throughout its length, Coolidge Police Department got stuck about half way.

- MT came out of his subdivision and headed [REDACTED] on [REDACTED]
- Took [REDACTED] to [REDACTED]
- Took [REDACTED] to [REDACTED]
- Took [REDACTED] to [REDACTED]
- Took [REDACTED] to [REDACTED]
- Took [REDACTED] to [REDACTED]
- Took [REDACTED] across [REDACTED] to an irrigation path, and along that path to a point where the bridge across the wash was washed out and impassible.
- Backtracked to [REDACTED] and found police officer (Pin 2). MT told Coolidge Police Officer he needed to get through the road blocks to [REDACTED]. He was directed to go to next road block and let the police officer know he needed to get to [REDACTED]
- Police officer escorted him to [REDACTED] to the EPNG pipeline right-of-way and then escorted him the remainder of the way until the officer got stuck in the mud.
- MT continued past the officer to MLV 38.

Approx. location where officer got stuck in the mud
