National Transportation Safety Board

WPR22FA196

VIDEO STUDY

February 2, 2023

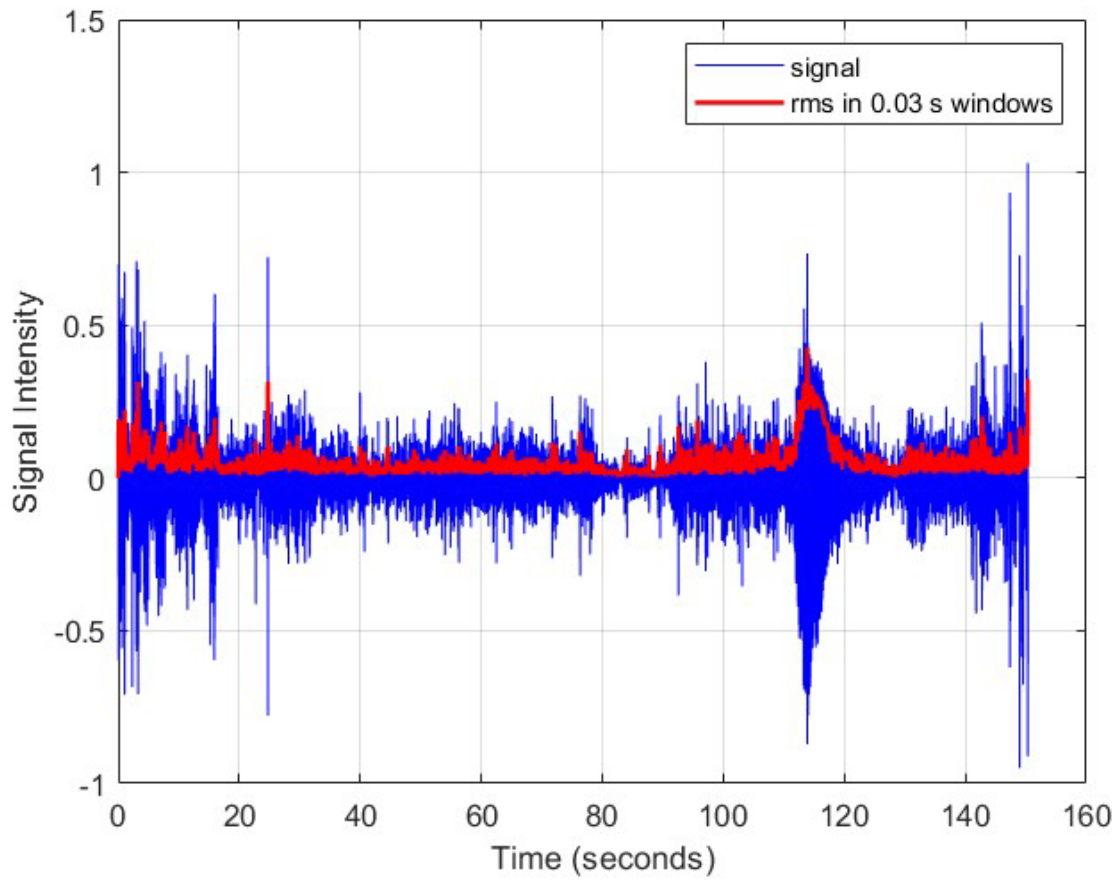
Figure 2. Signal intensity

Figure 2 shows the sound signal intensity and its root mean square (rms) value during the 150-seconds-long video. The rms has its maximum value at about video time 114 seconds, just past the time when the airplane was closest to the camera as seen in Figure 1. Past 114 seconds, the airplane was moving away from the camera and, therefore, decreasing sound intensity was expected. However, Figure 2 shows

that the intensity signal reached its highest value at about time 150 seconds and the rms level at that time was about four times higher than what it was 20 seconds earlier, at time 130 seconds. This unexpected intensity increase could be an indication of engine problems.

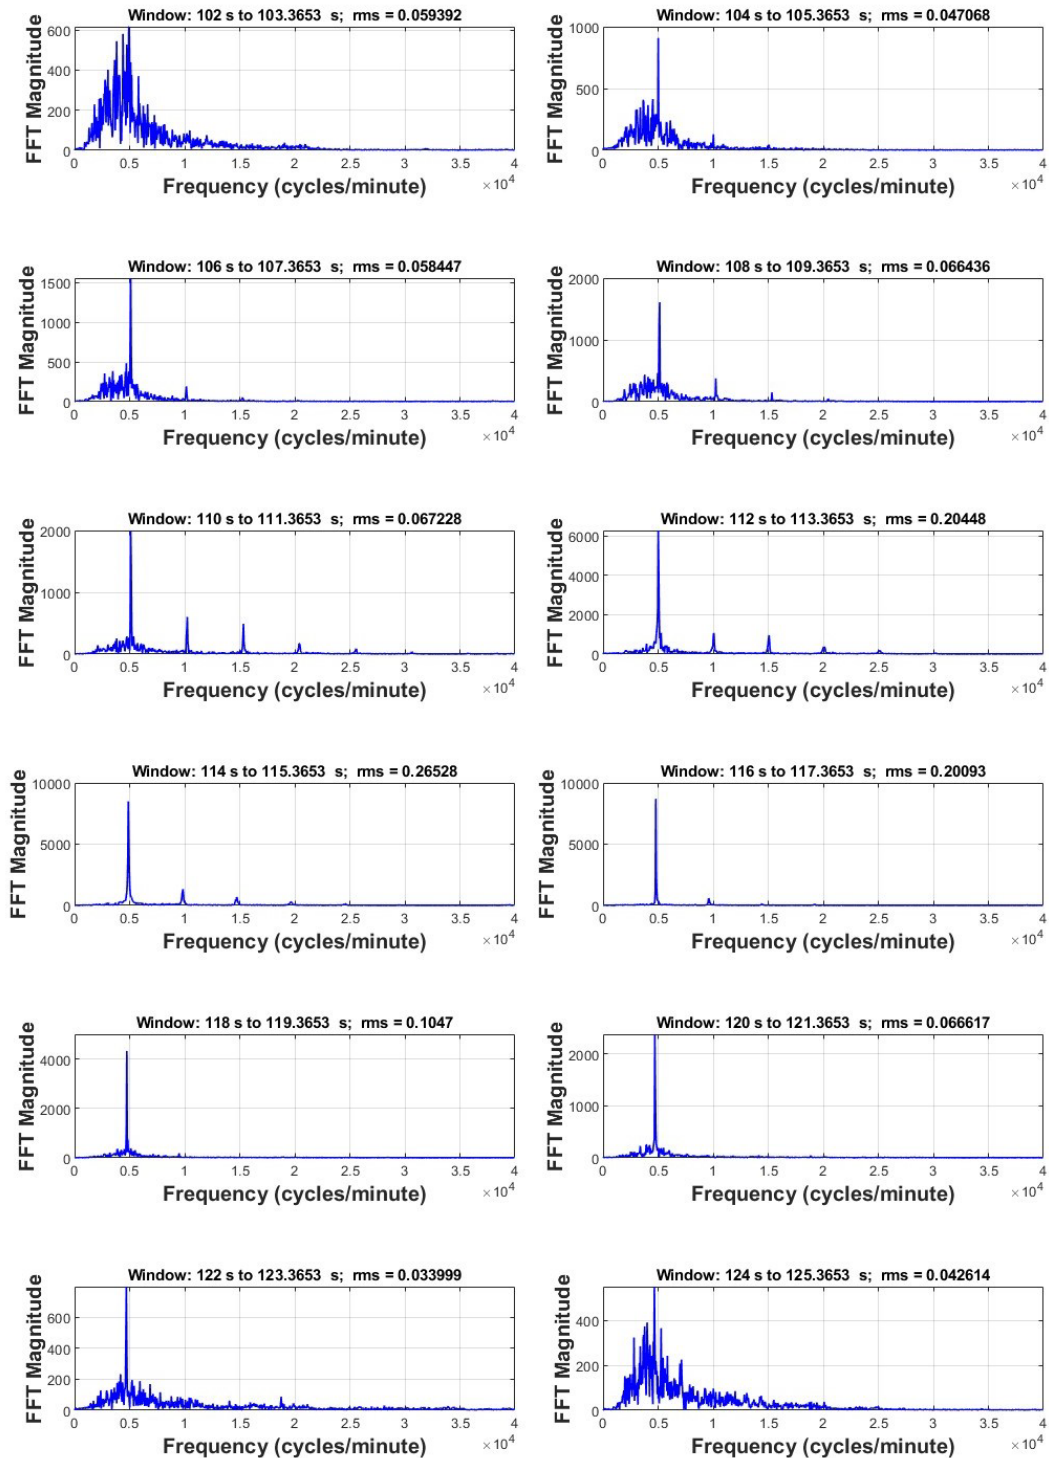
Figure 3. Sound spectra in windows starting at time 102 seconds

The spectrum of the signal was analyzed in an attempt to provide more information on the cause of the increasing signal intensity as the airplane was flying away from the camera location. Figure 3 shows sound signal spectra computed with the Fast Fourier Transform (FFT) algorithm in analysis windows with starting times from 102 seconds to 124 seconds. The 65536-point analysis windows were 1.3653 seconds wide and the frequency resolution was 44 cycles/minute (cpm). The window starting at time 114 seconds corresponds to the time when the airplane was close to the camera and, therefore, the Doppler effect was negligible. The frequency of the first spectral peak is 5000 cpm. Since the airplane used a two-bladed propeller, the engine speed at that time was 2500 rpm.

When the airplane was close to the camera, the spectrum consisted of the 5000 cpm peak and peaks at the harmonics of 5000 cpm. The FFT magnitude at other frequencies was negligible. This indicates that the engine was operating smoothly so that its combustion and exhaust sounds were negligible compared to the sound generated by the propeller blades.

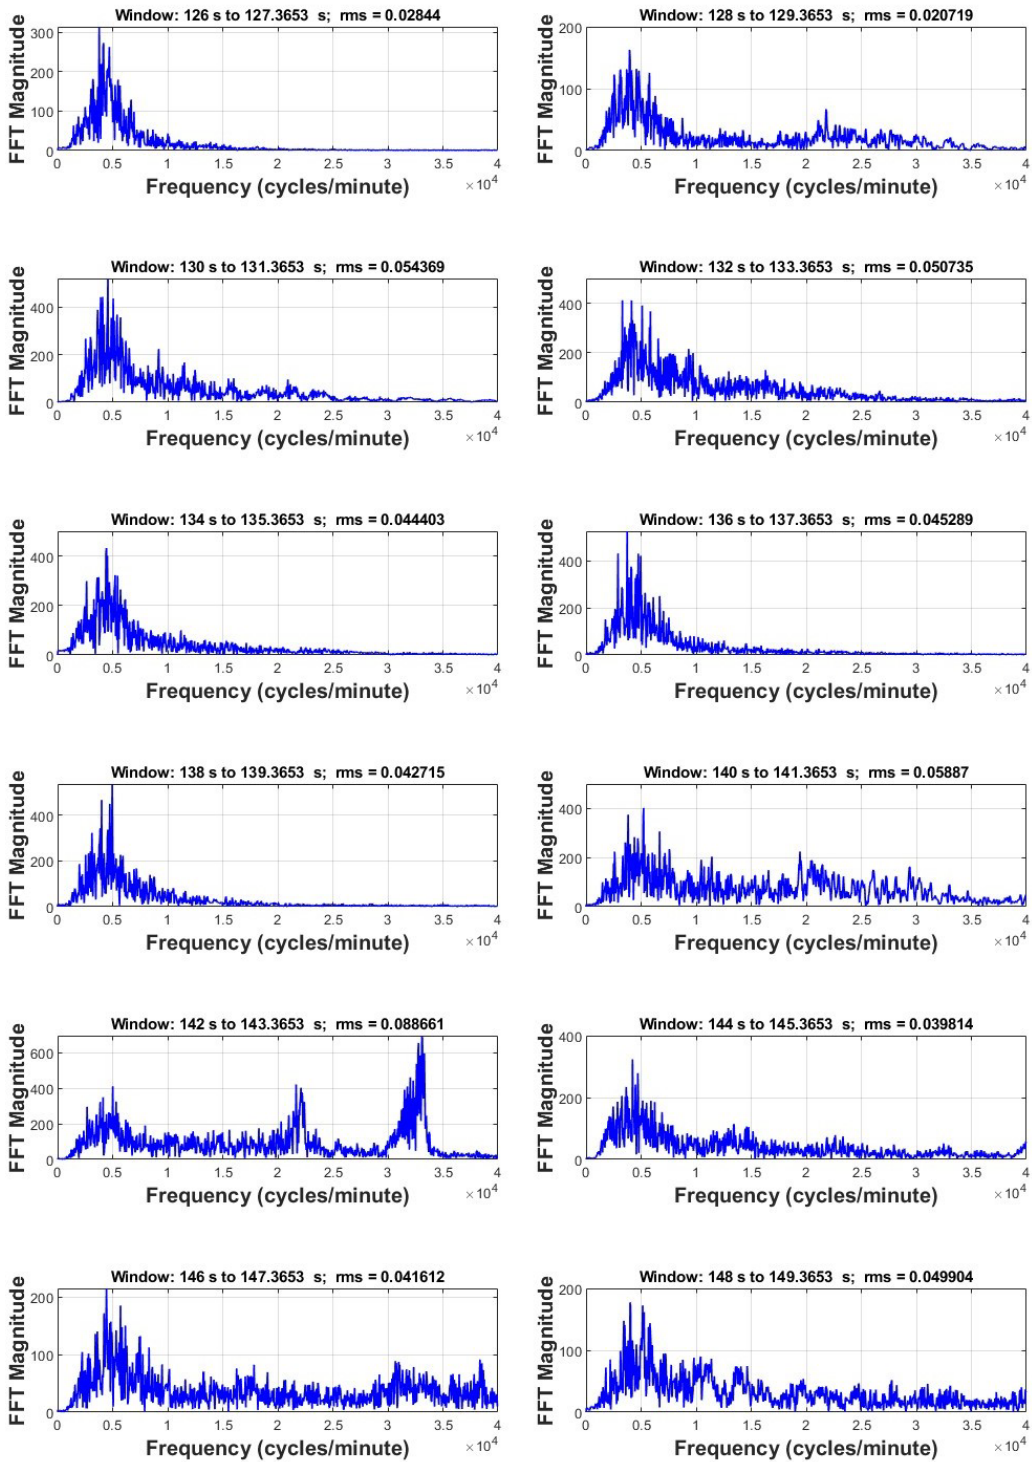
Figure 4. Sound spectra in windows starting at time 126 seconds

At time 124 seconds, the blade passage frequency became less dominant in the spectrum. Figure 4 shows sound signal spectra in windows with starting times from 126 seconds to 148 seconds. The figure shows that past time 140 seconds, the spectrum included components at higher frequencies than before that time. The spectrum in the window starting at time 142 seconds is especially interesting because of the elevated FFT magnitudes near 22,000 cpm and near 33,000 cpm. These spectral characteristics could be indications of engine problems. However, they could not be reliably associated with any specific engine failure modes. It is possible that the engine was emitting sound signals that carried information on a specific failure mode, however, by the time the signal reached the microphone over the increasing distance, that information was lost.
