Metallurgical Investigation Final Report

Subject: Metallurgical Investigation of Fan Blades from PW4077 Engine SN 777047

Date: February 24, 2023

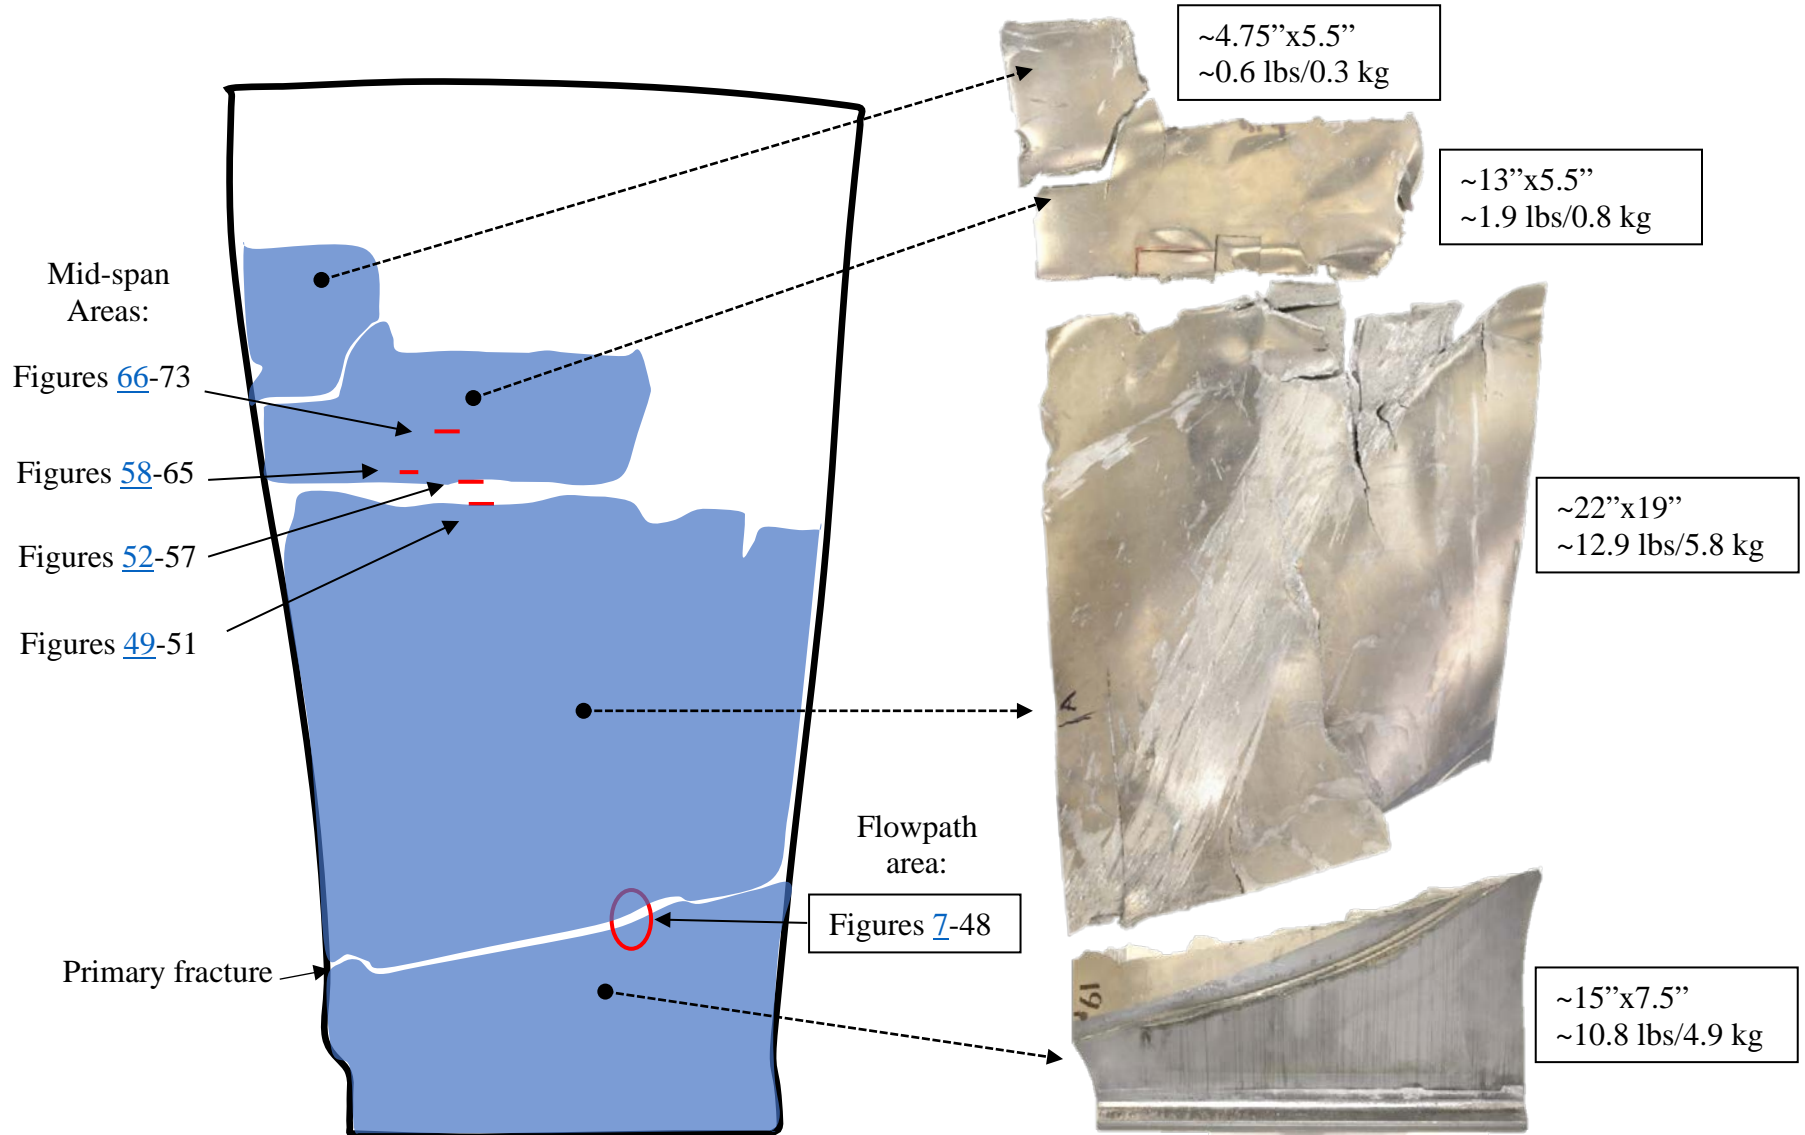
In addition to the primary fracture, multiple cracks were identified on the event blade fragments and further evaluated. Images showing the event blade fragments and the approximate fatigue fracture/crack locations marked on a blade diagram are shown in [Figure 1](#). The part manufacture and repair identification markings located on the root bottom of the event blade are shown in [Figure 2](#).

Figure 1: Diagram and images showing the recovered sections of the incident blade and fatigue fracture/crack locations (red circle indicating an area with multiple cracks and red lines indicating approximate locations of individual cracks on the diagram).

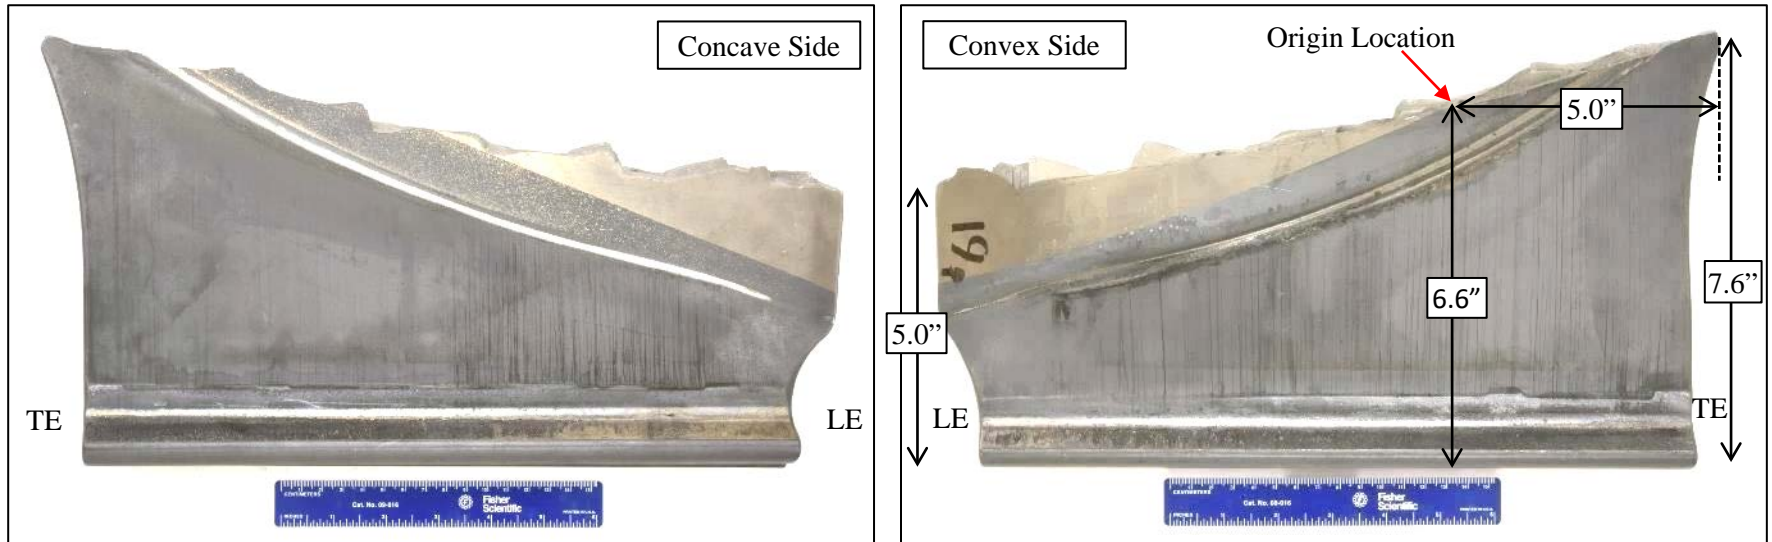
The transverse fracture through the flowpath region of the airfoil on the event fan blade was due to fatigue, which initiated internally at the forward end of cavity FA, approximately 6.6” outboard of the blade root bottom face and 5.0” from the trailing edge (TE) ([Figure 3](#)). The crack progressed from along the transition radius between the convex side wall and an internal spanwise rib, closer to the radius runout to the rib. A white deposit was observed on areas of the fracture surface and on the internal cavity walls ([Figure 4](#)). The deposit appeared secondary to the fracture and was removed with coolant during initial sectioning. It was reported that fire retardant, a white foamy material, was used following the event.

Figure 3: Overall images of the convex and concave sides of the fractured blade, CBDUAU9992. The fracture initiated approximately 6.6” outboard of root bottom and approximately 5.0” from the TE.

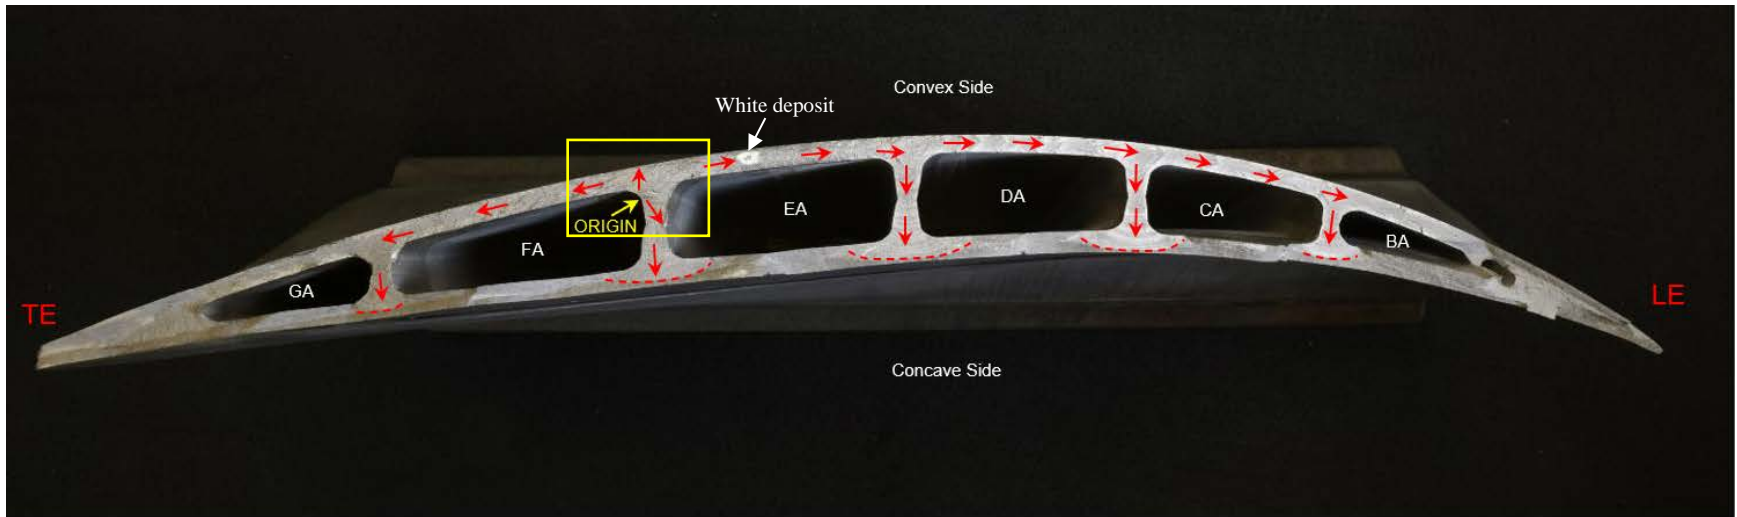
Figure 4: Overall and close-up views of fracture surface showing fatigue features propagating from an area located at the radius runout to the internal rib at the forward end of cavity FA. A white deposit was observed on areas of the fracture surface and on the internal cavity walls; this deposit was likely fire retardant used following the event.

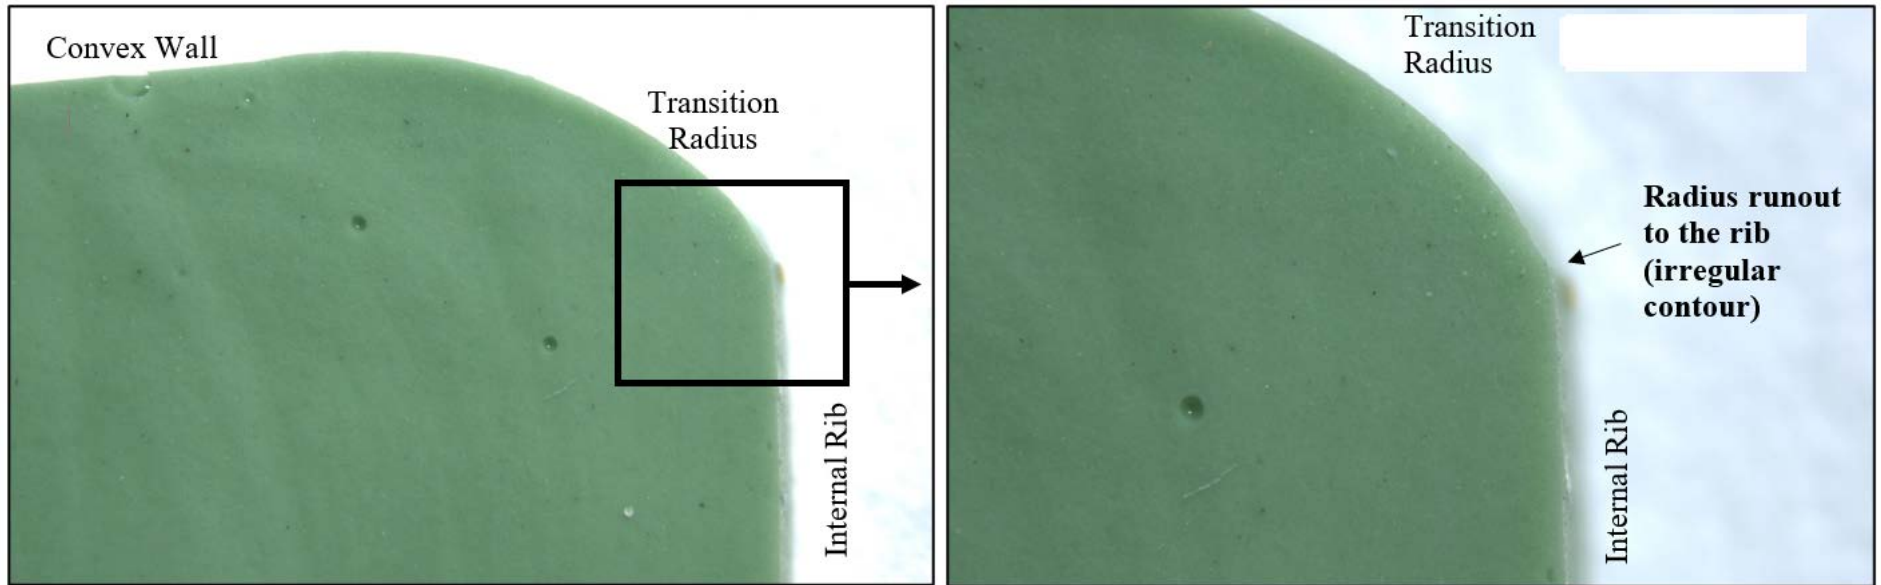
The transition radius between the internal rib and convex side wall in cavity FA was replicated just inboard of the fracture location using rubber replicating material. The radius runout to the rib exhibited an irregular contour (lack of tangency) ([Figure 5](#)). P&W structural analysis found this radius geometry resulted in a stress concentration at the fracture origin.

Figure 5: The transition radius between the internal rib and convex side wall in cavity FA was replicated inboard of the fracture location using rubber replicating material. The radius runout to the rib region exhibited an irregular contour (lack of tangency).

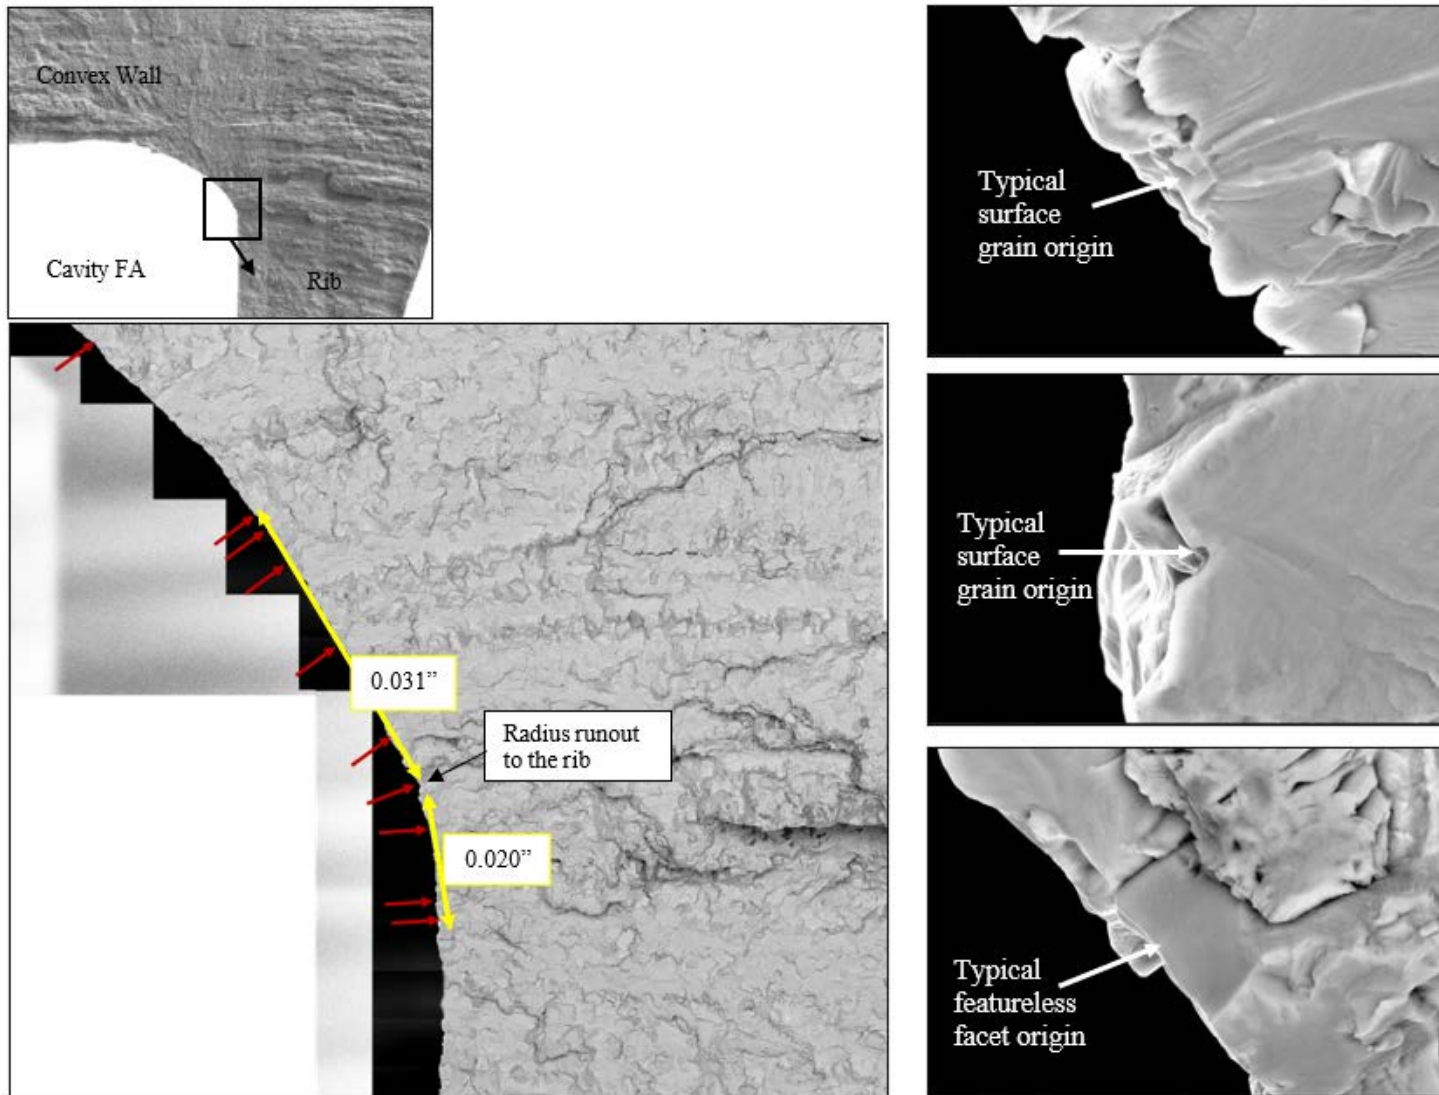
Scanning electron microscope (SEM) examination of the fracture surface identified multiple fatigue origins along the surface near the radius runout to the rib. Most of the origins were located within 0.031” of the radius runout to the rib. Both surface grain origins and featureless facet origins were identified ([Figure 8](#)). High magnification SEM examination of the cavity surface at the fatigue origins did not find evidence of damage or anomalies. Fractographic mapping of the fracture features identified three primary origins associated with most of the crack progression ([Figure 9](#)). The primary origin associated with the through-wall progression was located approximately 0.025” from the irregular contour located at the radius runout to the rib ([Figure 10](#)). The fractographic assessment did not identify microtexture regions (MTRs) at the primary origins. Subsequent electron backscatter diffraction (EBSD) of a metallurgical section planar into this area confirmed that no MTRs were present at the primary origin area (*Reference Section 2.2.1.3, Figure 44*).

Figure 8: SEM images showing the origin locations (red arrows) and representative images typical of the surface and featureless facet origins observed.

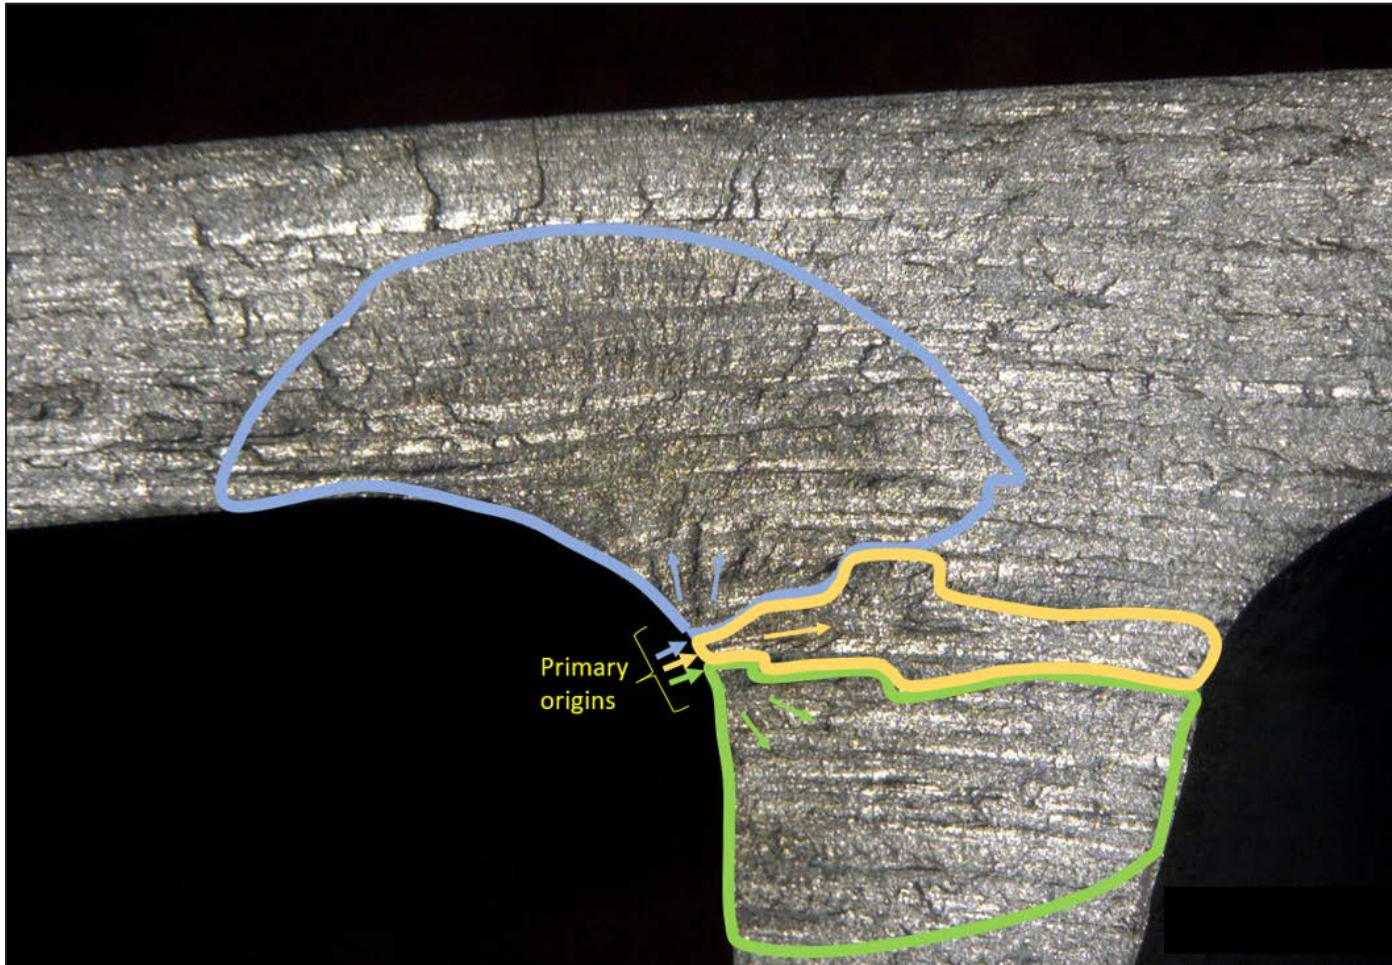
Field Emission Scanning Electron Microscope (FESEM) examination identified three primary surface origins associated with most of the crack progression. The early crack progression exhibited predominantly faceted growth mixed with occasional areas of fatigue striations. Beyond this early progression zone, about 0.063" deep (towards the convex wall), the fatigue crack transitioned to a predominantly striated growth mode consistent with stable low cycle fatigue (LCF) growth. Areas of the crack progression exhibited near fully faceted growth that tended to propagate in the chordwise direction, suggestive of microtexture regions (MTRs). There were no MTRs identified at the primary fatigue origins. A striation count conducted from 0.063" to 0.199" from the origin estimated 3,150 cycles of LCF crack propagation within the stable zone. Beyond the stable LCF zone, multiple separately nucleated faceted regions were encountered, consistent with MTRs. Beyond this region, the crack surface exhibited unstable progression, leading ultimately to final fracture.

Figure 9: Image of the fracture surface showing the three primary origins (arrows) and the areas of the crack progression that are dominated by the corresponding origin (i.e. green origin was associated with crack progression in the area outlined in green). Areas outside of the indicated regions were not further evaluated.

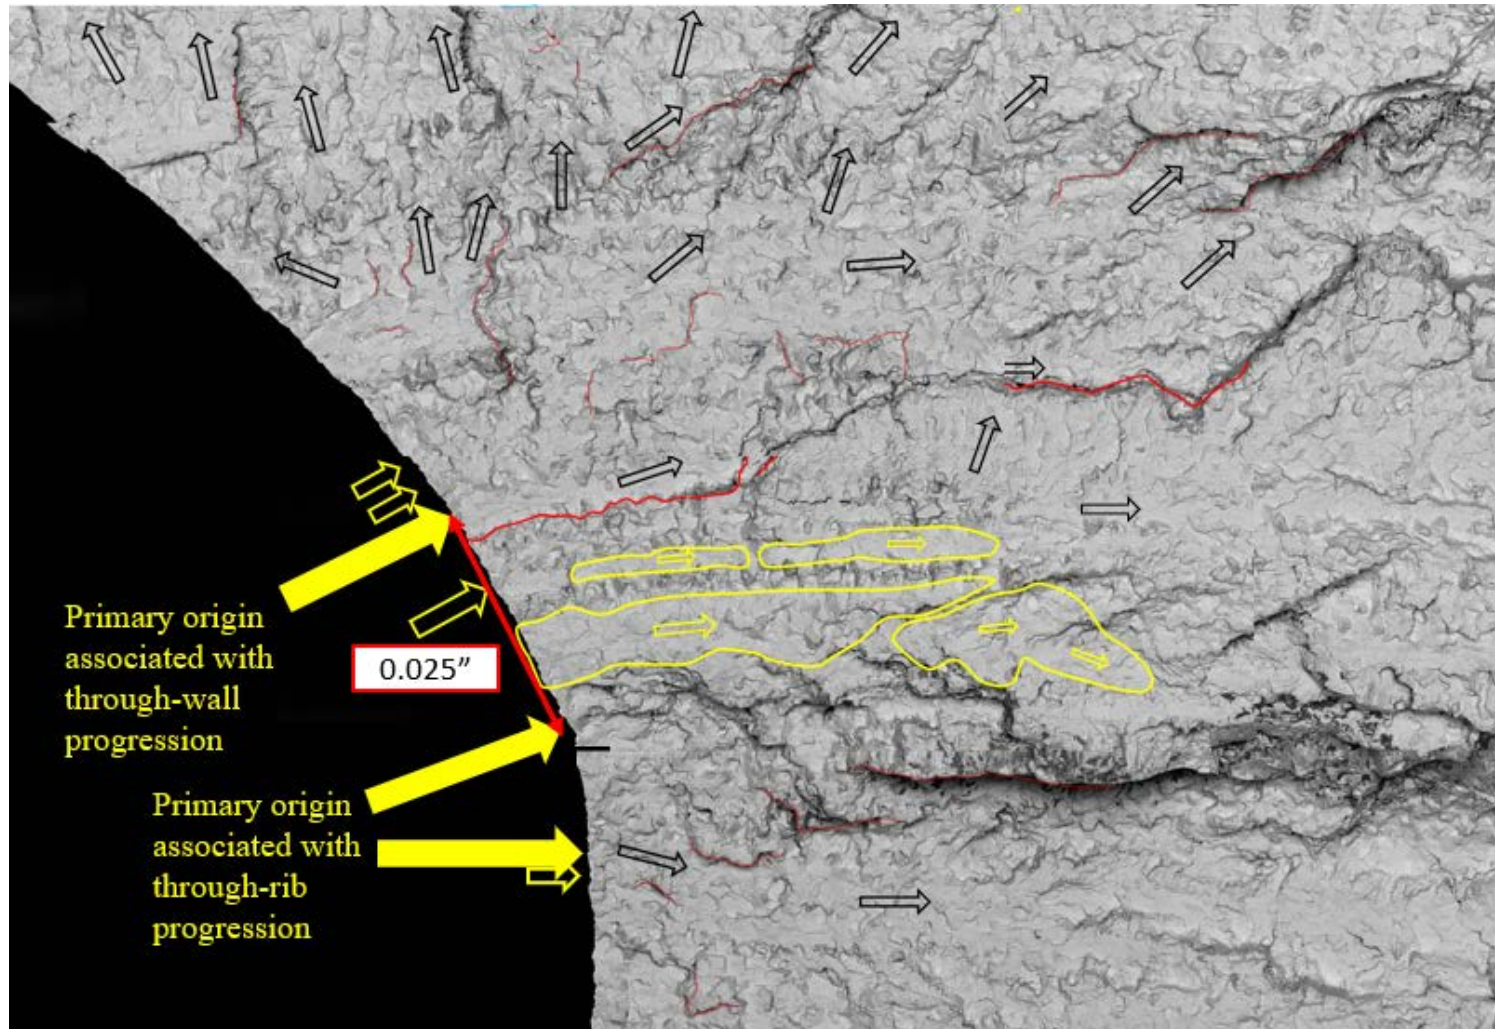
Figure 10: Image showing an annotated fracture map of the origin area. The three primary origins are indicated by bold yellow arrows. Other, relatively “weak” origins are indicated by outlined yellow arrows. Possible MTRs based on the fractographic features are outlined in yellow. The red lines indicate plane changes/separation in the fatigue regions.

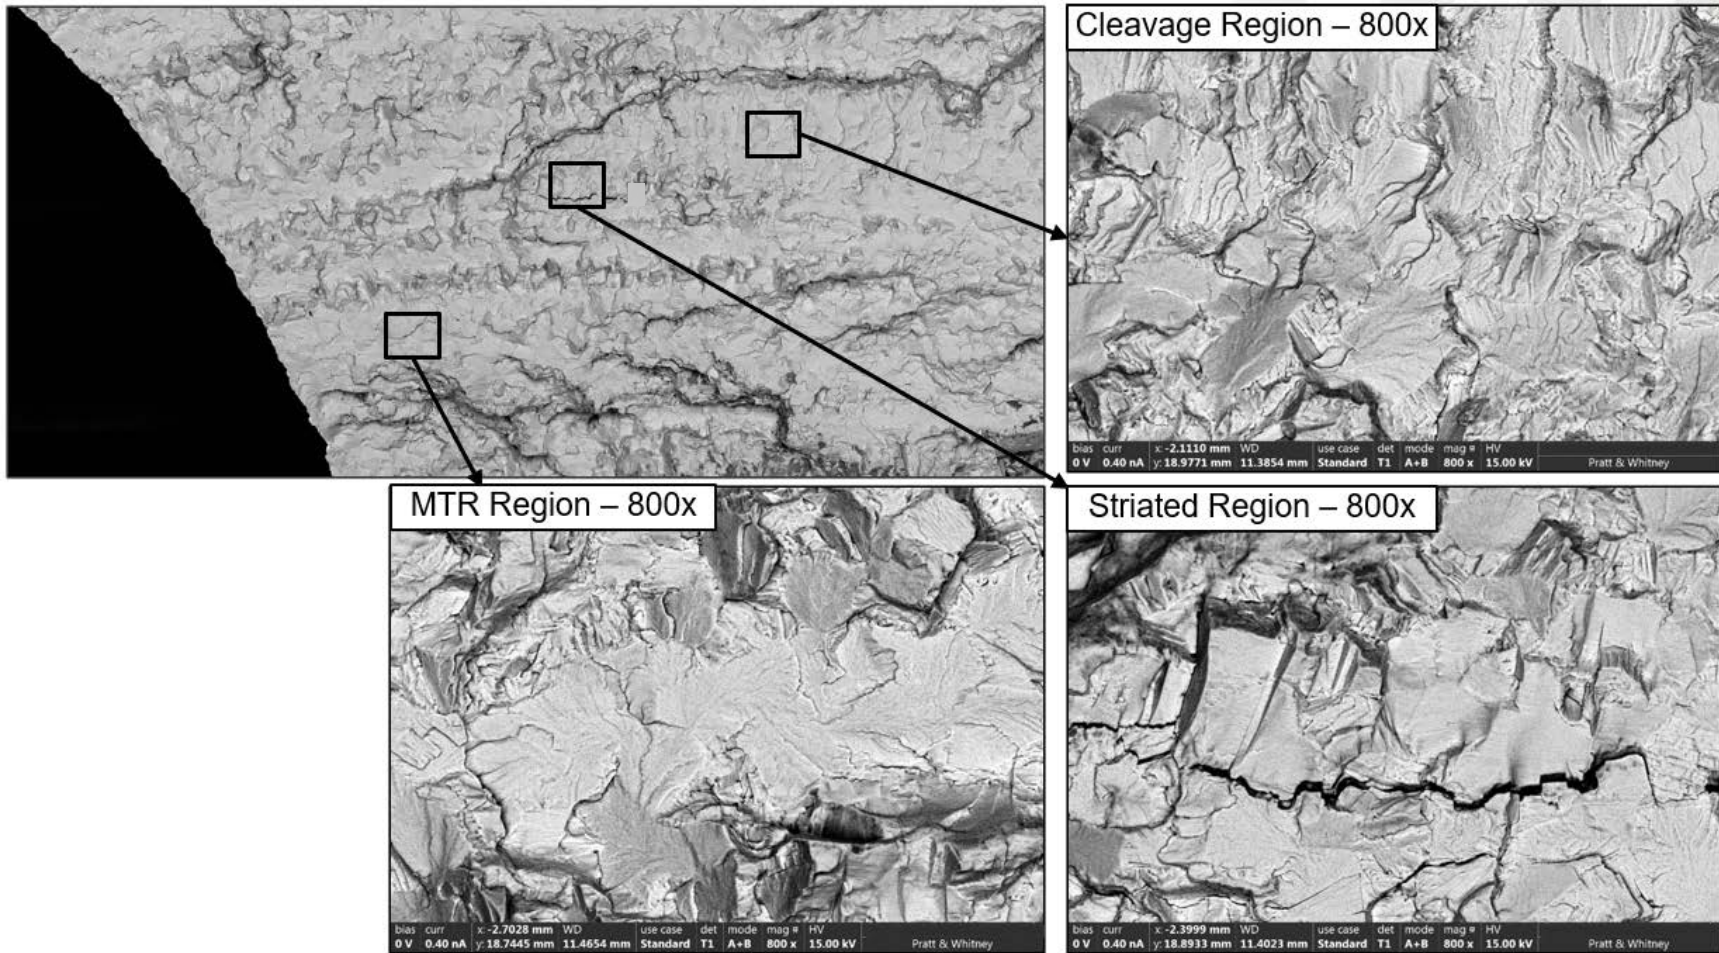
The early crack progression exhibited predominantly faceted growth with a mix of cleavage and striations ([Figure 11](#)). Beyond this early progression zone, approximately 0.063” deep, the fatigue crack transitioned to predominantly striated growth, consistent with stable low cycle fatigue (LCF), with faceted growth mixed in at varying levels ([Figure 12](#)). Occasional areas of the crack progression exhibited near fully faceted growth that tended to propagate in the chordwise direction, suggestive of MTRs. Beyond the stable LCF zone, approximately 0.199” from the primary origin, multiple separately nucleated faceted regions were encountered, consistent with MTRs. Beyond this region, the crack surface exhibited a gradual transition to dimple rupture features indicative of unstable progression, leading ultimately to final fracture.

Figure 11: SEM images showing features representative of the early fatigue progression. Predominantly faceted growth with a mix of cleavage and striations was observed within 0.063” of the origin.

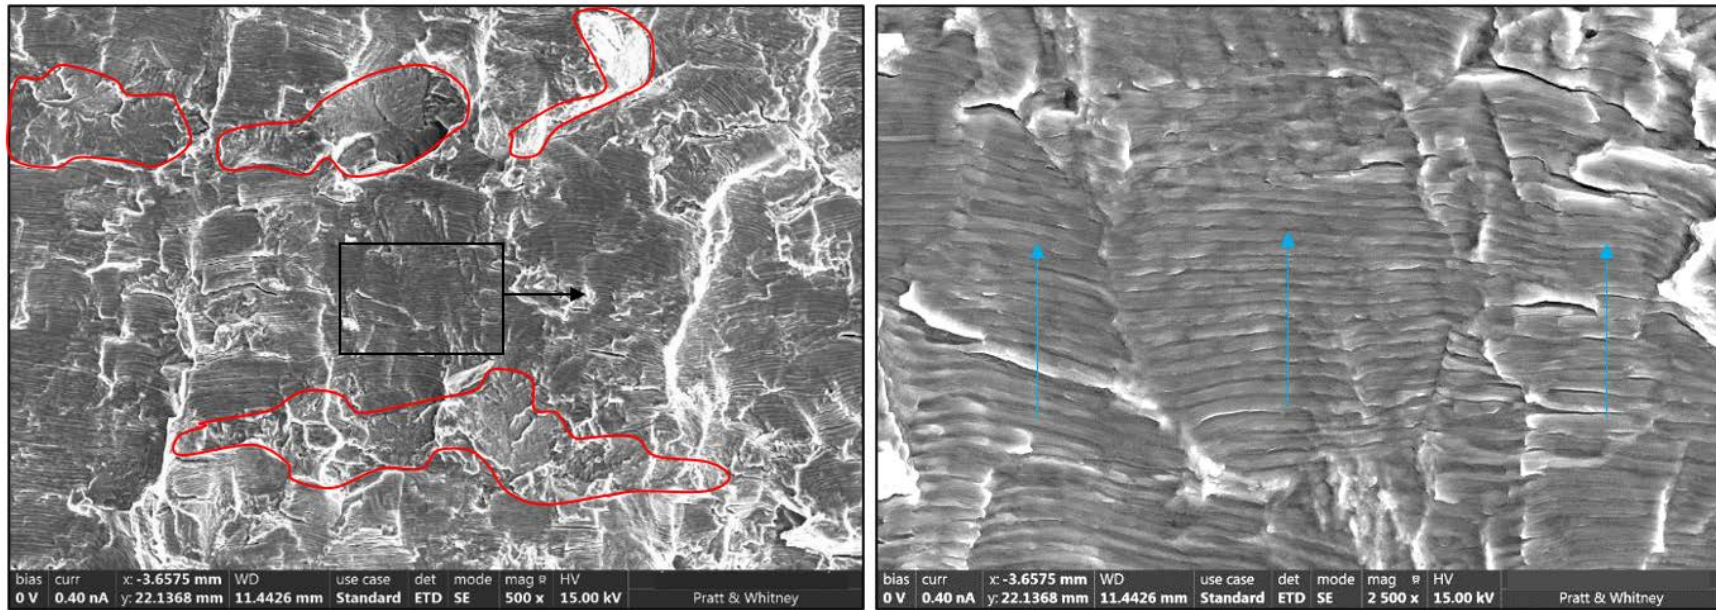
A striation count was conducted from 0.063” to 0.199” from the origin. The crack growth rate ranged from 5.4×10^{-6} to 6.7×10^{-5} inches/cycle. No credit was taken for cycles prior to 0.063” because the area was not predominantly striated. Additionally, no credit was taken for cycles beyond the separately nucleated MTRs (beyond 0.199” from the origin) because it was unknown whether or not the MTRs grew simultaneously with the rest of the crack progression ([Figure 13](#)). Since the crack growth rate observations were from predominantly striated areas that exhibited some amount of faceted growth mixed in, image analysis was used to determine the area fraction of striations at each observation. The area fractions were then used to adjust (reduce) the estimated crack growth cycles. No credit was taken for a region of crack growth that consisted of less than 50% striations. Relatively weak separately nucleated initiations were observed in the striation count region but did not impede the major crack progression. After the adjustments, the striation count estimated 3,150 cycles of LCF crack propagation within the stable zone ([Figure 14](#)). The blade was last inspected via thermal acoustic imaging (TAI) 2,979 cycles ago. Based on the striation count data, the crack would have been ~0.064” deep at that time.

Figure 12: SEM images showing predominantly striated fatigue features with faceted growth mixed in (red areas), representative of the stable LCF region located 0.063” to 0.199” from the primary origin.

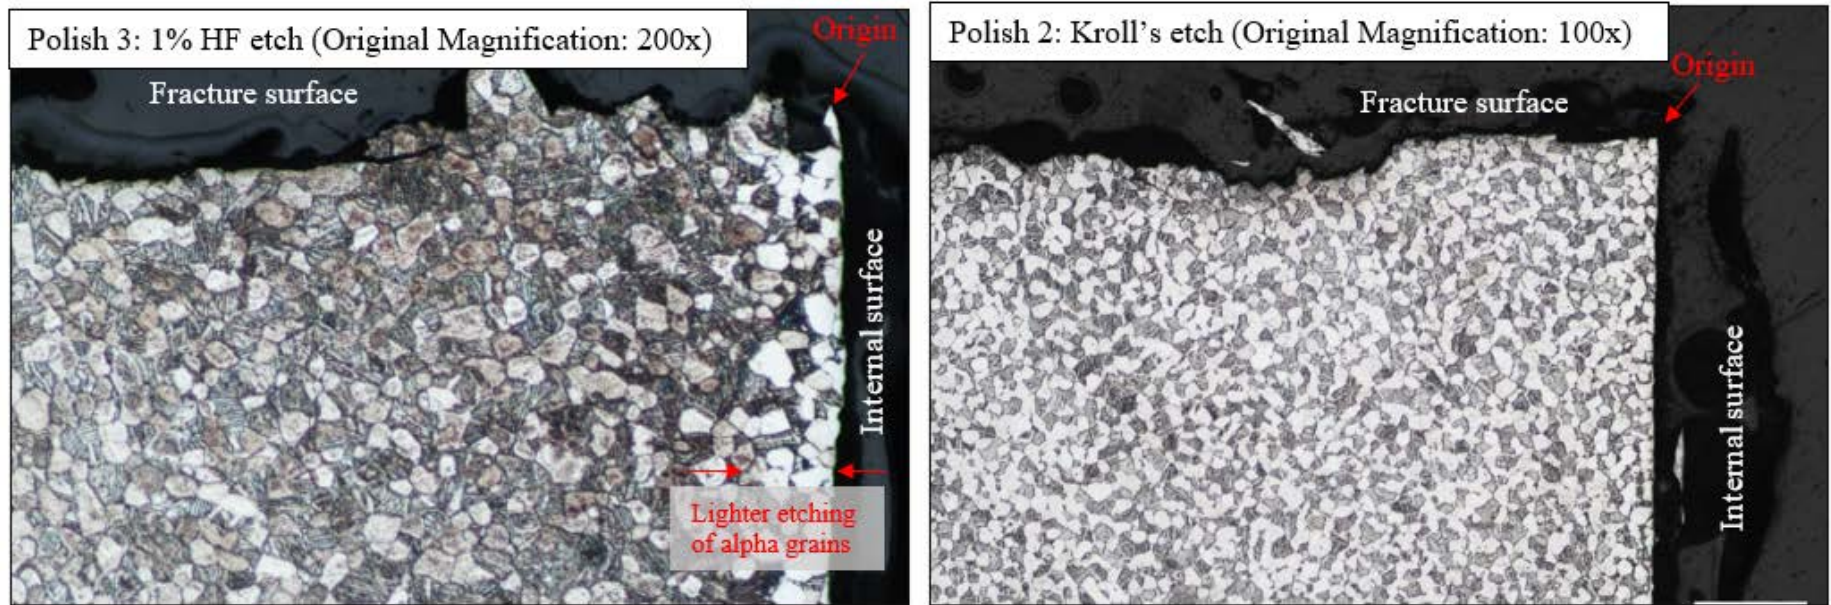
A spanwise metallographic section was also prepared into the primary origin as shown in [Figure 20](#). Three step polishes at 0.001” increments were made into the primary origin. The section was etched with Kroll’s and 1% HF at each increment. No distorted surface layer/deformation was observed. Alpha grains within 0.002”-0.003” of the internal surface etched lighter when etched with 1% HF. Representative images of the step polishes are shown in [Figure 21](#).

Figure 21: Three step polishes at 0.001” increments were made through the primary origin. 1% HF (left image) and Kroll’s (right image) etches were completed at each increment. Representative images of each are shown above. Alpha grains near the surface etched lighter when etched with 1% HF. No distorted surface layer/deformation was observed.

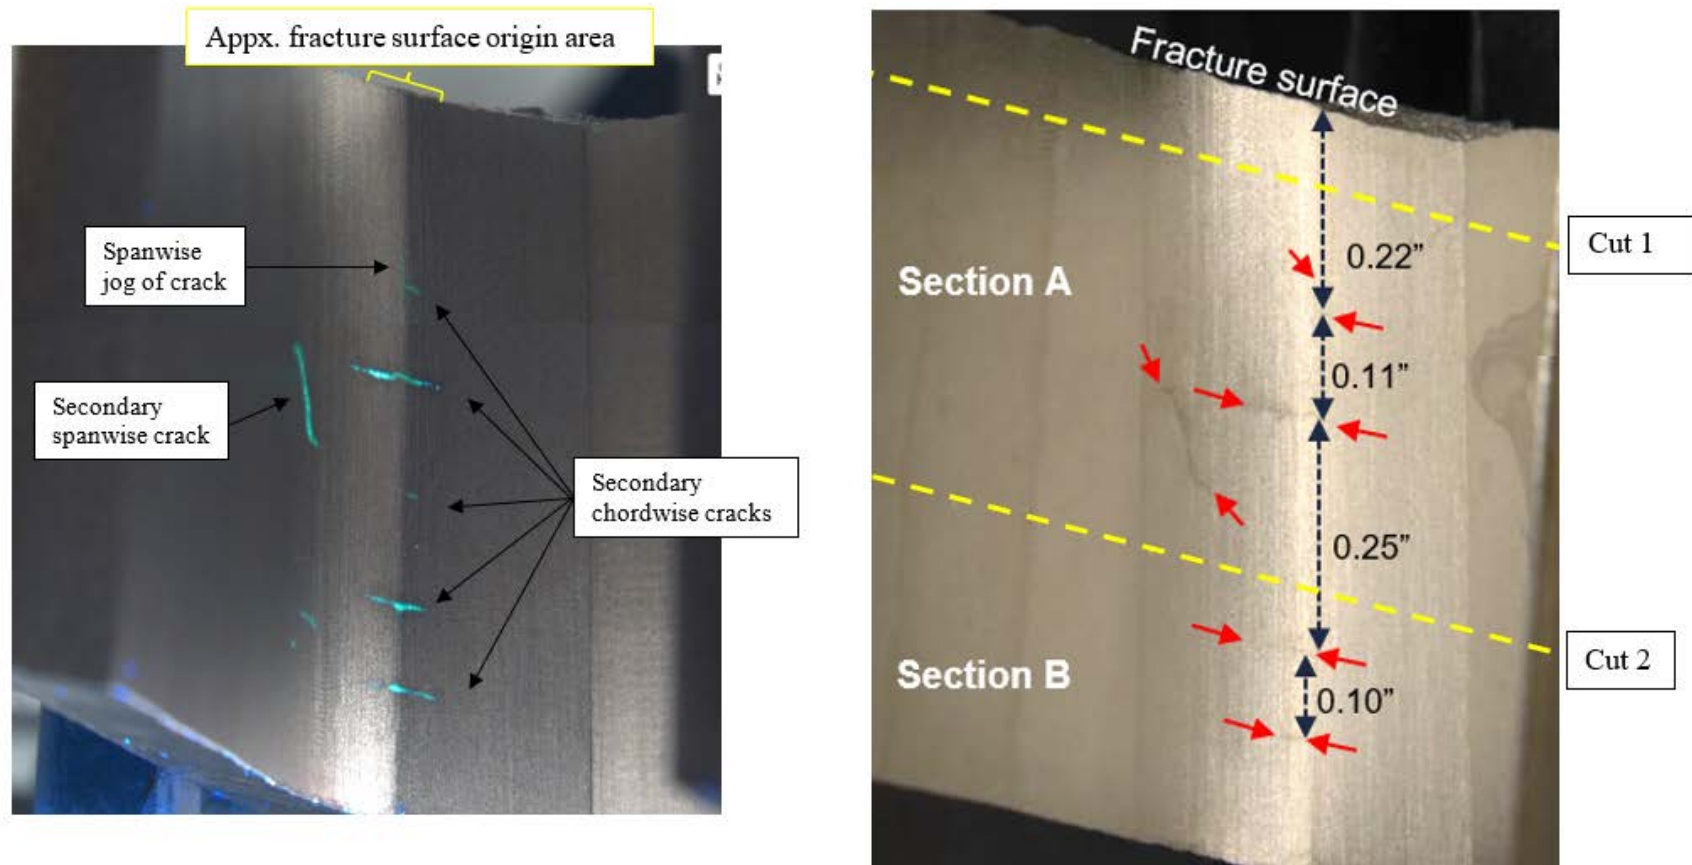
The secondary cracks identified inboard of the flowpath fracture were all located within 0.68” of the fracture surface. Multiple mostly-chordwise oriented cracks, parallel to the fracture surface, were identified in the transition radius between the convex wall and the internal rib at the forward end of the FA cavity. They were approximately aligned with the origin area on the fracture surface. The secondary crack closest to the fracture surface exhibited a spanwise jog of the crack that aligned with the irregular contour of the radius runout to the rib. After sectioning the fracture surface from the secondary cracks, an additional chordwise section was made via wire EDM as shown in [Figure 22](#) to prepare for metallography on the two cracks furthest from the fracture surface ([Reference Section 2.1.2.3](#)).

Figure 22: Images showing multiple secondary cracks within 0.68” inboard of the fracture surface (red arrows indicate the ends of the cracks). Multiple mostly-chordwise oriented cracks, parallel to the fracture surface, were identified in the transition radius between the convex wall and the internal rib at the forward end of the FA cavity which aligned with the origin area on the fracture surface. After sectioning the fracture surface from the secondary cracks (cut 1), an additional section along the yellow dotted line (cut 2) was made via wire EDM to prepare for metallography on the two cracks furthest from the fracture surface (section B).

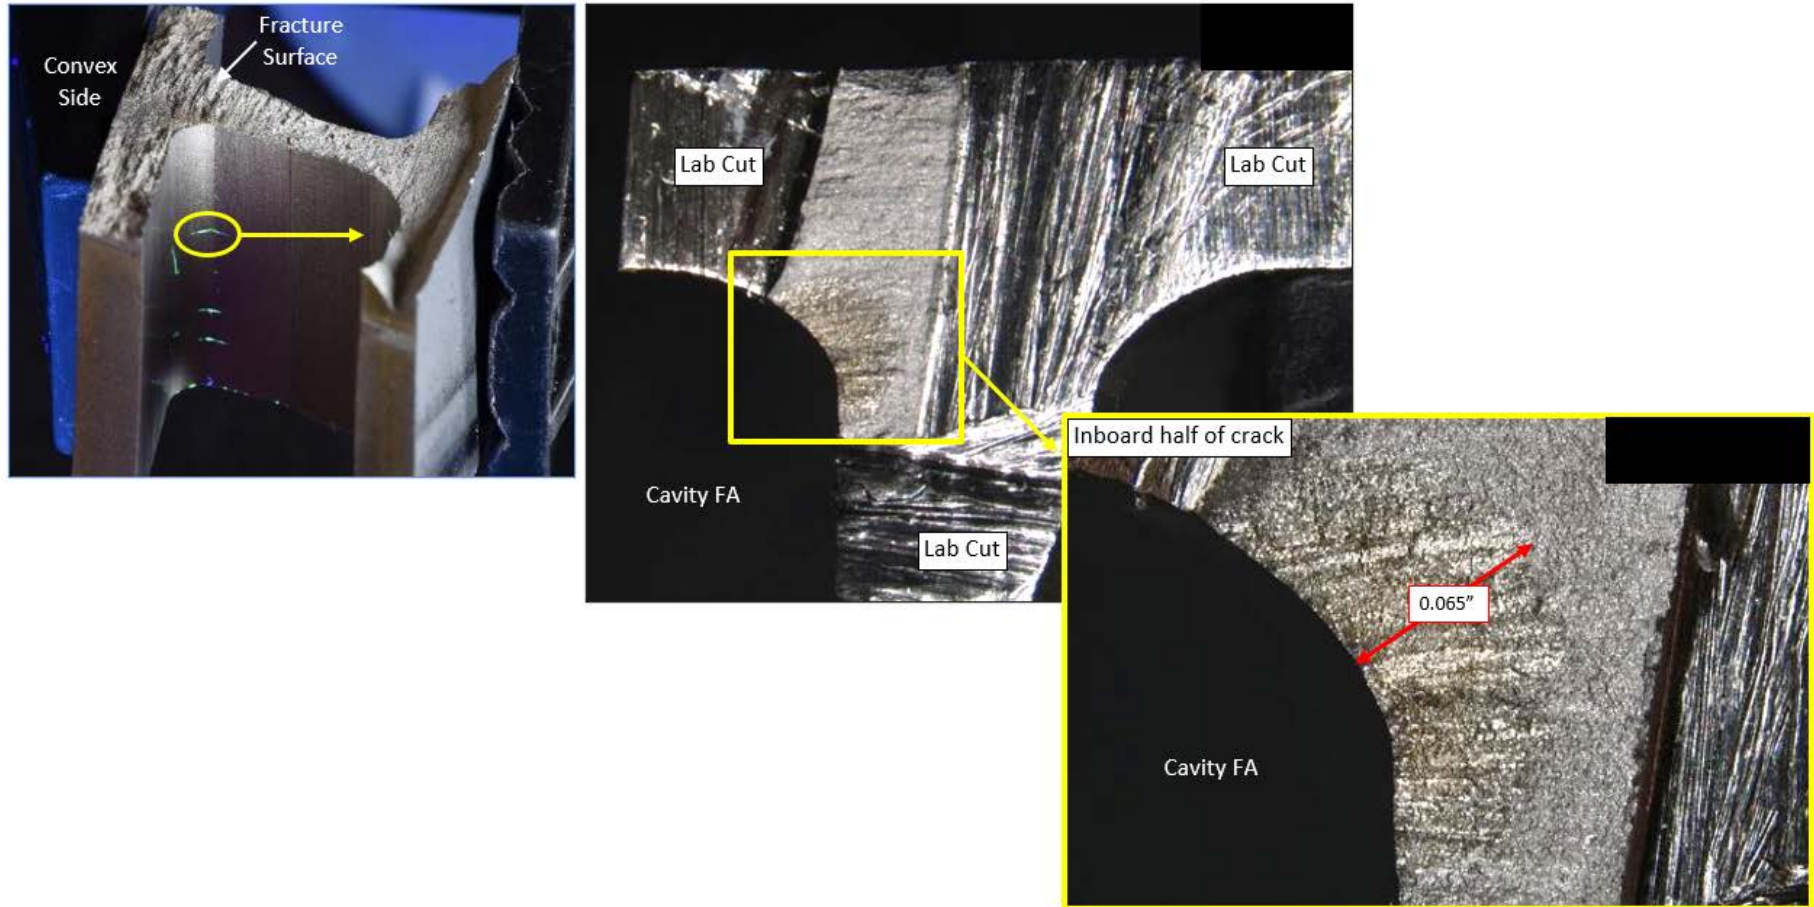
The largest of the chordwise secondary cracks inboard of the fracture surface was fractured open. The maximum crack depth measured 0.065” ([Figure 23](#)). Binocular review of the outboard half of the crack identified an additional crack plane at the irregular contour of the radius runout to the rib ([Figure 24](#)).

Figure 23: The largest of the secondary chordwise cracks inboard of the fracture surface was lab fractured open. The maximum crack depth measured 0.065”.

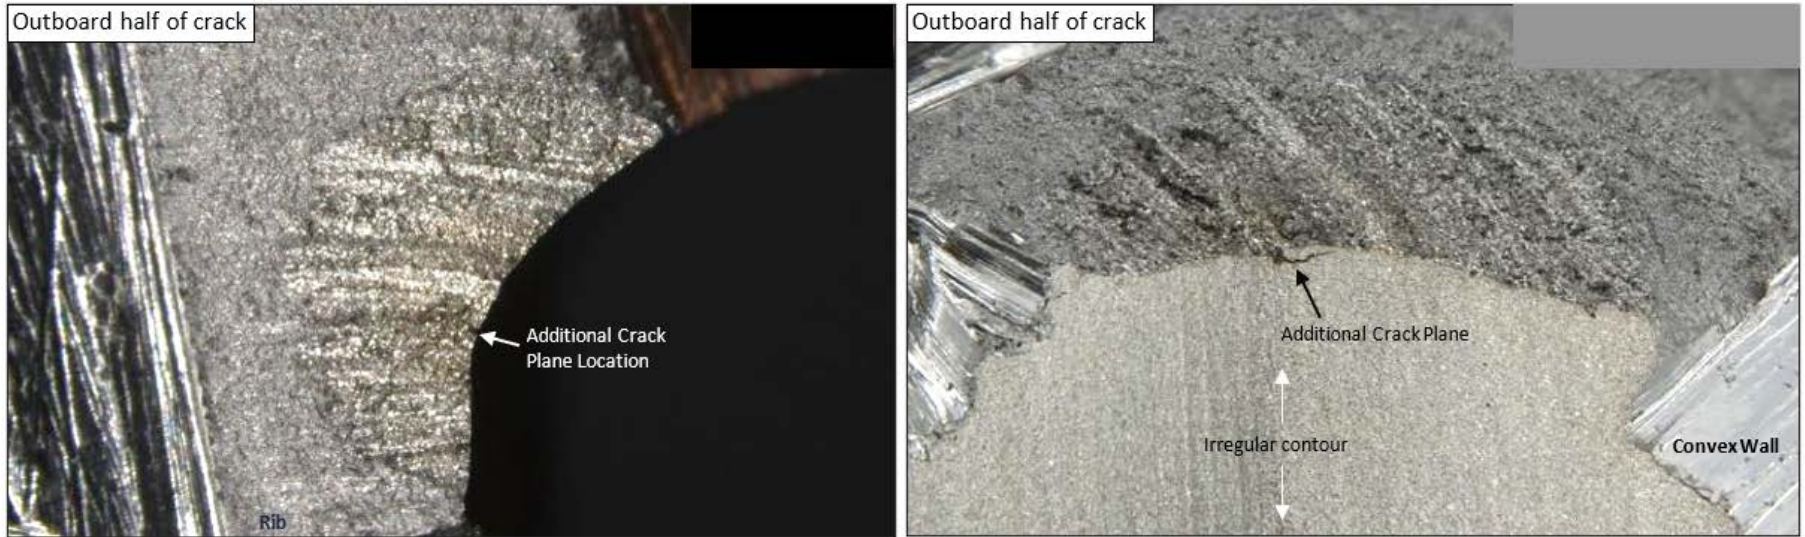
Figure 24: Images of the outboard half of the broken open secondary chordwise crack showing an additional crack plane near the radius runout to the rib.

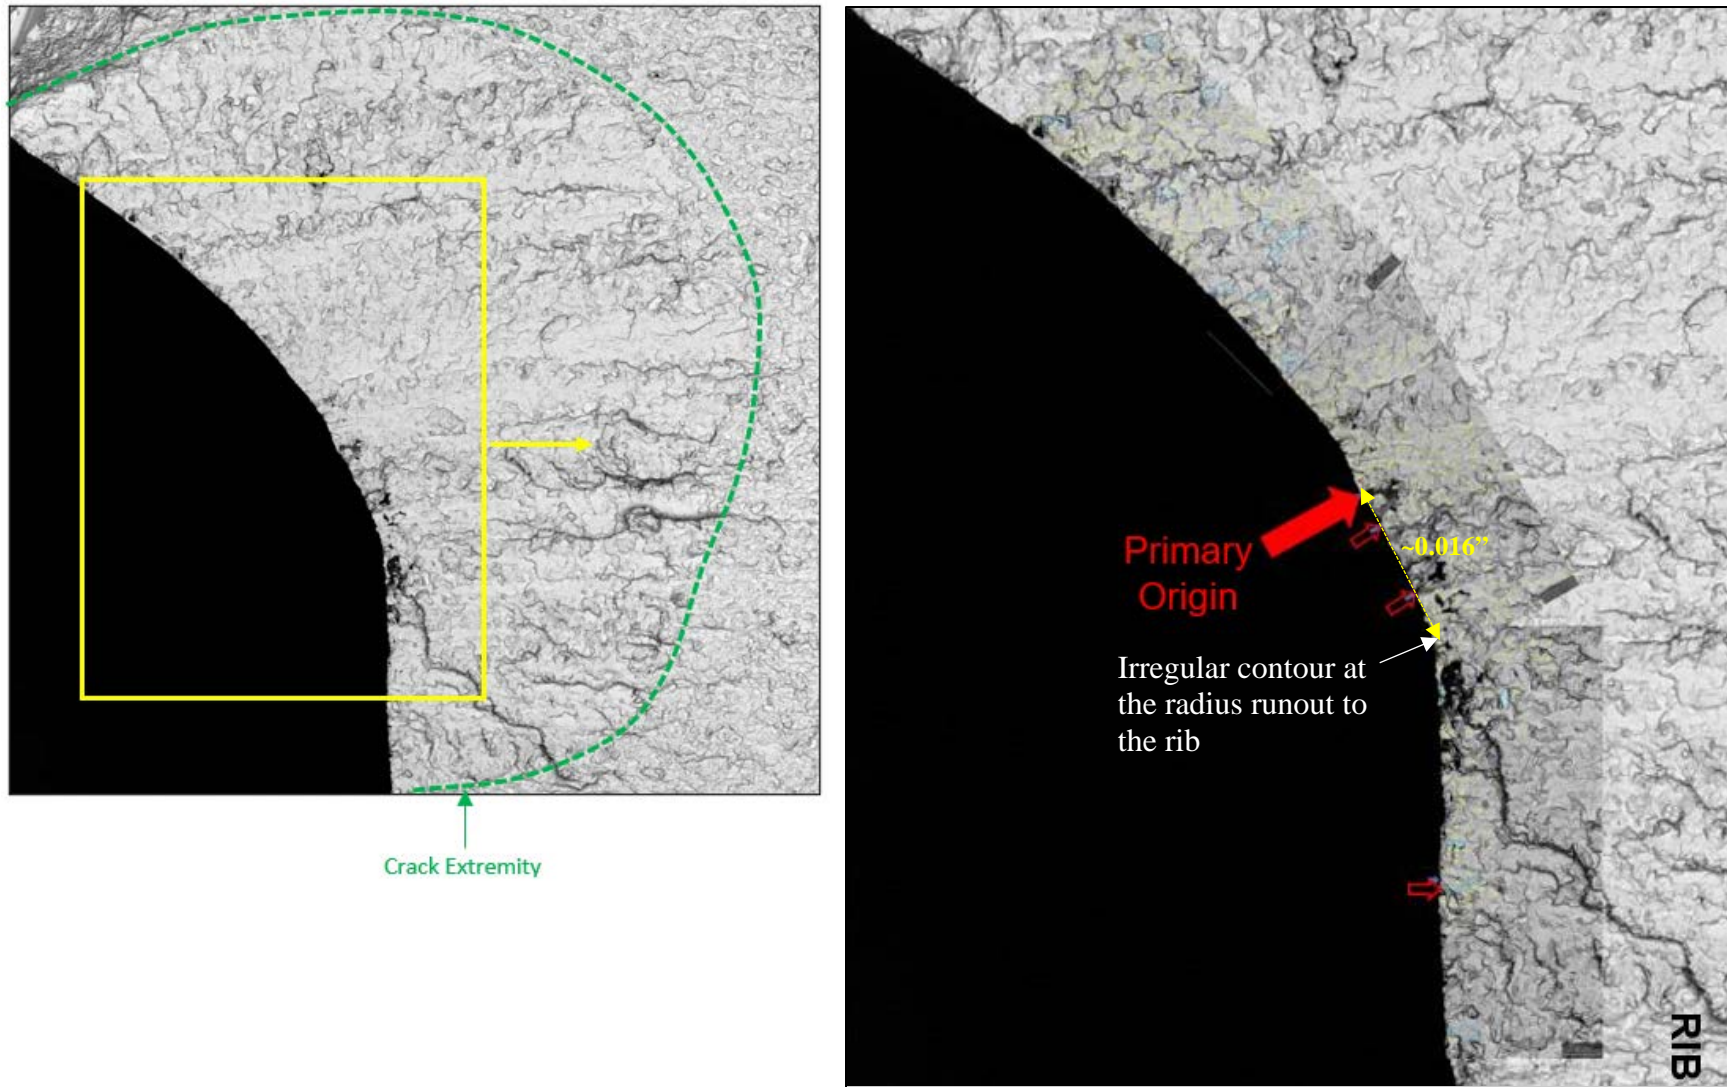
SEM examination of the fractured open secondary crack identified multiple origins near the radius runout to the rib, similar to what was observed on the primary fracture surface. A mix of featureless facets and surface origins were observed. The primary origin associated with the crack progression in the through-wall direction was in the transition radius, approximately 0.016” from the irregular contour at the radius runout to the rib ([Figure 25](#)). The early crack progression exhibited predominantly faceted growth with a mix of cleavage and striations, consistent with the fracture surface. Four discrete striated bands were observed in the crack progression between 0.015” and 0.063” from the primary origin. At these locations, less than approximately 50% striations were observed therefore a full striation count could not be completed. The crack growth rate ranged from 2.9×10^{-6} to 6.9×10^{-6} inches/cycle which followed a similar trend as the primary fracture ([Figures 26 and 27](#)).

Figure 25: SEM images showing the origins identified on the secondary chordwise crack that was lab fractured open, indicated by the red arrows. Featureless facets and surface origins were both observed.
