Metallurgical Investigation Final Report

Subject: Metallurgical Investigation of Fan Blades from PW4077 Engine SN 777047

Date: February 24, 2023

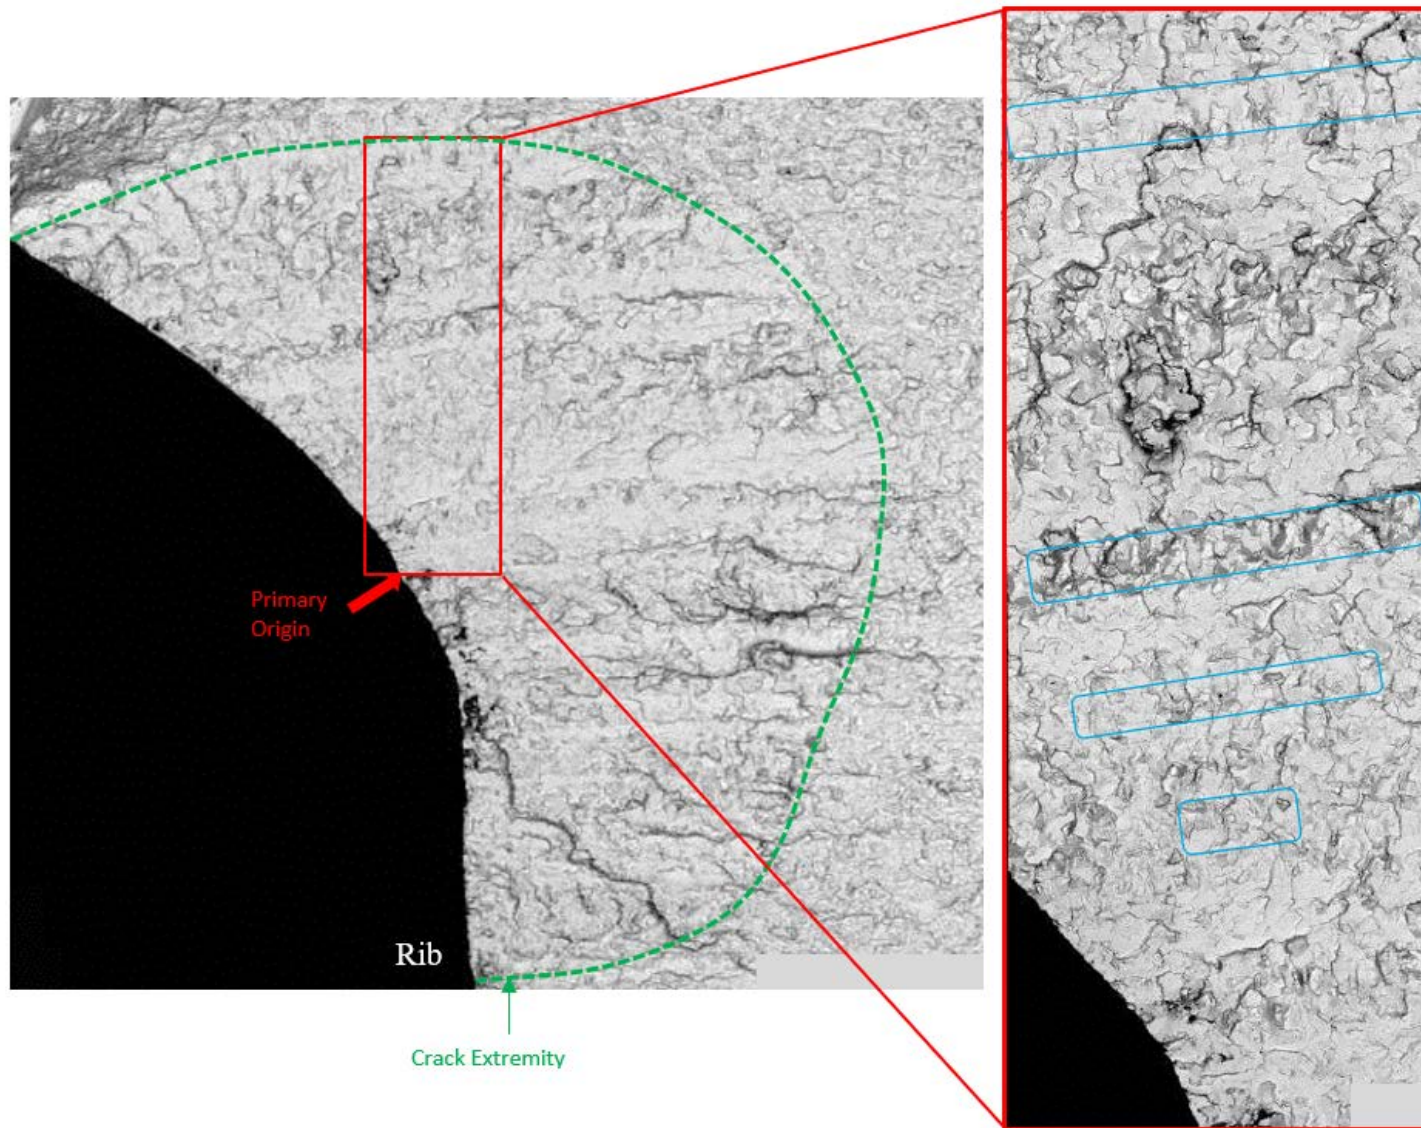
Figure 26: SEM images showing the bands of striations observed in the crack progression (blue boxes). Striation spacing was measured at multiple locations in each of these 4 blue boxes; the rate ranged from 2.9×10^{-6} to 6.9×10^{-6} in/cycle.

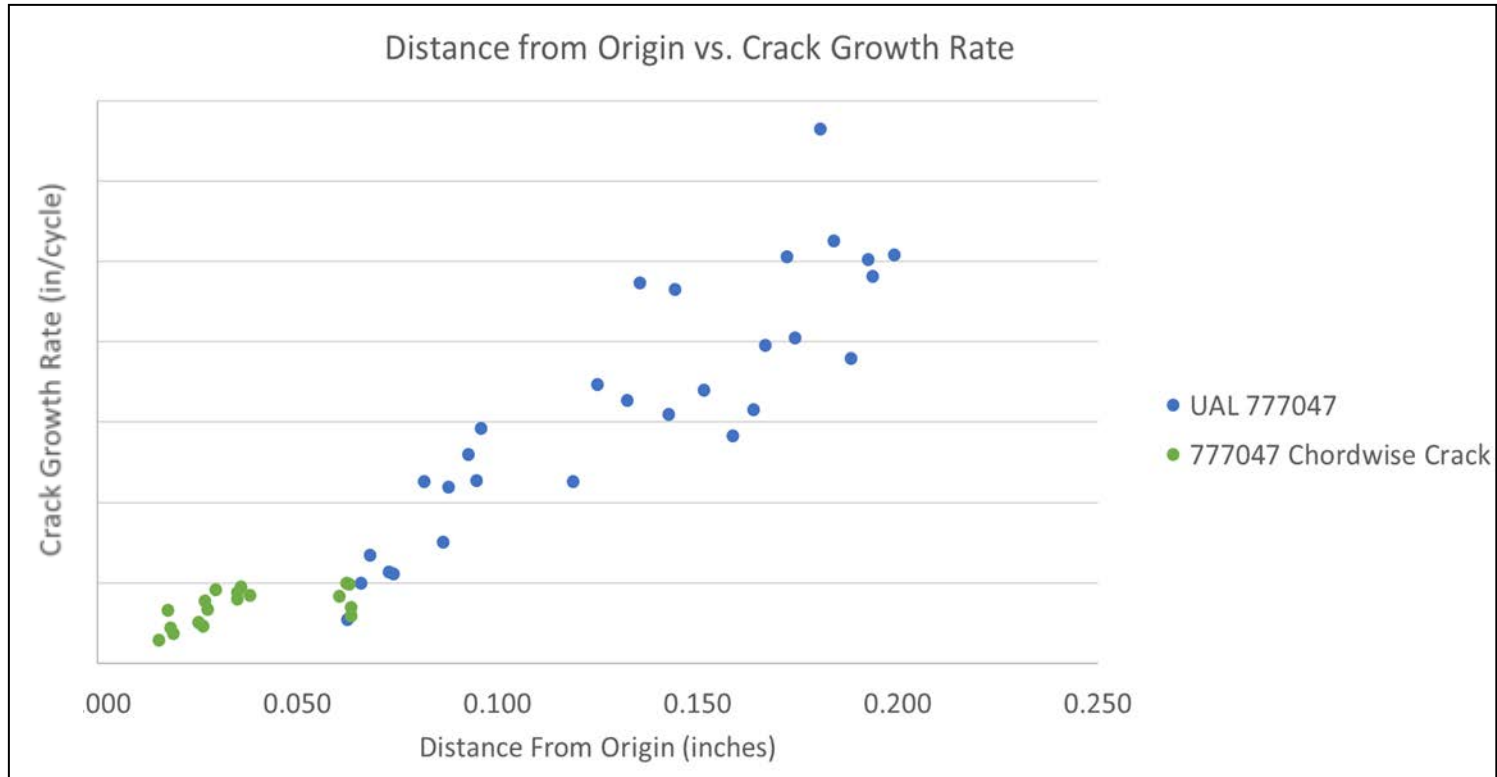
Figure 27: Graph showing crack growth rate vs. distance from the origin of both the primary fracture and the secondary chordwise crack.

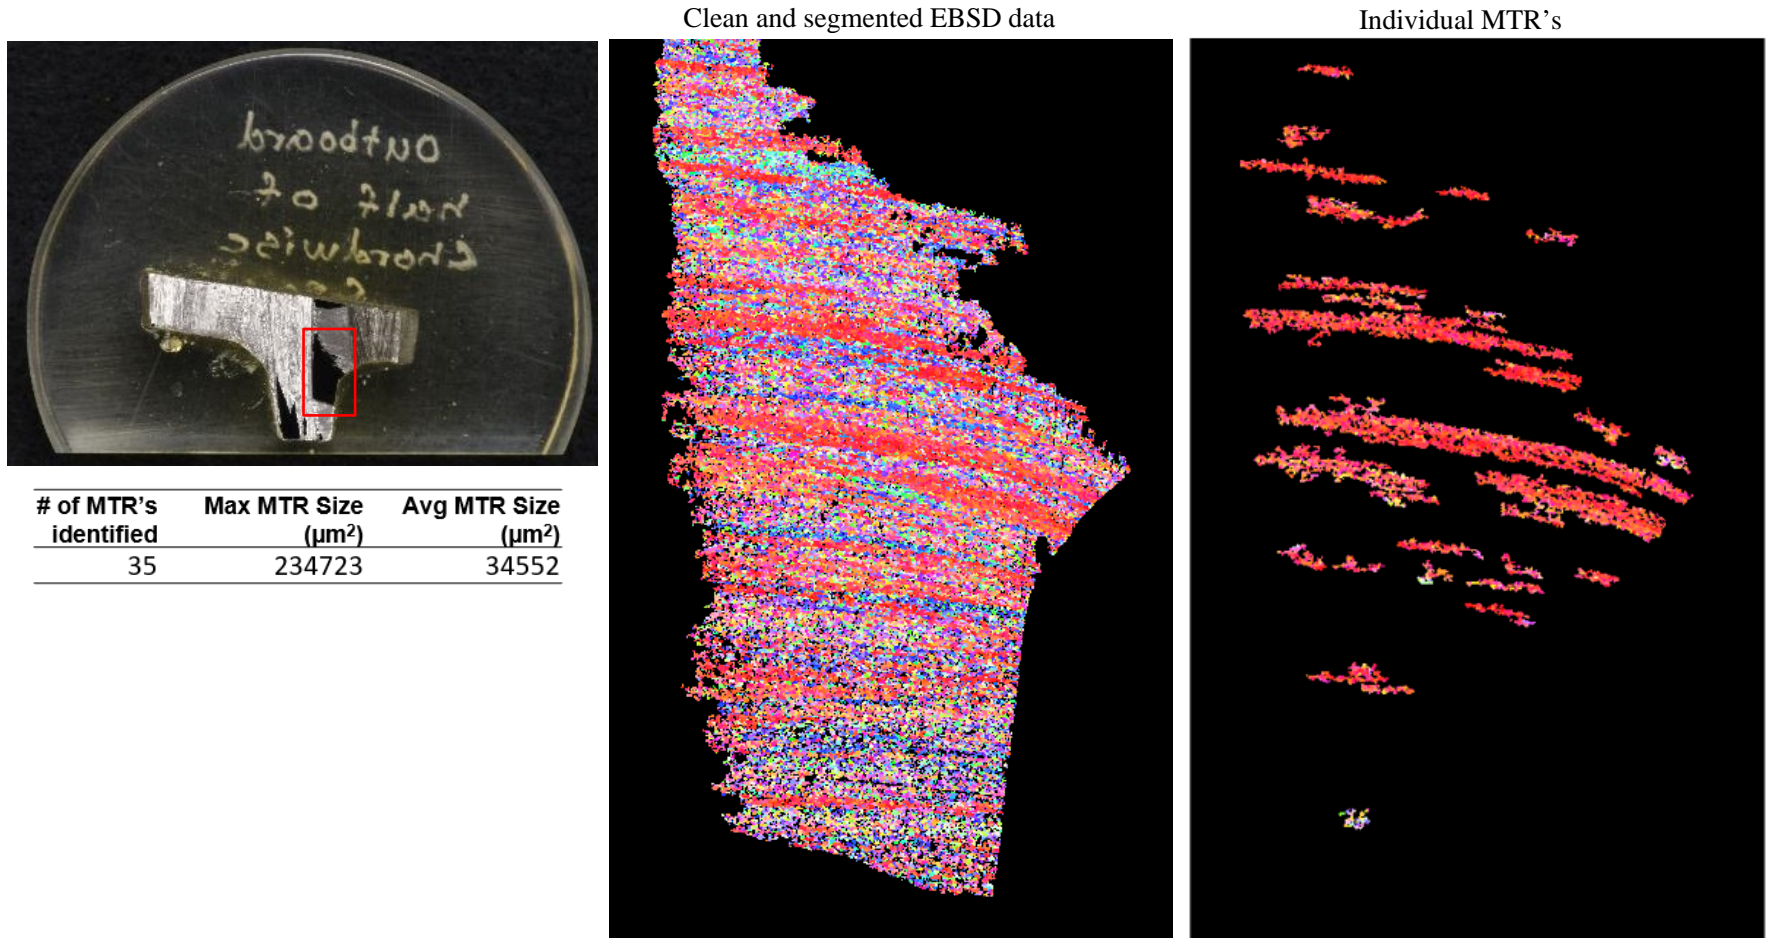
A planar section was prepared into the outboard half of the largest secondary chordwise crack that was previously broken open. EBSD/orientation image mapping (OIM) was completed to characterize MTRs near the origins. The primary origin on the crack aligned with an MTR which may have contributed to crack growth ([Figures 28 and 29](#)). The section was etched with 1% HF and Kroll’s after EBSD/OIM. Alpha grains near the surface etched lighter when etched with 1% HF but no distorted surface layer/deformation was observed ([Figure 30](#)).

Figure 28: Images showing the EBSD/OIM results on the section planar into the secondary chordwise crack. Red areas represent basal texture regions (MTRs).

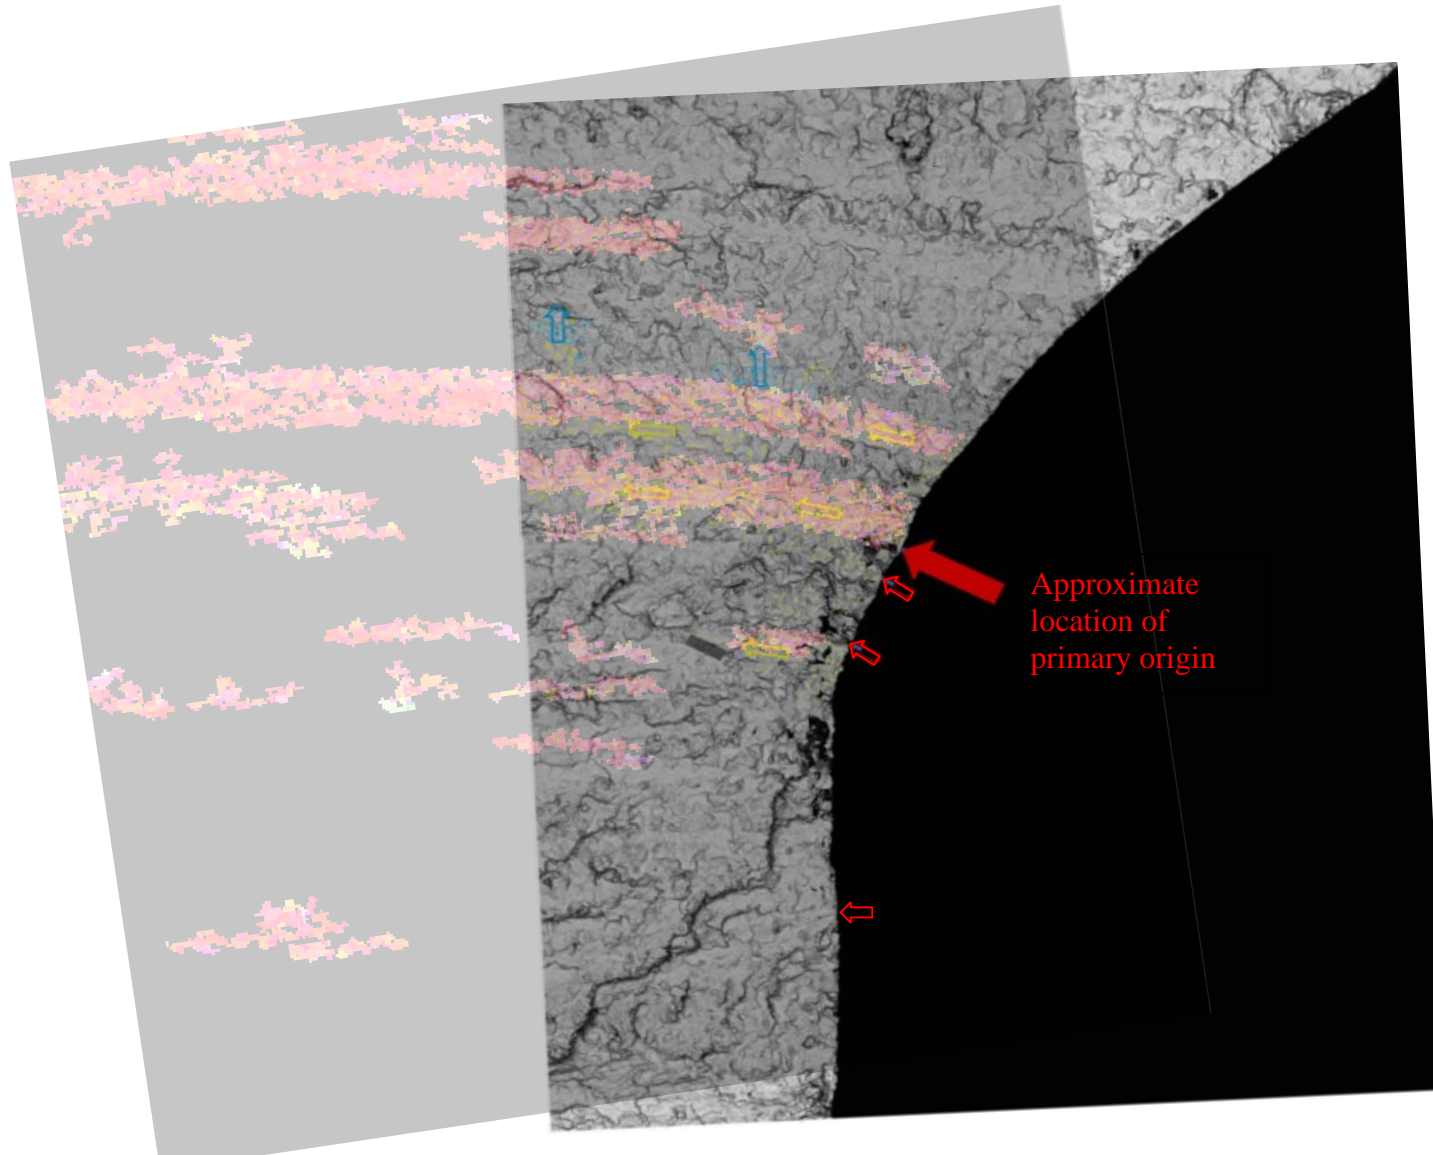
Figure 29: The individual MTR data from Figure 28 aligned with the fracture features. The primary origin on the crack (bold red arrow) was near an MTR which may have contributed to crack growth.

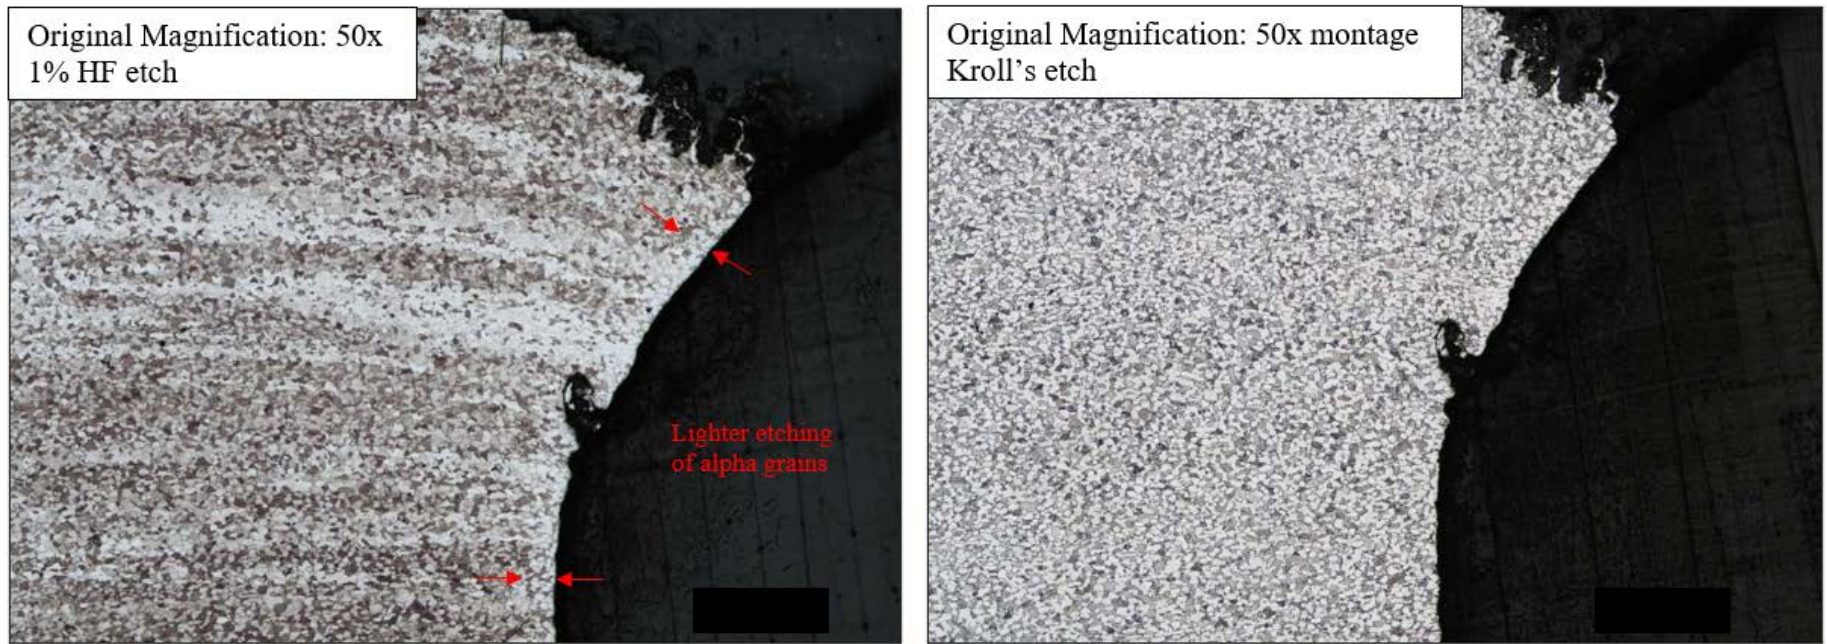
Figure 30: Metallographic images of the planar section into the chordwise crack. The section was etched with 1% HF and Kroll's after EBSD/OIM. Alpha grains near the surface exhibited a lighter etching when etched with 1% HF. No distorted surface layer/deformation was observed.

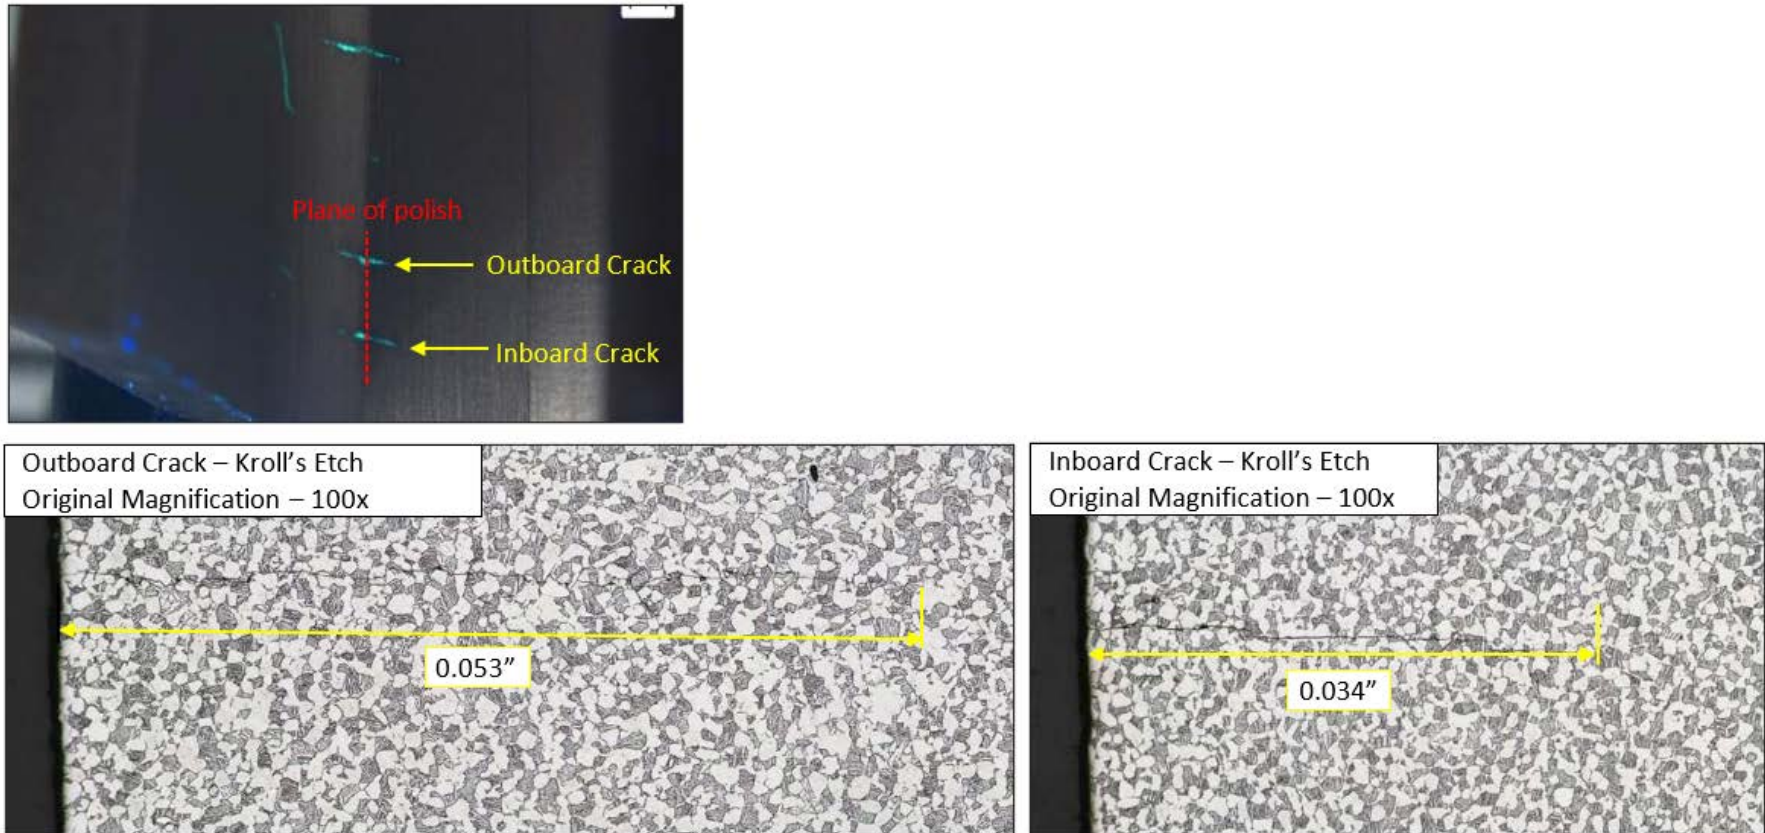
A longitudinal/spanwise section was prepared into the two secondary chordwise cracks furthest away from the fracture surface. Multiple polishes at 0.005” increments were completed into the cracks until the plane of polish was located at approximately the radius runout to the rib, near where the origins were located on the previously evaluated secondary crack and fracture. The maximum crack depths observed in the polishes were 0.053” and 0.034” for the outboard and inboard cracks, respectively. The section was etched with Kroll’s and 1% HF. The bulk microstructure appeared typical of Ti 6Al-4V. Light etching of the alpha grains within 0.002”-0.003” of the internal surface was observed. No surface deformation or microcracking along the surface was observed ([Figure 31](#)).

Figure 31: Metallurgic images showing the section through the two secondary cracks furthest inboard from the fracture surface etched with Kroll's. The maximum crack depths observed in the polishes were 0.053" and 0.034" for the outboard and inboard cracks, respectively.

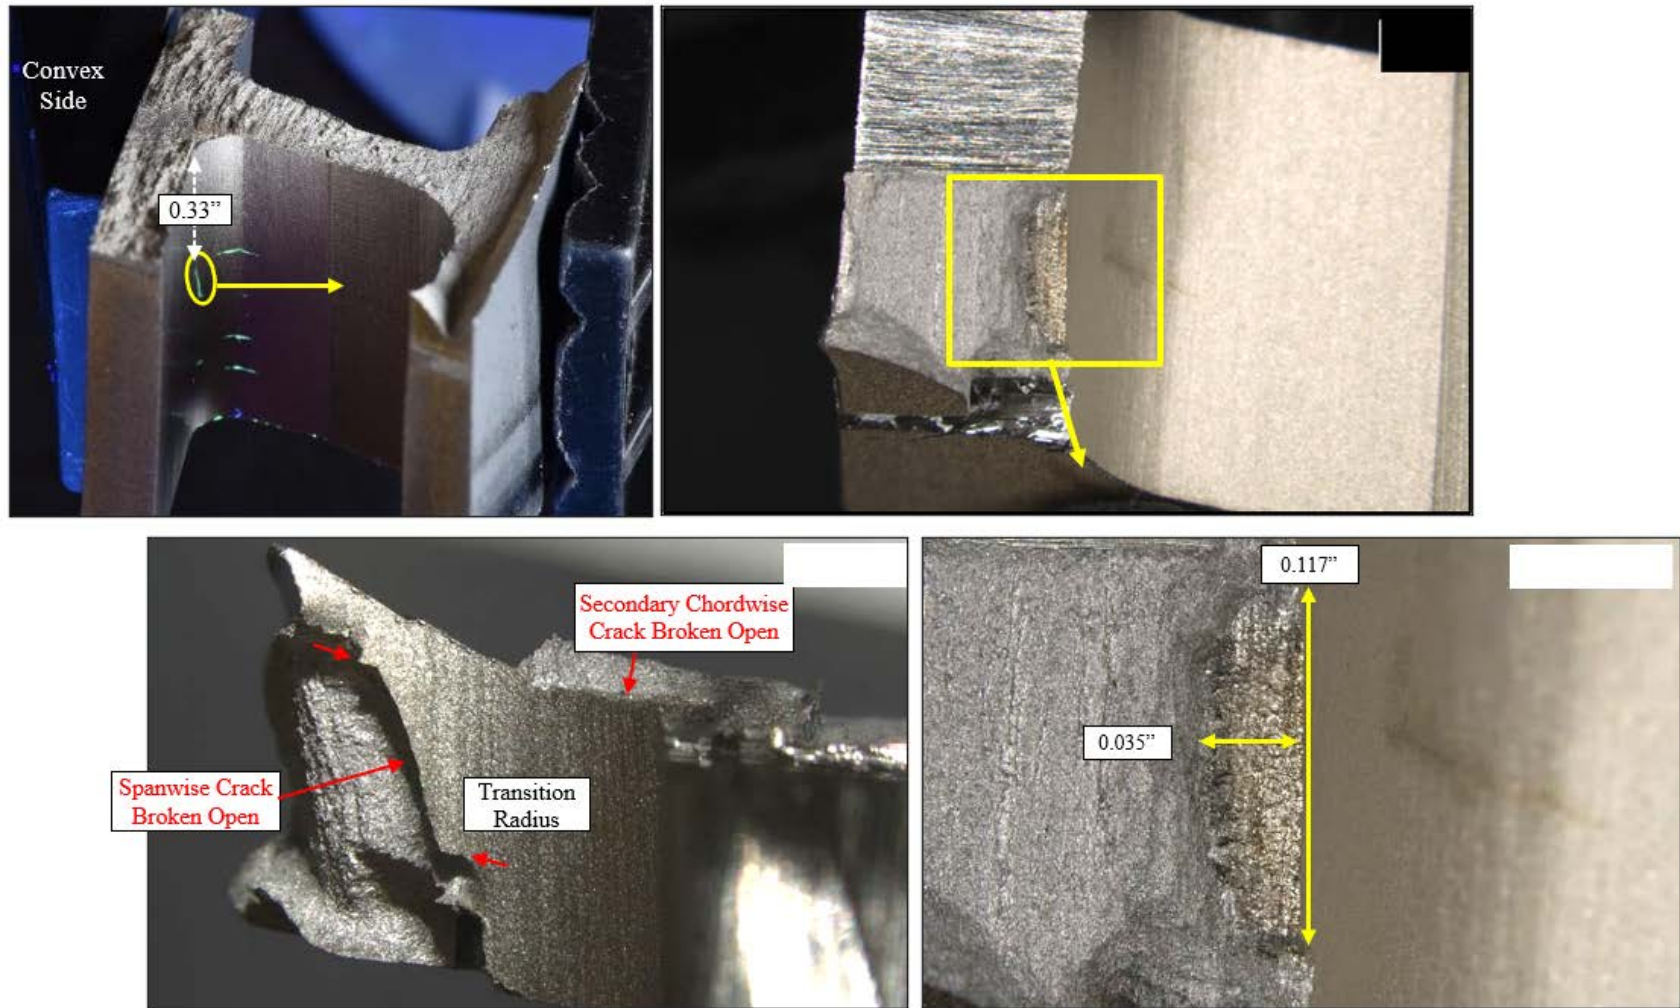
Visual and binocular review of the secondary cracks inboard of the fracture surface also identified a more spanwise oriented crack located in the convex wall side of the transition radius. The outboard edge of the crack was located approximately 0.33” from the fracture surface. The outboard and inboard edges of the spanwise crack were oriented in a more chordwise direction. The spanwise crack was broken open. It measured approximately 0.117” in length and 0.035” in depth ([Figure 32](#)).

Figure 32: Images of the spanwise secondary crack in the convex wall side of the transition radius. The broken open crack measured approximately 0.117” in length and 0.035” in depth.

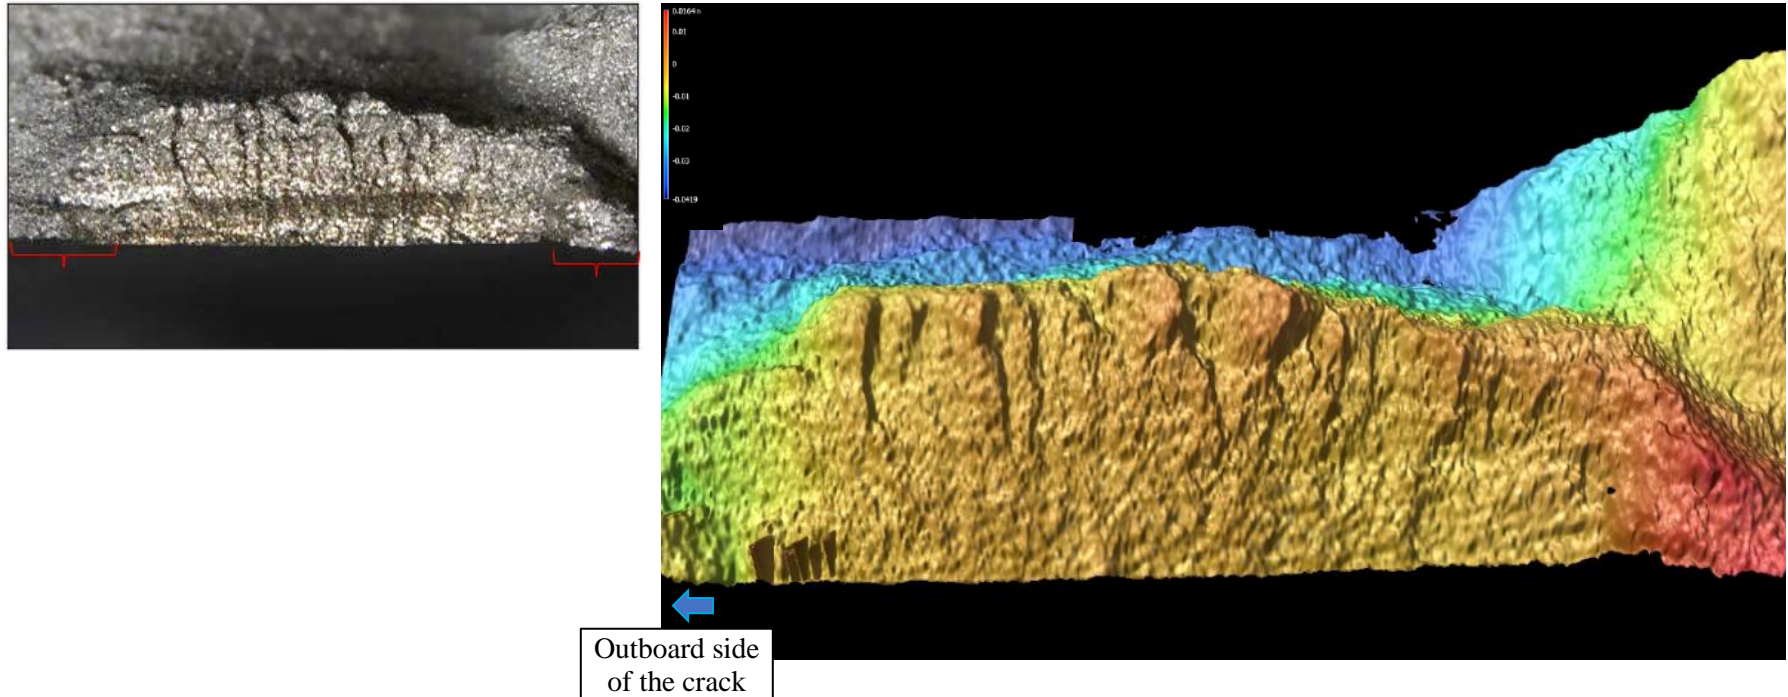
A 3D scan of the spanwise crack showed the crack was changing planes at the extremities. The features appeared to grow into a more chordwise plane direction, particularly at the inboard and outboard edges of the crack ([Figure 33](#)).

Figure 33: Keyence 3D scan showing the plane changes at the extremities of the crack (red brackets). The green/blue areas in the 3D scan are going into the page and the red areas are coming out of the page.

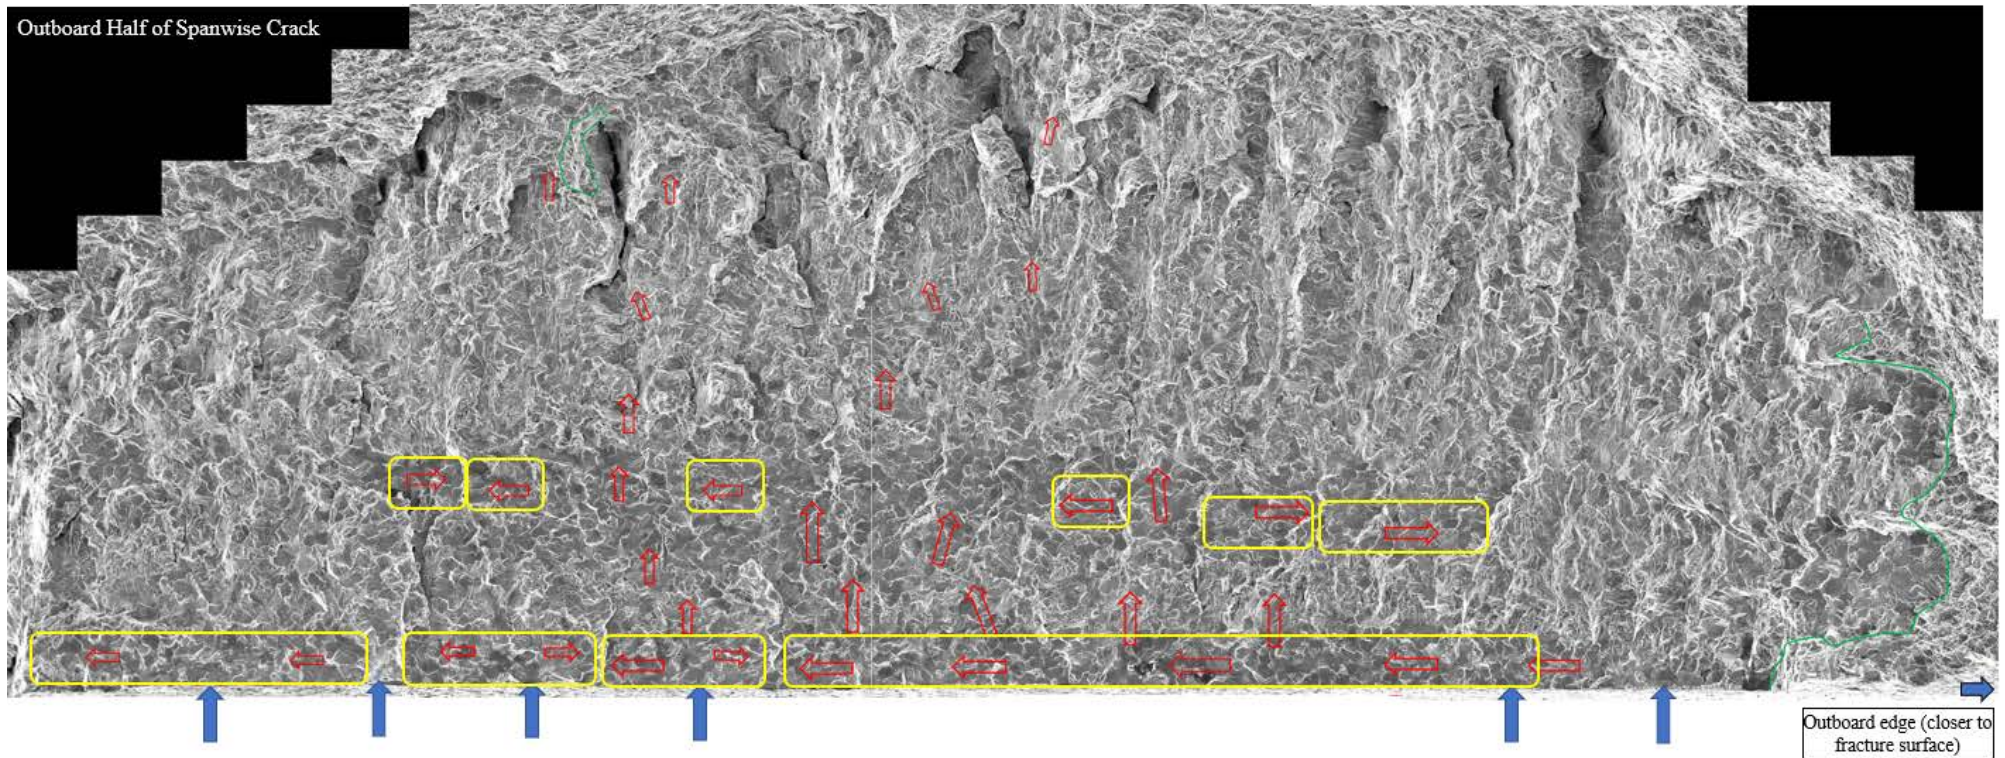
SEM examination identified multiple origins along the surface of the spanwise crack. Both surface grain origins and featureless facet origins were identified. Crack growth at the origins was made up of predominantly faceted features that progressed along the surface, indicating a possible MTR contribution. Areas of the crack progression exhibited near fully faceted growth that tended to propagate in the spanwise direction, suggestive of MTRs. Toward the crack extremity, features appeared to propagate into a chordwise plane direction ([Figures 34 - 36](#)). Further examination identified multiple secondary cracks beyond the spanwise crack extremity. Faceted grains were observed along the surface of the secondary cracks ([Figure 37](#)).

Figure 34: SEM image showing mapping of the crack progression. Multiple origins were observed along the surface (blue arrows). Crack growth at the origins was made up of predominantly faceted features that progressed along the surface, indicating a possible MTR contribution. Predominantly cleavage features were observed progressing from potential MTR regions at the surface. The yellow boxes indicate possible MTRs based on the fractographic assessment. The red arrows indicate general crack propagation direction.

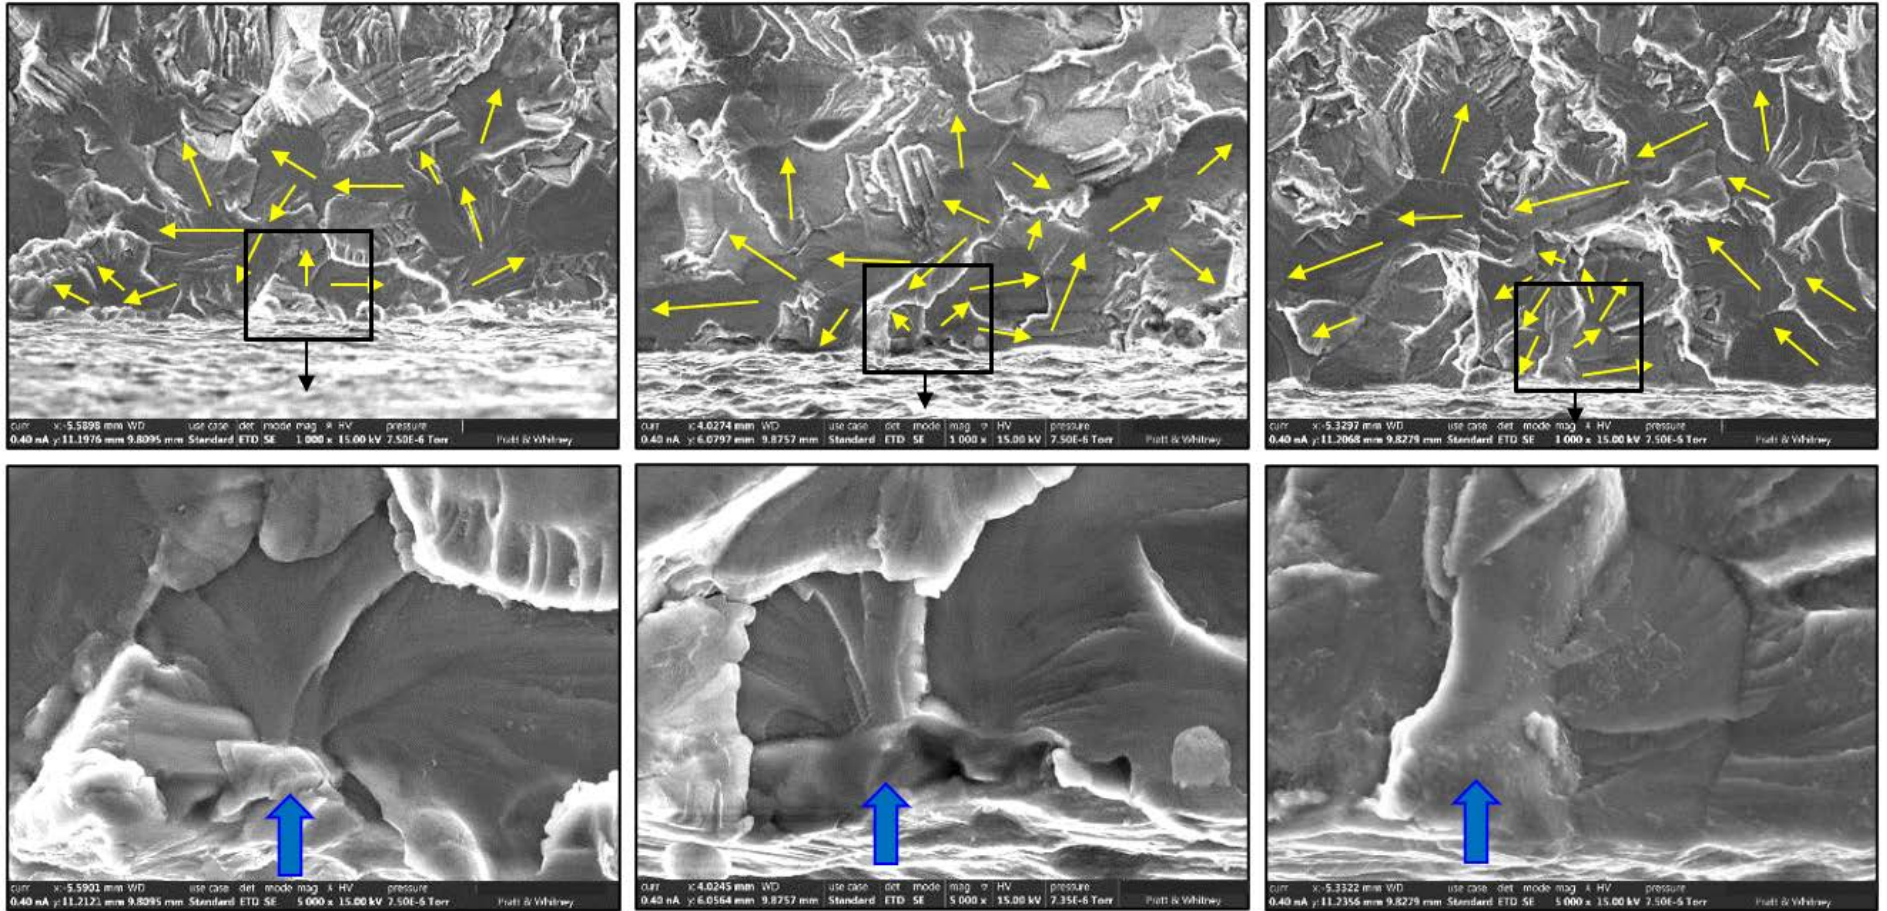
Figure 35: SEM examination showing representative images of the origins observed on the spanwise crack (blue arrows).

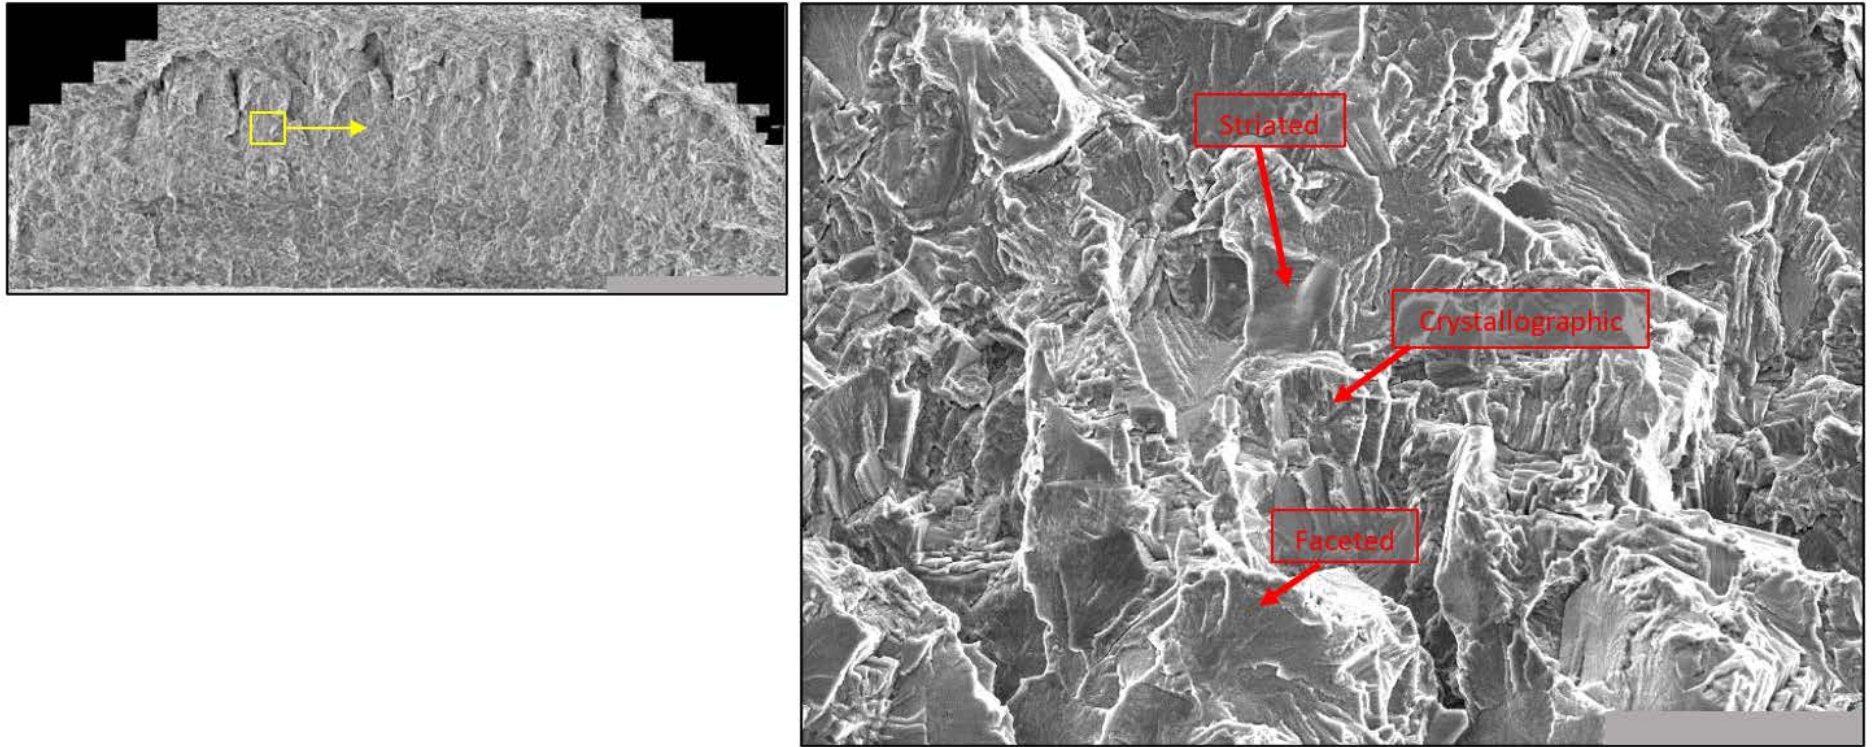
Figure 36: SEM image showing features representative of the crack progression. The crack exhibited a mix of faceted, striated, and crystallographic growth.

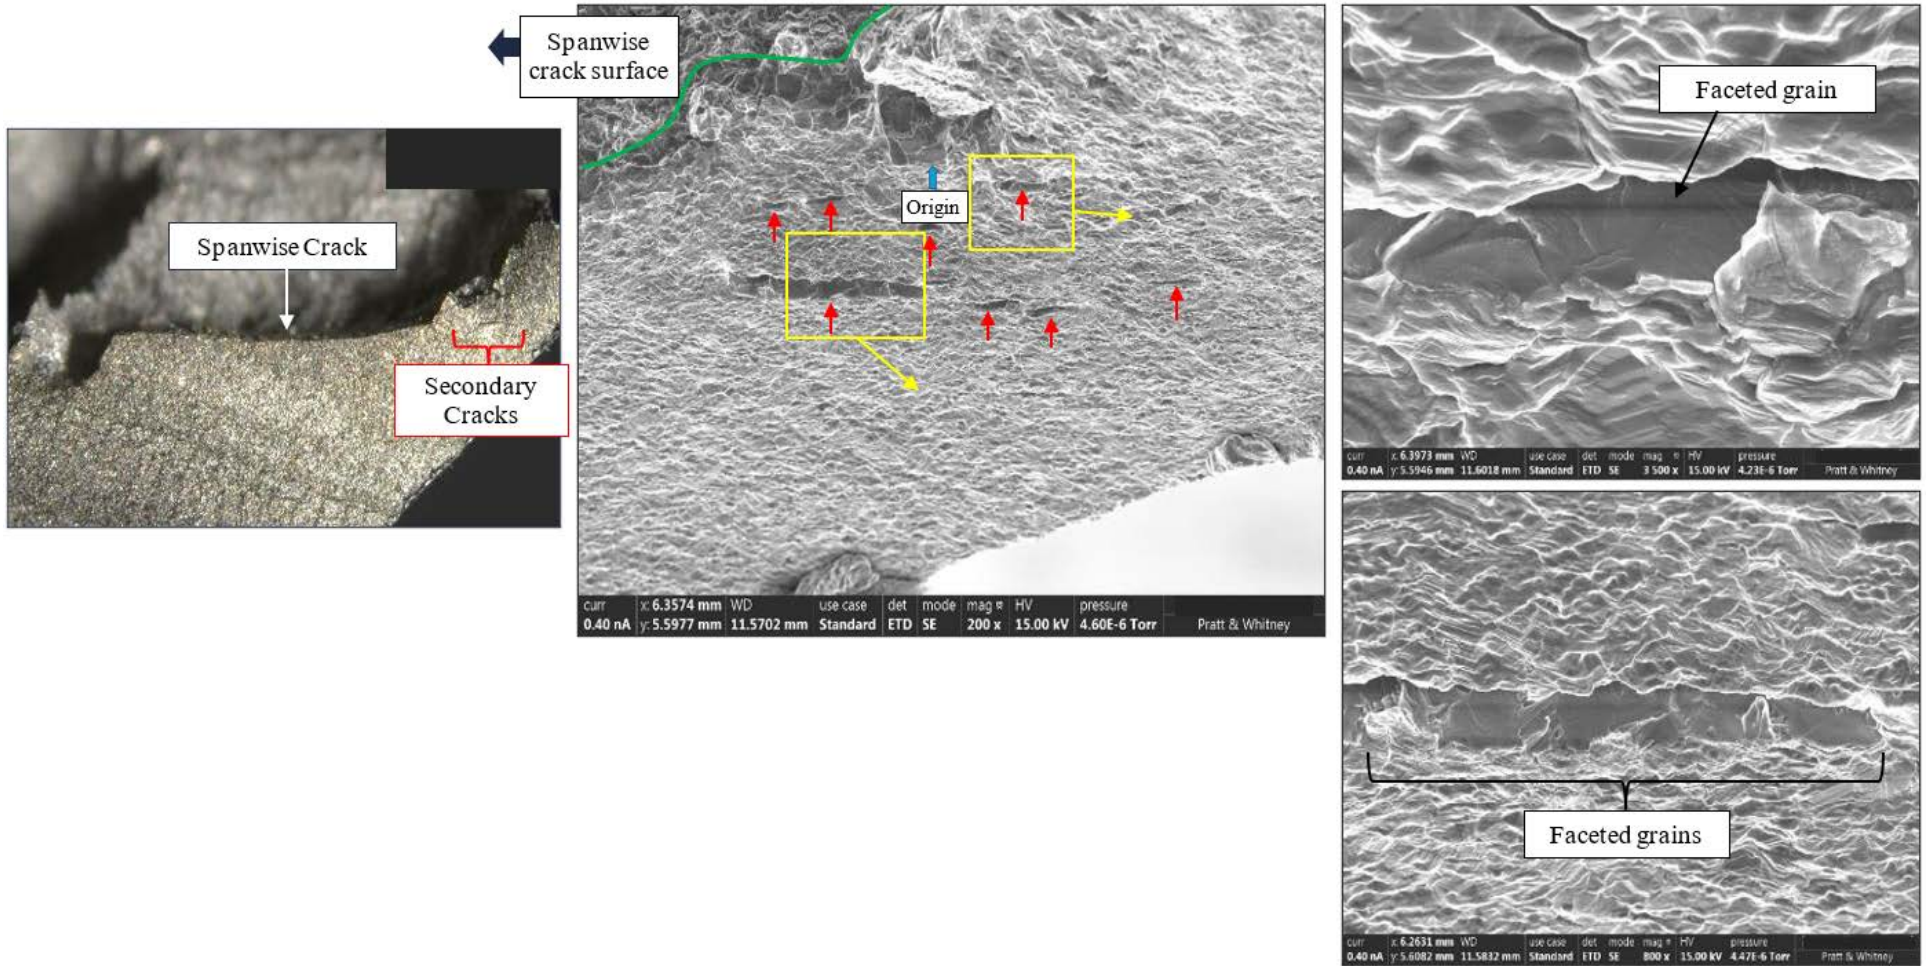
Figure 37: Additional binocular and SEM examination identified secondary cracking adjacent to the spanwise crack extremity (red arrows). Faceted grains were observed along the surface of the secondary cracks.

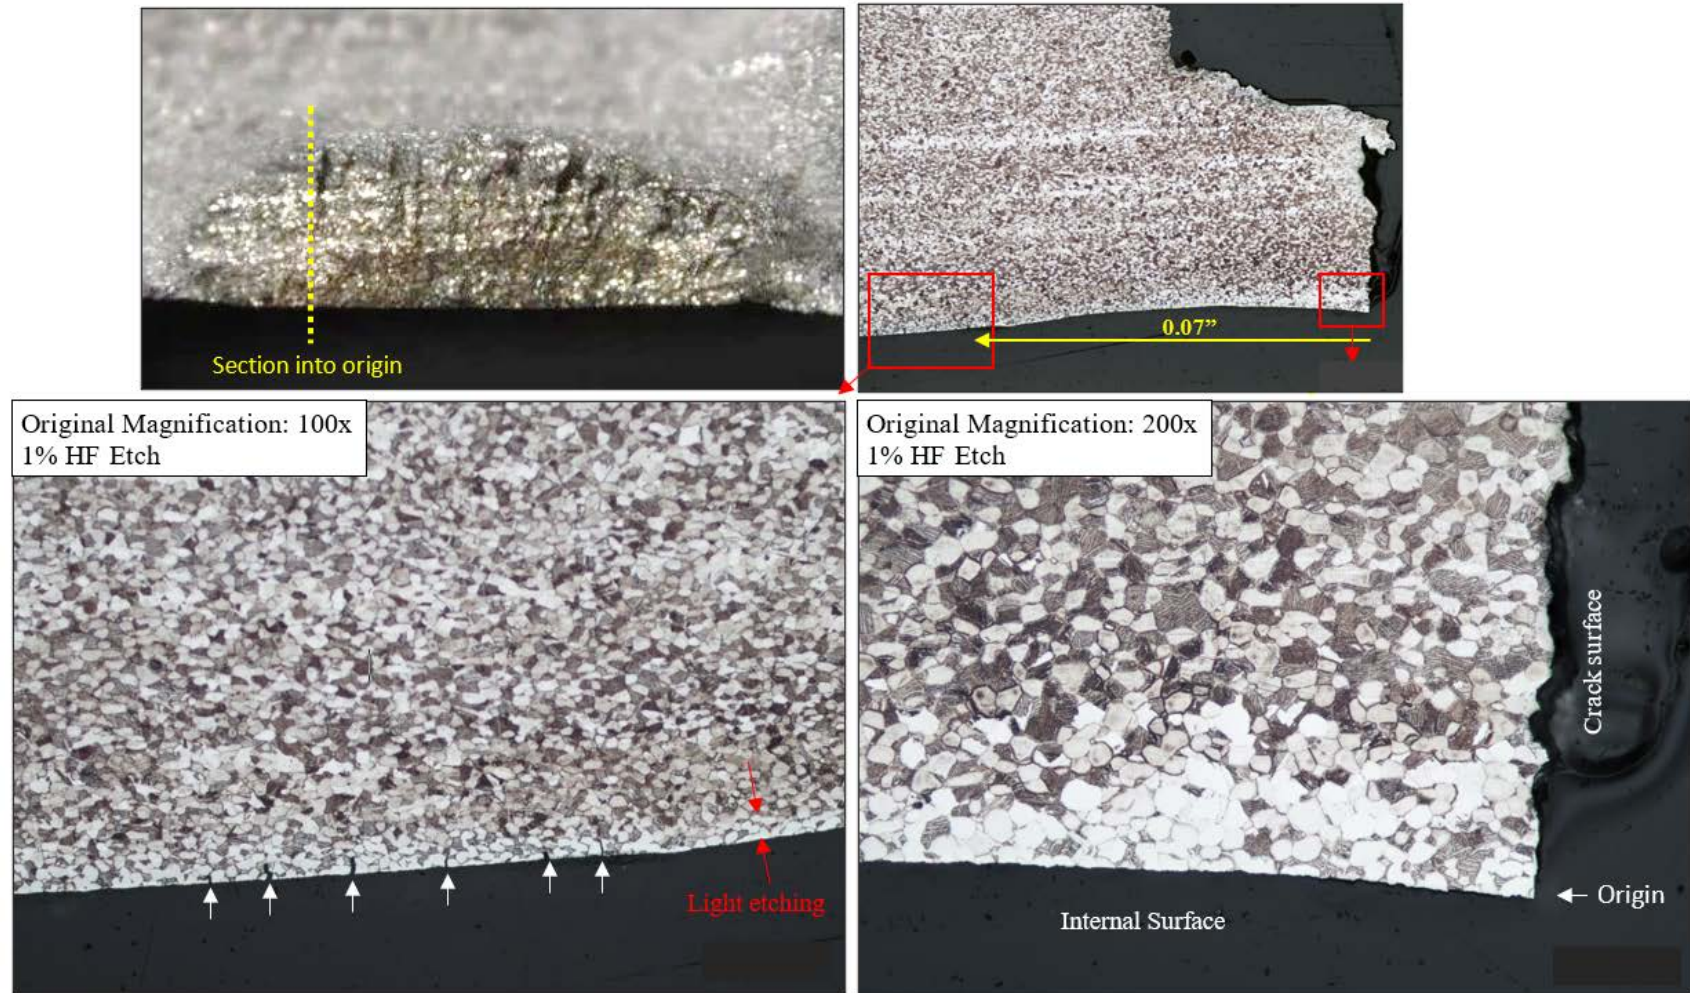
A transverse section was prepared into the primary origin on the half of the crack away from the radius where the chordwise cracks were located. Four step polishes were prepared through the primary origin on the spanwise crack. 1% HF and Kroll's etches were completed at each increment. Alpha grains near the surface etched lighter when etched with 1% HF. There was also banding of the microstructure observed near the origin. No distorted surface layer/deformation was observed, and no abnormalities were noted at the origin. Secondary cracks, up to 0.001" in depth were observed approximately 0.07" from the spanwise crack. It was unclear if these cracks were a result of breaking the spanwise crack open or if they were prior existing ([Figure 38](#)).

Figure 38: Four step polishes were prepared through the primary origin on the spanwise crack. 1% HF and Kroll’s etches were completed at each increment. The images shown above are from the 1% HF etch on the second polish. Alpha grains near the surface exhibited a lighter etching when etched with 1% HF. No distorted surface layer/deformation was observed. Secondary cracks up to 0.001” in depth were observed approximately 0.07” from the spanwise crack (away from the radius).
