Metallurgical Investigation Final Report

Subject: Metallurgical Investigation of Fan Blades from PW4077 Engine SN 777047

Date: February 24, 2023

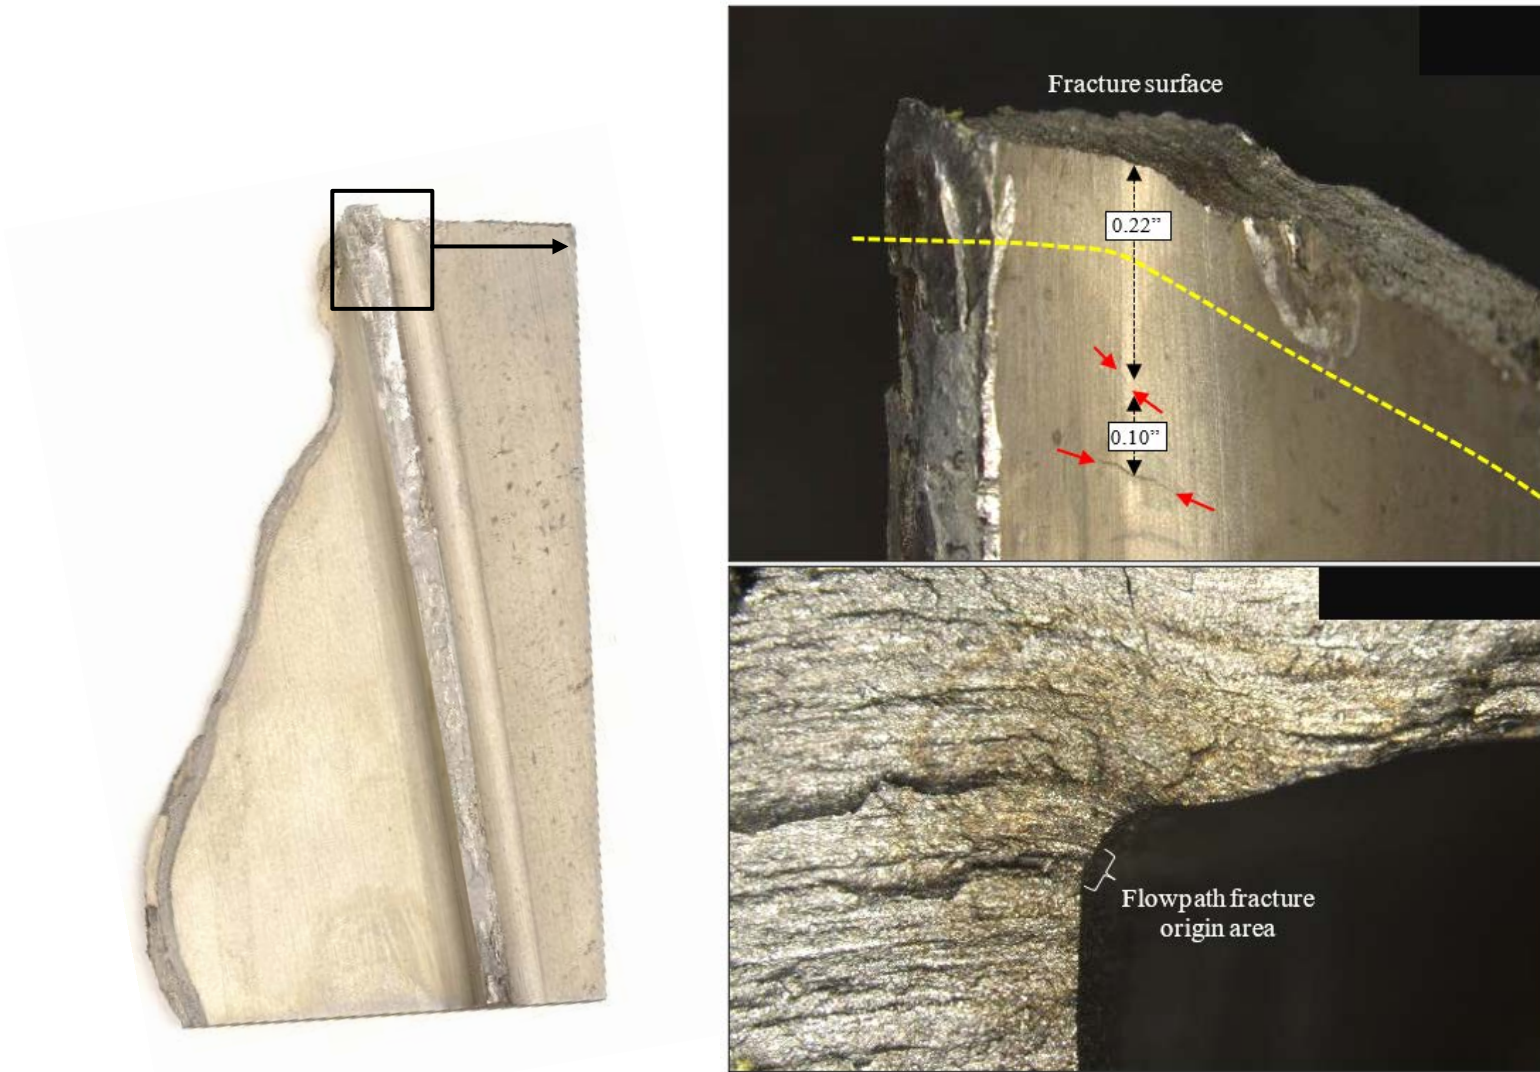
The mating flowpath origin area was mostly intact but exhibited secondary damage from the post-fracture event. The convex and concave sides of the blade were disbonded at several spanwise ribs in the flowpath due to secondary damage. The origin area was sectioned from the fragment for further evaluation ([Figure 40](#)). Binocular review identified two additional secondary cracks outboard of the fracture surface. The furthest outboard crack was located ~0.32" from the fracture origin. The fracture surface was sectioned from the secondary cracks via wire EDM for further evaluation ([Figure 41](#)).

Figure 41: Images of the outboard half of the fracture surface. Two additional secondary cracks were identified within 0.32” of the fracture surface (red arrows). The origin area was intact (bottom right image). The fracture surface was sectioned from the secondary cracks for further evaluation (yellow dotted line).

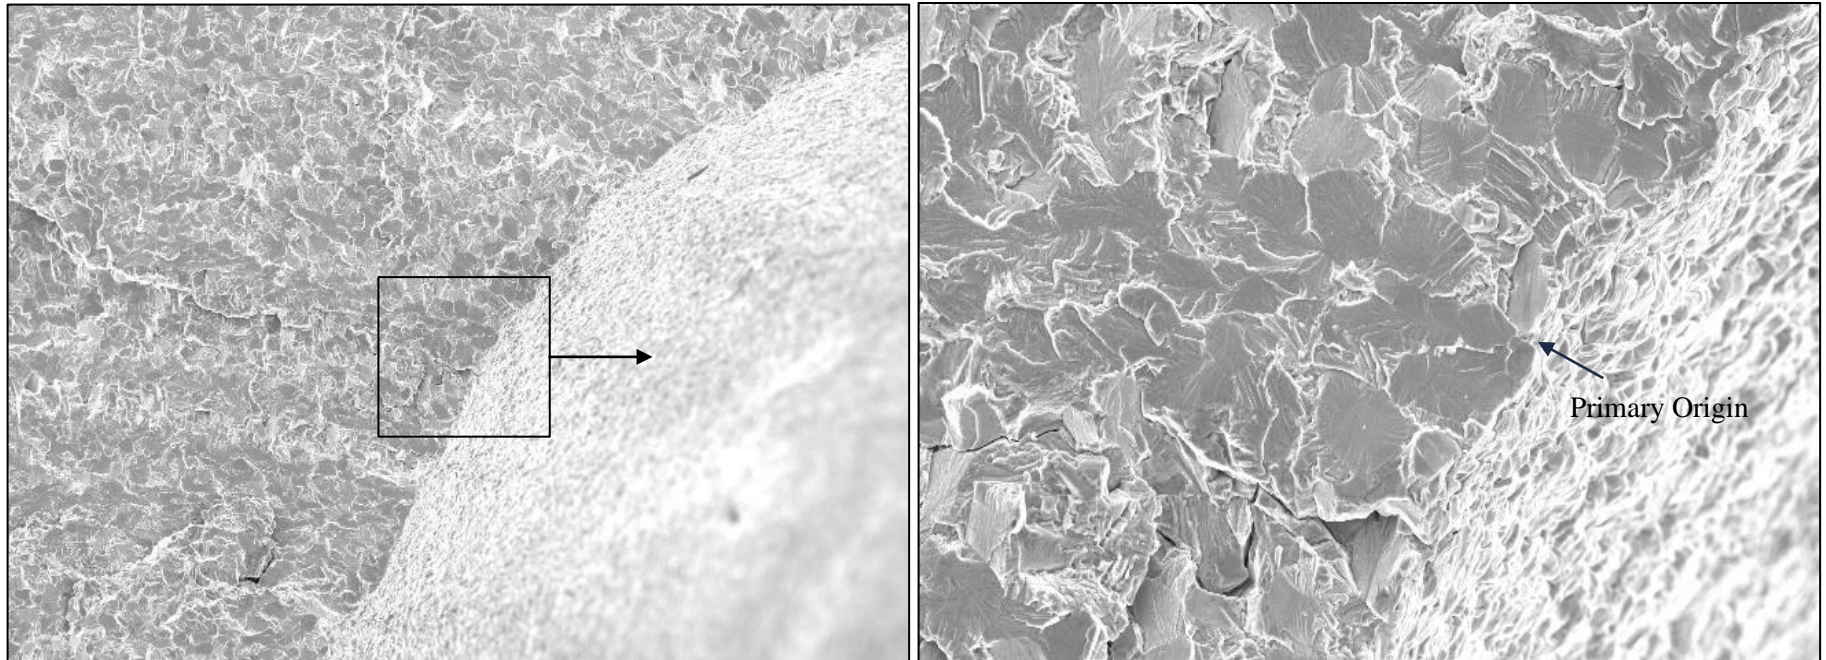
SEM examination of the outboard half of the fracture surface found features consistent with those observed on the inboard side of the fracture. Further examination did not identify any additional anomalies or discontinuities at the origins ([Figure 42](#)).

Figure 42: SEM examination of the outboard side of the fracture found features consistent with the inboard side of the fracture. No anomalies were observed at the surface at or near the origin area.

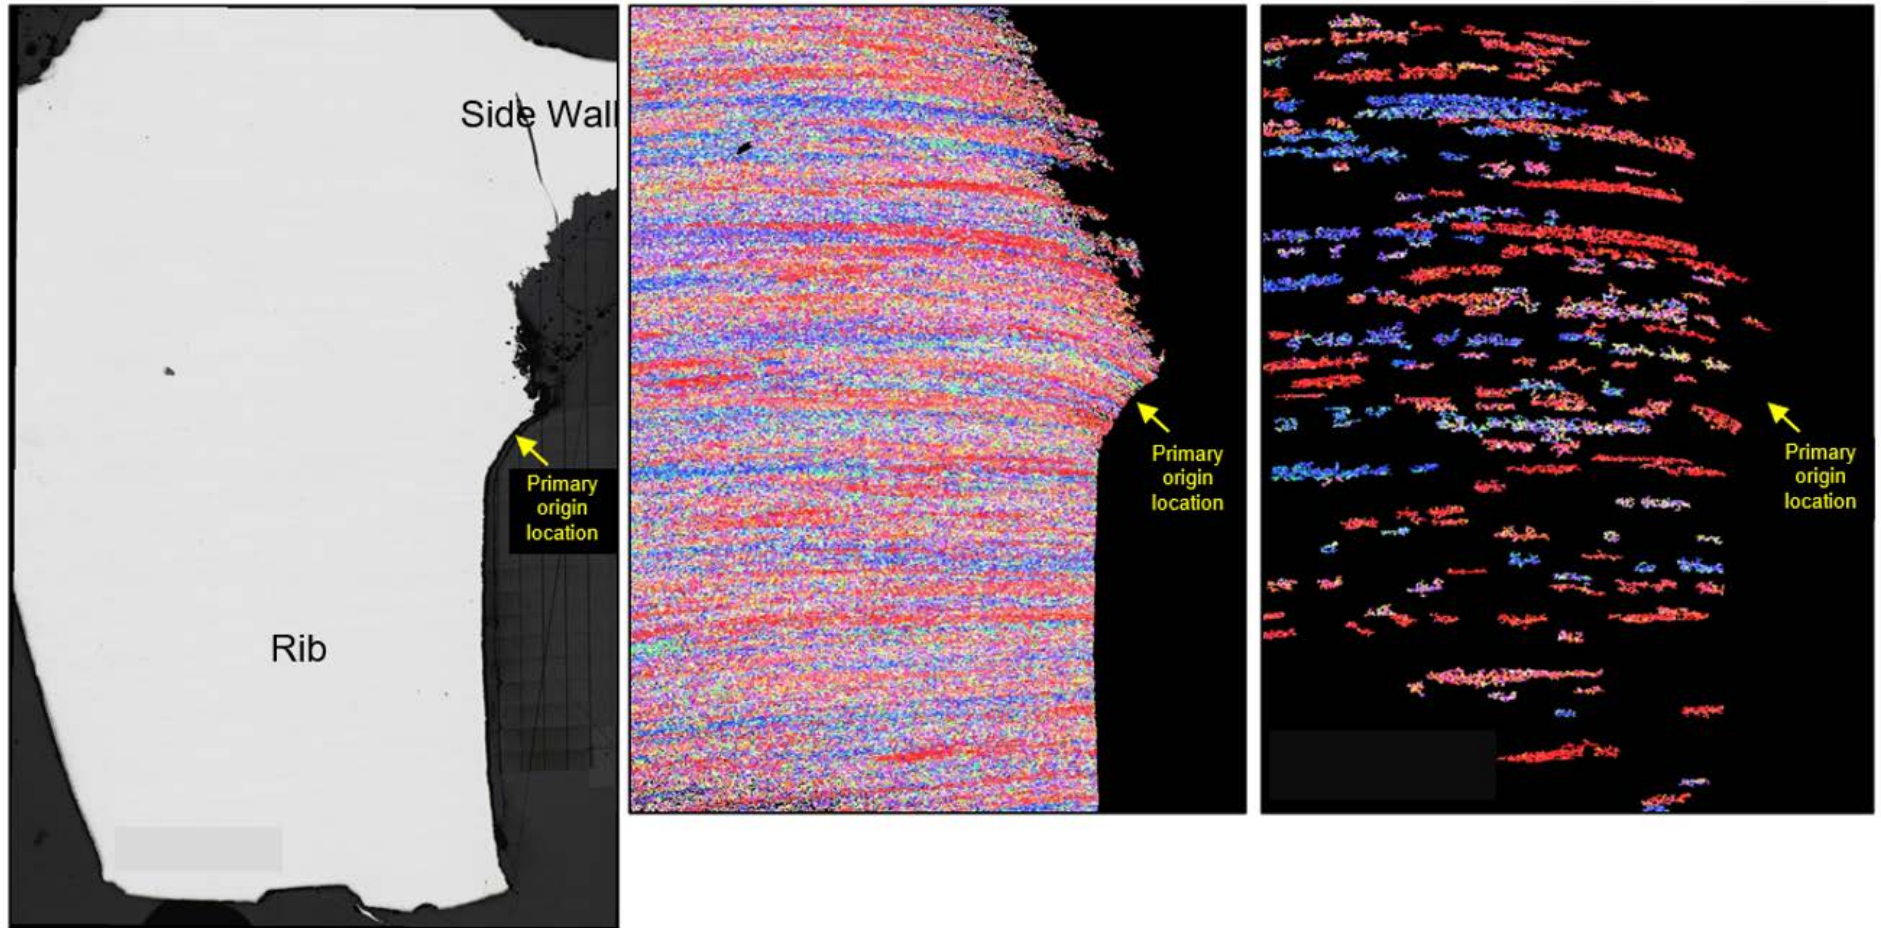
Figure 44: Images showing the EBSD/OIM results on the section planar into the fracture origin. Red areas represent basal texture regions. No MTRs were identified at the primary origin that was associated with the through-wall progression.

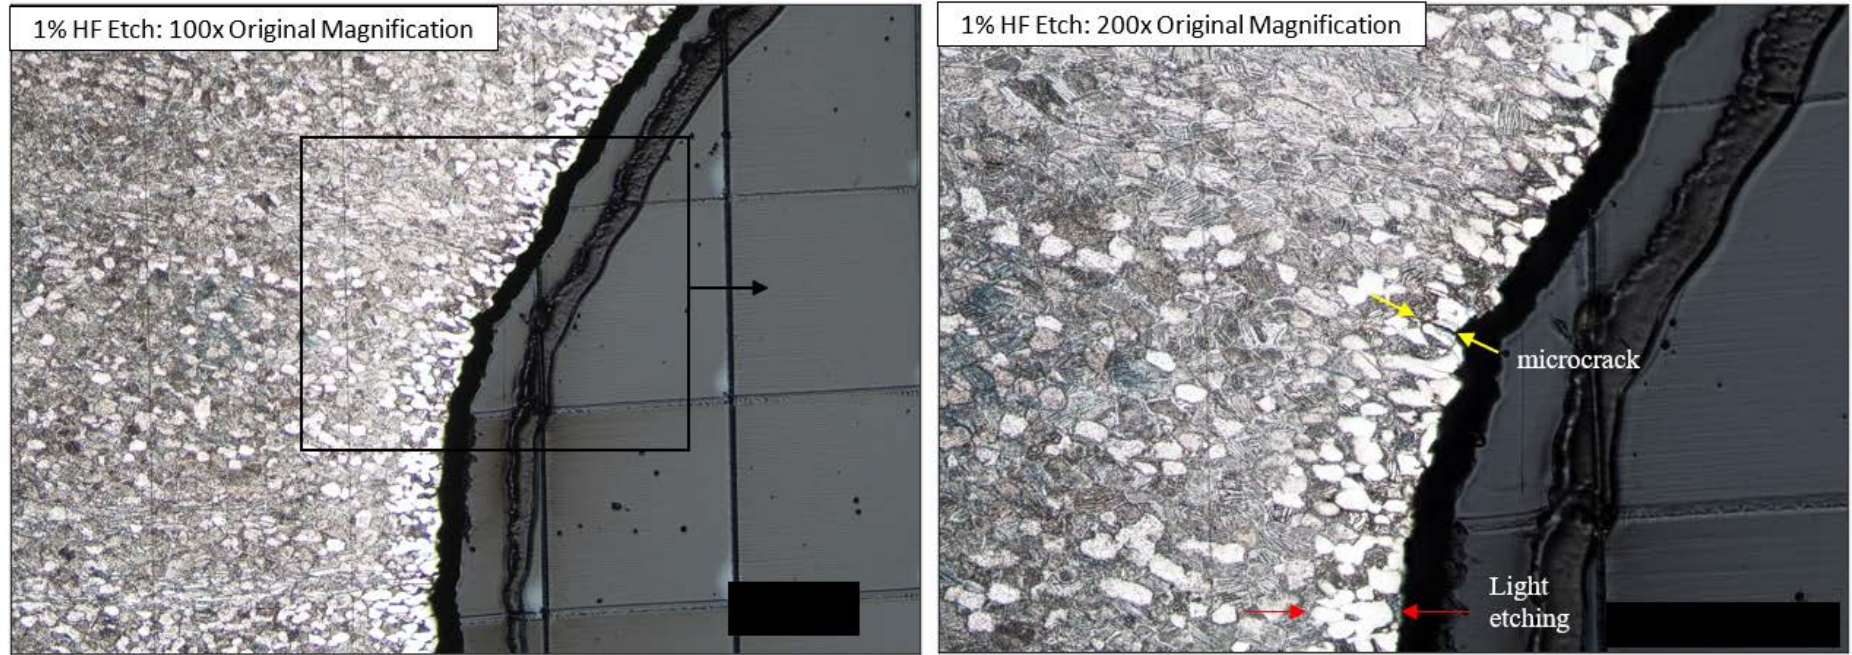
A metallographic section was prepared planar into the outboard half of the fracture surface as shown in [Figure 43](#). EBSD/OIM evaluation of the section confirmed that there were no MTRs at the primary origin ([Figure 44](#)). The planar section was etched with 1% HF. The alpha grains near the cavity surface etched lighter. No distorted surface layer/deformation was observed. A spanwise microcrack, approximately 0.001” in depth, was observed at the radius runout to the rib ([Figure 45](#)).

Figure 45: The planar section into the outboard half of the fracture origin area was etched with 1% HF. The alpha grains near the cavity surface exhibited a lighter etching layer. No distorted surface layer/deformation was observed. A spanwise microcrack, approximately 0.001” in depth, was observed at the radius runout to the rib.

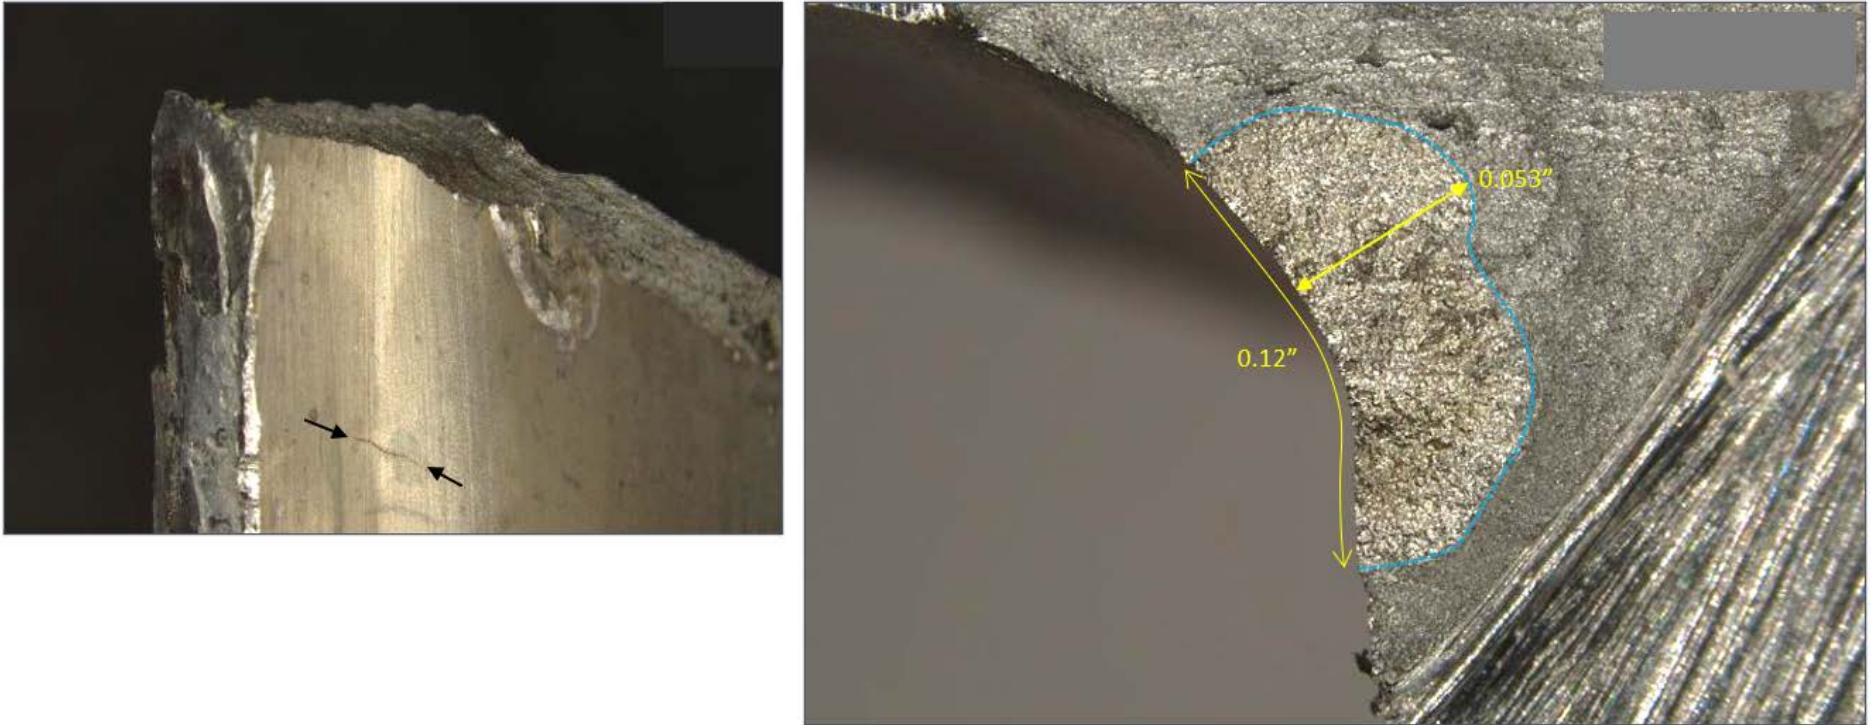
The large crack outboard of the fracture surface was broken open. The maximum crack depth measured 0.053” ([Figure 46](#)). In total, the fracture origin area and parallel secondary cracks outboard and inboard of the fracture spanned approximately 1.0” in the cavity, from approximately 5.9” to 6.9” above root bottom.

Figure 46: The large crack outboard of the fracture surface was broken open. The maximum crack depth measured 0.053”.

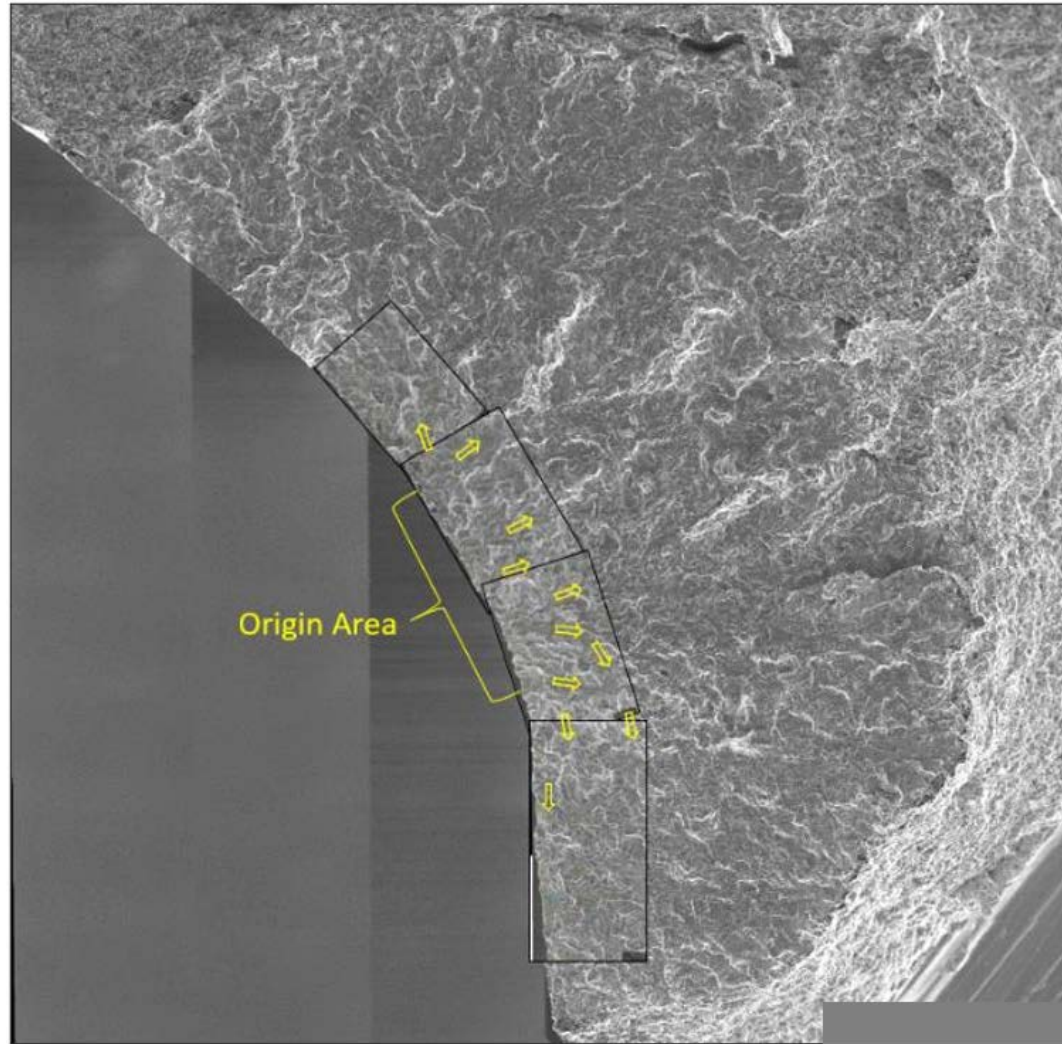
The outboard secondary crack origin area was located at the radius runout to the rib, consistent with the flowpath fracture surface and other secondary cracks. Some of the crack surface was smeared, likely due to damage during the event ([Figure 47](#)). During SEM examination of the surface surrounding the crack, a spherical metallic deposit, consistent with what has been previously determined to be a “spark” from original machining, was observed 0.070” outboard of the secondary crack. There were no sparks observed at the origin area of the secondary crack and there were no cracks observed at the spark ([Figure 48](#)).

Figure 47: The outboard secondary crack origin area was located at the radius runout to the rib, consistent with the flowpath fracture surface and other secondary cracks. Some of the crack surface was smeared, likely due to damage during the event.

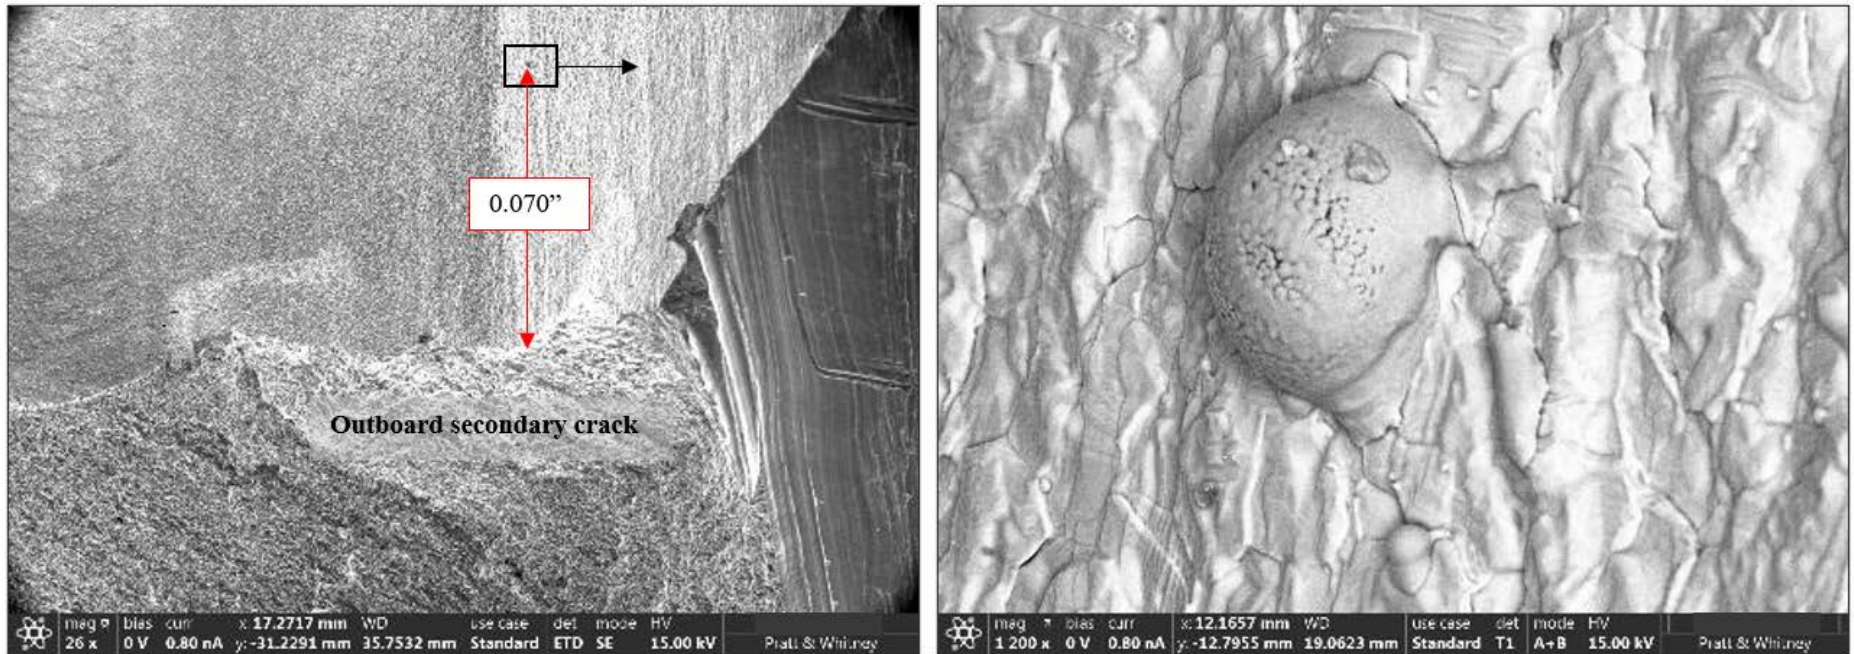
Figure 48: SEM images showing a spherical metallic deposit, consistent with what has been previously observed determined to be a “spark” from original machining, 0.070” outboard of the secondary crack. There were no sparks observed at origin area of the secondary crack and there were no cracks observed at the spark.

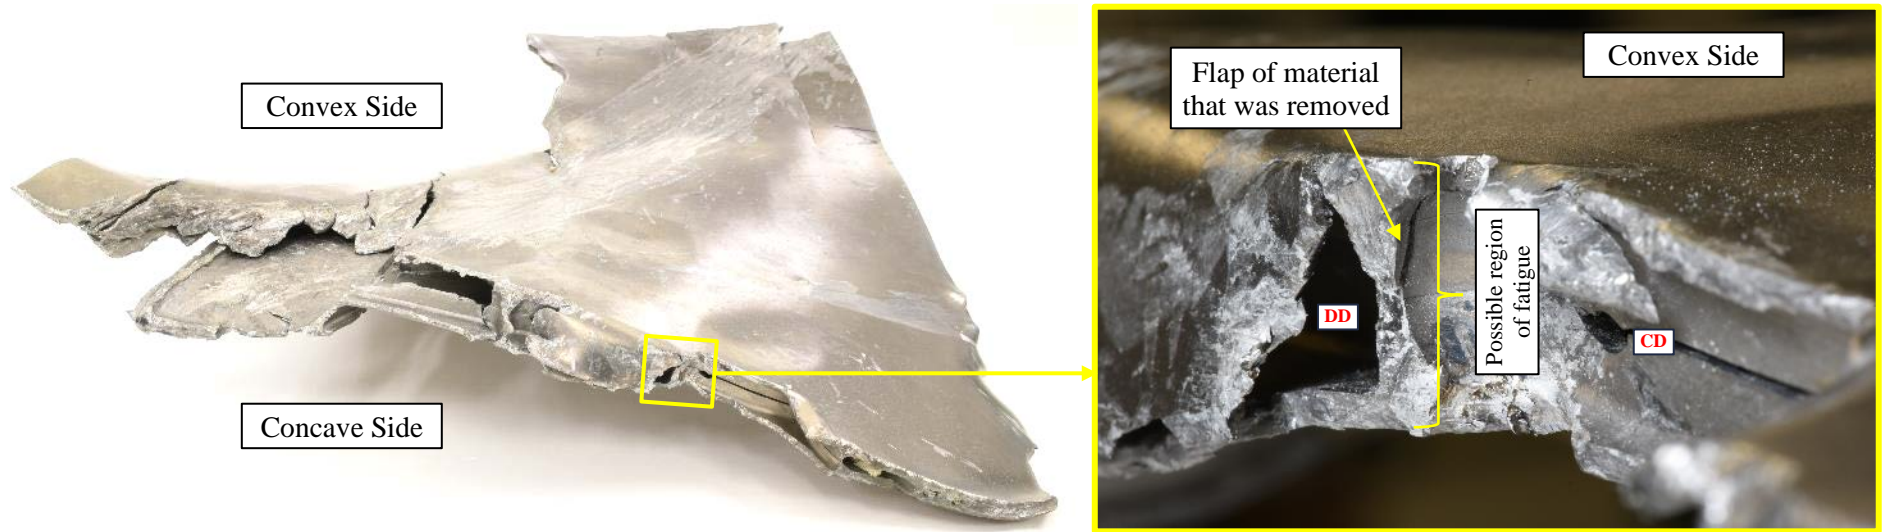
Figure 49: Binocular examination identified a region of possible fatigue on the outboard surface of the damaged piece that was removed from the case.

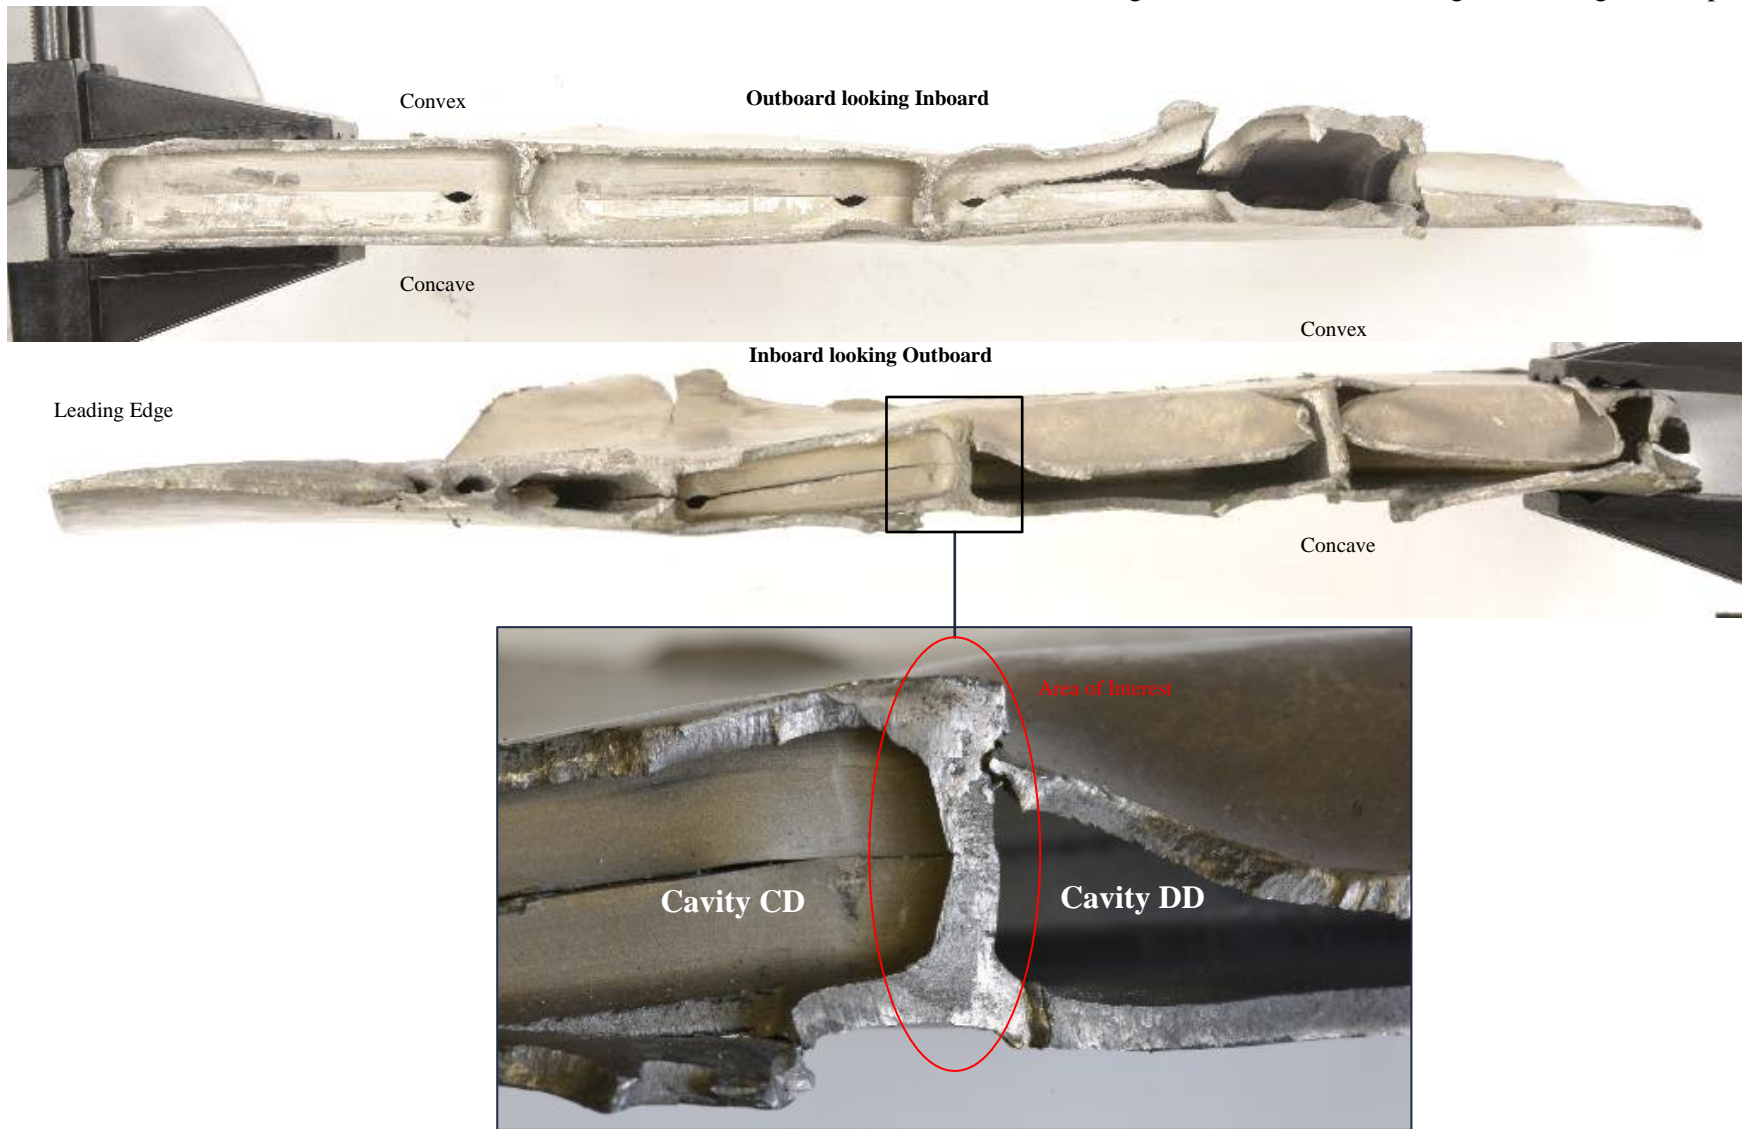
Figure 53: Binocular microscope inspection of the fracture surfaces identified possible fatigue on the inboard side of the fragment between cavities CD and DD.

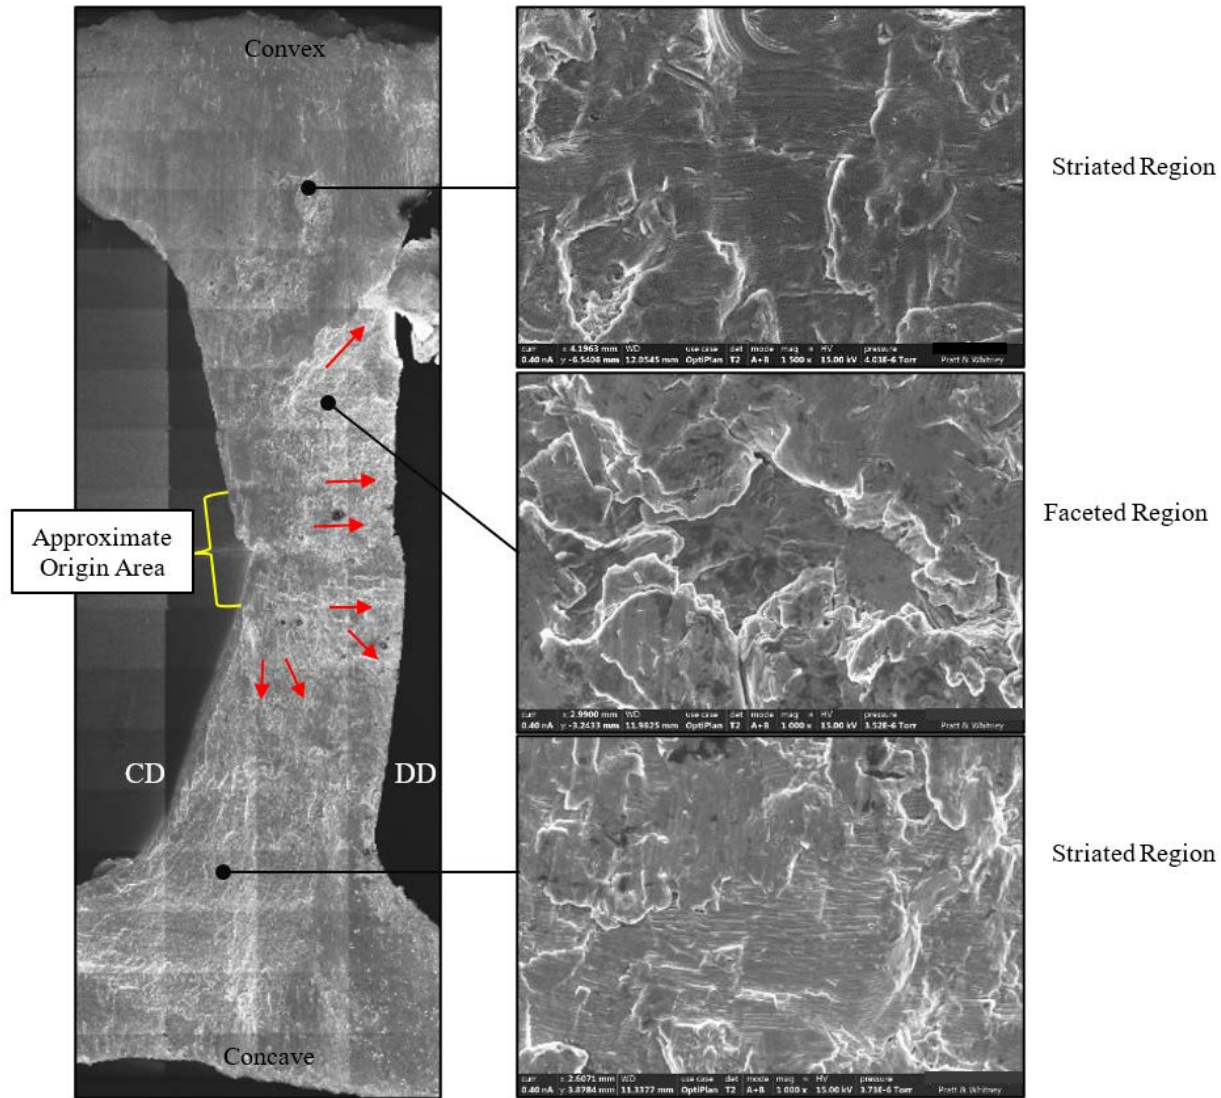
Figure 55: SEM examination confirmed fatigue on the fracture surface. Areas of striated and faceted features were interspersed among large areas of secondary damage/smearing. Features were progressing from an area near the bond line in cavity CD. Due to the damage, the exact origin area could not be identified.

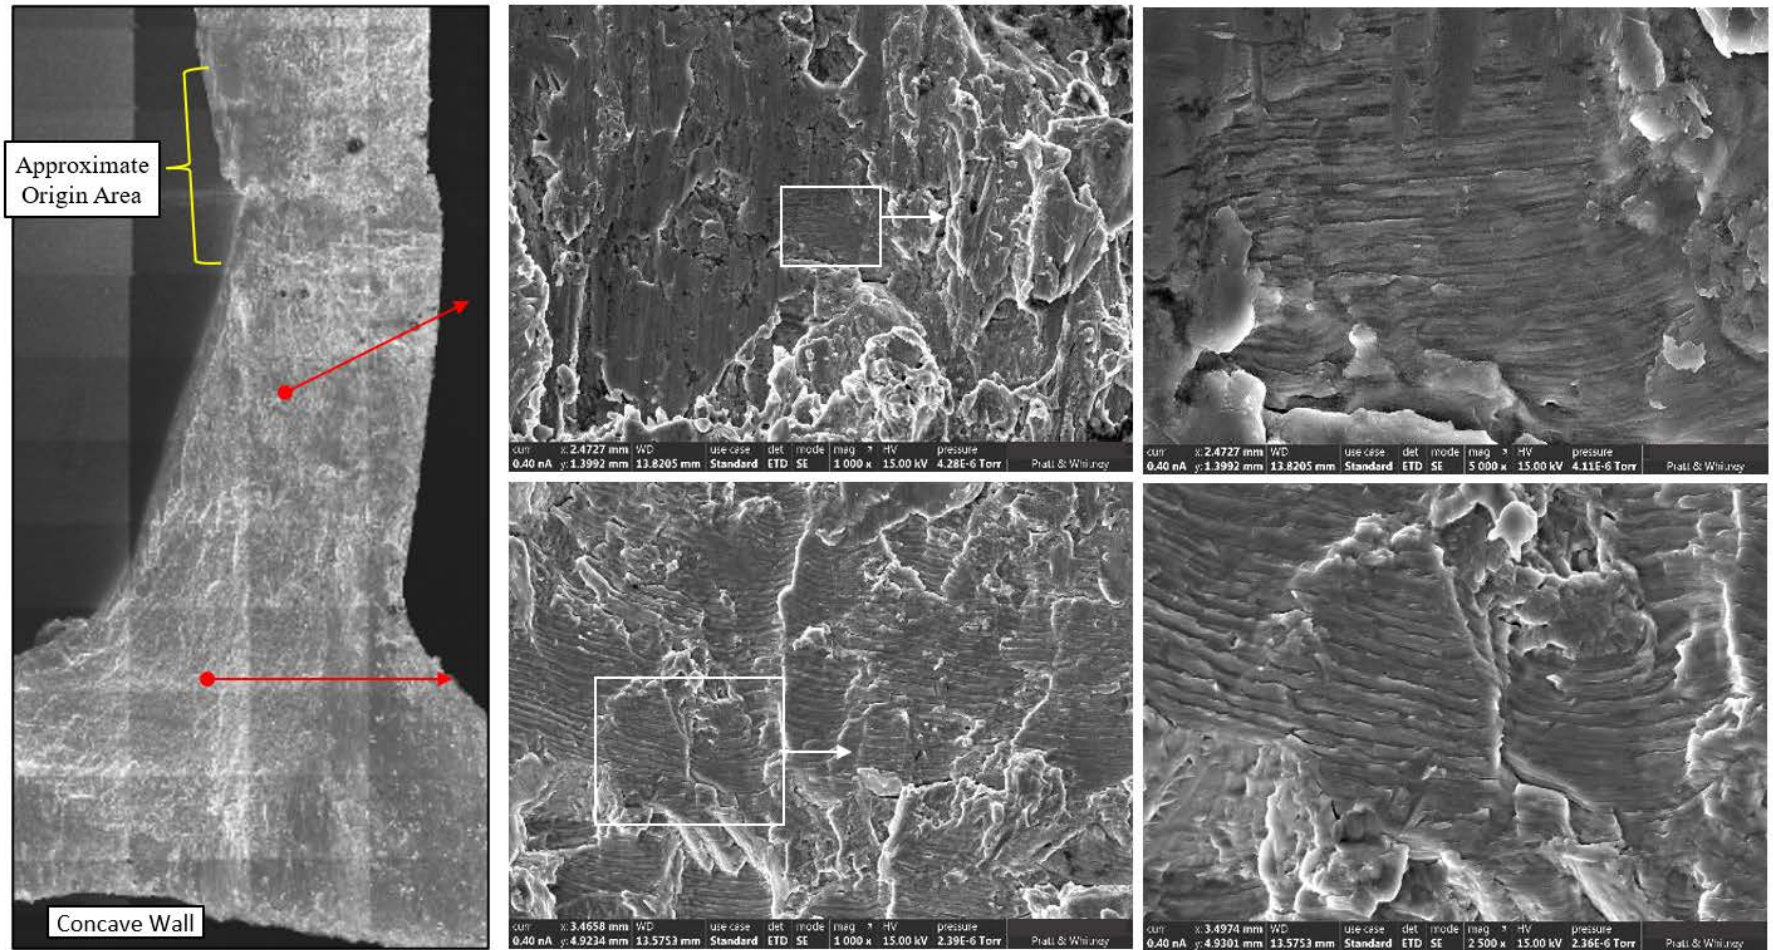
Figure 56: SEM images taken of the crack progression towards the concave wall. The progression exhibited a mix of striated and faceted features. Crack growth rate towards concave wall ranged 6.0×10^{-6} – 4.9×10^{-5} in/cycle.

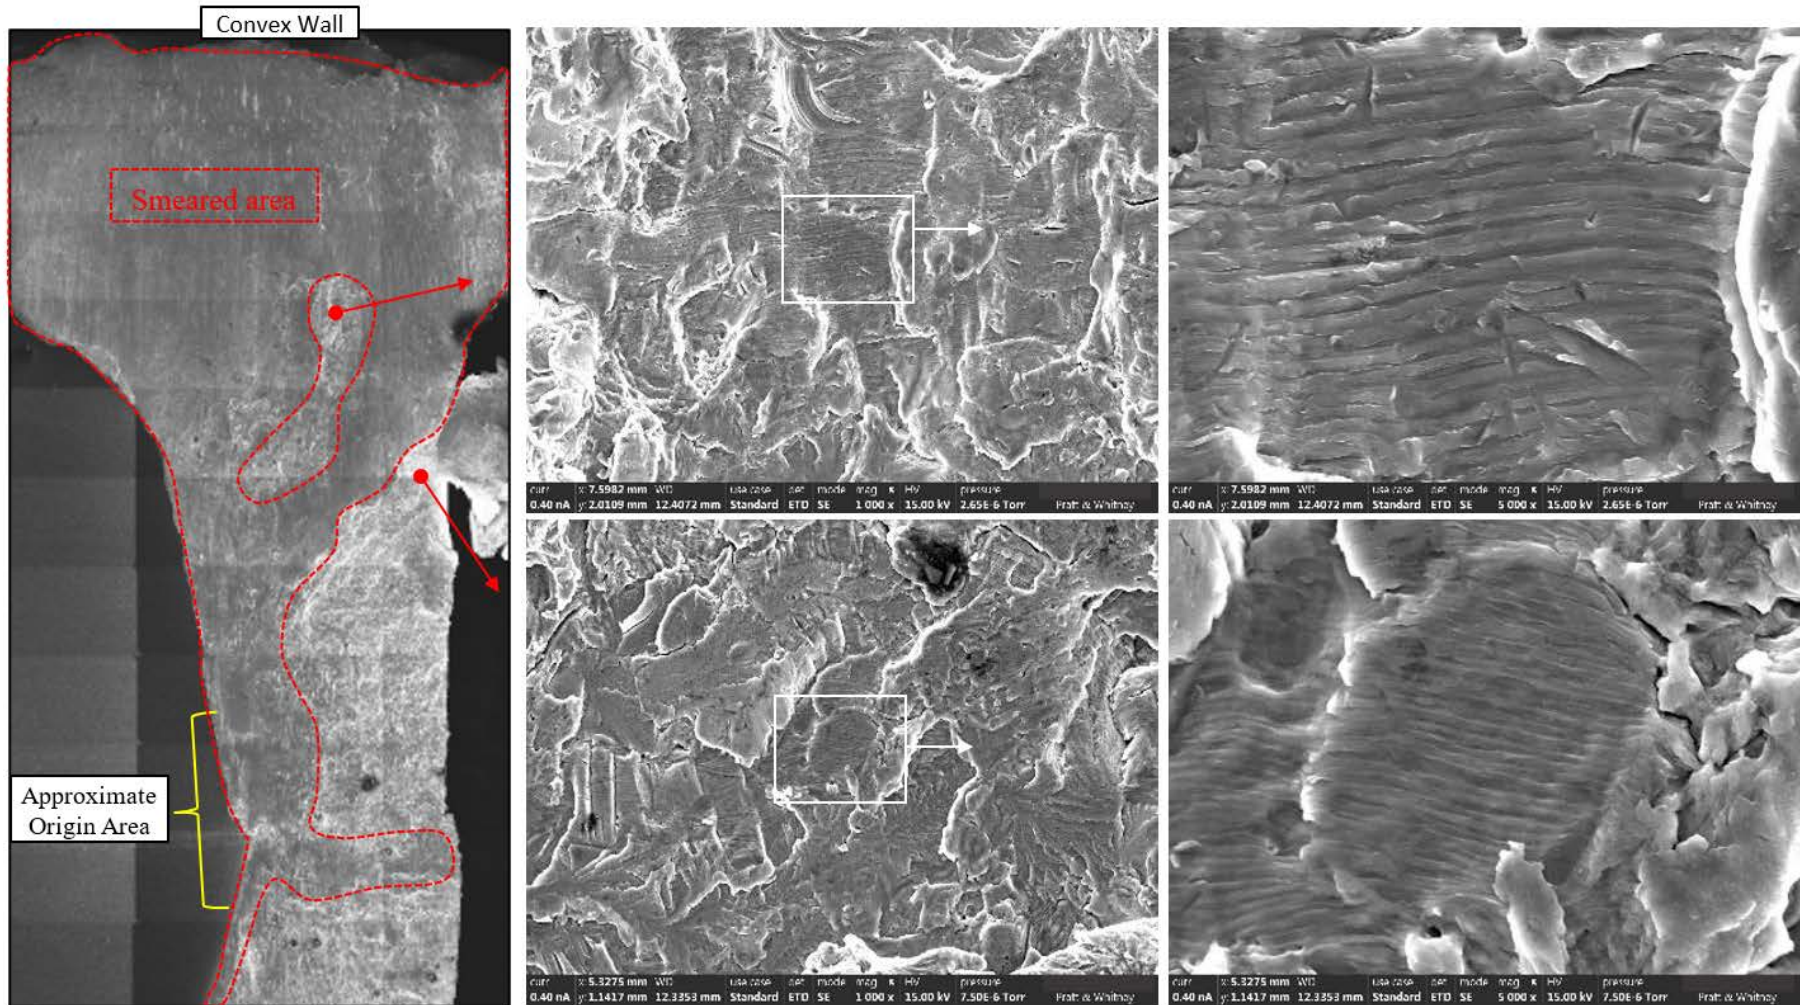
Figure 57: SEM images taken of the crack progression towards the convex wall. The progression exhibited a mix of striated and faceted features. Crack growth rate towards convex wall ranged $6.5 \times 10^{-06} - 2.9 \times 10^{-05}$ in/cycle. The areas circled in red were smeared. The exact origin could not be identified due to the damage.

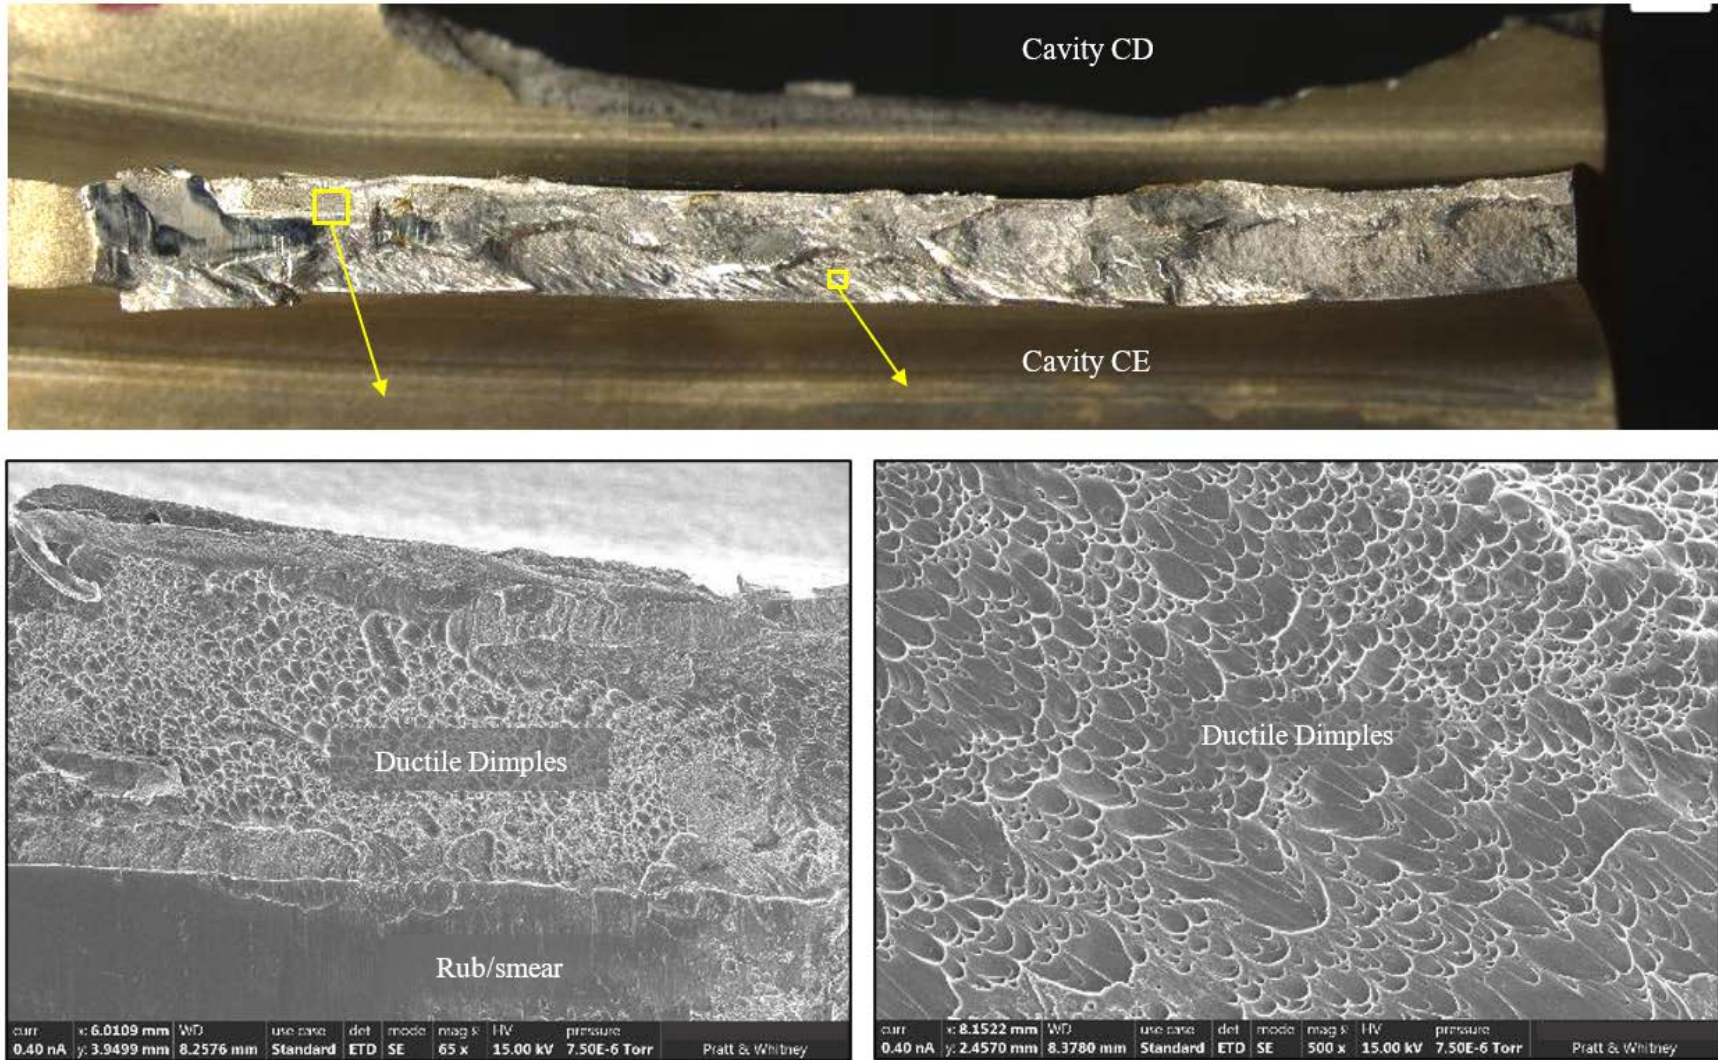
Figure 59: Binocular and SEM examination of the disbonded rib between cavity CE and CD identified elongated ductile dimples and rub/smear. No fatigue was observed.

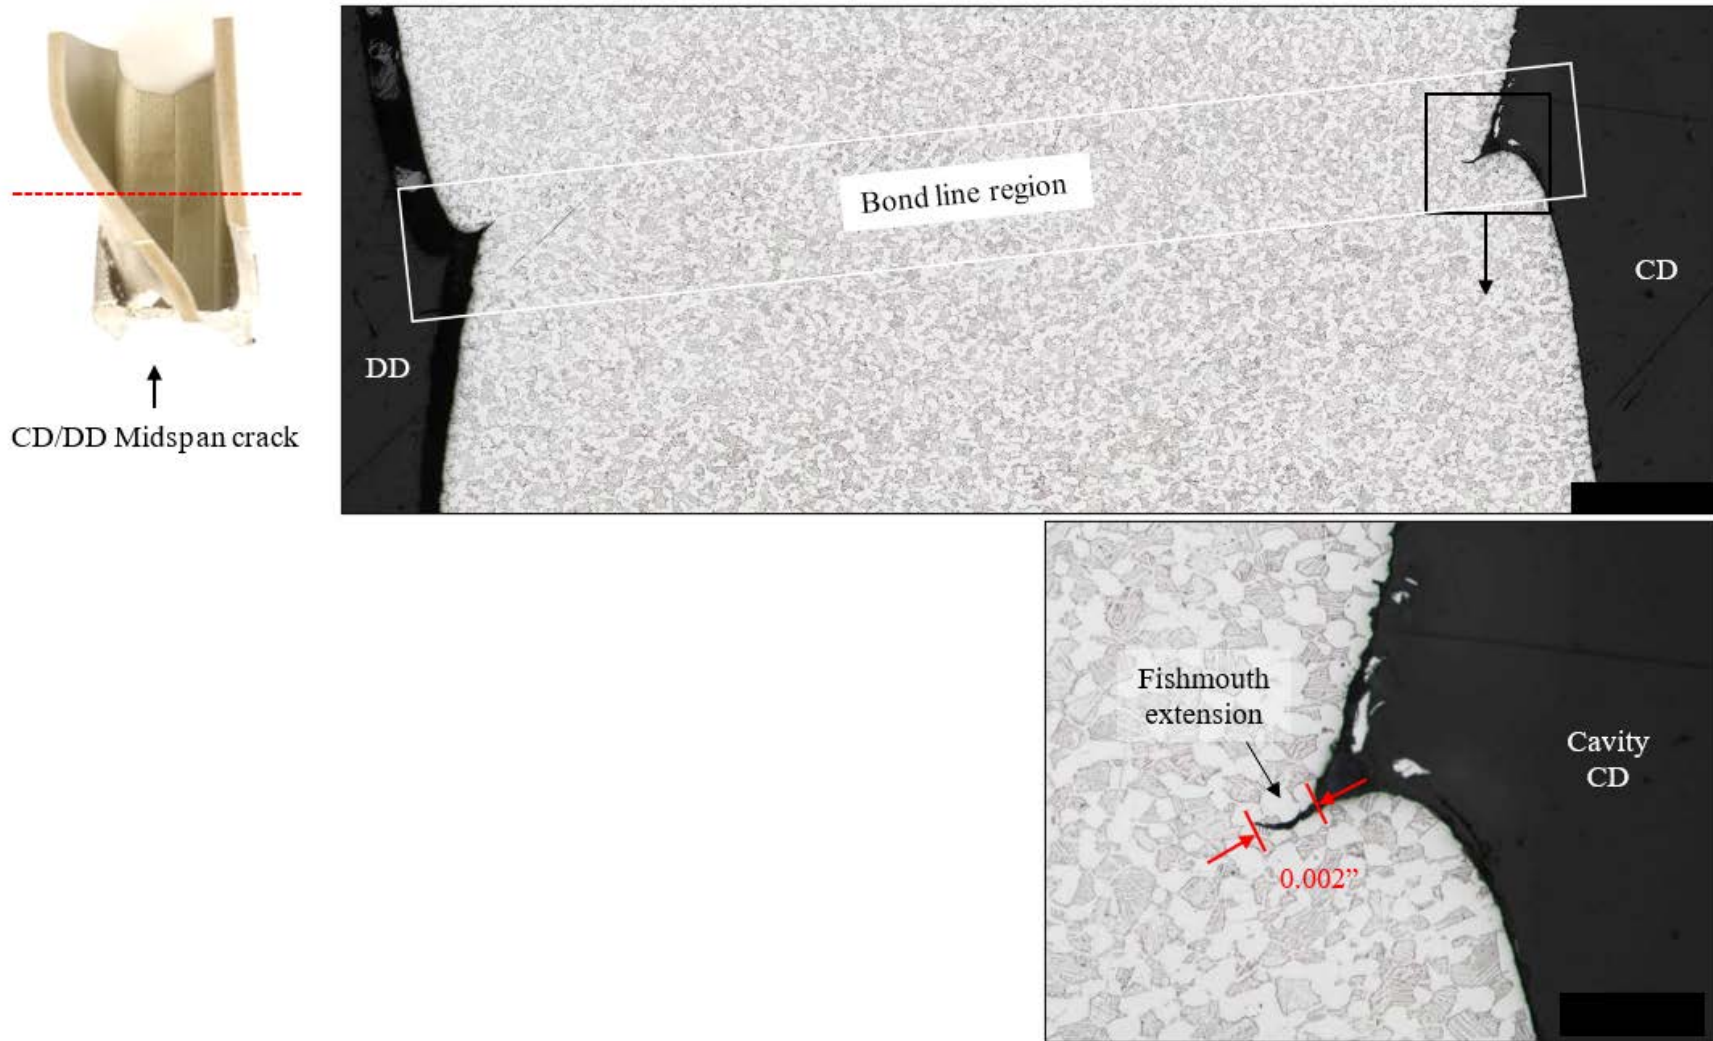
Figure 60: Metallographic images showing a transverse section through an area of the spanwise rib that appeared intact just outboard of the midspan crack in the outboard blade fragment. No voids or unbonded areas were observed. The fishmouth feature extended 0.002" which was acceptable per bond quality requirements.
