Metallurgical Investigation Final Report

Subject: Metallurgical Investigation of Fan Blades from PW4077 Engine SN 777047

Date: February 24, 2023

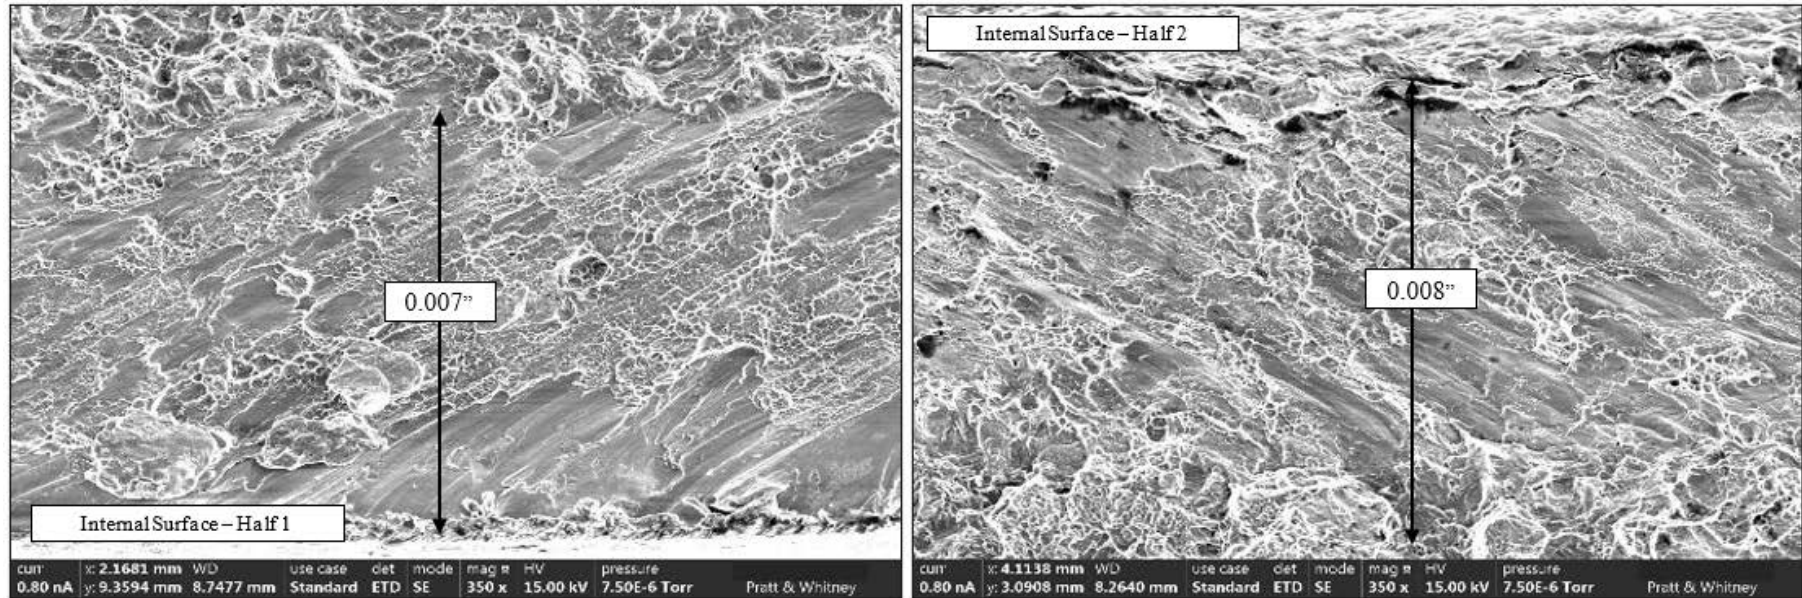
Figure 64: SEM images showing smear and ductile dimple features at an area at the TE of cavity CE that was force fractured open.

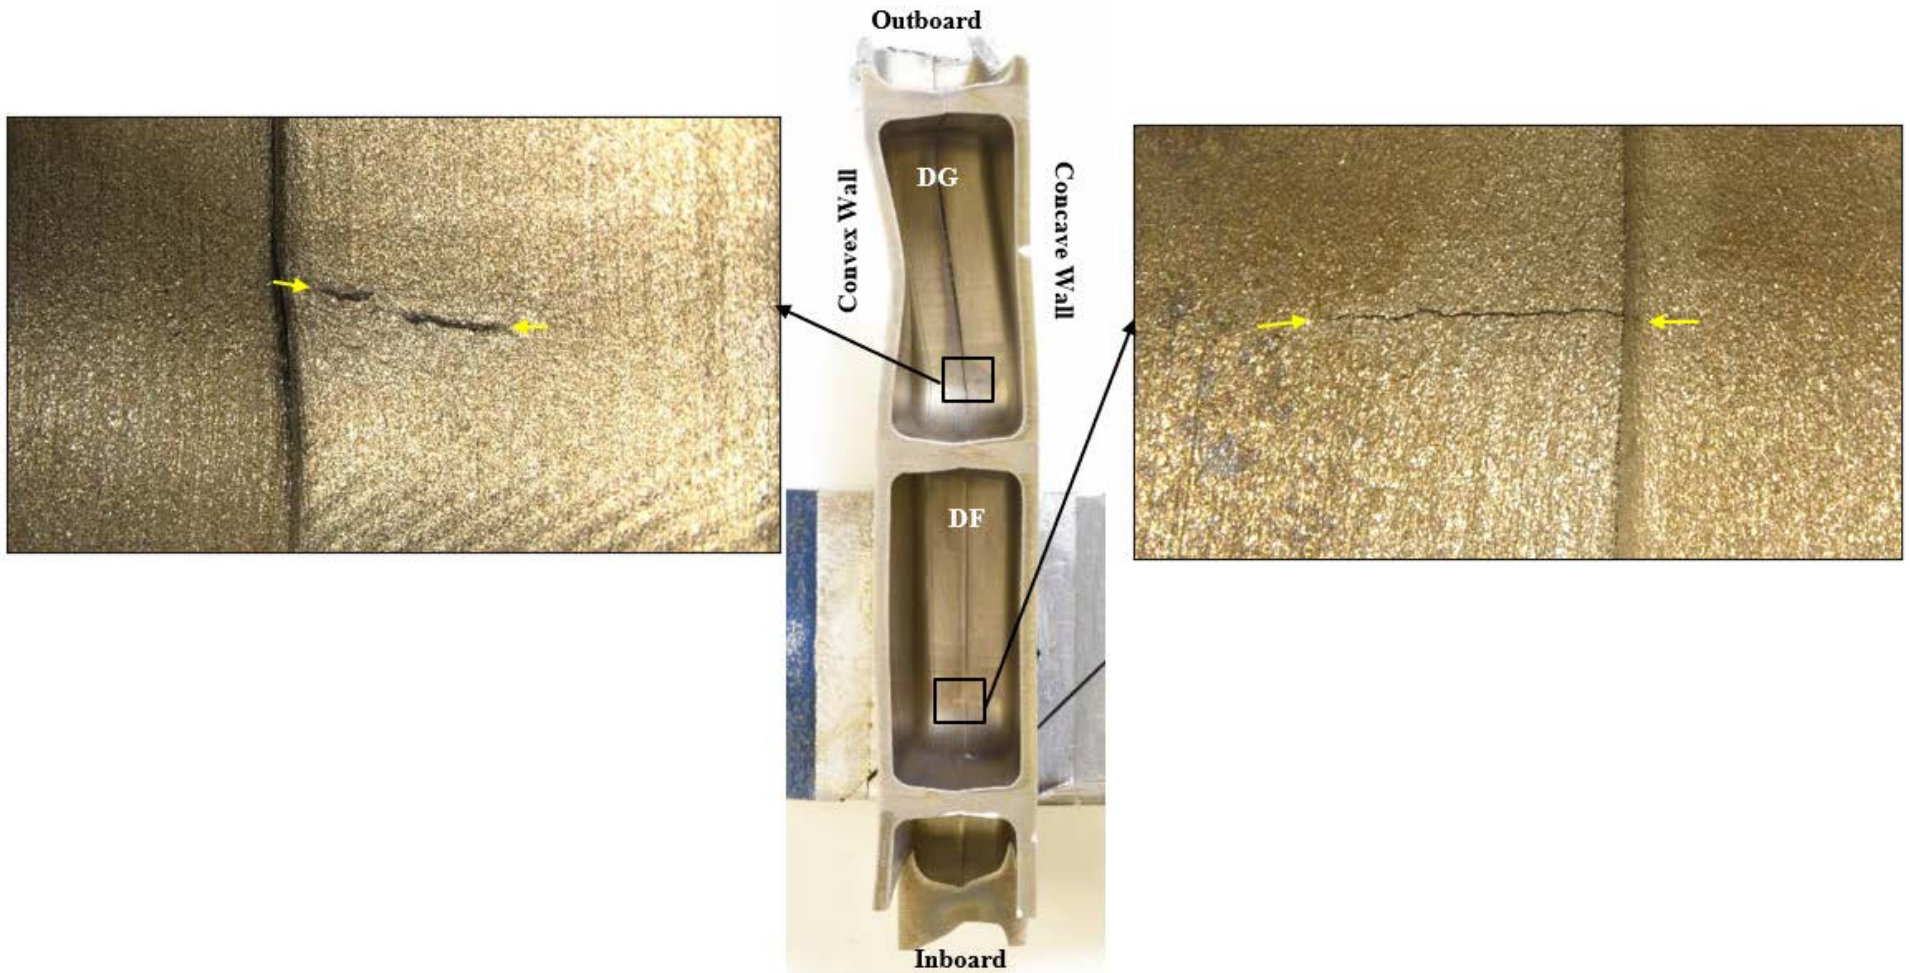
Figure 67: Images of the cracks observed at the forward sides of cavities DF and DG. Both cracks were located just outboard of the chordwise ribs.

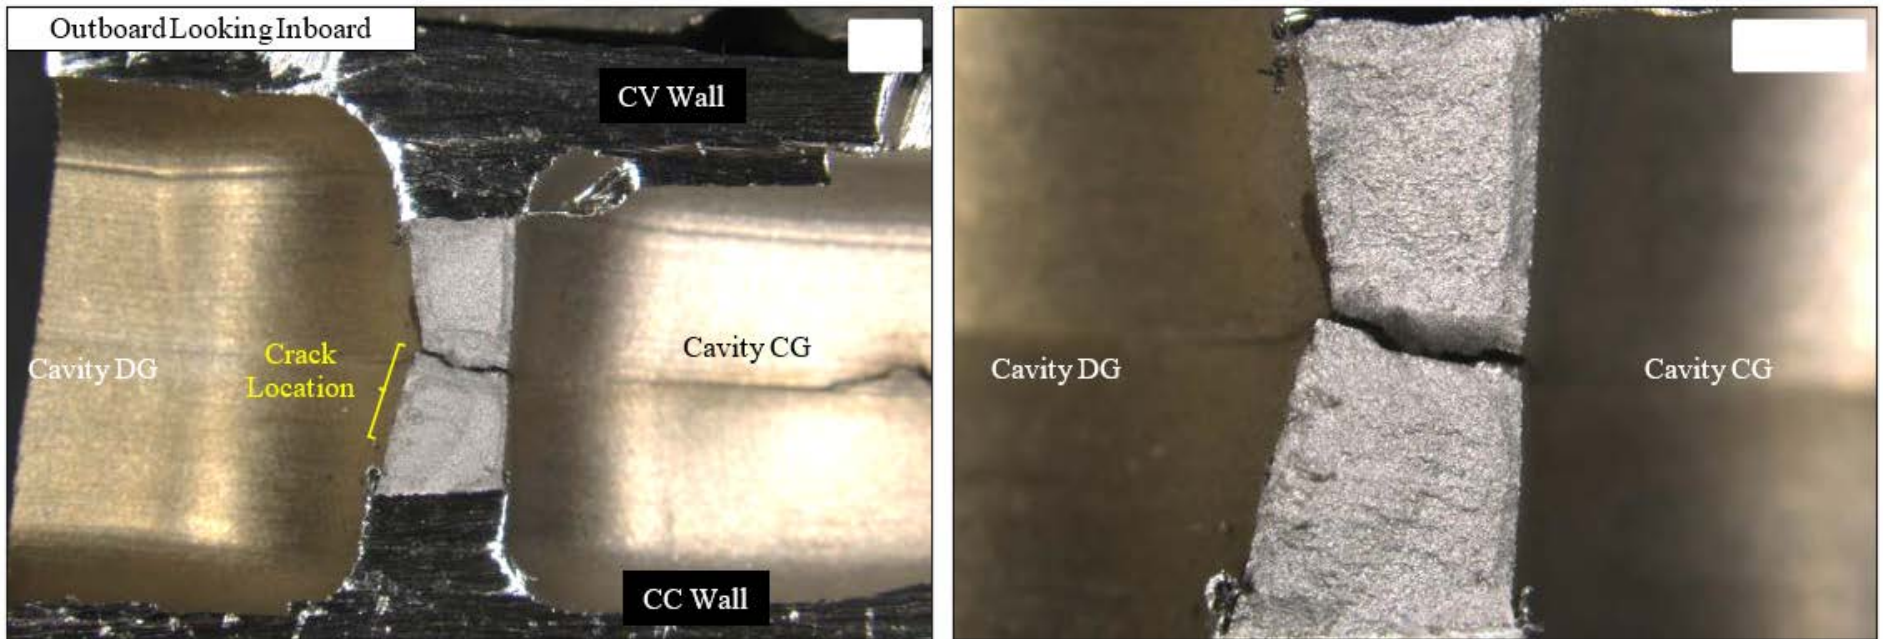
Figure 68: Images of the broken open crack indication in cavity DG showing no fatigue features.

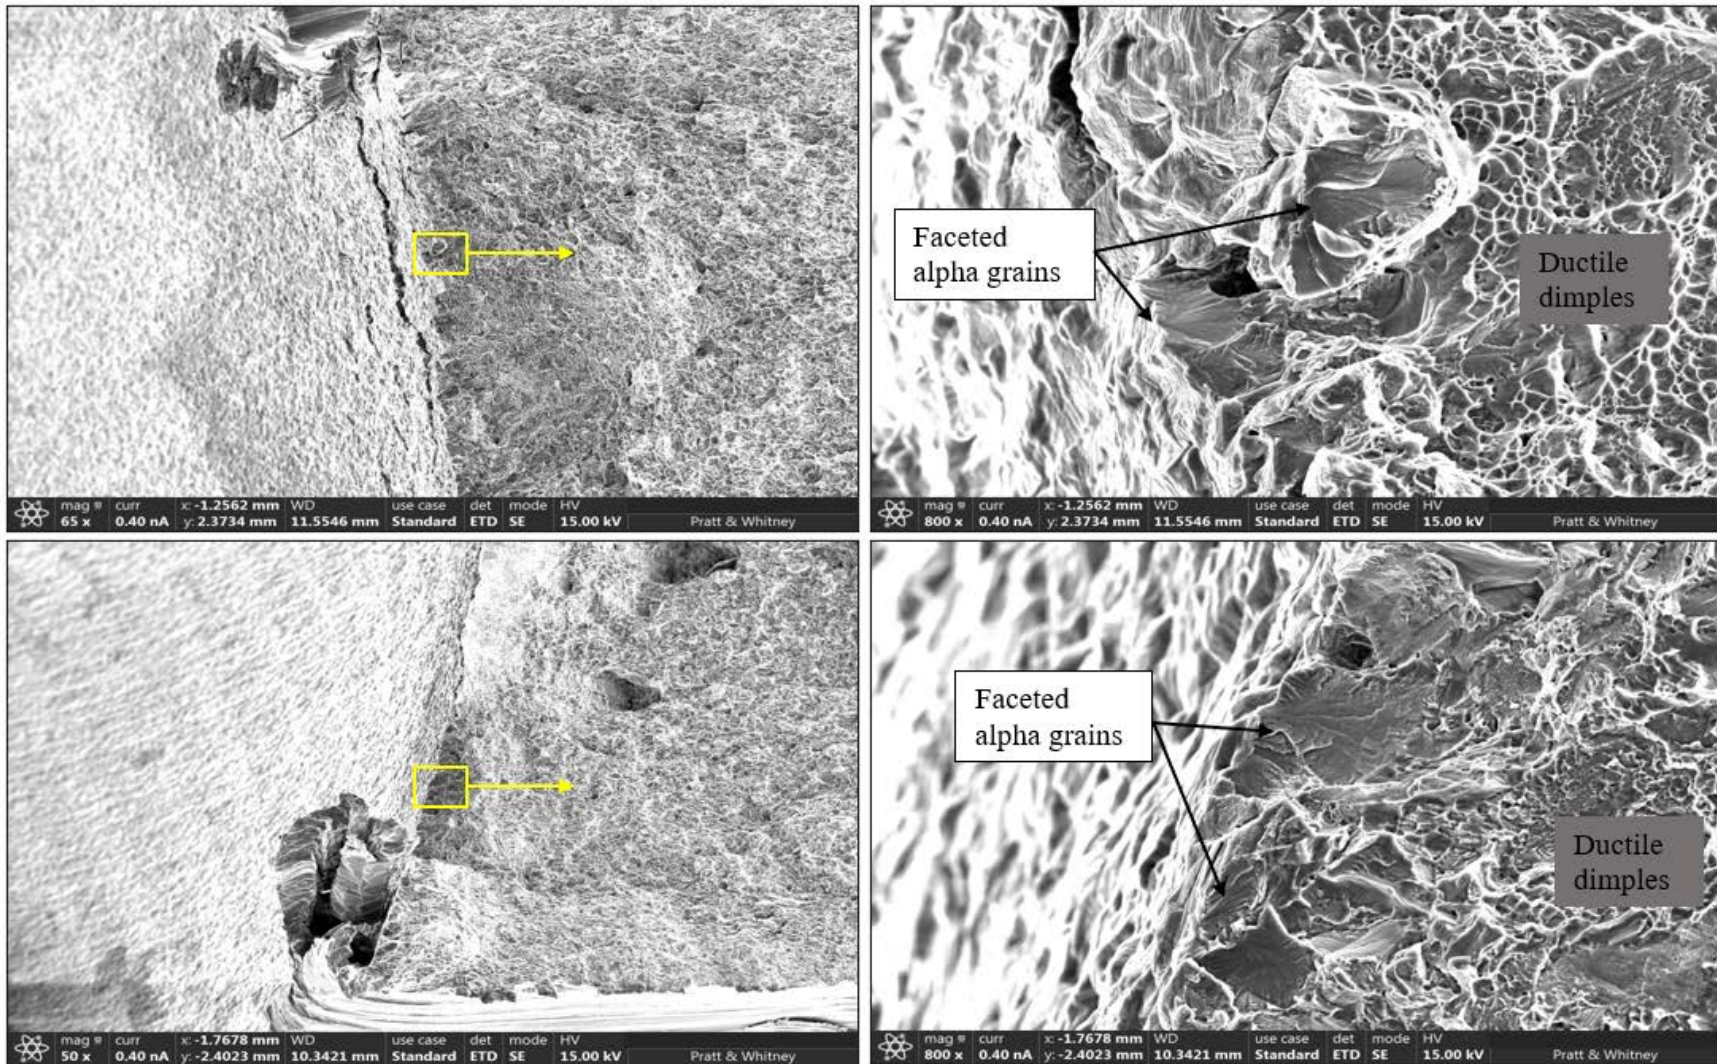
Figure 70: SEM images showing the features in cavity DG after force fracturing the crack open. Faceted alpha grains were observed along some of the fracture at the edge of the cavity surface. The remainder of the features exhibited ductile dimples, indicative of overstress.

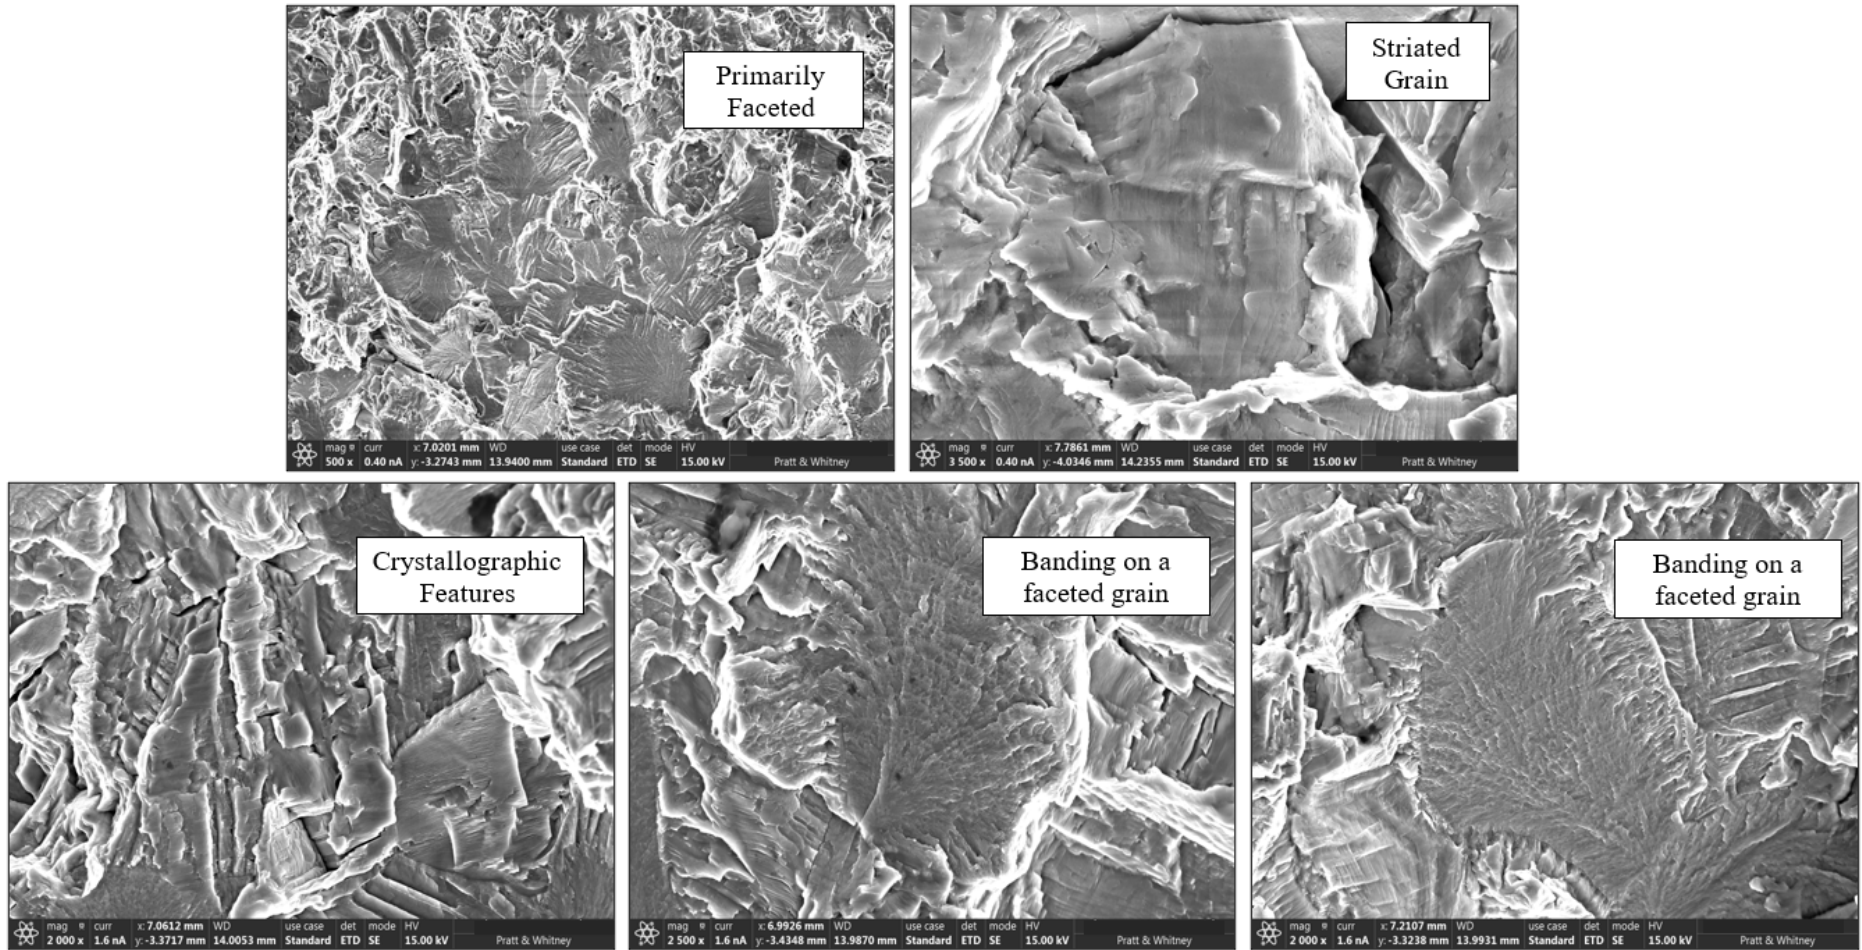
Figure 72: SEM images of crack progression features in cavity DF. These fatigue features indicate low delta K cracking.

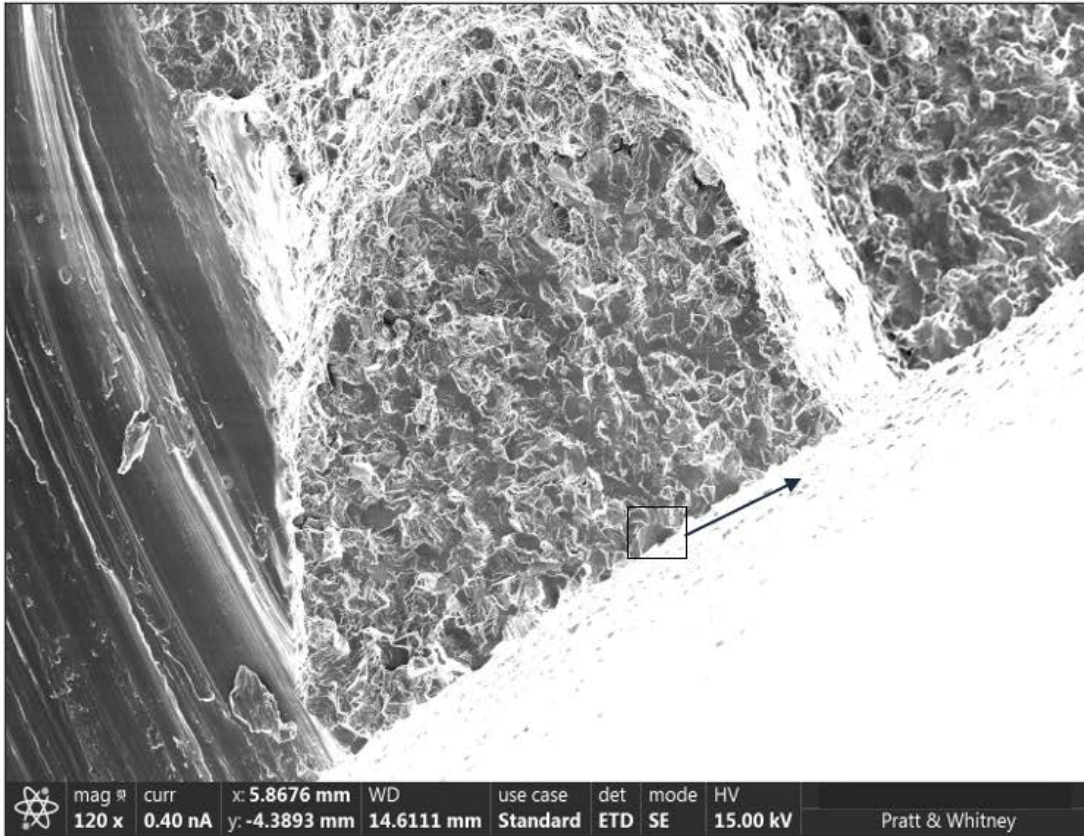
Figure 73: SEM images of the smaller crack on the concave side of the rib in cavity DF. A single surface origin was observed (red arrow).

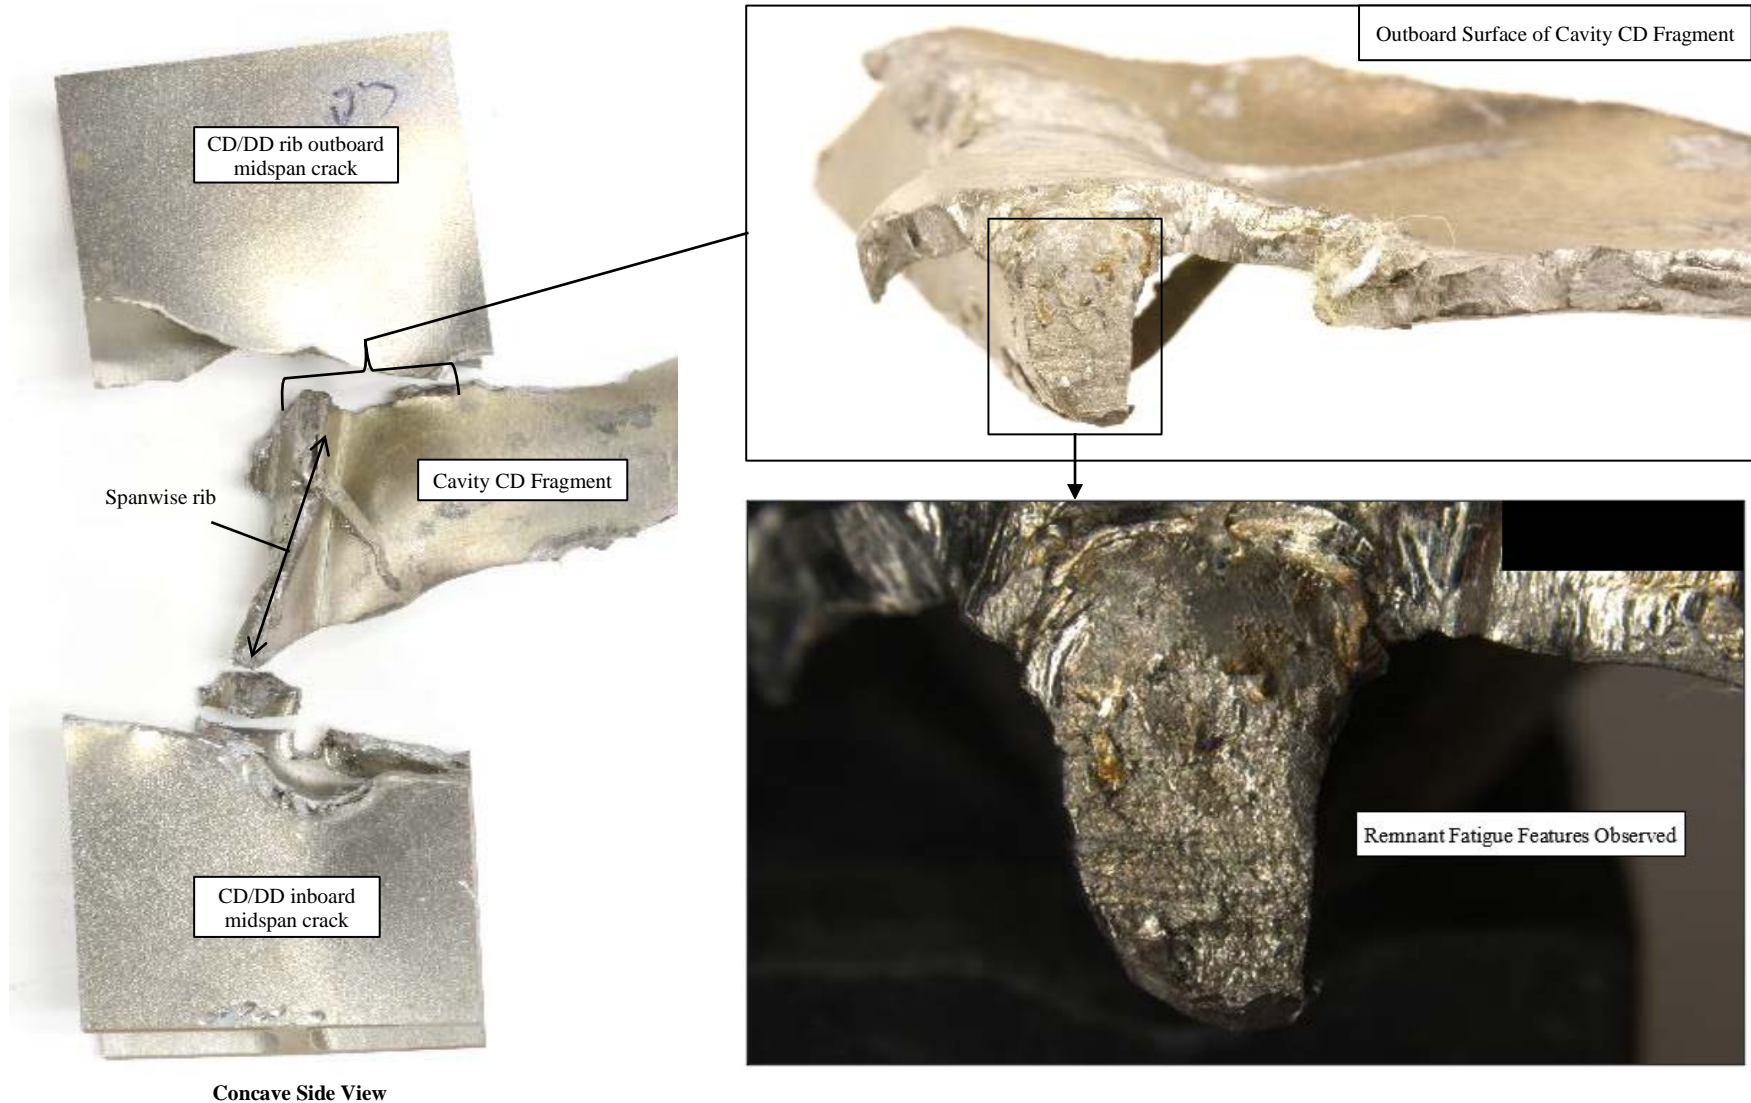
Figure 75: Images showing how the small fragment mated with the other blade pieces in cavity CD. The fatigue features observed on the fragment correlated with the midspan crack that was identified on the larger outboard midspan fragment.

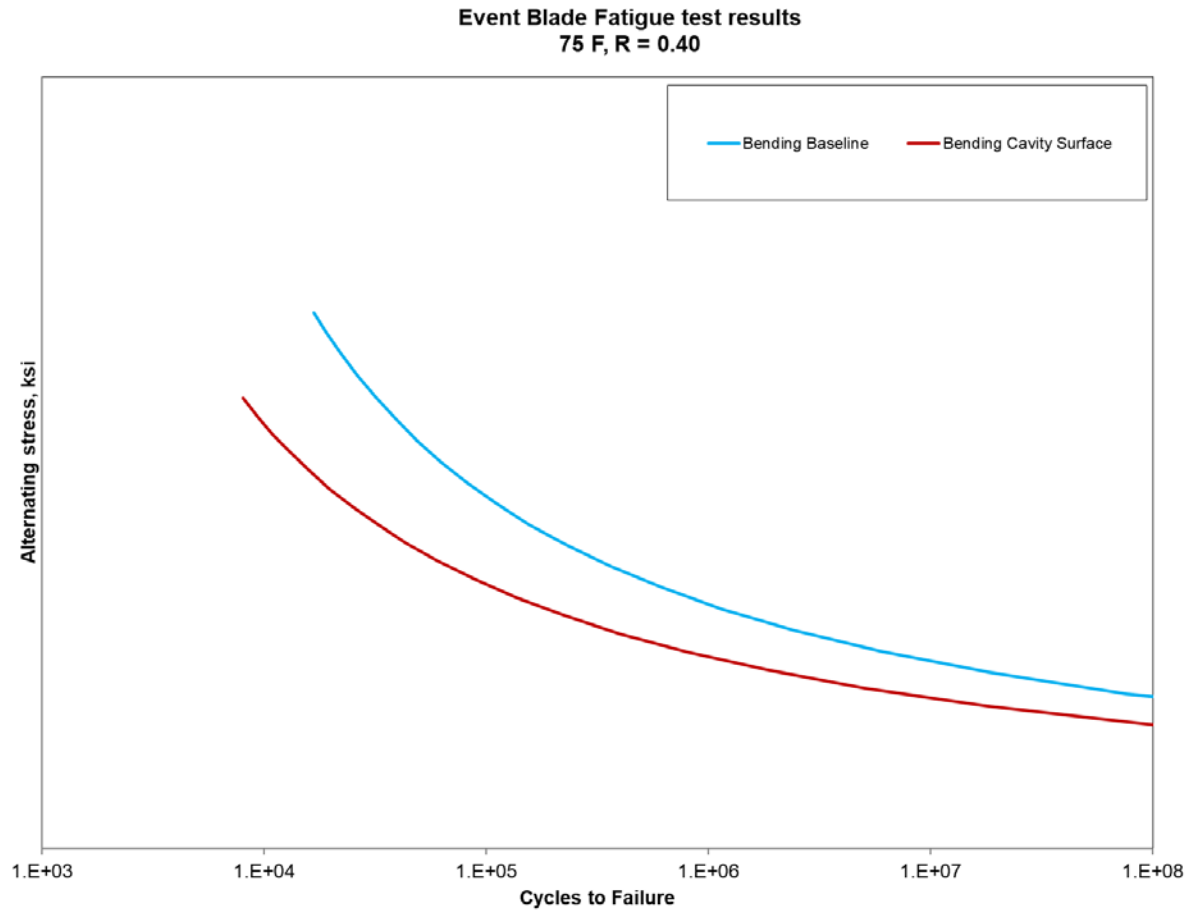
Metallographic sections through multiple internal cavities on the blade identified light etching of the alpha grains within 0.003" of the surface, indicating possible surface contamination. Fatigue test results of specimens removed from the cavity surfaces verses specimens removed from the bulk material of the blade identified a lower fatigue capability of the cavity surfaces. Microhardness testing revealed a slight increase in hardness within 0.005" of the surface. Additionally, areas of the blade that were force fractured open exhibited faceted grains, 2-3 grains deep, along the cavity surfaces before transitioning to dimple overstress features. Advanced characterization confirmed a carbon contamination gradient that extended from the cavity surfaces.

Figure 76: Event blade fatigue test results. The samples representing the as-produced cavity surface from the root of the subject event blade exhibited lower fatigue capability compared to the bulk material specimen from this blade.
