P38 Jack Placement Study

Review of Jack Dimensions for Tire Replacement

On October 4th, 2021, Honda Engineering received a request to review any issues that may arise from the use of a TRONAIR 02-7813C0100 Jack to replace an Main Landing Gear Tire

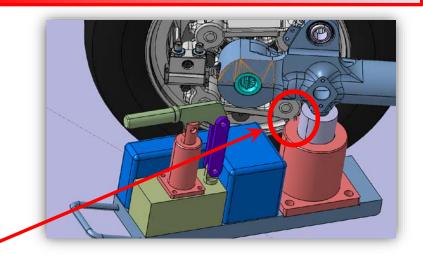
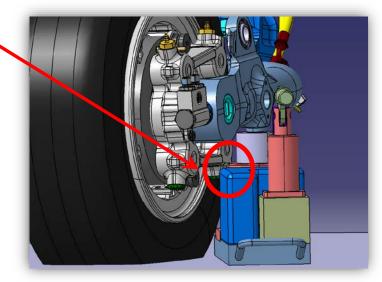
Installation of the Jack – Weight ON Wheels

- With the 02-7813C0100 jack, orientation is required to clear the tire.
- Interference is noted between the jack and the brake depending on Aircraft Loading
 - Lighter weight aircraft may have less contact than that shown in these pictures.

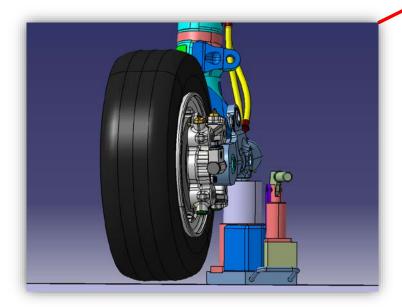
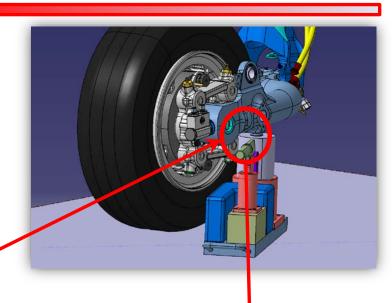
Installation of the Jack – Weight OFF Wheels

- Interference is noted between the outer jack piston and the brake.
 - Outer piston may have contacted the brake prior to full piston displacement, causing the next concentric piston to extend.
 - May be possible to inspect brake for indication of contact.

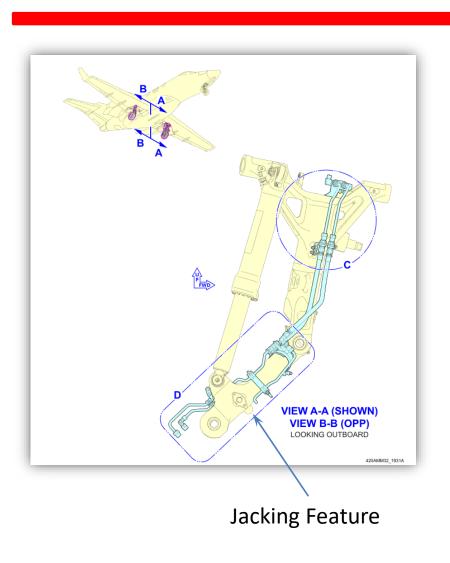
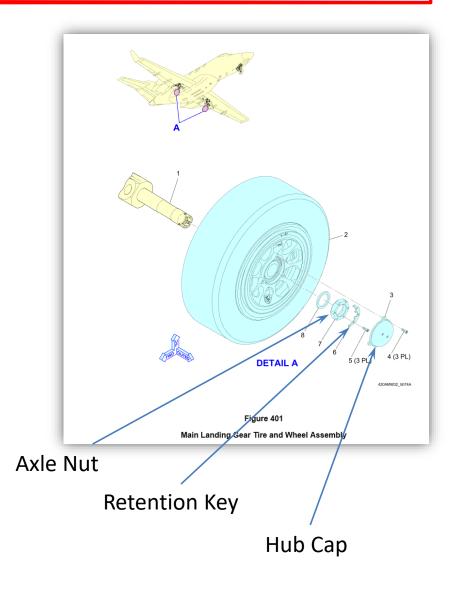
Cross Section of Wheel / Brake / Trailing Arm Stack

- With the Jack in orientation shown on previous slides, there is potential for it to interfere with the Brake.
 - When the torque is removed from the Axial Nut, contact between the Jack and the Brake would have an tendency to push the Brake OTBD.

- If the Brake has migrated OTBD, when re-installing the Wheel / Tire Assembly, the Wheel / Tire Assembly may be prevented from fully seating. In addition, the Axle Nut may not seat properly and may prevent the Retention Key from engaging the Key Slot on the Axle.

- Torqueing of the Axle Nut would still be possible due to the Nut Torque being reacted by the interference between the Jack and the Brake
