## NORCOAST MARINE SURVEYORS, INC.

**SURVEY# 1154281**

**DATE OF REPORT: 10/20/2015**

**VESSEL: F/V "LONE FISHERMAN"**

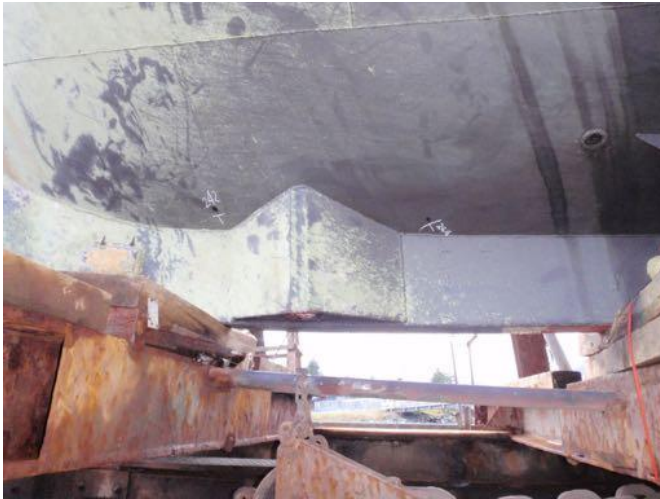
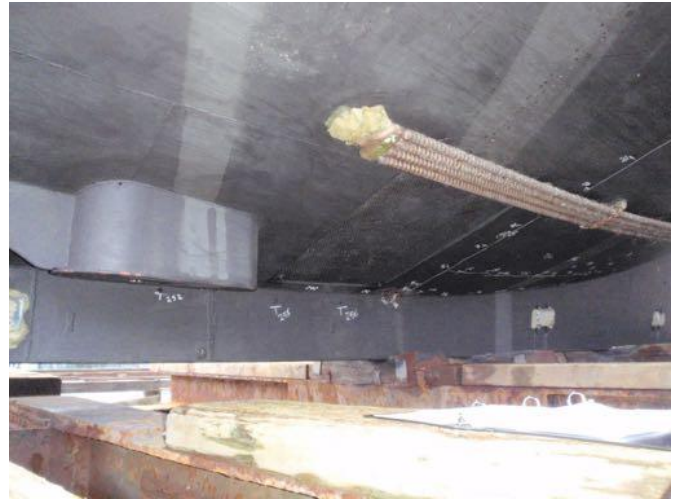
Girth band #1; from keel to chine, 4" forward of the aft engine room bulkhead (ERB in photos), readings approx. 12-16" on center .238", .242", .242", .246", .248", keel cooler, .250", .250", .250", .252", .250".248", chine

Shell plate around forward transducer and to forward engine room bulkhead .242" to .244", keel side shell .252" to .258". Note .238" to .240" at shell plate adjacent keel and forward of aft engine room bulkhead, location of electric bilge pump.

**UT testing Port, forward keel to aft engine room bulkhead**

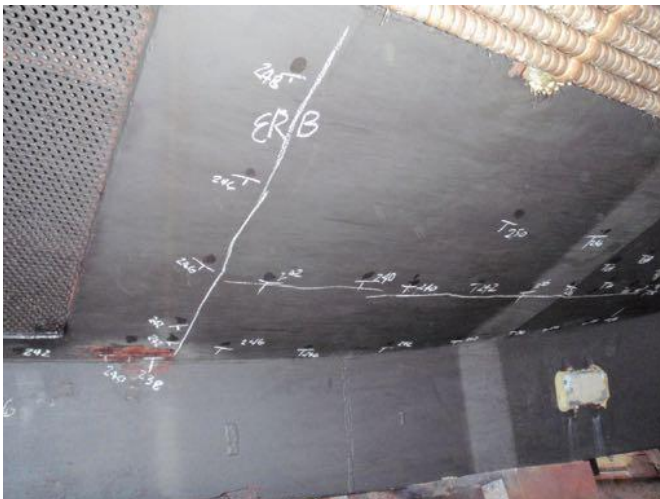
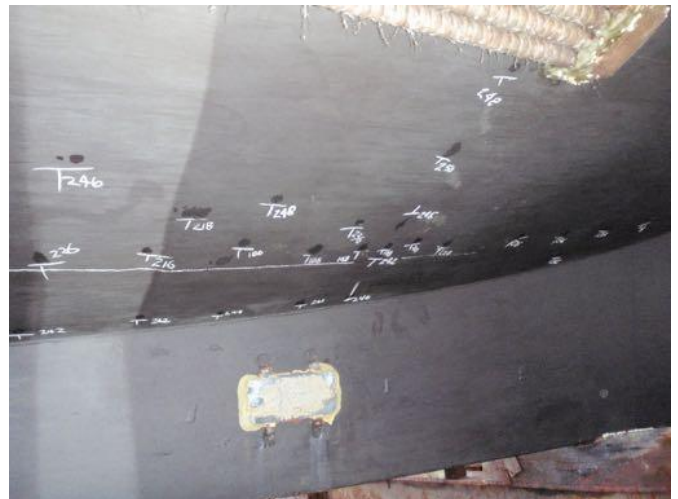
Above upper side of shaft alley wall, moving aft of sea chest, .242", .240", .240", .242", .226", .216", .186", .188", .198" at Girth band #2, then .198", .210", .220", .226", .246", and steady .244" to .250" well aft. Along lower shell plate in shaft alley, .242" to .246" well aft, at end of keel .240", then in a short girth band aft of the lazarette bulkhead, .224", .230", .226", .222", .230", .200".

Good overall readings, with minor deficiencies at shell plate in shell plate immediately forward of aft engine room bulkhead, where a 12V bilge pump has been located, in the area outboard of the main fish hold shaft alley, primarily Port side, also at aft side of forward lazarette bulkhead, primarily Port side.

**Between girth bands along shaft alley wall and keel**

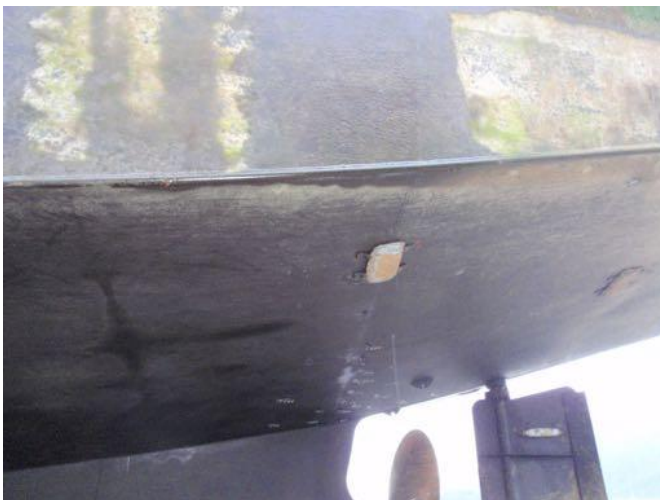
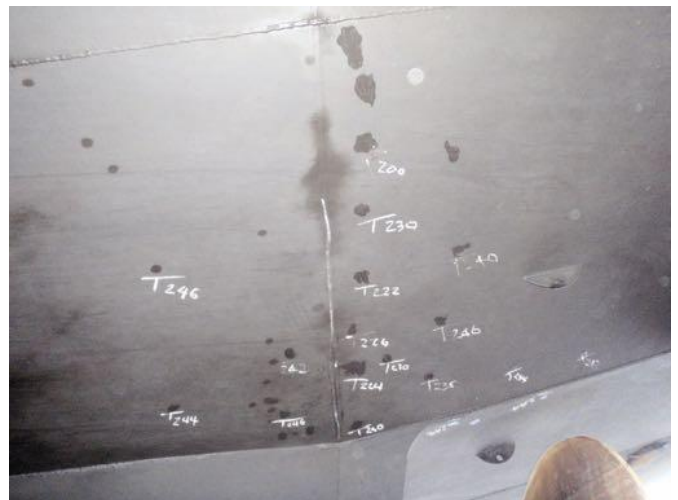
- 16. Repair broken circulation piping in aft hold as found necessary. Renew with Sched. 80 PVC or galvanized steel.
- 17. Paint failure and minor corrosion in lower corners of lazarette compartment, to be renewed. Tank void also with interior corrosion as indicated by UT testing. Renew interior bilge coatings.

**Stern section, Port, and bottom of tank void bottom**
