Atmos Energy Corporation Natural Gas-Fueled Explosion  
Dallas, Texas  
February 23, 2018

NTSB/PAR-21/01  
PB2021-100901

# Pipeline Accident Report

**Abstract:** On February 23, 2018, at 6:38 a.m. local time, a natural gas–fueled explosion occurred at 3534 Espanola Drive, Dallas, Texas. The residence sustained major structural damage, but when first responders arrived on scene at 6:44 a.m., they observed no smoke or fire. Four family members were injured, and one was killed in the explosion. Following the explosion, National Transportation Safety Board (NTSB) investigators located a through-wall crack in the 71-year-old natural gas main that served the residence. In the 2 days before this explosion, two gas-related incidents occurred on the same block at houses that were served by the same natural gas main, each resulting in significant structural damage and burn injuries to one occupant. The first occurred on February 21, 2018, at 5:49 a.m., and resulted in one injury involving second-degree burns and significant structural damage to 3527 Durango Drive. The second incident occurred on February 22, 2018, at 10:21 a.m., and resulted in one injury involving second-degree burns and

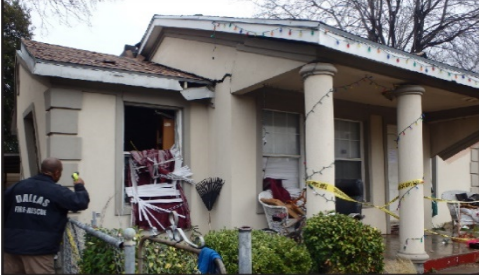
<p><b>3527 Durango Drive</b></p>

<p><b>February 21, 2018</b></p> <p><b>5:49 am</b> Explosion and fire reported</p> <p><b>5:53 am</b> Dallas Fire-Rescue (DFR) arrives</p> <p><b>6:17 am</b> Dallas Fire-Rescue (DFR) reports fire under control</p> <p>Atmos Energy technician responds, does not detect gas, unable to test customer-owned piping.</p>
<p><b>3515 Durango Drive</b></p>

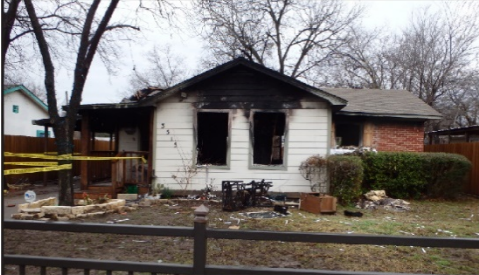
<p><b>February 22, 2018</b></p> <p><b>10:21 am</b> Fire reported</p> <p><b>10:27 am</b> Dallas Fire-Rescue (DFR) arrives</p> <p><b>1:17 pm</b> Fire extinguished</p> <p>Atmos Energy technician responds, requests assistance that resulted in over a dozen personnel investigating and repairing leaks.</p>
<p><b>3534 Espanola Drive</b></p>

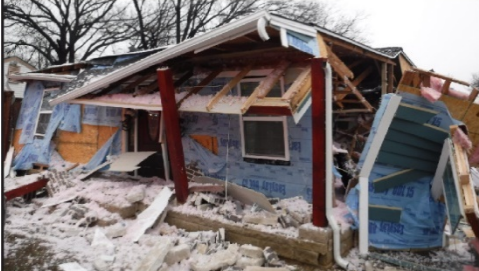
<p><b>February 23, 2018</b></p> <p><b>6:38 am</b> Explosion reported</p> <p><b>6:44 am</b> Dallas Fire-Rescue (DFR) arrives observe no smoke or fire</p> <p>Atmos Energy crews who were in the area began evacuations.</p> <p><b>7:45 am</b> System isolation began</p>

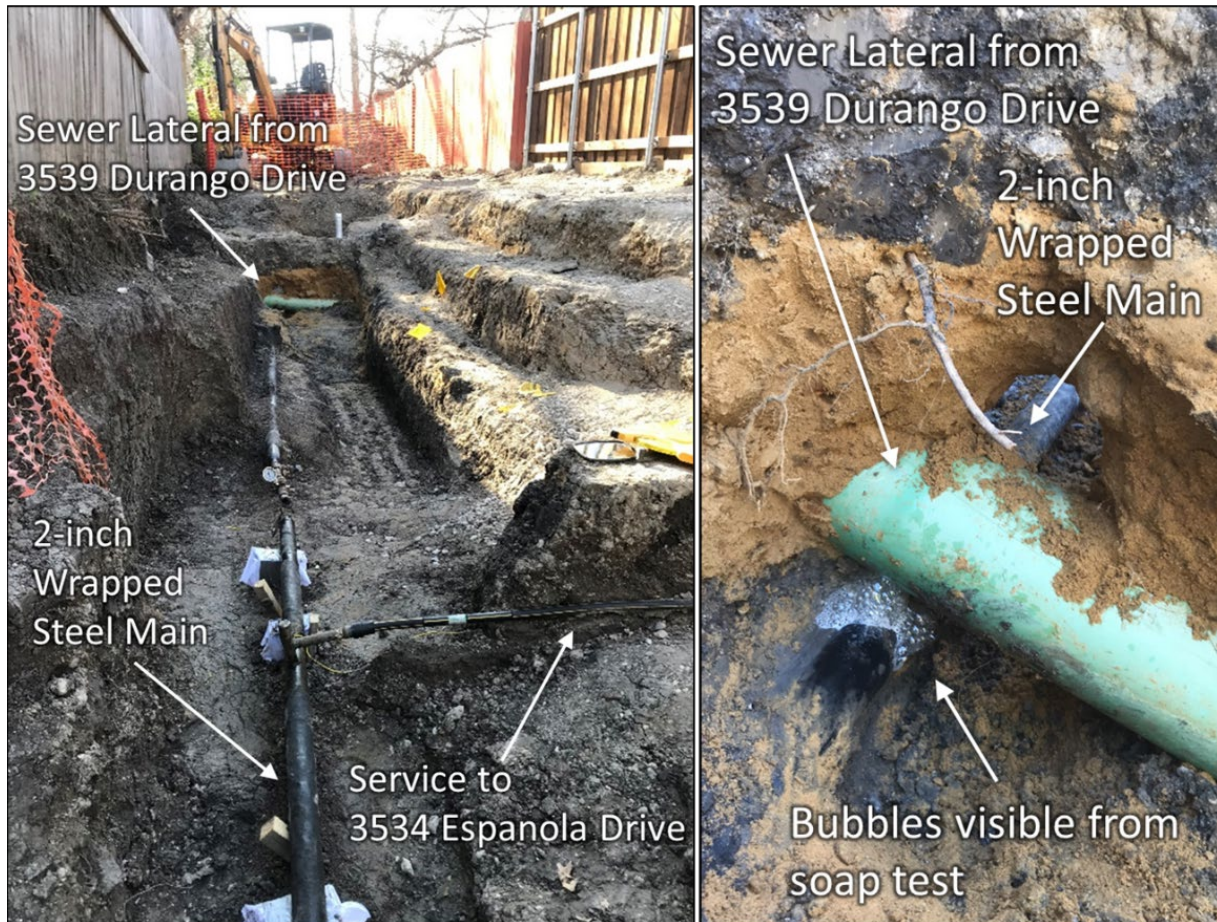
the main. Coating damage was evident across about 25 inches of pipe, mostly concentrated on the top of the pipe in the area directly beneath and to both sides of the sewer lateral.

**Figure 7.** Crack in natural gas main at 3539 Durango Drive sewer lateral crossing. (Courtesy of Atmos.)

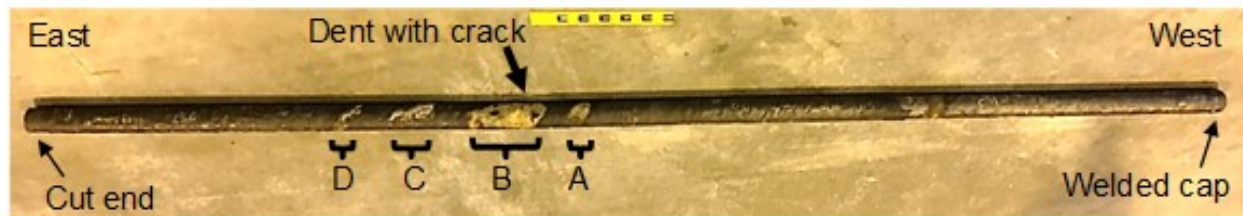
Visual examination of the gas main segment from behind 3539 Durango Drive revealed the top surface of the gas main coating was damaged in four locations, as evidenced by missing pieces of the coal tar enamel spiral wrap indicated by brackets “D”, “C”, “B”, and “A” in figure 10.

**Figure 10.** Natural gas main recovered near 3539 Durango Drive sewer lateral crossing.

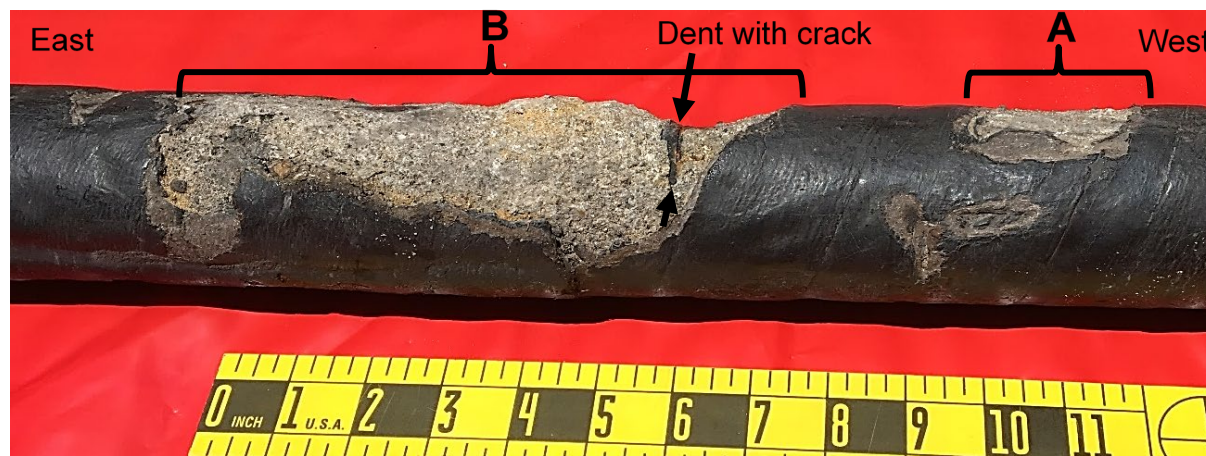
The exposed surface of the gas main in the four locations of coating damage was covered with a hard, compacted, adherent deposit that had formed on the exposed pipe surfaces. The circumferential crack intersected the dent. (See figure 11.) The dent was about 0.46-inch deep and about 1.4 inches in diameter. The crack occurred within one of the coating damage areas. The pipe had a slight downward bow with the greatest vertical deformation in the general area of the dent with the crack.

**Figure 11.** Side view of the damaged natural gas main showing the dent with a crack.

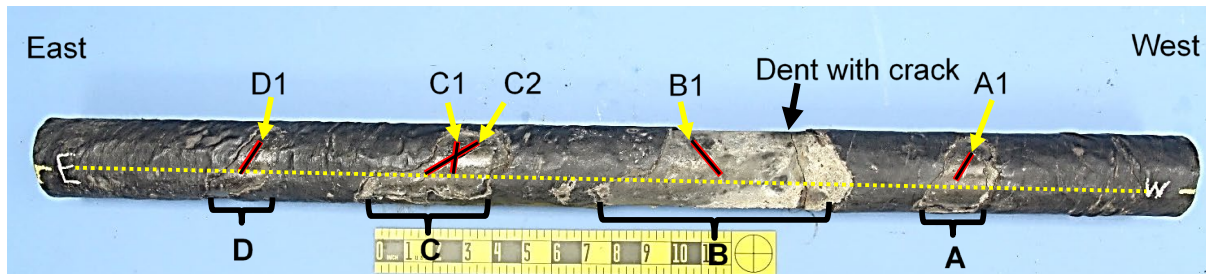
NTSB investigators identified five major diagonally oriented pipe wall gouges along the 10-foot length of the gas main. The five major gouges are indicated in figure 12 as “A1,” “B1,” “C1,” “C2,” and “D1.” There was at least one major gouge within each of the four coating damage areas, along with evidence of several other minor gouges. The gouges exhibited evidence of metal flow deformation, consistent with a gouge that started on the south and ended at the north. The gouges had round profiles and lengths that ranged between 0.9 inch and 1.8 inches, widths that measured between 0.13 and 0.25 inch, and depths that ranged between 0.007 and 0.018 inch.

**Figure 12.** Top surface of the natural gas main showing the five major gouges.

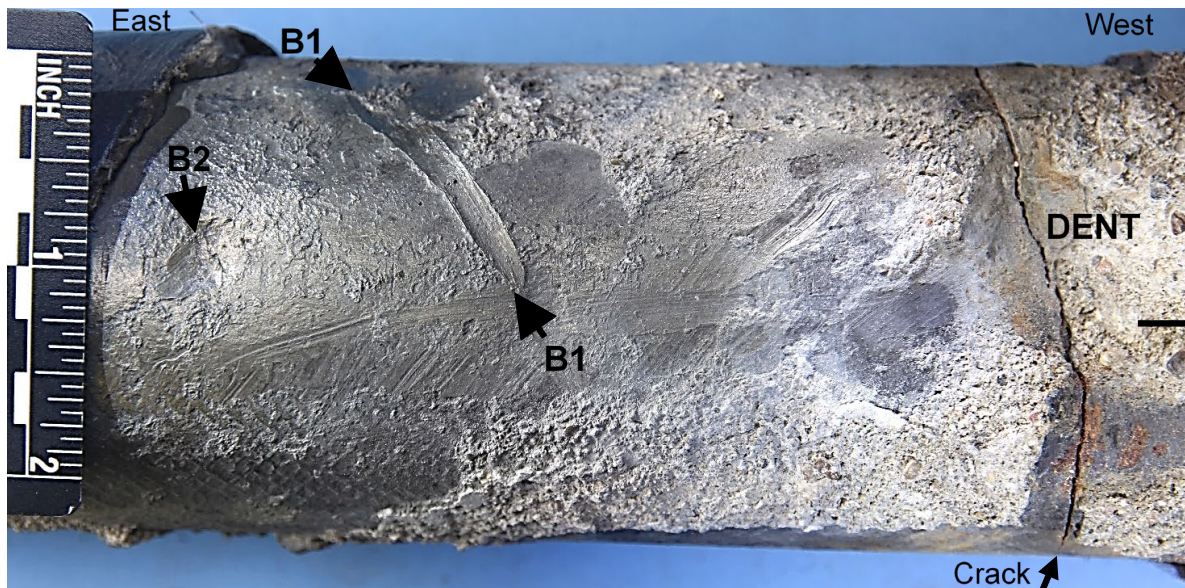
Figure 13 shows the crack and dent in the top side of the main in region “B,” after removing hard deposits from the surface in areas outside of the dent and exposing a gouge, indicated as “B1.” A smaller dent, about 0.25-inch diameter, was found in the area indicated by arrow “B2.”

**Figure 13.** Crack and dent on top surface of natural gas main after removing surface deposits.

A microscope examination of the west face of the fracture revealed evidence of ratchet marks that emanated from multiple origins at the outer dent surface. There was a 20 percent reduction in wall thickness at the area of the dent. The crack propagated from the bottom of a

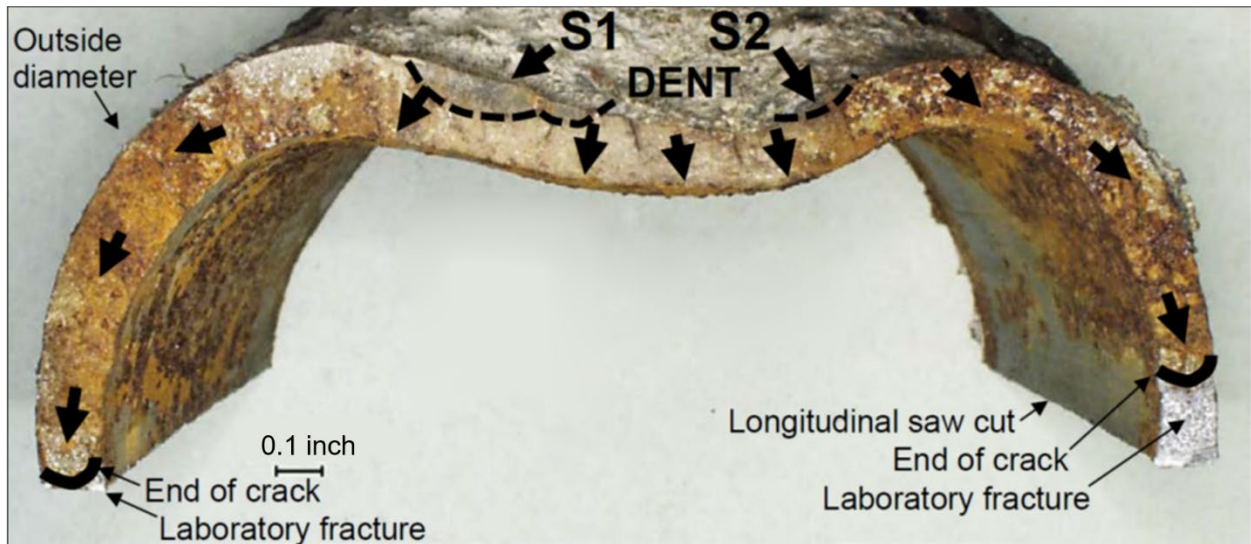
dent through the wall thickness and extended circumferentially to the approximate axial centerline of the pipe. (See figure 14.) The fracture surface exhibited moderate corrosion product deposits.

The fracture face at two isolated areas contained barely visible black regions adjacent to the dent on the external surface, in the areas indicated by regions “S1” and “S2” in figure 14. The remaining portion of the fracture surface exhibited a lighter orange-brown corrosion deposit. The black regions extended between the outer surface and as deep as about 0.07 inch below the surface, to the approximate areas indicated by black dashed lines in figure 15. The black regions appeared similar to thumbnail-like patterns. Scanning electron microscopy (SEM) also revealed the fracture surface contained cleavage fracture features that were pitted. The cleavage fracture features extended the entire length of the crack.

**Figure 14.** West face of pipe fracture after separating mating faces of circumferential crack.

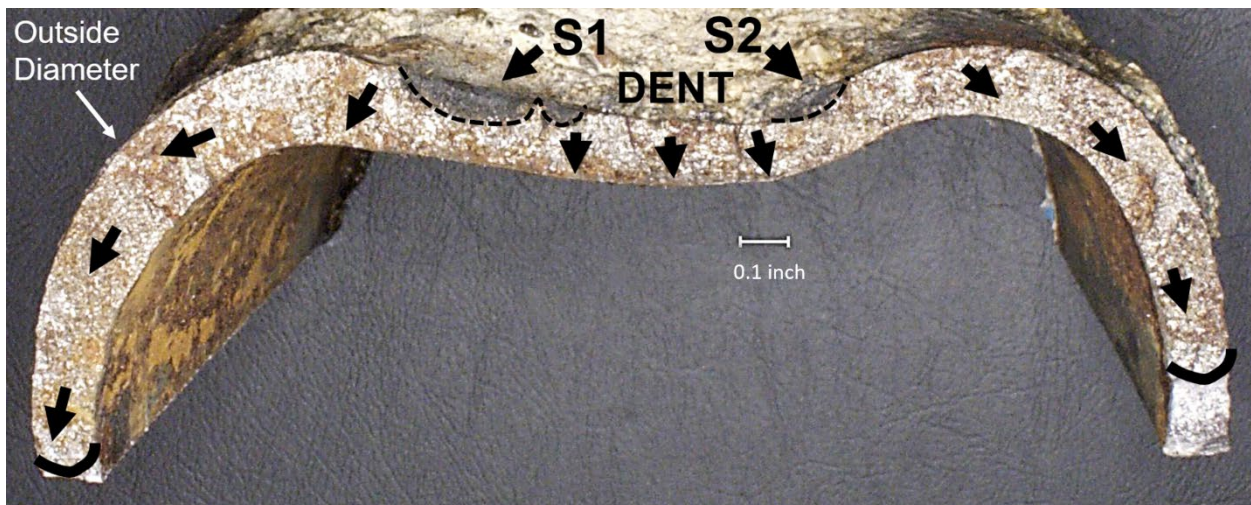
**Figure 15.** West face of the pipe fracture, after cleaning procedure.

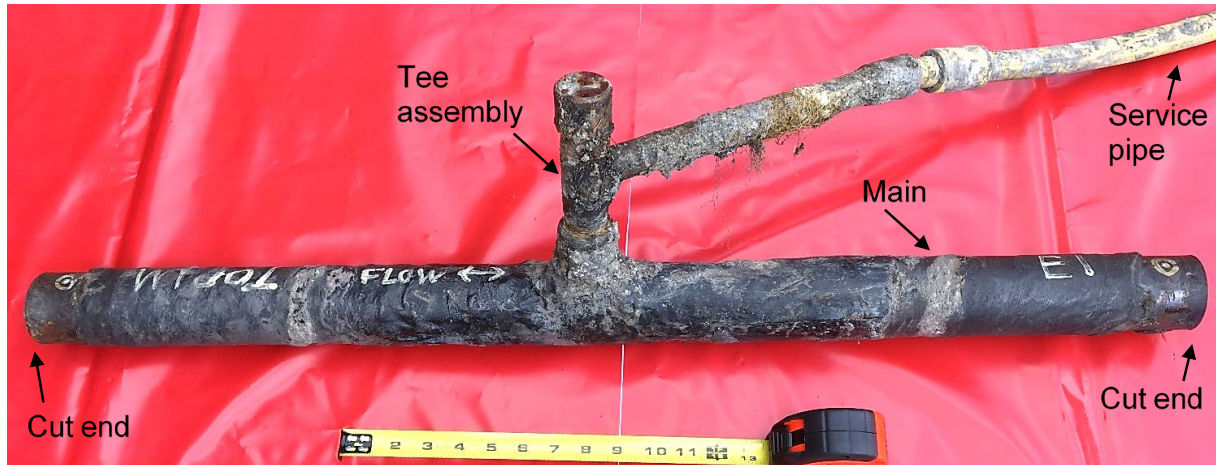
**Figure 16.** Natural gas main, with service line recovered from behind 3524 Espanola Drive.

Visual examination found no evidence of a crack in either the service pipe, tee assembly, service riser, or gas main segment. The outer wall of the 0.75-inch service pipe was marked with an indication that Performance Pipe manufactured it on June 3, 1997, from medium-density polyethylene. The measured diameter and thickness of the main and service pipe were within the specified size.
