Pacific Gas & Electric Third-Party Line Strike and Fire
San Francisco, California
February 6, 2019

Accident Report

NTSB/PAR-21/02
PB2021-100925

Pipeline Accident Report

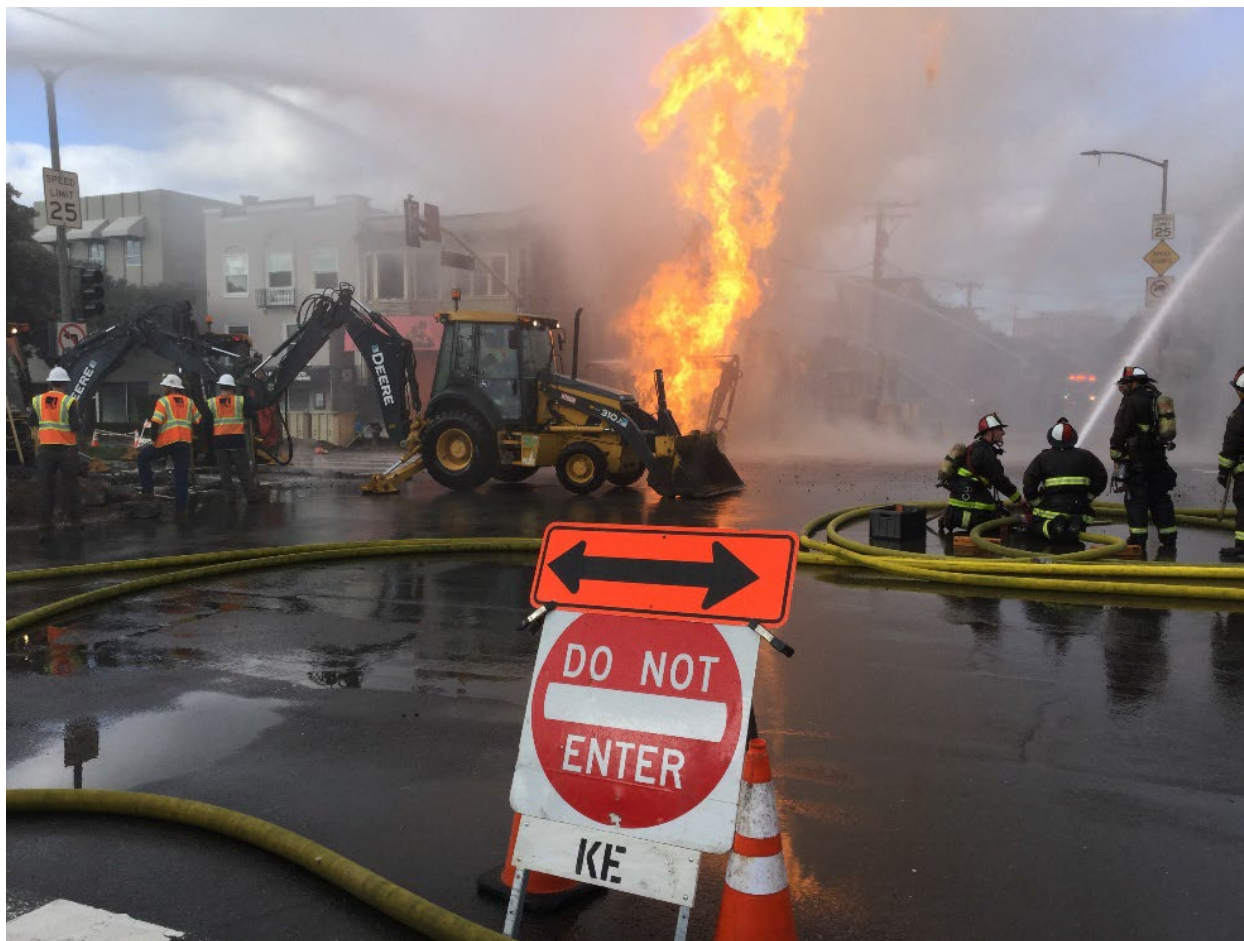
Figure 1. Northwest-facing view of fire during emergency response. (Photo courtesy of PG&E.)

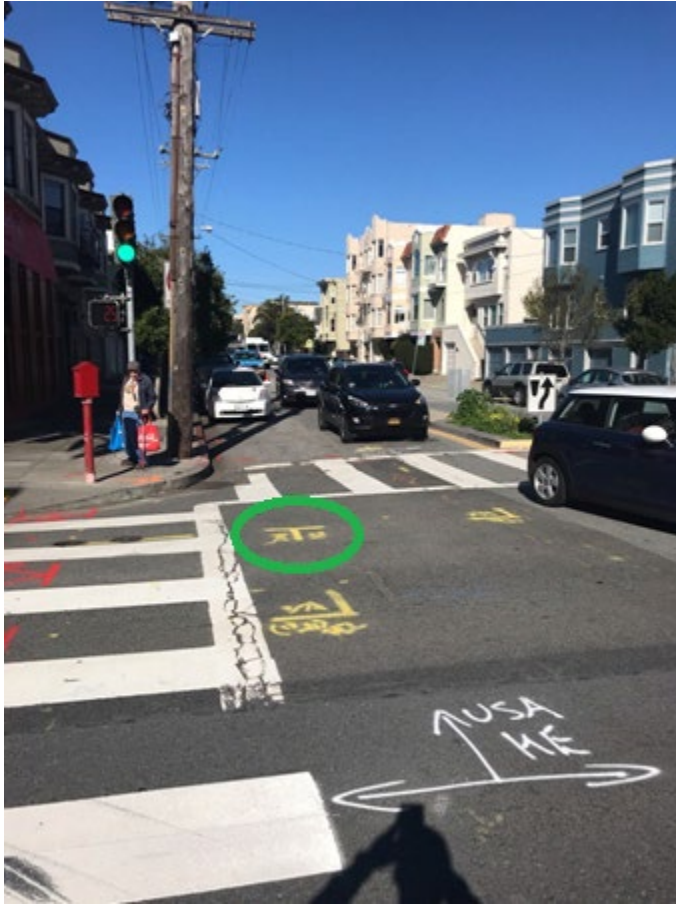
Figure 3. One-call street markings at northwest corner of Parker Ave. and Geary Blvd. (Photo Courtesy of PG&E.)

Note: The buried gas utilities are marked in yellow. A green circle has been placed on the figure to indicate the location of the branch connection that was ultimately struck.

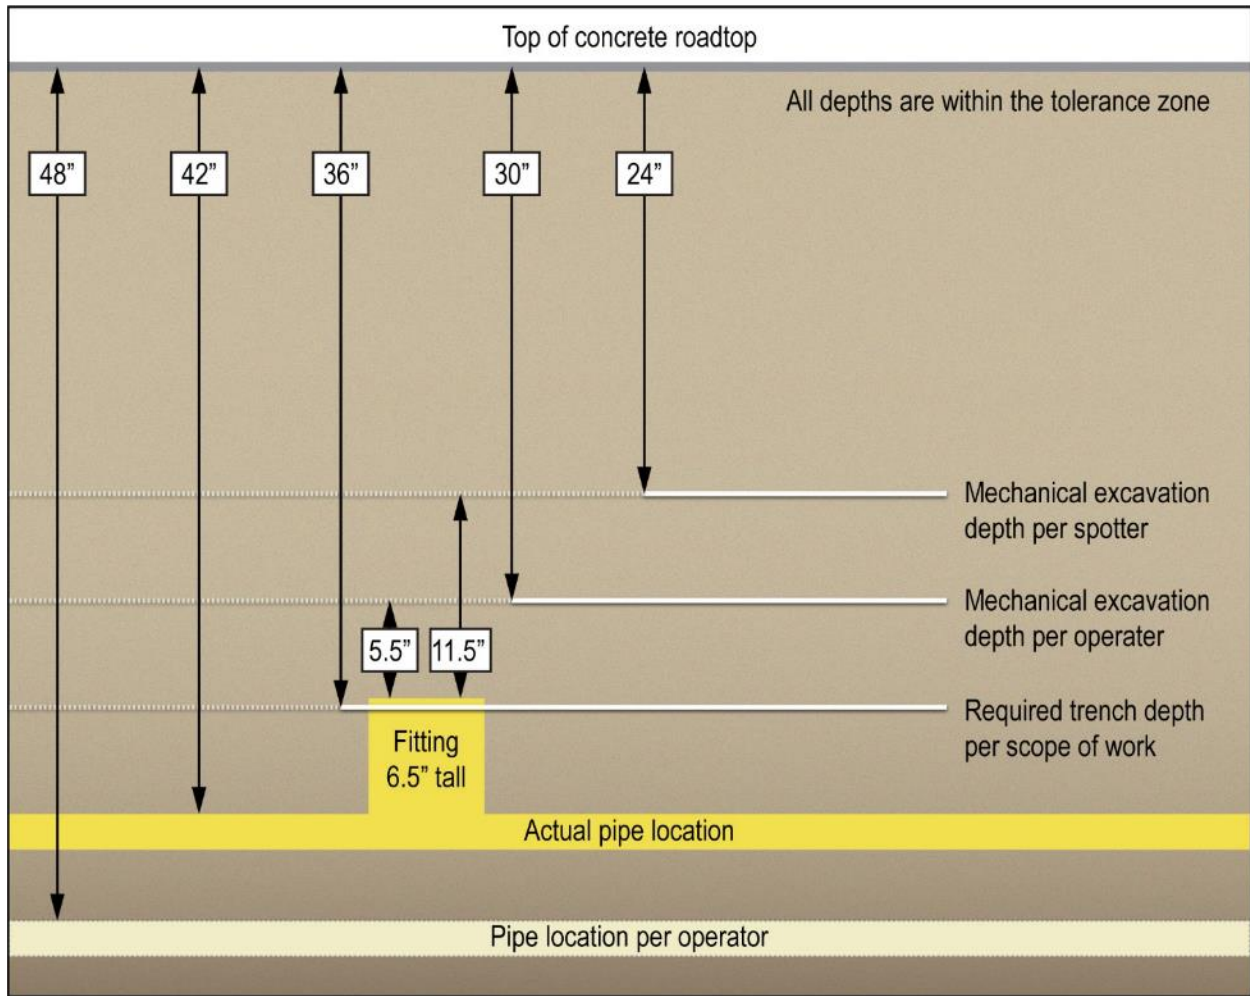
The operator also reported that he decided to dig to 30 inches, even though the scope of work called for 36-inch trench depth. The spotter reported that the trench was only 24 to 30 inches deep where the mini excavator was working at the intersection. (See figure 6.)

Figure 6. Trench depth comparisons.

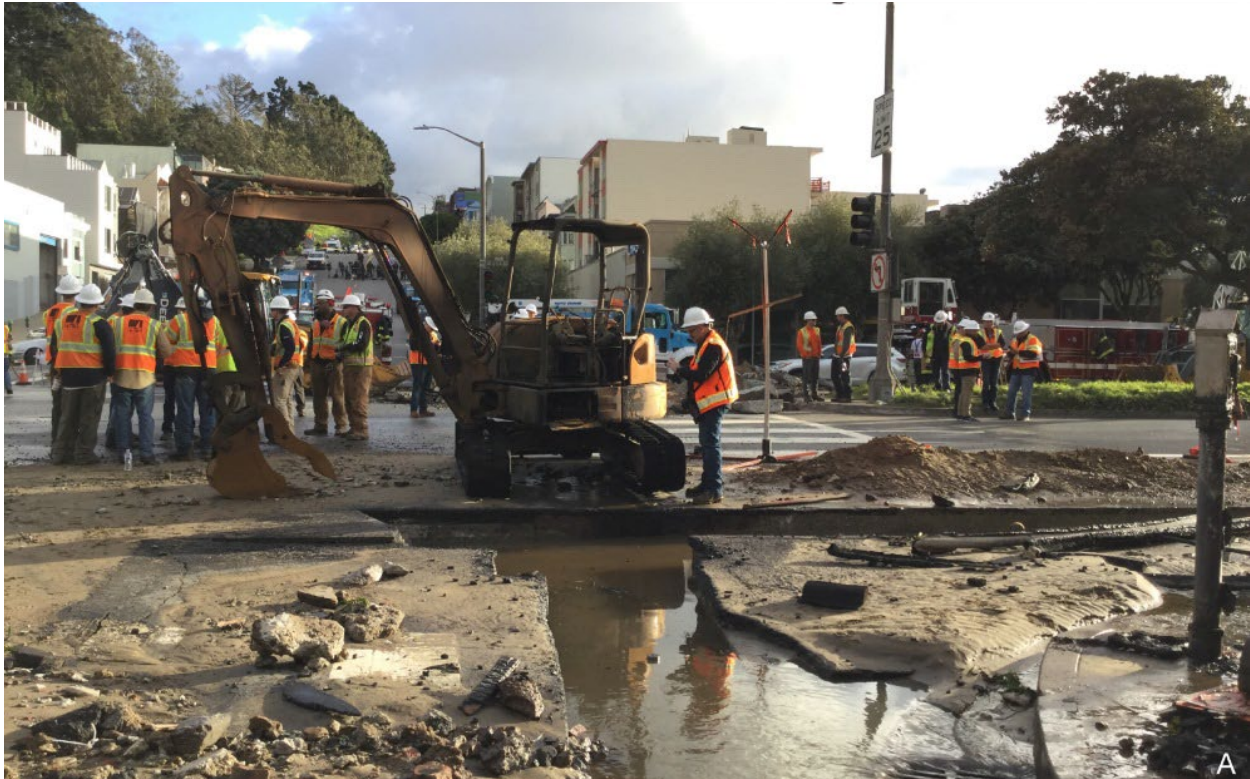
Figure 7. Postfire south-facing view of trench and excavator on Parker Ave. (Photo courtesy of PG&E)

Note: Figure 7 shows the mini excavator as found after the fire was extinguished.

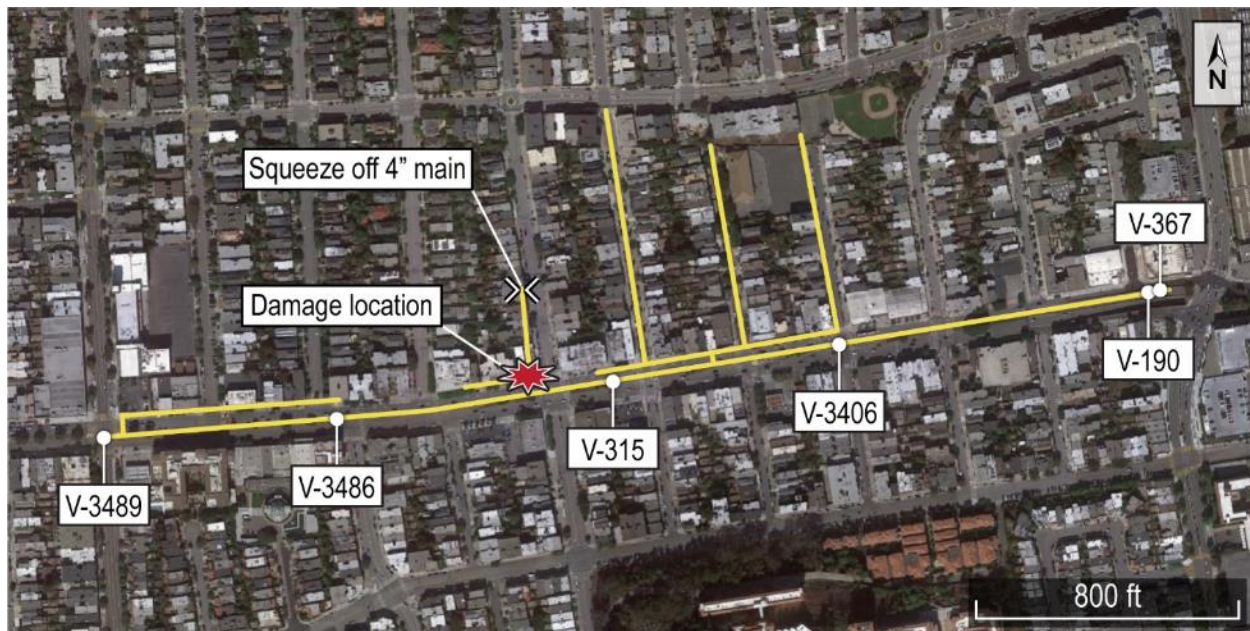
Figure 9. Final valve isolation plan with valves closed and location of damage.

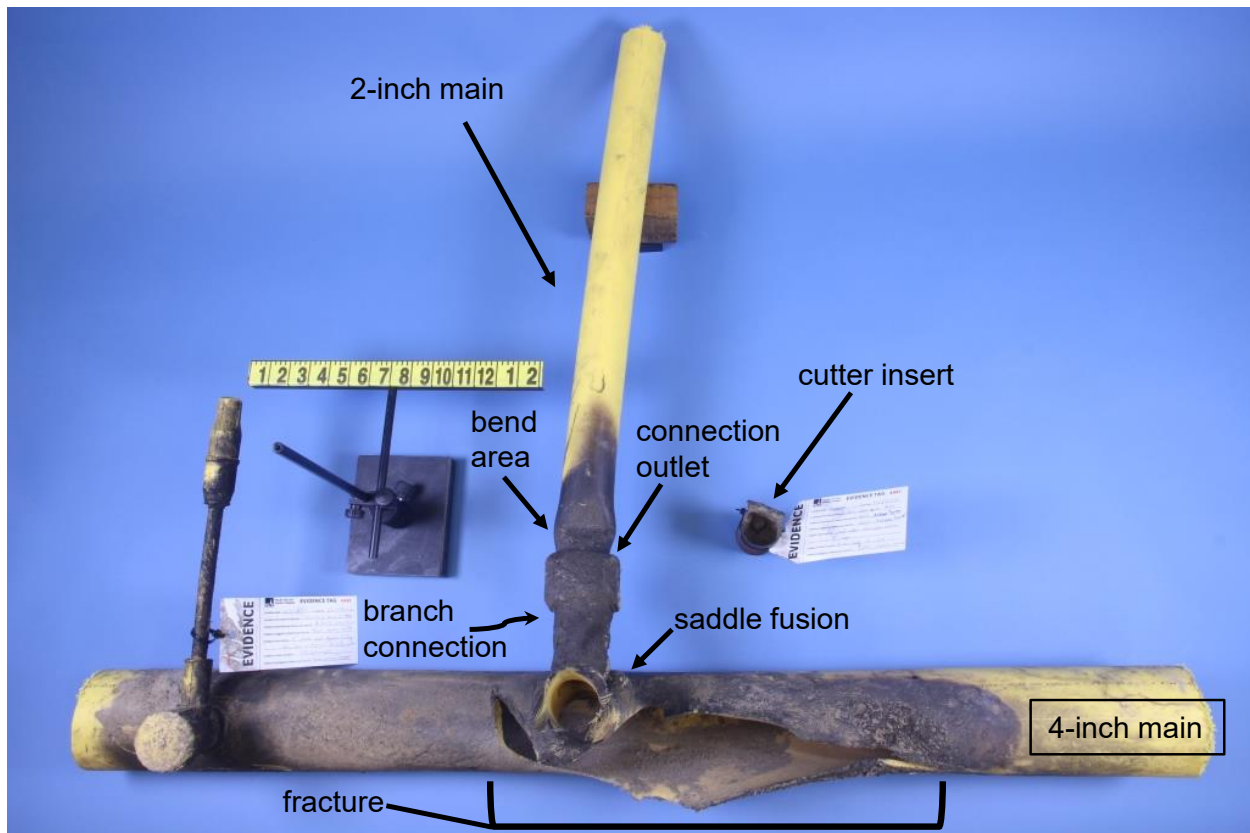
The segment of damaged 4-inch pipeline connected to the 2-inch pipeline by the branch connection and a cutter insert were removed by PG&E during the postaccident pipeline repair and transported to the NTSB Materials Laboratory for examination and testing.²² (See figure 10.)

Figure 10. Postaccident 2-inch pipeline, 4-inch pipeline, branch connection, and cutter insert.

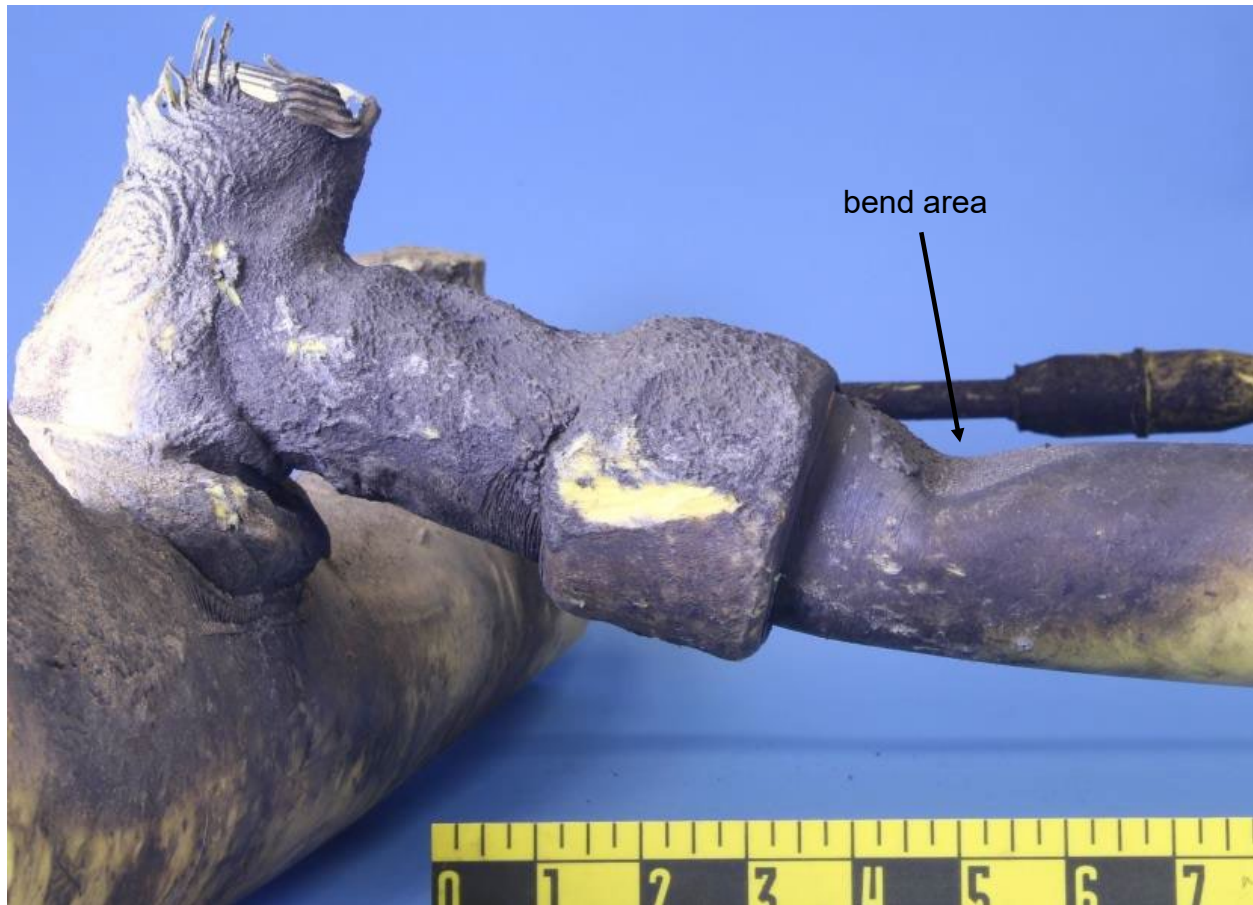
2-inch pipeline was found 1.25 inches from the outlet of the saddle-fused branch connection. (See figure 11.) No impact marks or scrapes were found in the bend area.

Figure 11. Close-up view of bend area in 2-inch pipeline.

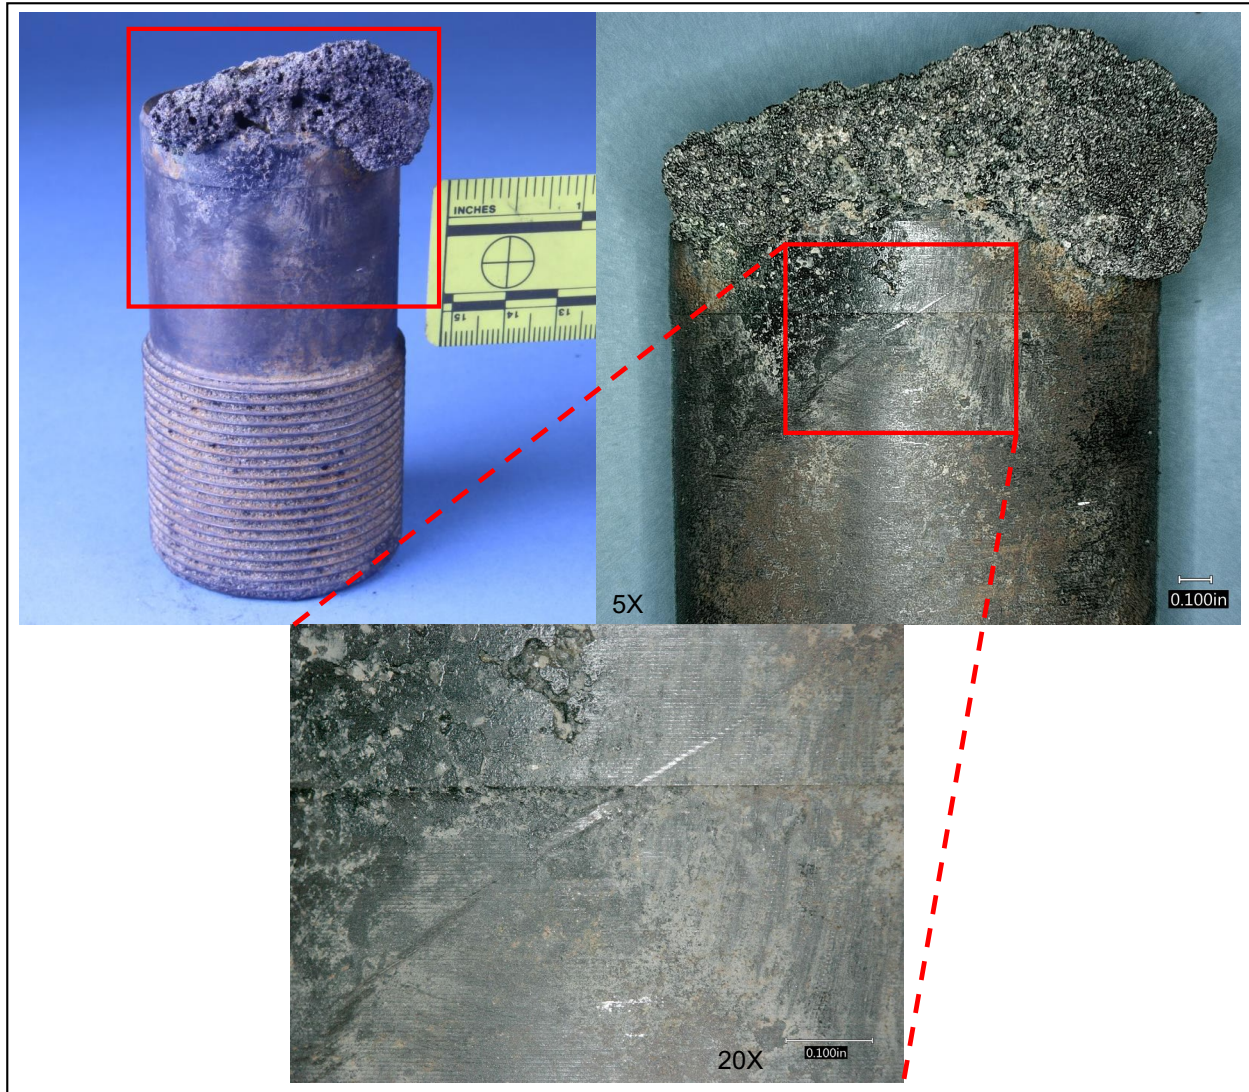
The cutter insert was further examined using a microscope. A diagonal gouge was observed across the insert. Figure 12 is a side view of the cutter insert showing the diagonal gouge at different magnifications.

Figure 12. Side view of cutter insert showing diagonal gouge.

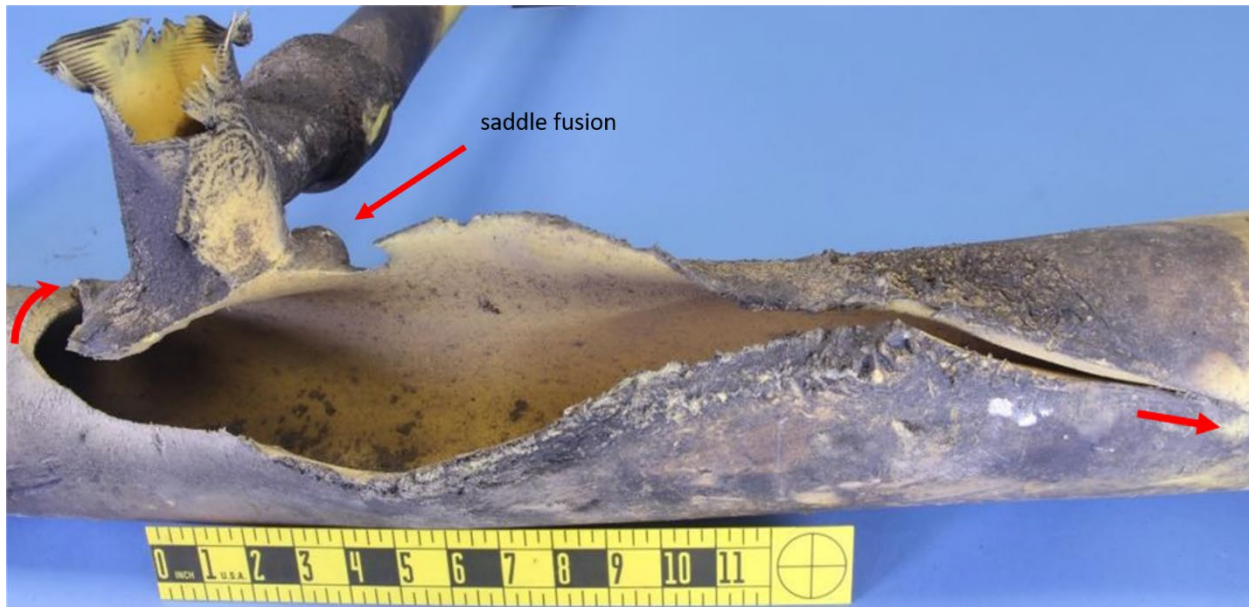
A longitudinal fracture was observed in the 4-inch pipeline along the top of the pipeline near the fusion with the branch connection. (See Figure 13.) Along most of the fracture surfaces, features were not identifiable due to thermal fusion and loss by melting or pyrolyzation. However, chevron marks were found on the fracture surface to the left of the saddle fusion. To the right of the branch connection, the fracture features were relatively smooth with hackle marks consistent with the direction of fracture, as indicated by red arrows in Figure 13.²⁵

Figure 13. View of fracture area in the 4-inch pipeline.
