Re: Crash of Pilatus PC-12/45 N128CM Report No. NTSB/AAR-11/05 PB2011-910405

**Petition for Reconsideration and Modification of the
National Transportation Safety Board's Findings and
Determination of the Probable Cause for the Crash of
Pilatus PC-12/45 N128CM**

NTSB Report No. NTSB/AAR-11/05 PB2011-910405

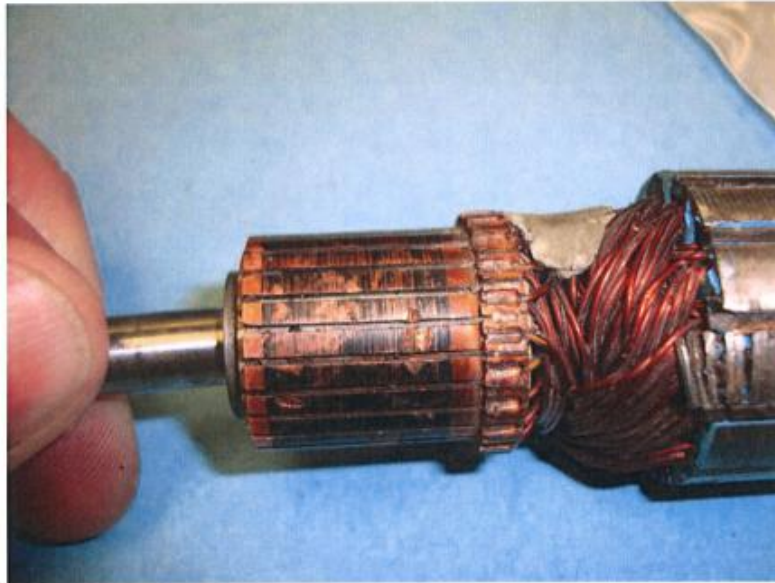
investigation, Petitioners conducted a wreckage inspection (also attended by Pilatus representatives). The inspection took place in December 2012 in Pearblossom, California, where the aircraft wreckage was stored after transport from Montana. Petitioners' representatives combed through the wreckage and located several key components of the fuel system, including the armature assembly (or pump motor) of the left FBP, depicted below.

An analysis of these components provided significant new evidence which necessarily alters the NTSB findings by providing a tangible explanation for the limited left-hand fuel flow and resulting imbalance.

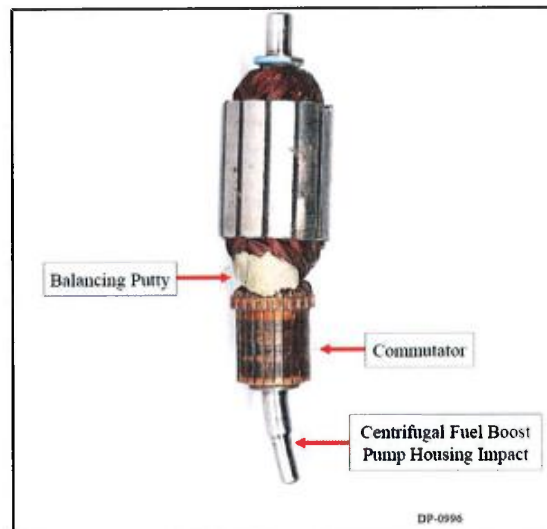
The subject left hand pump armature assembly shown below was bent on the end that passes through the pump housing and into the impeller. The left pump exhibited static impact signatures where the impeller contacted the pump housing on impact in a non-rotating manner, with resulting fractures of only three impeller vanes. (McSwain Decl. at ¶13.)

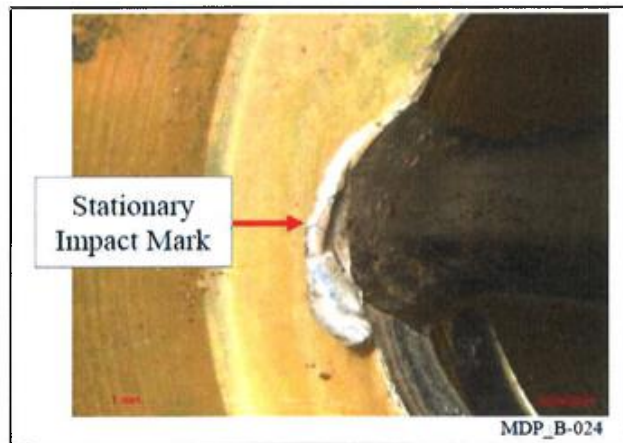
Laboratory examination of the pump housing revealed non-rotational contact damage in the armature shaft bore from the armature shaft. (McSwain Decl. at 25-28.) The damage was caused by impact of one of the armature shaft flats with the bore of the pump housing. The stationary impact marks can be clearly seen in the optical stereo micrographs below (*Id.*, Attachment 3.)

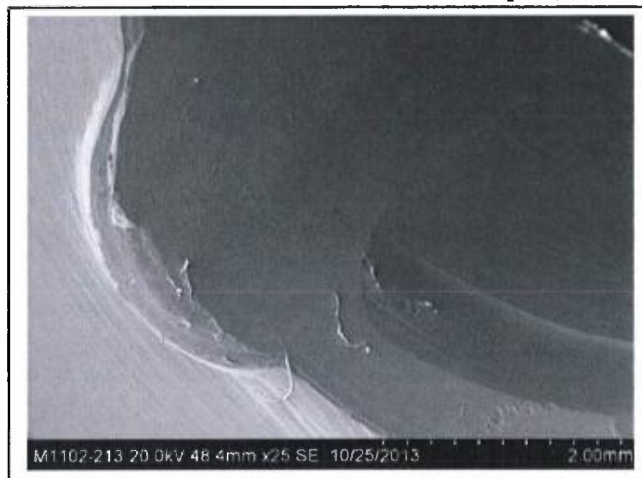
The marks were also examined with the SEM, which further confirmed that there was no evidence of significant rotation of the armature at the time of impact, as shown below (*Id.*, Att. 4.)

The left FBP motor *should* have been rotating at impact because logs from the plane’s onboard computer show that the left FBP was activated about one hour into the flight and continuously activated after that until the crash. When the pump is in an active state, the motor should be rotating at approximately 7800 rpm. The lack of rotation establishes that the left FBP had failed.

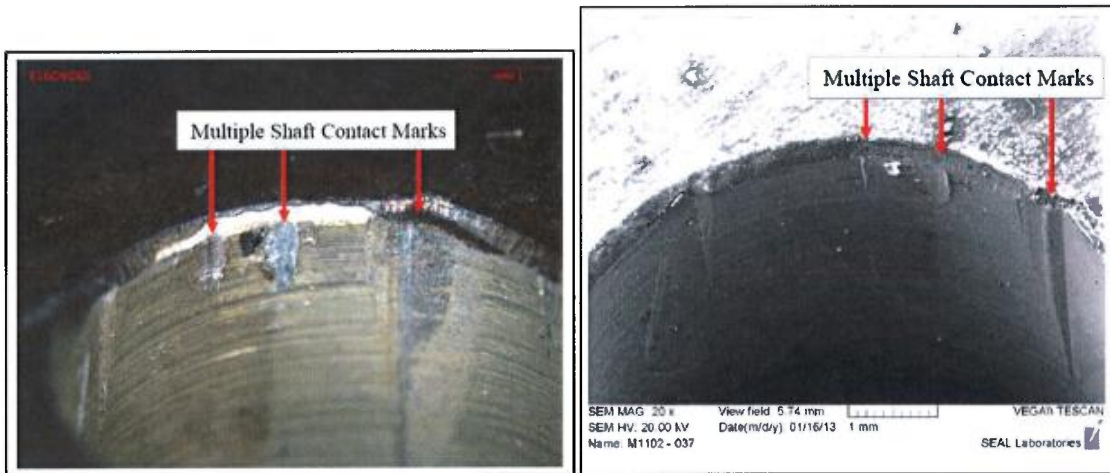
In contrast, the right FBP exhibited clear evidence of rotation / operation at impact. (McSwain Decl. at ¶29.) Stereomicroscopic examination of the edge of the bore revealed multiple pump armature impact marks, consistent with “chatter” caused by the armature rotating at impact, as shown below on the left (*Id.* at ¶17, Att. 19.). The same marks were observed using the SEM, shown below on the right (*Id.*, Att. 20.). The pump armature shaft contact-induced marks in the right boost FBP shaft bore were significantly different than those in the subject left FBP. The left did not exhibit the characteristic chatter marks indicative of armature rotation.

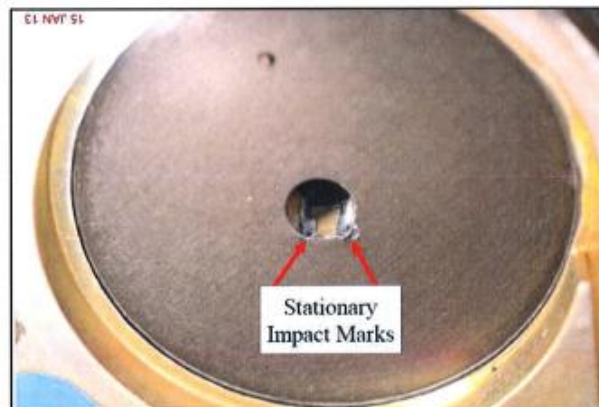
Examination of the impeller side of the FBP housing reveals that the stationary impact marks extended into the fuel boost pump impeller cavity as shown below (*Id.* at ¶13, Att. 5.) There were no indications of left FBP operation at the armature shaft bore exit point in the pump housing impeller cavity at impact. (*Id.* at ¶13.)

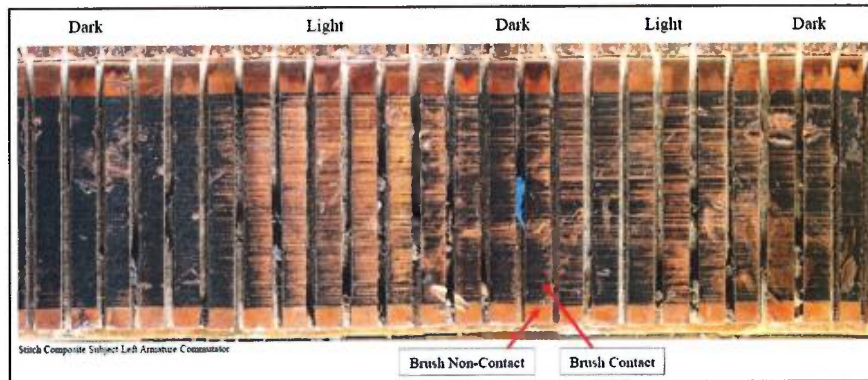
iii. Commutator imbalance

A combined photo of commutator bars of the left-hand boost pump commutator is shown below. (*Id.*, Att. 6.) The commutator bars are darkened at the brush contact sites. The circumference of the commutator reveals a banding of both dark and light surface conditions. This banding is indicative of an out-of-balance commutator condition and non-uniform contact between the brushes and the commutator. (McSwain Decl. at ¶¶14 and 27.) This condition resulted in alternating contact pressures between the commutator and the brush assembly. (McSwain Decl. at ¶¶14, 15, 35.)

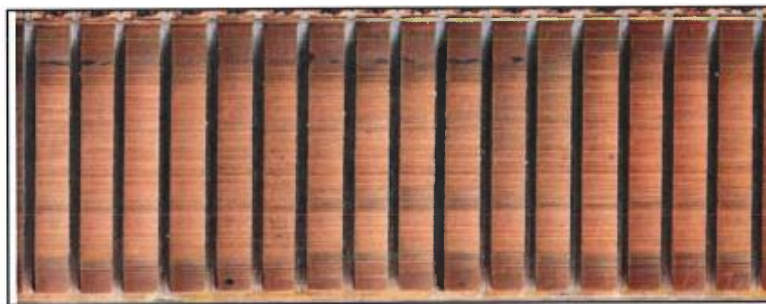
In a properly operating pump, the patina on the commutator bars should be a reflexive sheen with a predominately copper color. An out-of-balance commutator causes the brush to glide over one area and then come down hard on others, causing the patina to scrape away. The result is seen in the varying light and dark patterns. The photo below is what normal wear on the patina of the commutator should look like. This shows homogenous wear, color and banding.

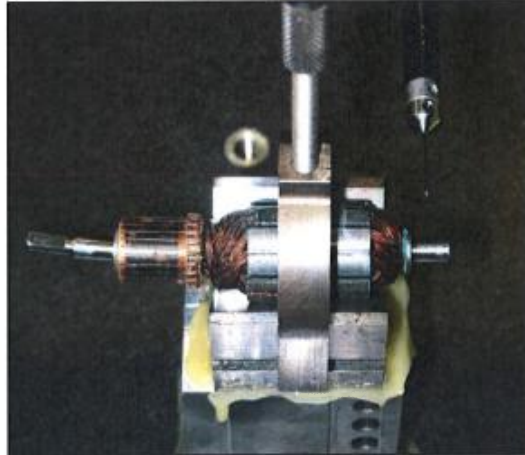
were made in both the non-contact and contact areas of the commutator bars, as shown below (*Id.*, Att. 8.)

The CMM scanning touch probe data was used to construct the roundness condition of the commutator. (McSwain Decl. at ¶15.) Areas of impact-induced surfaces were removed from the CMM data to ensure representative pre-accident surface data for the non-contact areas of the commutator. (*Id.*) The results—which are purely objective—showed that the LH boost pump commutator TIR was *four times* the accepted limit. (*Id.*) This is the discrepancy measured on the non-contact surfaces (surfaces not subject to wear through use) and correlates directly with the runout measurement when the part left the factory. (*Id.*) The derived TIR measurement for the left-hand pump commutator is shown on the graph below. (*Id.*, Att. 23.)

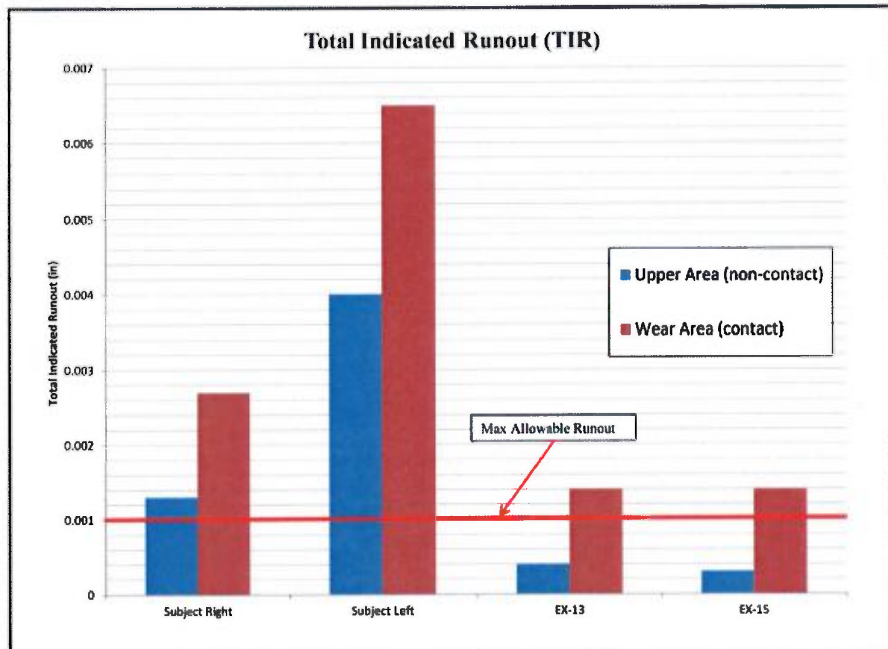
The out-of-round condition of the as-manufactured left FBP commutator was a manufacturing defect and would not have changed after the pump was in service. (McSwain Decl. at ¶15.) The dynamic imbalance of the commutator, as evidenced by the alternating dark and light bands on the commutator, combined with the dimensional stack-up condition between the commutator and the brush holder, led to the in-service commutator-to-brush holder contact. (*Id.*)

In contrast, examination of exemplar FBPs were shown to exhibit roundness within the Crane specification limits. (McSwain Decl. at ¶33.) The right FBP commutator measured a TIR that only slightly exceeded the Crane specification, as shown below (*Id.* at ¶¶19 and 30, Att. 23.) Laboratory investigation revealed, however, that the right FBP commutator had not been running in an out-of-balance condition. (McSwain Decl. at ¶19.)

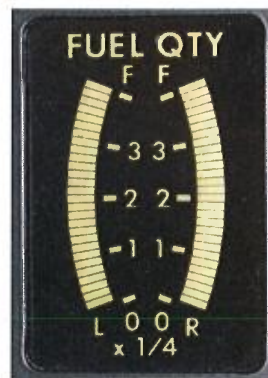
The fuel gauges in the PC-12 (shown on the right) are highly indefinite and never actually state the fuel differential in pounds. Instead, a small 2-inch gauge with 28 segments is used to illustrate the fuel in each tank. Because each segment could represent a variance of up to 50lbs of fuel in either direction, a three-bar differential may represent any amount across a 100 lb range. This observation is merely meant to demonstrate the angle taken by the Report which “assumed the worst” and blatantly excluded equally viable predictions. Such is directly related to the Report’s criticism of the pilot’s actions and ultimate Probable Cause determination. This evidence strongly indicates that Pilatus’ and the Report’s conclusions as to what the pilot was seeing during the accident flight are based on pure speculation.
