# CRASH OF PILATUS PC-12/45 N128CM

June 30, 2017 Petition for Reconsideration of the  
NTSB's Findings & Determination of Probable Cause

Supplemental Presentation  
Dated: June 29, 2018

**Re: Crash of Pilatus PC-12/45 N128CM Report No. NTSB/AAR-11/05 PB2011-910405**  
***Supplement to June 2017 NTSB Petition for Reconsideration***

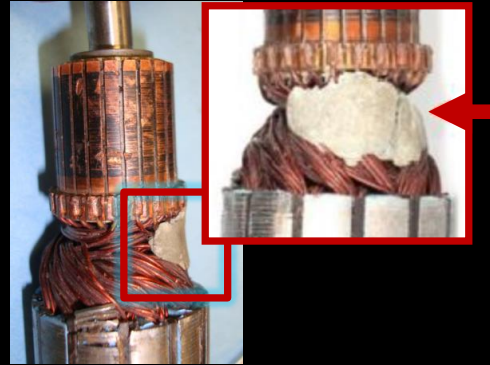
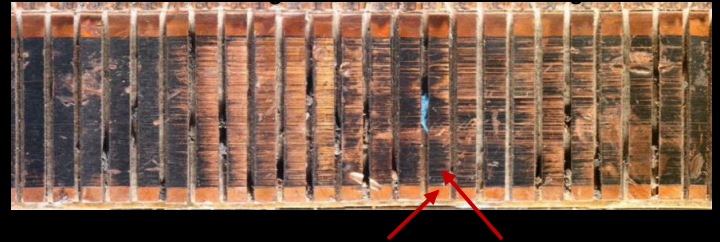
*Left Boost Pump suffered a mechanical failure*

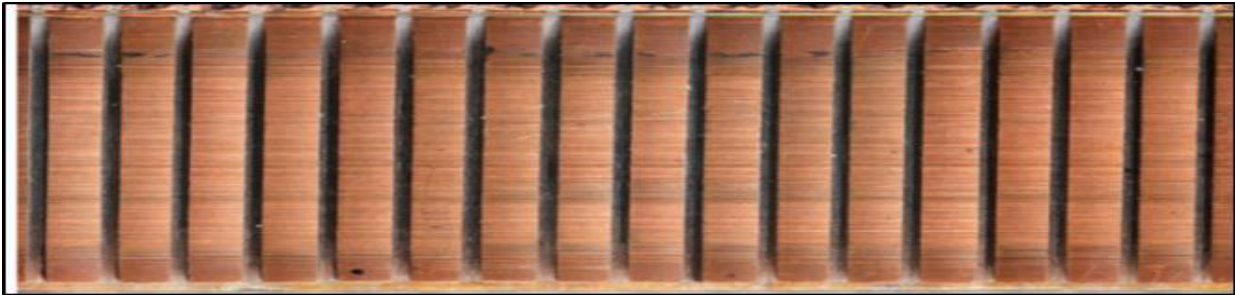
Normal wear on motor shows homogeneous color and banding:

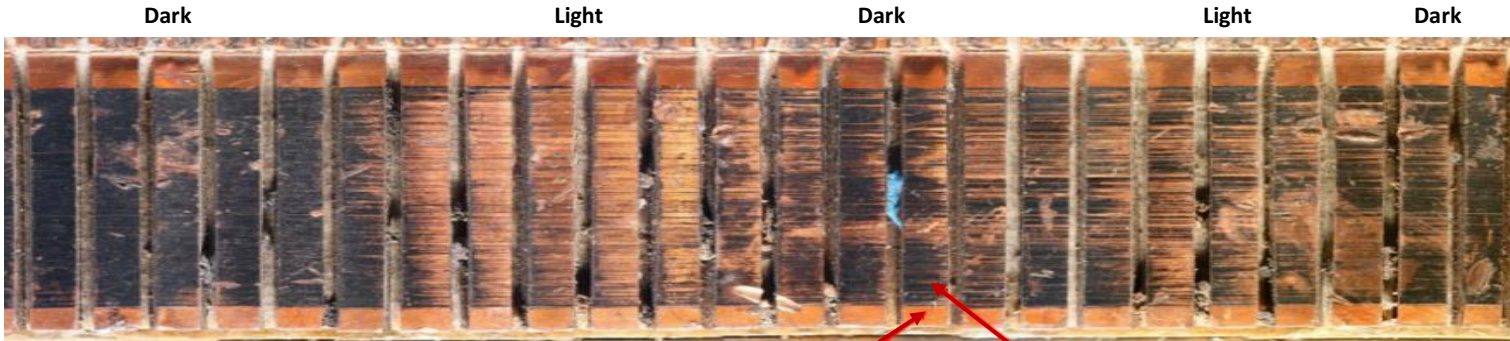
Stitch Composite – Subject Left Armature Commutator

Abnormal wear on the subject motor shows varying light and dark patterns:

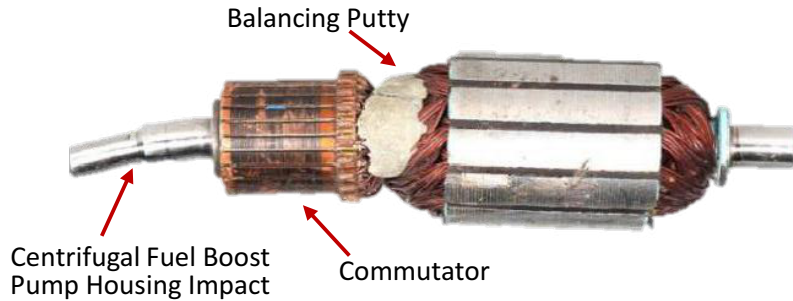
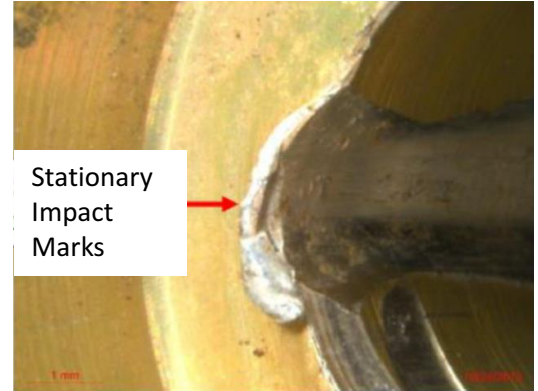
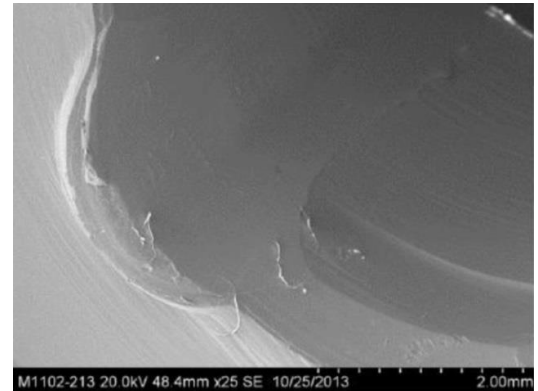
- The Left Boost Pump shaft hole shows static, non-rotational contact damage
- Damage was caused by impact of one of the armature shaft flats with the hole
- Microscope photos confirm the impact marks are stationary

***Left Boost Pump***  
***NO ROTATION = NO OPERATION***

***Right Boost Pump was operating at the time of impact***

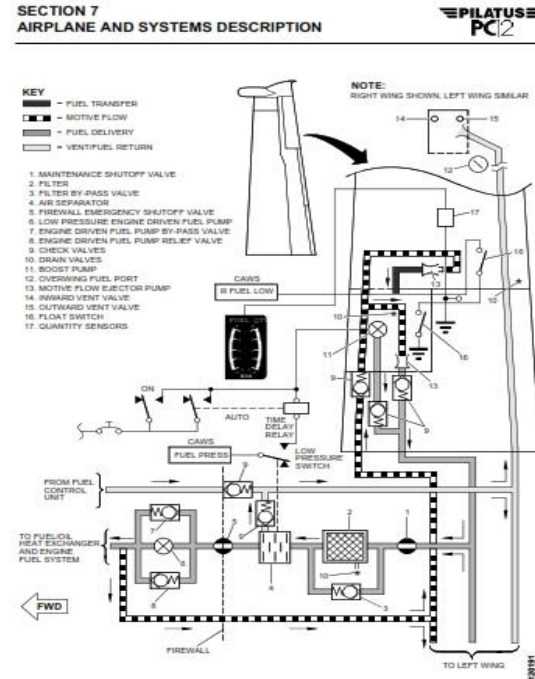
Figure 7-12. Fuel System  
(Sheet 1 of 4)

- If a Fuel Boost Pump fails when its function is required (i.e. a foreseeable icing event), the system design will cause an increasing fuel imbalance in the opposite wing which is uncorrectable, resulting in a dangerous asymmetric fuel imbalance that is beyond the design characteristic of the airplane.

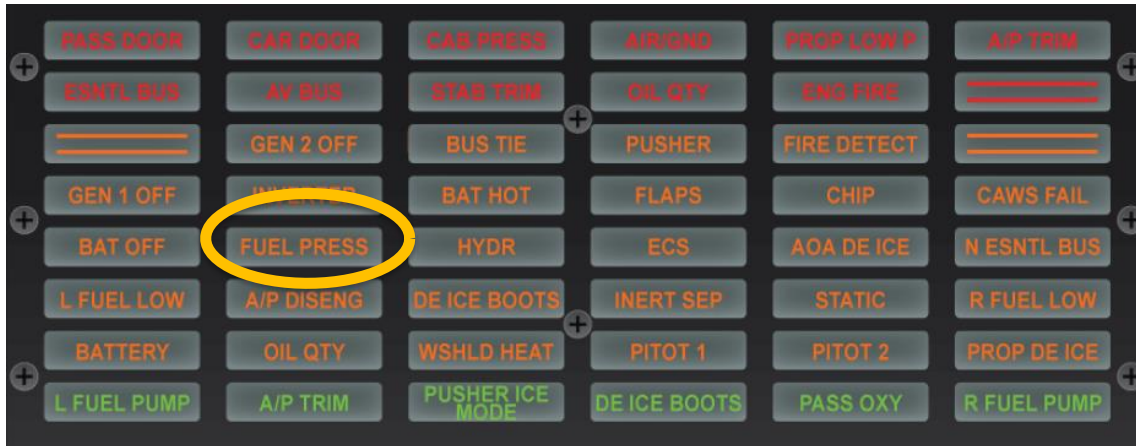
# The PC-12 Low Fuel Pressure light violates FAR 1305

**FAR § 23.1305:** requires certain indicators for emergency conditions involving aircraft powerplants. It requires turbine engines to be equipped with a **warning means** for Low Fuel Pressure – fuel pressure below 2psi.

The PC-12 Low Fuel Pressure light is not **red**, but **amber**:

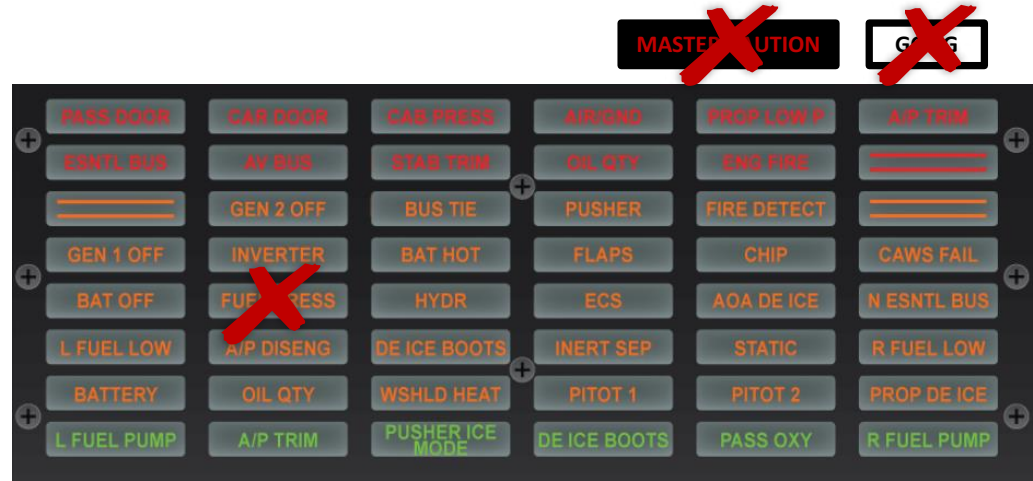
- Blocked Fuel Filter →
  - Low Fuel Pressure Condition →
    - Boost Pumps Activated →
      - Pressure Restored
- Blocked Fuel Filter Continues →
  - Cycle Repeats...

***This cycle occurred 307 times  
without lighting the  
Fuel Pressure warning light***

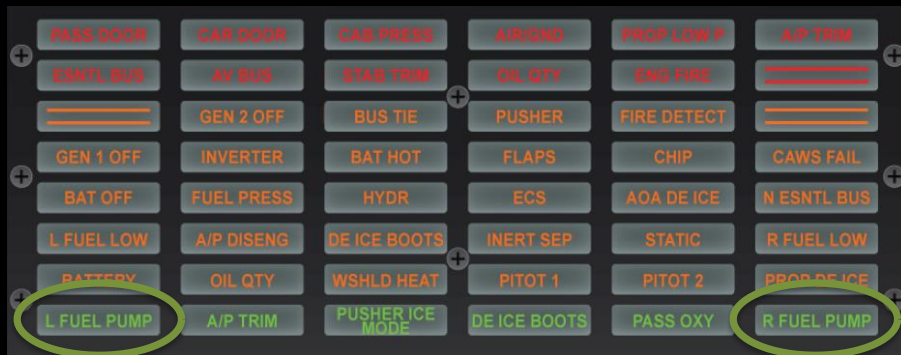
- Because of a ***programmed time-delay, Low Fuel Pressure cautions will not occur*** unless the condition exists for more than 0.3 second
- Fuel Boost Pumps are designed to clear a low pressure condition in less than 0.3 second
- Therefore, ***cautions were never displayed*** even though there were ***307 low pressure conditions*** on the accident flight
