Pipeline Investigation Report: NTSB/PIR-22/02

Enbridge Inc. Natural Gas Transmission Pipeline Rupture and Fire

Danville, Kentucky
August 1, 2019

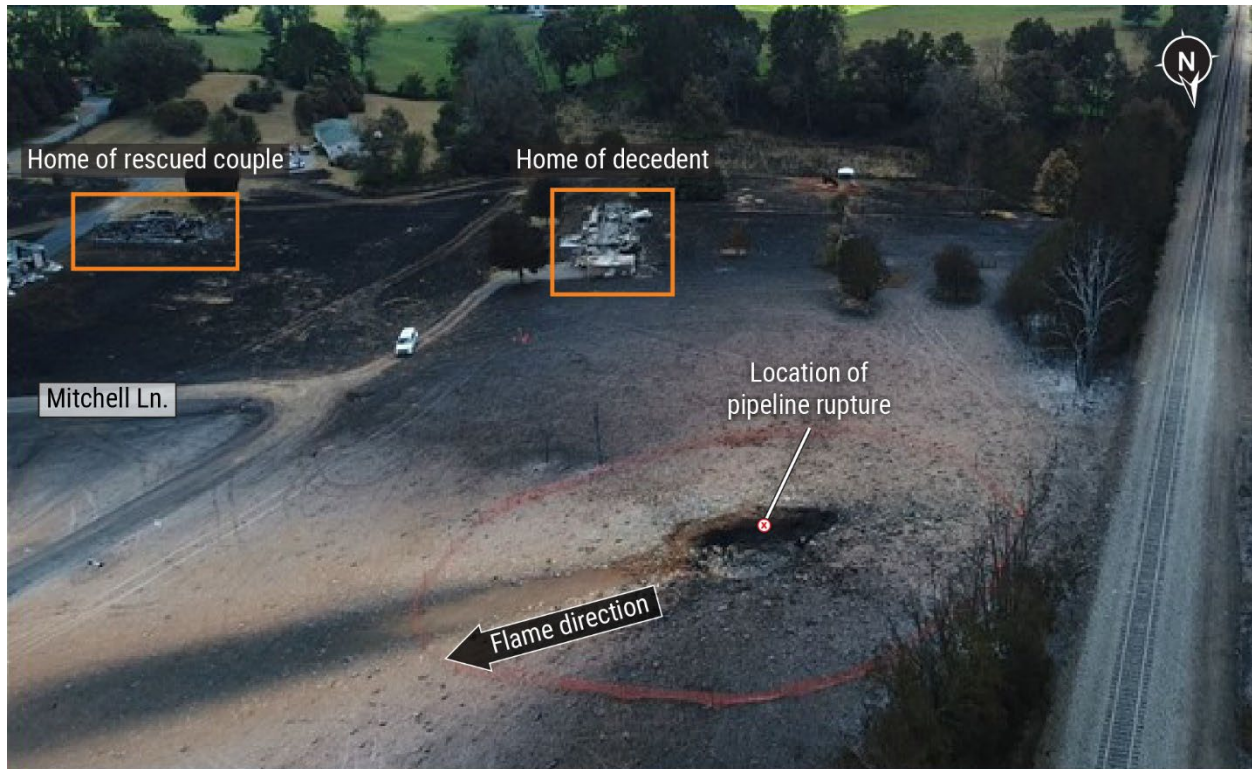
Figure 3. Homes of decedent and rescued couple, rupture location, and gas flame direction.

The home of the deceased was located about 310 feet south of the rupture location. The deceased individual was about 640 feet south of the natural gas fire when she was found by the deputy sheriff.

Five residences were destroyed by resulting structure fires. Fourteen other residences suffered property damage to various degrees; some were 1,100 feet from the rupture crater. The gas flame direction, as shown by the darkened area of soil indicated with a black arrow in figure 3, was oriented along a true bearing of about 80°, or just north of due east. This flame direction was consistent with the direction of the pipeline at the rupture location.

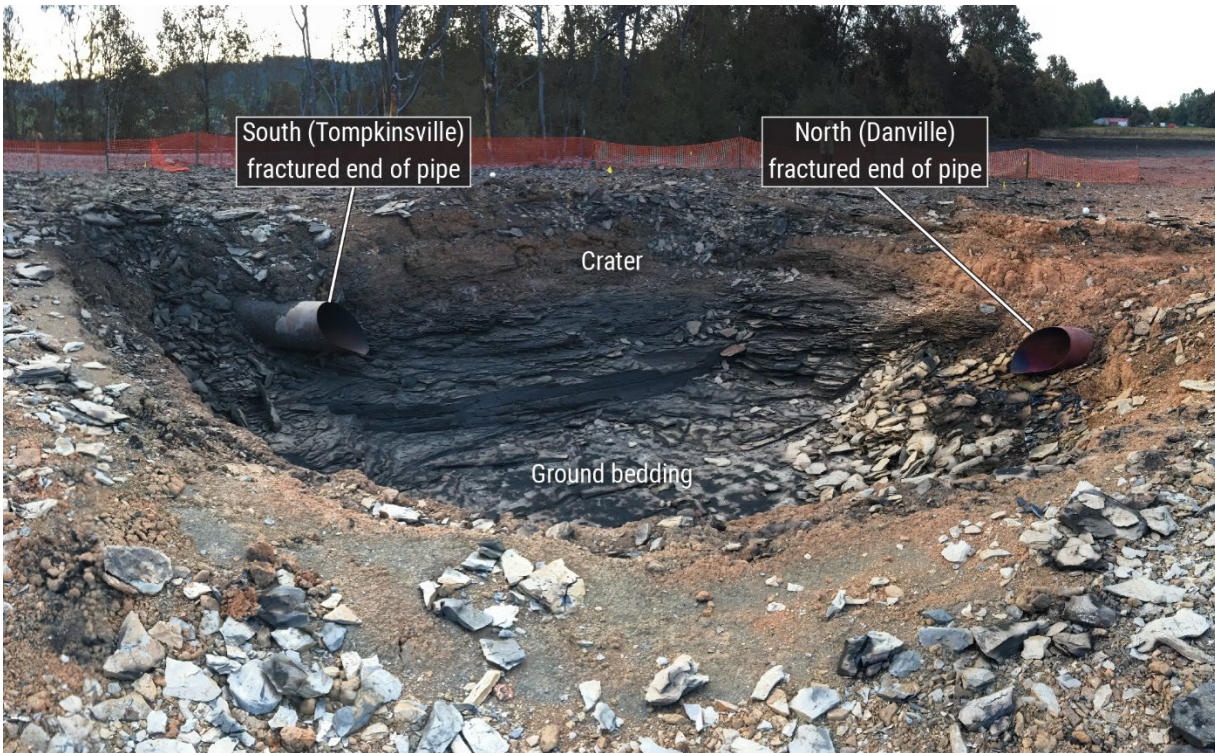
Figure 4. Crater and ground bedding at rupture site.

A crater was located in the area of the rupture; the crater and ground bedding under the pipe consisted of soil and broken pieces of shale. (See figure 4.)

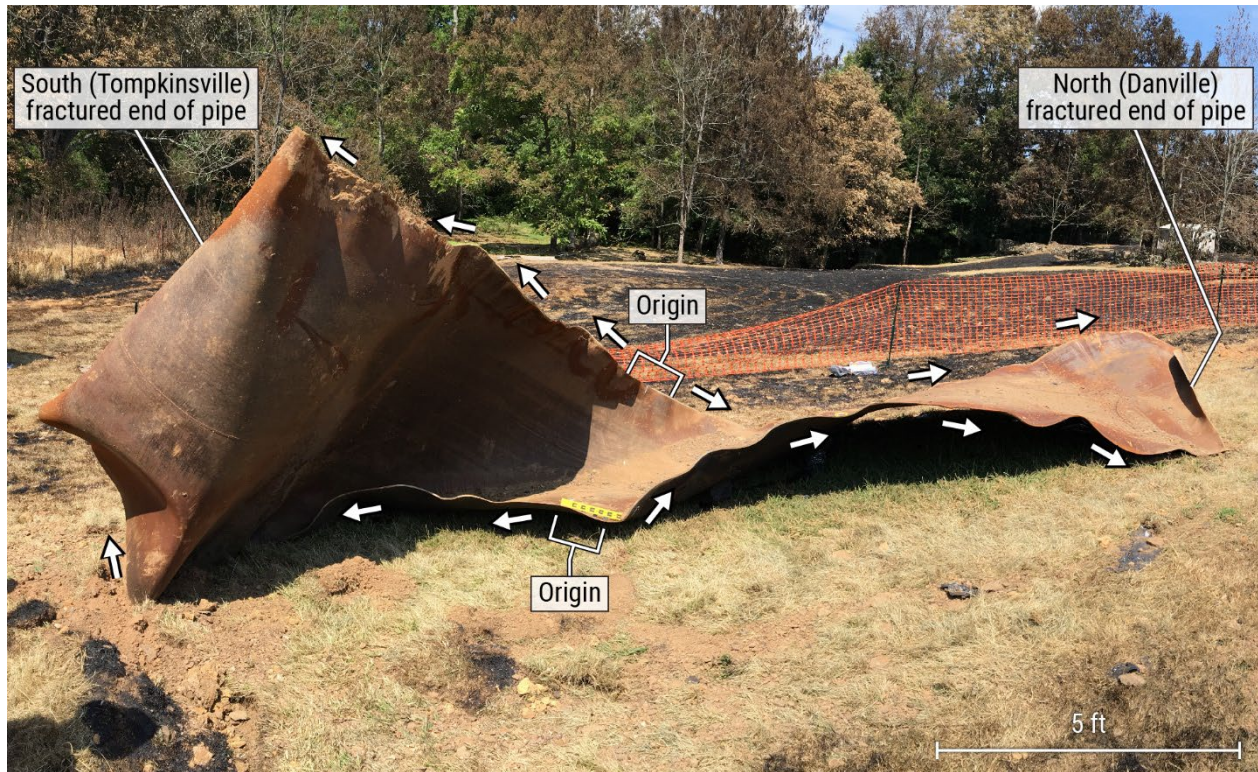
Figure 5. Ejected pipeline segment.

The NTSB's on-scene examination of the ejected pipeline segment revealed that most of the external coal tar coating was consumed by fire, leaving large regions of the external pipe surface bare. The fracture face of the ejected segment exhibited chevron fracture features, helping investigators locate the origin of the fracture.⁹ Figure 5 shows the origin of the fracture as indicated by the brackets; the arrows indicate the general direction of fracture propagation.

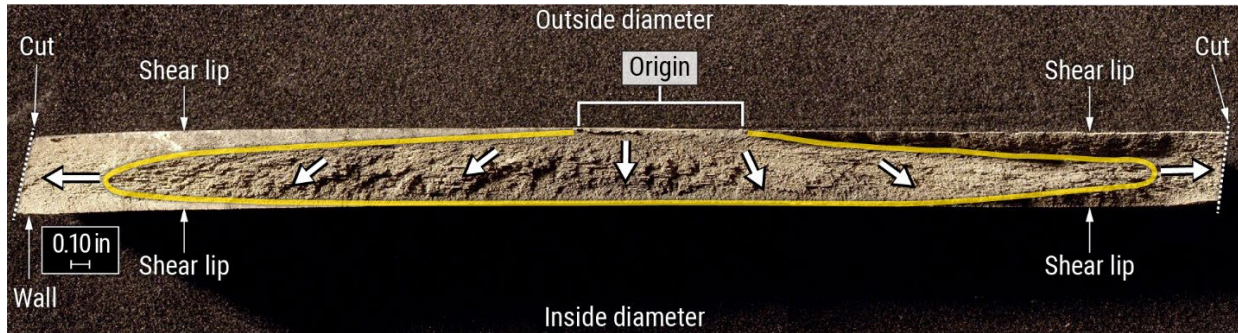
Figure 6. East face of the fracture origin.

The NTSB Materials Laboratory examination of the fracture faces from the ejected pipe revealed that the fracture originated at the outer surface, as indicated in figure 6. The origin of the fracture and an area extending below it contained a flat region with a rough texture, shown enclosed by a yellow line. Fracture propagation was in the general direction indicated by the arrows.¹⁰ The origin of the fracture showed no evidence of a gouge or dent and did not originate from a weld. The length of the origin at the outer surface measured about 0.8 inches, and shear lips extended from both ends.¹¹ The fracture face at the inner surface (opposite the

fracture origin) contained a minor shear lip, indicating the fracture did not start at the inner surface of the pipe. The fracture areas located outside of the north and south ends of the flat region were on a slant plane and contained a chevron pattern, consistent with overstress separation.

A detailed scanning electron microscope examination of the fracture face revealed that the origin exhibited intergranular fracture features, which came from localized embrittlement caused by exposure to hydrogen.¹² The amount of intergranular fracture features decreased toward the inner surface of the pipe.

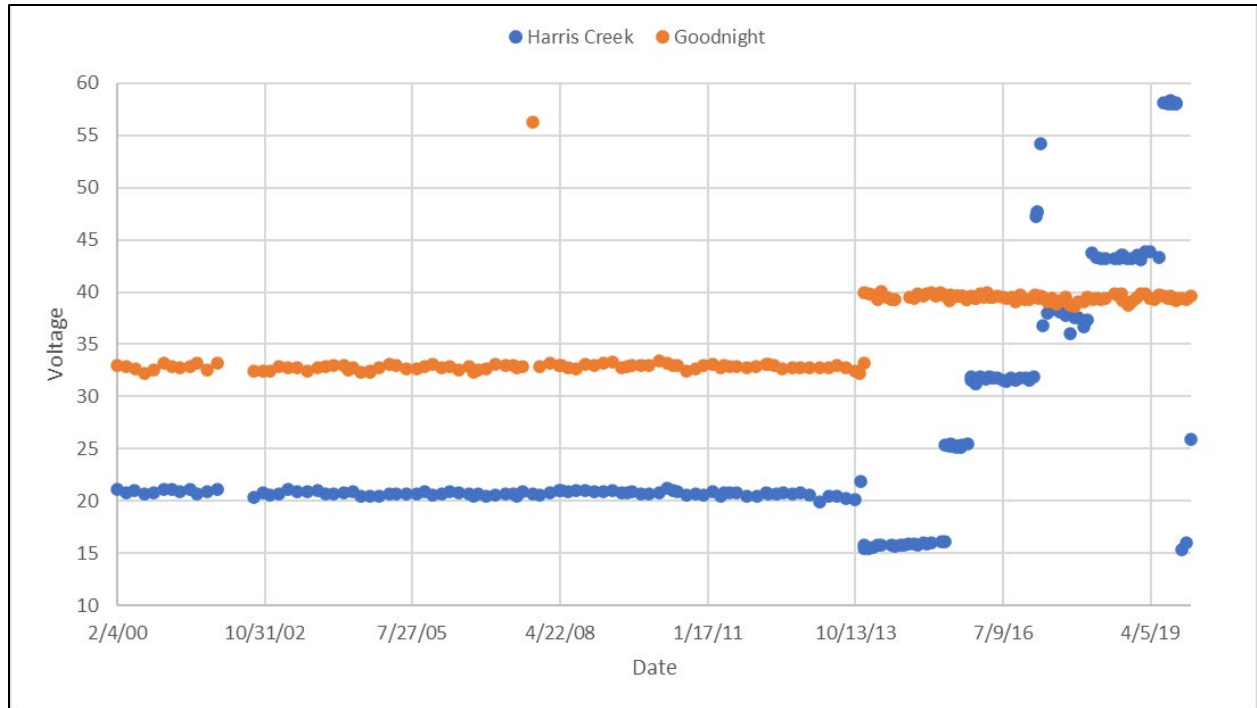
Figure 9. Voltage outputs at Goodnight and Harris Creek rectifiers.

Investigators examined 10 years of maintenance activities related to cathodic protection at Goodnight and Harris Creek. In 2017 and 2019, the output from the Harris Creek rectifier was increased to address dropping potential readings.²⁸ These dropping potentials began in early 2014 after the flow reversal project was completed. Before the flow reversal, cathodic protection voltages were regular and consistent; after the flow reversal, technicians were unable to stabilize readings; at Harris Creek, voltages were increased by 18 percent, and the voltages at Goodnight increased by 58 percent. (See figure 9.) The plot in figure 9 shows the steady potentials up to 2013; after that, they became unstable. In 2018, a new anode was installed at Harris Creek, but it did not successfully raise potentials.

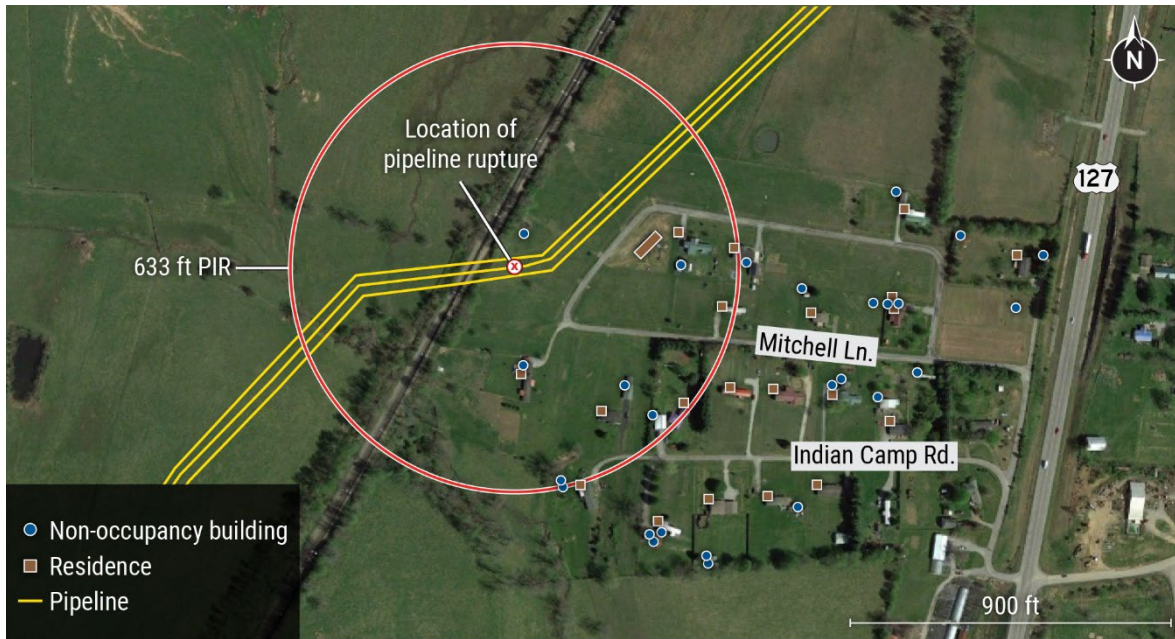
Figure 11. Human-occupancy buildings within the potential impact radius. (Courtesy of Enbridge.)

On the date of the accident, PHMSA’s gas transmission integrity rule applied only to pipeline segments located in HCAs. As such, Enbridge was not required to implement any of the regulations in 49 *CFR* Part 192 Subpart O for the area containing the rupture site, including management of change, risk assessments, or integrity assessments. However, Enbridge voluntarily included pipeline segments that fell outside of HCAs in its integrity management program; these sections were called assessment segments. The rupture site was located within a non-HCA assessment segment known as Line 15 Valve Section 4 (L15 VS4). L15 VS4 extends from milepost 408.5 to milepost 427.5, which is all of Line 15 between the Highway 49 valve station and the Danville CS.
