Atmos Energy Corporation Natural Gas–Fueled Explosion During Routine Maintenance

Farmersville, Texas
June 28, 2021

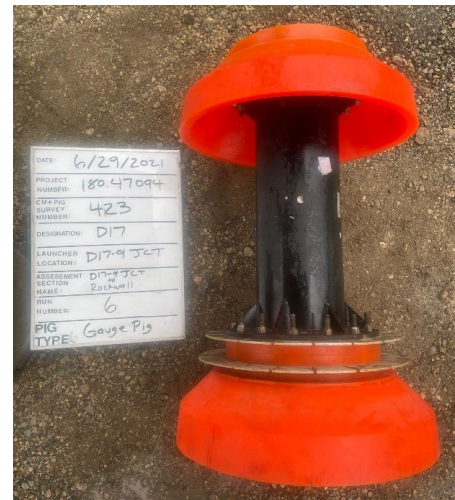
Figure 1. Pig before the explosion. (Courtesy of Bobcat Contracting.)

Atmos.³ The explosion occurred while the workers were removing the pig insertion tool during the sixth of a series of in-line inspections.⁴ The explosion was directed through the open launcher door, ejecting the pig from the launcher, injuring two of the workers and killing two more. At the time of the accident, the weather was 75°F with light to heavy rain showers. No cloud-to-ground lightning strikes were reported within 15 miles of the accident site. Atmos estimated property damage at the site to be about \$580,000.

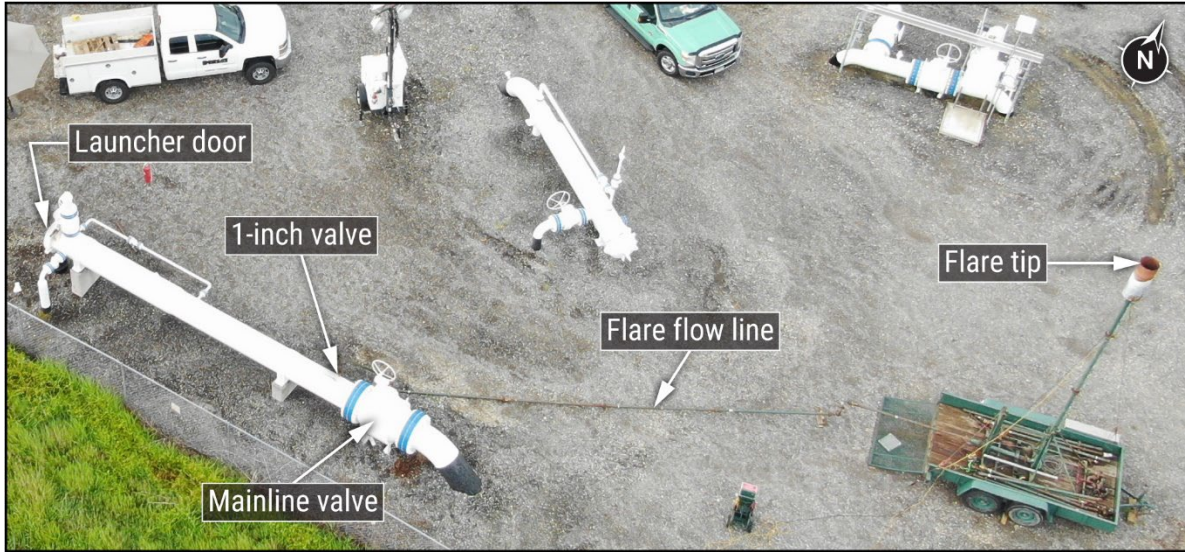
Figure 2. Accident site. (Courtesy of Wylie Fire Department.)

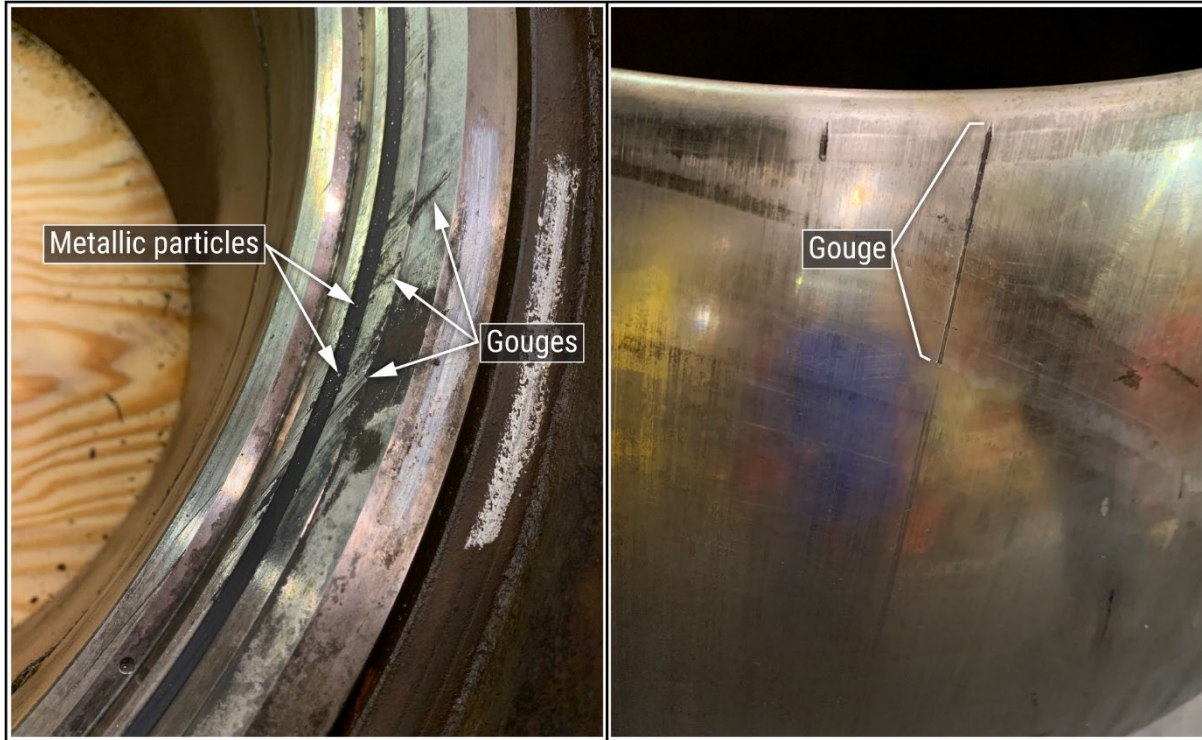
Investigators tested and examined the mainline valve, which was a 24-inch-diameter side-entry ball valve. Pressure testing revealed that the mainline valve was leaking, and examinations found that its sealing surfaces were scratched and gouged. (See figure 3.) This damage created leak paths along the sealing surfaces. The damage was consistent with foreign debris (such as metallic particles) entering the valve from an external source, and the scratches' and gouges' orientations were consistent with wear incurred during normal valve operation. The mainline valve seals were adequately lubricated at the time of the explosion and no abnormal wear was reported. No issues were found with the materials or the process for manufacturing the valve.

Figure 3. Damaged mainline valve sealing surfaces visible after disassembly into ring (left) and ball (right) components.

Opening the launcher door did allow natural gas to vent to atmosphere, decreasing the concentration within the launcher. However, the mainline valve was leaking, which allowed additional natural gas to enter the launcher while workers were loading the pig. After the pig was loaded into the launcher, the pig obstructed the pipe between the mainline valve and launcher door. This obstruction and the leaking mainline valve caused natural gas concentrations between the pig and mainline valve to rise to an explosive concentration. The workers were not using any means of detecting or measuring gas that could have alerted them to the hazardous condition. The gas ignited, causing an explosion.

The National Transportation Safety Board determines that the probable cause of the June 28, 2021, explosion was a leaking mainline valve that allowed natural gas to enter the launcher where it mixed with air, creating a flammable gas-air mixture that was ignited by an undetermined source. Contributing to the explosion and its severity were Atmos Energy Corporation's procedures and training practices that did not prepare workers to recognize and safely respond to abnormal operating conditions.

Atmos suspended all pigging operations on in-service pipelines immediately following the accident and initiated a review of its related processes and procedures. Atmos revised their pigging procedure, established a new covered task for pigging operations, and developed associated training. The revised procedure standardizes launcher designs, requiring additional ports for venting, pressure gauge measurements, and gas monitoring; a grounding lug; and double block and bleed valving for valves that connect launchers to their natural gas transmission system.¹⁸ The revised procedure also requires a site-specific valve sequencing plan, job safety analyses, oversight by a third-party inspector, purging natural gas from the launcher with nitrogen, mandatory stabilization periods, criteria for stopping work if pressure and gas concentration levels rise beyond a defined threshold, and delineation of hazard zones in proximity to launchers and receivers. Additional specifications for on-site tools and grounding requirements were also included to further reduce the risk of inadvertent ignition.

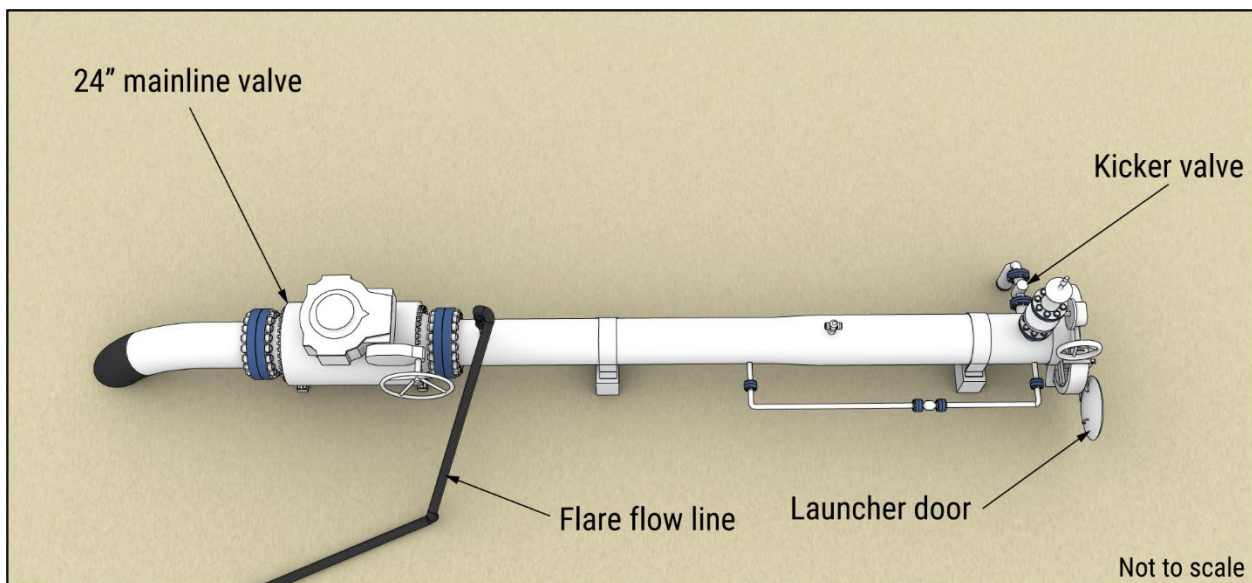
Figure 4. Diagram of pig launcher.

Insertion of the pig was modeled as a complete blockage within the launcher barrel.¹⁶ When the pig fully obstructs the launcher barrel, the *equalizer piping* (a valved pipe that allows equalization of pressure within the launcher on both sides of the pig) is the only way for gas to move between the launcher barrel sections on either side of the pig. (See figure 4.) Modeling that included the leak from the mainline valve showed that once the blockage was introduced, the concentration of natural gas in the launcher between the pig and open launcher door would have decreased while the concentration between the pig and mainline valve would have increased.
