PARTY RESPONSE TO LINE 15 PIPELINE EXPLOSION AND FIRE

Operator: Enbridge Inc./Texas Eastern Transmission, LP

Location: Danville, KY

NTSB No.: PLD19FR002

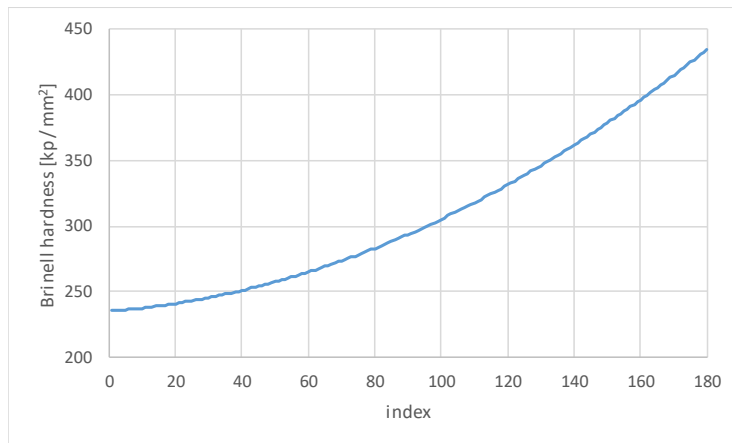
Figure 2 Calibration curve used for calculating the Brinell hardness of a hard spot.

The basic shape of the NDT S&S calibration curve was fixed and comprised 180 values ranging from a Brinell hardness of 235.5 to a Brinell hardness of 434.5. The system could not report values lower than 235.5 Brinell and could not report values higher than 434.5 Brinell.

Data analysts, such as those who reviewed the Line 15 data, would visually identify indications in the MFL data but did not have the ability to control the software's assessment of the hardness value. The hardness value was provided by the system's algorithm and recorded by the analyst in the report provided to the client. The NDT S&S specification sheet and marketing documentation stated the reported hardness value had a +/- 50 BHN tolerance. The tolerance was based on the historical performance of the curve when compared to field and initial testing results completed by NDT S&S. Unlike the NDT S&S MFL data algorithm used to identify metal loss, the hard spot algorithm did not have a software check that reviewed the data identified or

selected by the analyst. Any data identified or selected by the analyst, even an area with no apparent hard spot, would be given a Brinell Hardness value between 235.5 and 434.5.

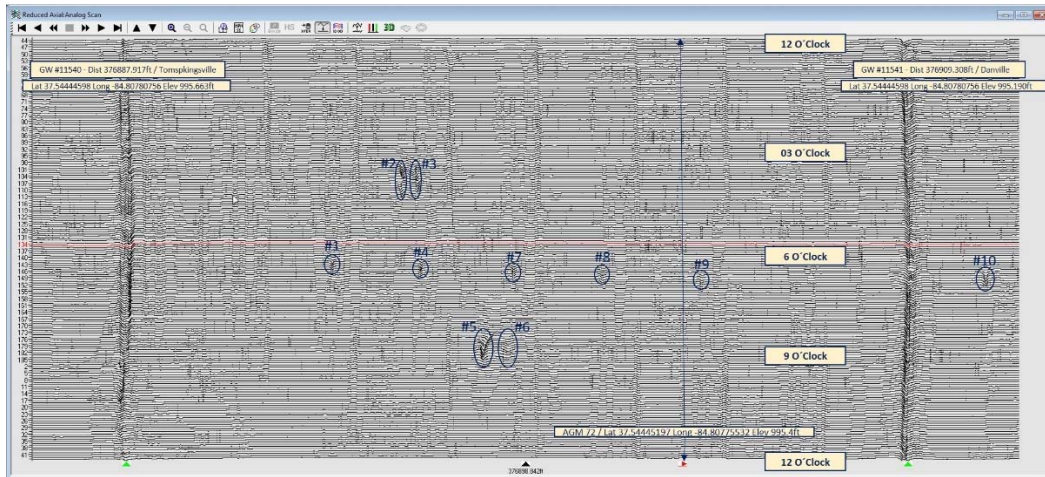
Figure 1 Analog Reduced axial scan of the failed joint on Line 15.

As part of the re-analysis, NDT Global provided an expedited initial review of the 2011 inspection data for the failed joint to the on-site investigation team. The data analyst highlighted nine hard

spot indications within the failed joint. A similar set of information using the high contrast view is included in the Factual Reports as provided by NDT Global. The view below in Figure 4, however, is the typical view used by data analysts for the inspection review.

Indication "4," reviewed in detail within the Mears report in Appendix 5, was indicated by NDT Global at a hardness value of 236 BHN. The NTSB Metallurgical Factual Report showed no evidence of an elevated hardness reading in this area. The indication "4" was reported at regular spacing, and within the same general "clock" orientation, as four other hard spots in the failed joint (#1, #7, #8, #9). An additional indication (#10) is at the same apparent "clock" position and has a similar reported hardness value, 238 BHN.

NDT Global found that 235.5 BHN is the lowest evaluation value the NDT S&S ILI software system could report within the embedded calibration algorithm. Six of the 10 indications identified in the 2019 NDT Global review were reported at 236 BHN, or the lowest value allowed by the software.

hardness was proximate to the hard spot indication #2 and #3 reported by NDT Global in the expedited report and later in the re-analysis report. The indications #2 and #3 were reported to have an elevated hardness of 245 and 241 BHN respectively. Neither indications from the inspection in 2011 matched the reported hardness in the NTSB metallurgical review. It is unclear from the NDT Global review of the technology, the inspection data, and the information in the Metallurgical report why the hardness values collected by the NDT S&S MFL inspection system did not match the post-incident results. The NDT S&S technology was Industry leading at the time of the inspection in 2011. Enbridge was ahead of the industry in evaluating pipeline systems for hard spot threats through the application of this technology. As with all inspection technology, the NDT S&S MFL inspection tool had limitations related to the several metallurgical factors and the system's Probability of Detection.

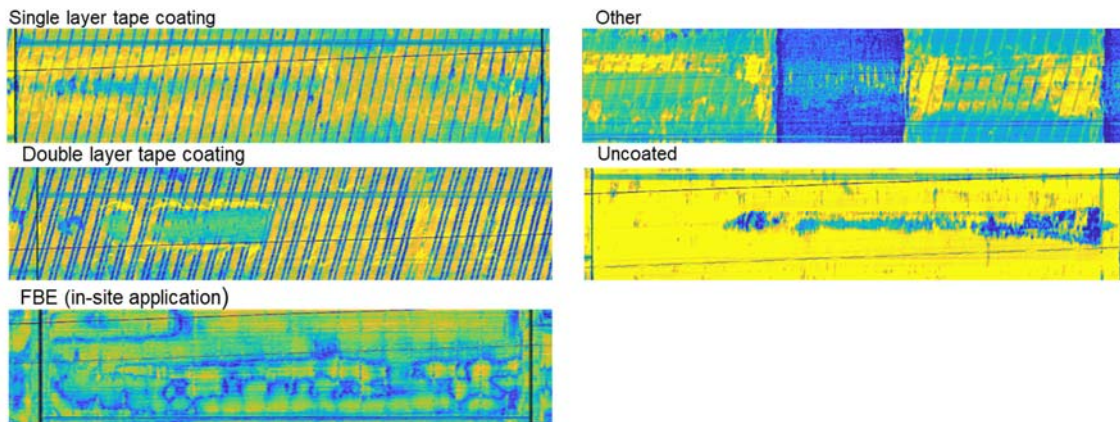
Figure 4 Coating Disbondment

Detection of indications of coating disbondment relies on identifying change in the signal attenuation compared to the adjacent area. The relative difference in the tail energy values will depend largely on the external interface, which in turn is affected by the acoustic impedance of the two materials. Whenever there is an energy difference exclusively in the tail energy plot, it is due to coating disbondment or a change in the coating, e.g., a double coating layer.

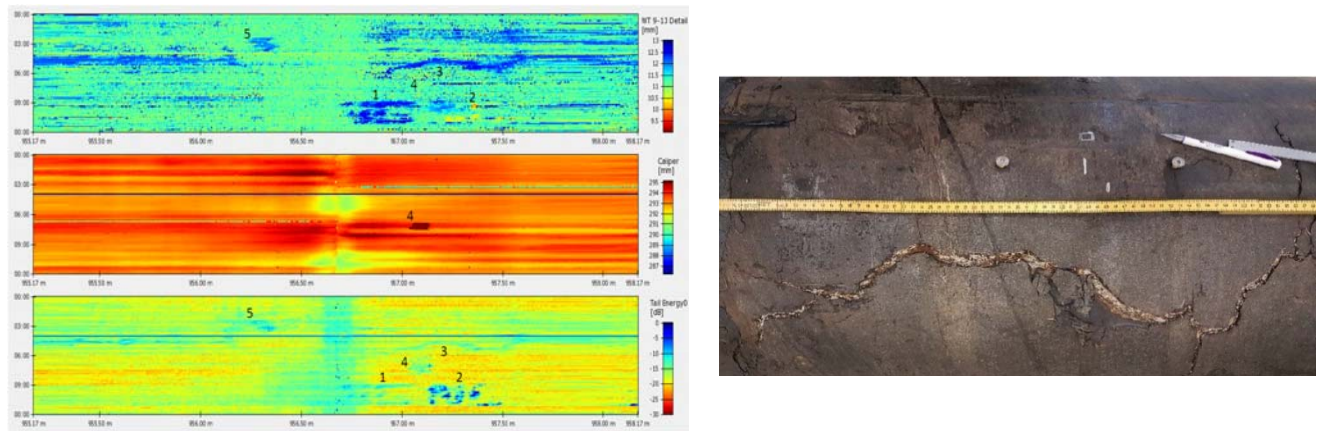
Figure 5 Results from Coating Disbondment Testing

To illustrate the effectiveness of this technique, NDT Global conducted performance testing on a 24" pipe (WT 11.9 mm) with cracked and disbonded coal tar coating. This coating is similar to the coating found on Line 15. The test yields wall thickness measurements and highlights areas

1. Represents nominal wall thickness with no coating (residual coating on steel).
2. Metal loss with no coating
3. Natural cracked coating
4. Internal metal loss feature
5. Hidden feature. No visual on anomaly.
