# PRELIMINARY REPORT

### Enbridge Inc. Natural Gas Pipeline Rupture and Fire

Hillsboro, Kentucky  
May 4, 2020  
PLD20LR001

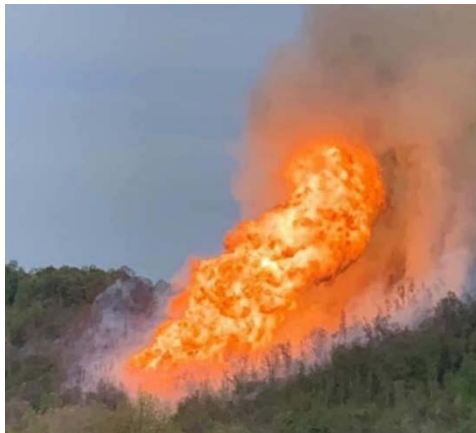
On May 4, 2020, at 4:36 p.m. local time, a 30-inch-diameter natural gas transmission pipeline owned and operated by Enbridge Inc. (Enbridge) ruptured near Hillsboro, Kentucky. The resulting fire burned vegetation over 5 acres of heavily forested land. (See figure.) There were no injuries, fatalities, or evacuations. About 148 million cubic feet of natural gas was released during the rupture and resulting emergency response blowdown.<sup>1</sup> A parallel pipeline in the same right-of-way ruptured at a location about 100 miles away in Danville, Kentucky, on August 1, 2019. In that 2019 accident, one person died and five nearby residents were injured when a rupture released natural gas and ignited. Preliminary information indicates the two events are not related. The 2019 accident is also being investigated by the National Transportation Safety Board (NTSB).<sup>2</sup>

**Figure 1.** Postrupture fire. (Photo courtesy of Kentucky Public Service Commission.)
