**Supplemental Submission of
UGI Utilities, Inc.**

National Transportation Safety Board

West Reading, Pennsylvania

Investigation No. PLD23LR002

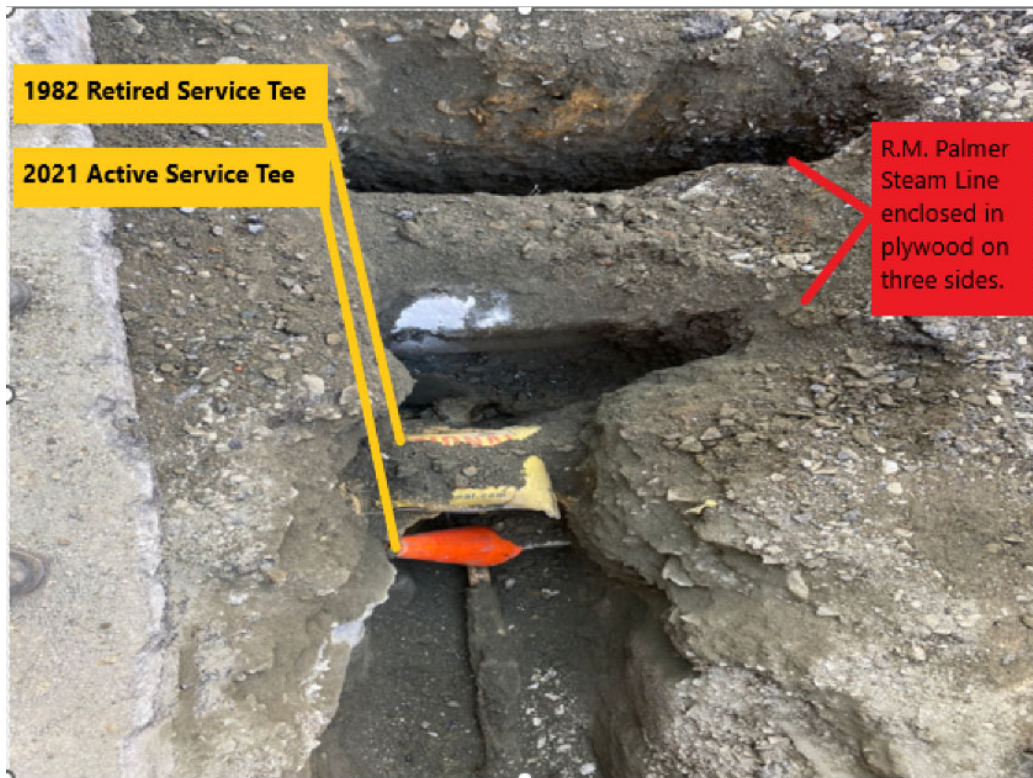
During the post-incident field investigation, the participants did not observe any indication of excavation damage or pre-existing damage around the east side of the steam enclosure, which was the side facing the 2021 excavation work. The plywood box encasing Palmer-owned assets and the white powder backfill around the steam line was found to be intact (Figure 2). Additionally, the new service line was installed farther away from the steam line than the retired tee, thus increasing the distance from the steam line to the new service.⁹ UGI’s Mechanic IIA recalled centering his excavation over the 1982 service line to Building 2, he also recalled a statement from a Palmer employee that the steam line was on the western edge of the excavation

facing North toward Building 2.¹⁰ When installing the new service tee for Building 2, Mechanic IIA also recalled moving the service tee farther away from the steam line to the eastern side of the excavation downstream of the 1982 Aldyl A service tee.¹¹ This narrative aligned with the layout of the assets when exposed during field investigations.

Figure 1: April 24, 2023, Excavation of R.M. Palmer Steam Line, facing West (Courtesy of PA PUC Image 2393)
