Preliminary Report: PLD23LR002

# UGI Corporation Natural Gas-Fueled Explosion and Fire

West Reading, Pennsylvania

March 24, 2023

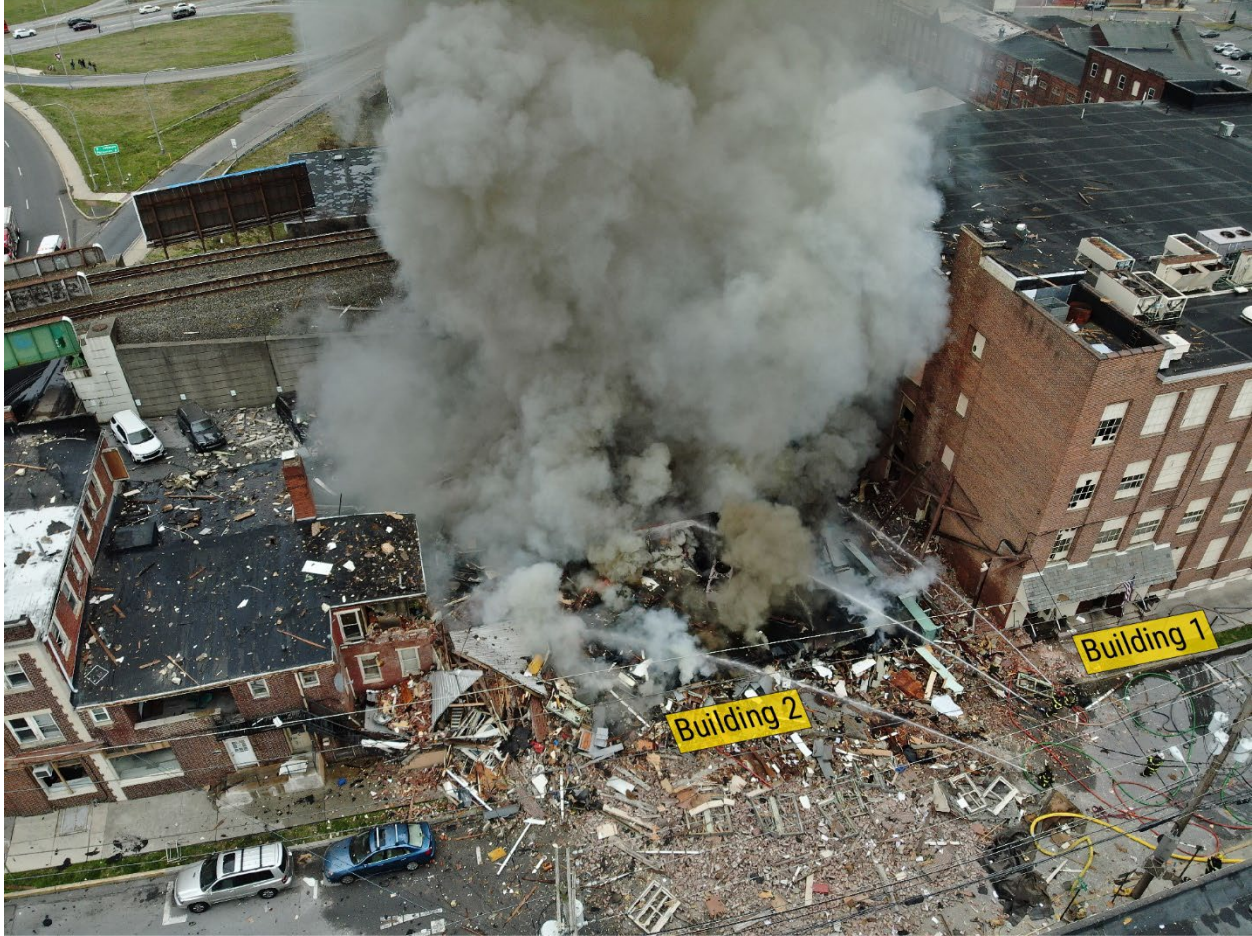
On March 24, 2023, about 4:55 p.m. local time, a natural gas-fueled explosion and fire occurred at Building 2 of the R. M. Palmer Company (Palmer) in West Reading, Pennsylvania. The explosion destroyed Building 2 and caused significant structural damage to the adjacent Building 1 and other surrounding structures. (See figure.) Seven people were killed, 11 people were injured, 3 families were displaced from a neighboring apartment building, and many more people were evacuated from the area. Visibility conditions at the time of the accident were clear with no precipitation, the temperature was 51.8°F, and winds were about 4.6 mph. Damage costs are currently unknown.

**Figure.** Overhead image of the accident. (Source: Western Berks Fire Department.)
