Preliminary Service Report

MAN PrimeServ

PRESIDENT EISENHOWER
APL Maritime Ltd.

Vessel:	PRESIDENT EISENHOWER	IMO no	9295220
Engine type:	12K98MC-C	Run. hours:	93400
Engine builder:	HYUNDA	Engine no.:	AA2024
Newbuilding yard:	Hyundai Heavy Industries Co. Ltd. (HHI) Engine Customer Service Dep't	Hull no.:	1584
Job order no.:	D.2802111	Sea trial:	2005-09-30
Spare parts from MAN:		Spare order no.:	
Place:	Long Beach		
Visit by:	H. Due		
Period:	2021-04-30 – 2021-05-03		
Owner/manager:	APL Maritime Lte.		
Requested by, P/O no.:			
Reason:	Inspection of main engine due to engine room fire

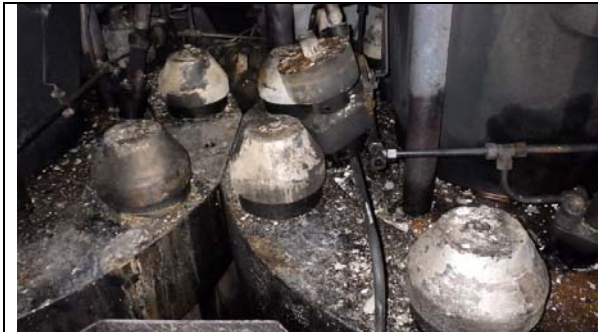
The reason for the return pipe to get pulled out of the cutting ring fitting was likely due to incorrect assembly in way of insufficient tightening of the union nut or steel ferrule not mounted correctly, i.e. the pipe was not fully inserted through the steel ferrule at tightening.

Return pipe for fuel valves disconnected/pulled out of fitting.

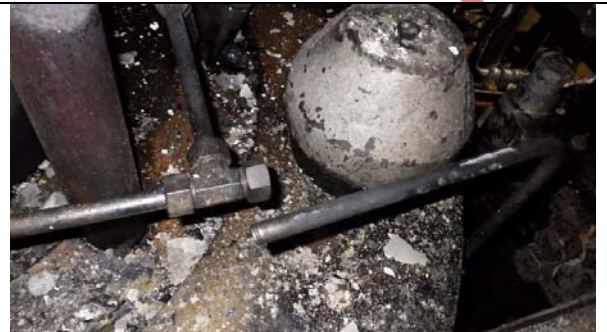
Return pipe for fuel valves disconnected/pulled out of fitting

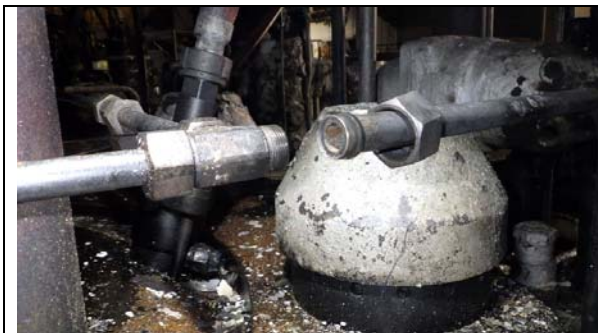
Ferrule not mounted correctly. (Ferrule and union nut mounted on pipe for example of explanation)

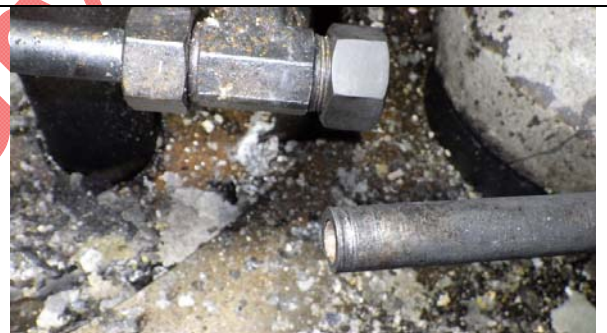
Pipe end pulled out of fitting

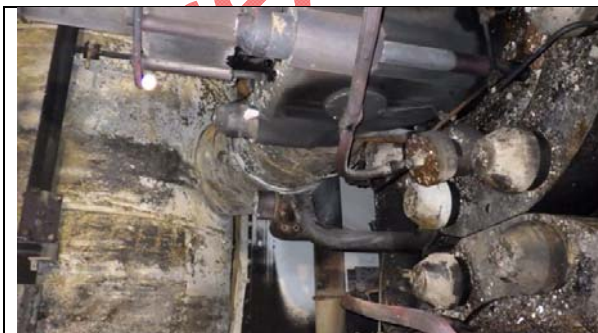
Fuel return pipe spraying on start air valve, exhaust gas receiver, exhaust valve compensator.

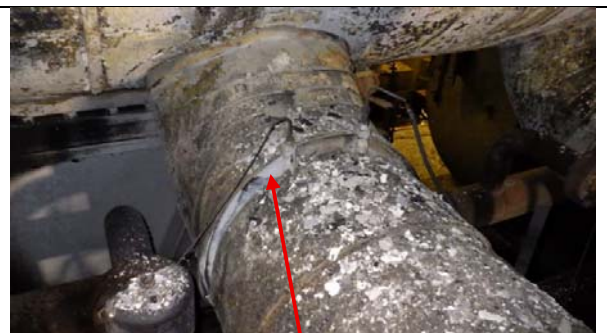
According to saved CCTV recordings, it was observed that the fuel leak started on top of cylinder cover #5 and was spraying fuel oil (gas oil) onto the exhaust valve compensator area where the gas oil it caught fire on the hot exposed compensator flange.

Exposed compensator flange where the fuel oil/gas oil caught fire.

All surfaces with temperatures above 220°C has to be properly insulated.

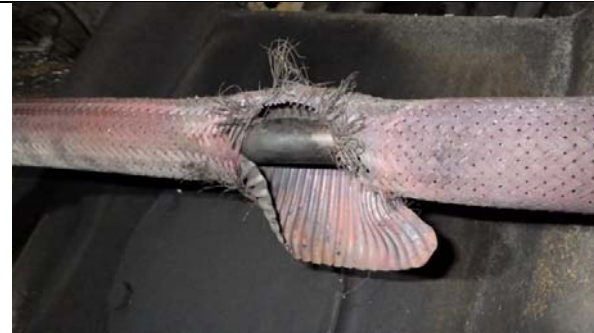
The reason for bursting of the steel protection hose on #5 fore fuel oil high pressure pipe and #6 centre fuel oil high pressure pipe have to be investigated further when dismantling of engine parts are possible and allowed by the USCG. It is unknown if the steel hose burst due to heat exposure or excessive pressure in drain passage between the high pressure pipe and the steel protection hose.

#5 fuel valve high pressure pipe "fore": Steel protective hose burst

- Dismantle complete fuel pump with roller guide for overhaul, inspection and calibration of affected parts.
- Replace fuel valve high pressure pipes.
- Replace fuel pump VIT Control components, reversing cylinder and lifting gear.

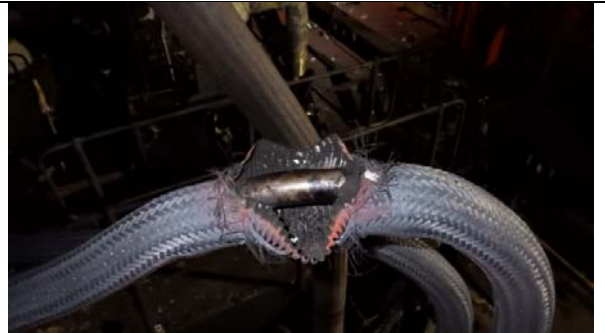
#6 fuel valve high pressure pipe "centre": Steel protective hose burst

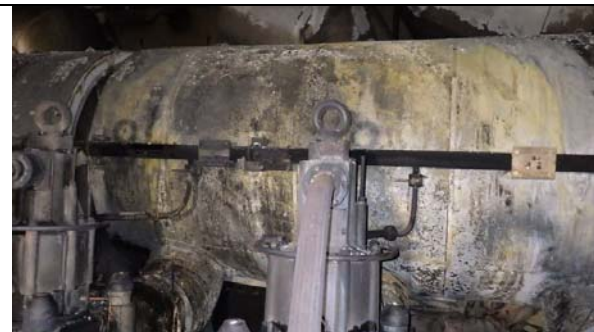
Exhaust gas receiver sheet metal and insulation damaged

- Dismantle complete cylinder unit for overhaul, inspection and calibration of affected parts, i.e. exhaust valve, cylinder cover and cylinder liner.
- Replace sheet metal and insulation on exhaust gas receiver and exhaust gas compensators.

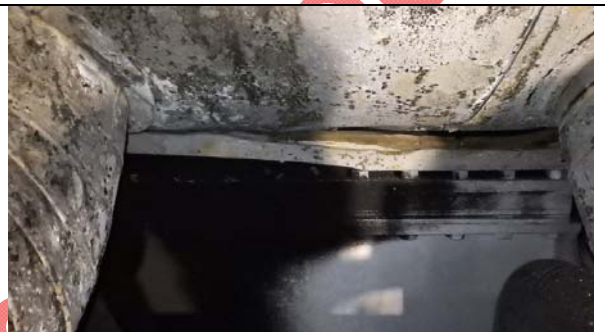
Exhaust gas receiver sheet metal and insulation damaged

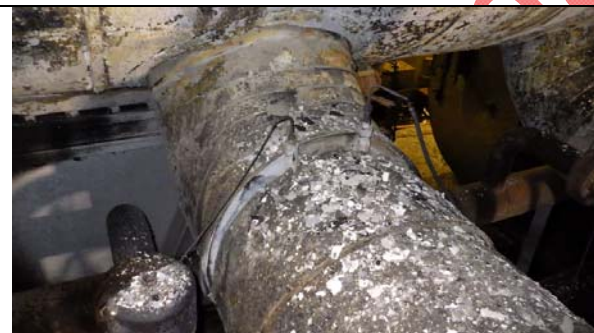
Exhaust valve compensator sheet metal and insulation damaged

- Replace gaskets for piping systems.
- Sheet metal and insulation for all 12 exhaust valve compensators has to be rectified.
- Inspection and pressure test of all remaining fuel valve high pressure pipes.

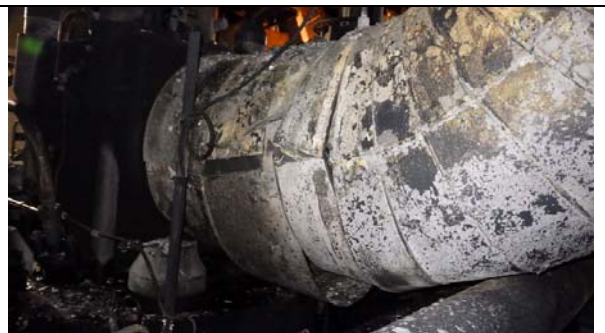
Exhaust valve compensator sheet metal and insulation damaged

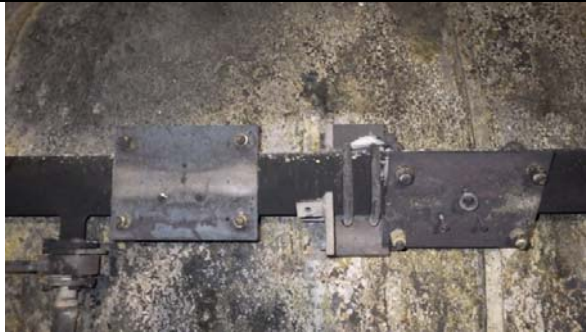
Cylinder unit monitoring instruments missing/melted

- Replace engine monitoring instruments.
- Replace electrical cabling for engine instruments and engine monitoring. Cables located at top of cylinder frame in exhaust side. Cables for the entire engine has to be replaced as they run from the fore end of engine to the aft, passing the area where fire has damaged the cabling.

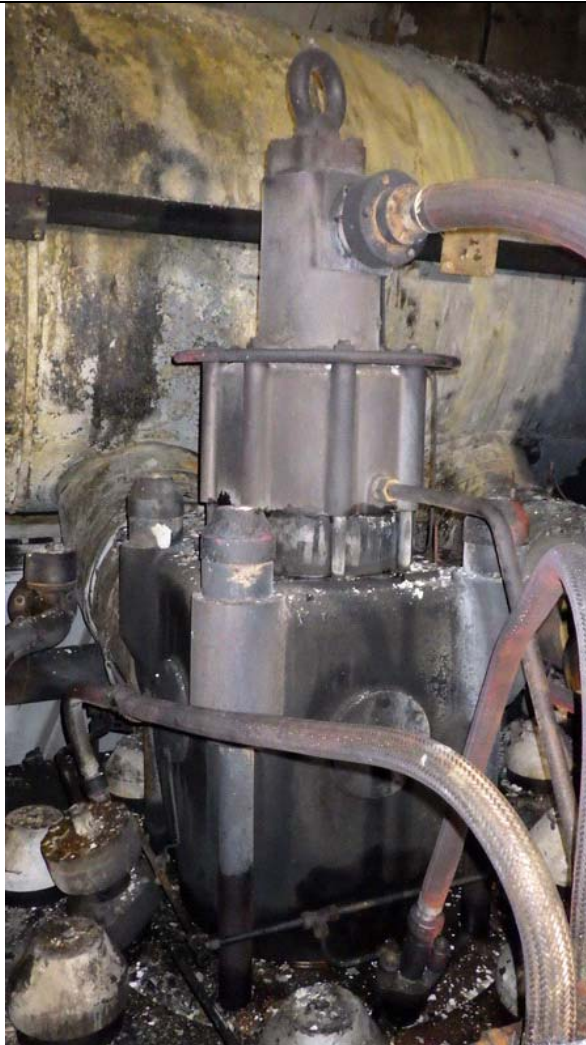
#5 cylinder unit: Exhaust valve, fuel valves, fuel valve high pressure pipes, starting air valve, cylinder cover. Condition unknown

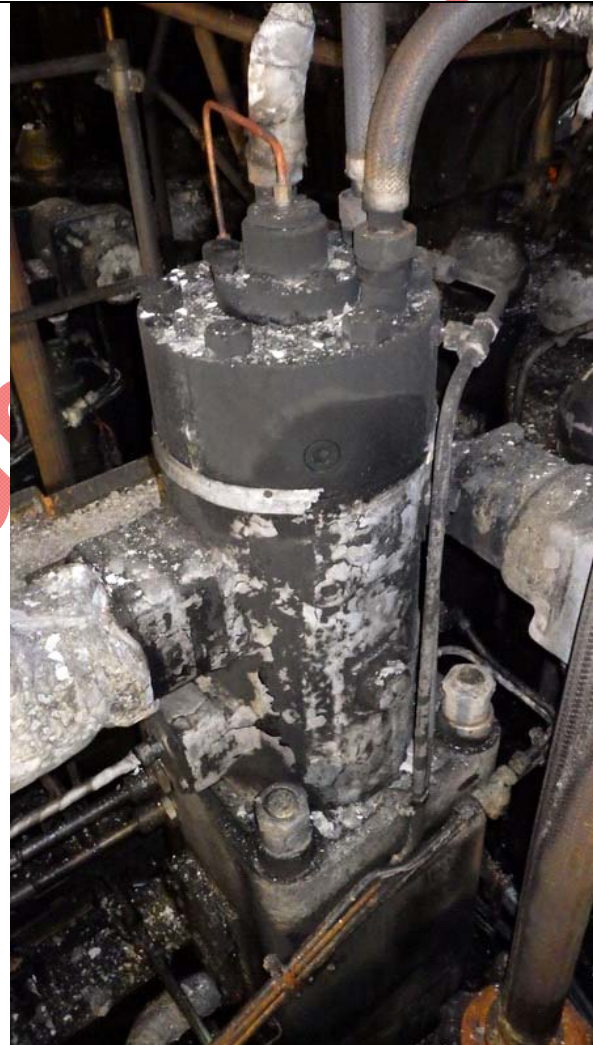
High pressure fuel pump, shock absorber, roller guide bush/housing. Condition unknown

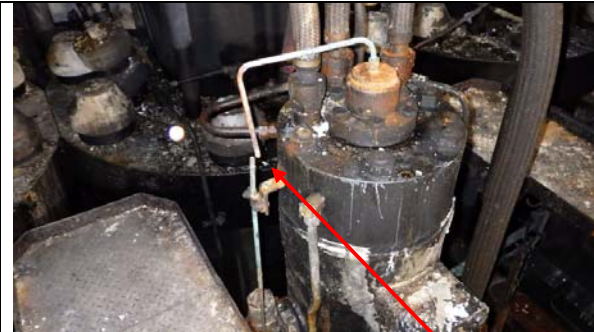
Fuel pump top cover with puncture valve.
Brass fitting, straight male coupling, for puncture valve copper tube missing (melted)

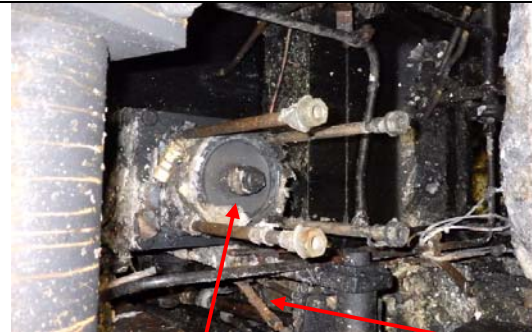
Fuel pump reversing cylinder and lifting gear cylinder (both aluminium) melted

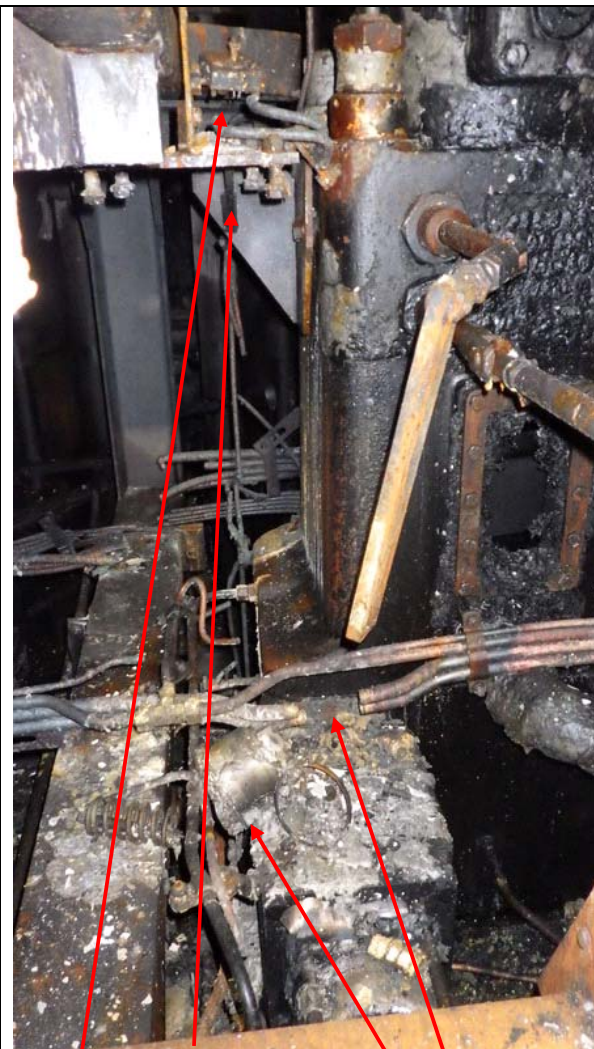
VIT Cylinder melted, remaining laying on top of housing for reversing mechanism.
Device for lifting gear controlling melted.
Copper tubing for control air sagging, brass fittings (T-pieces and straight male couplings melted)

- Replace all copper tubing, pneumatic valves and pneumatic components for control and safety air.
- Likely replace all steel pipes and steel tubes due to extreme heat exposure. Material experts should determine this.

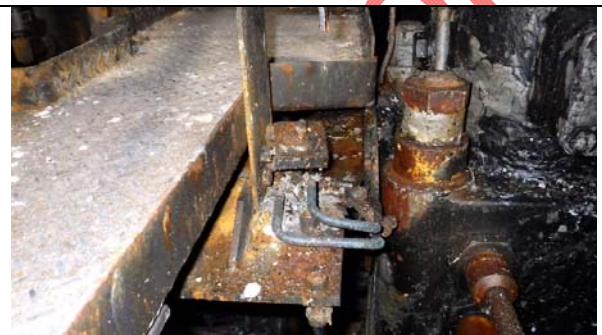
Device for lifting gear controlling melted.

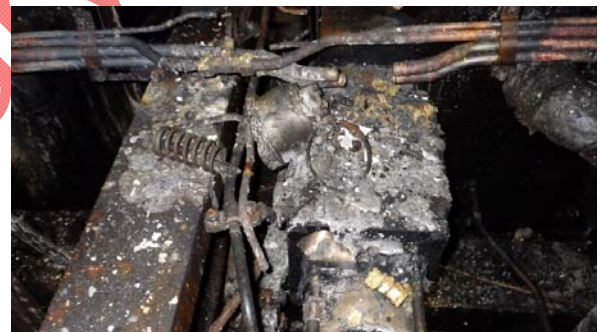
VIT Cylinder melted, remaining laying on top of housing for reversing mechanism.

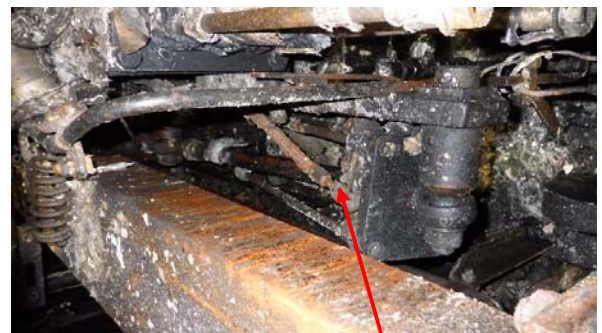
Air Cylinder for lifting gear melted

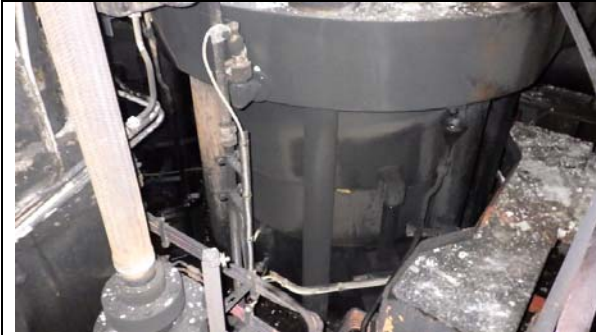
#6 Cylinder cover and cylinder liner. Condition unknown

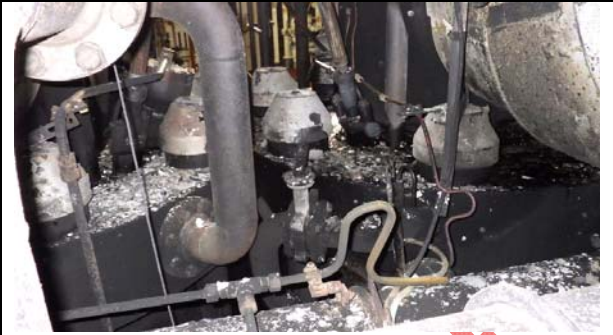
#4, #5 cylinder cover, seen from exhaust side. Condition unknown

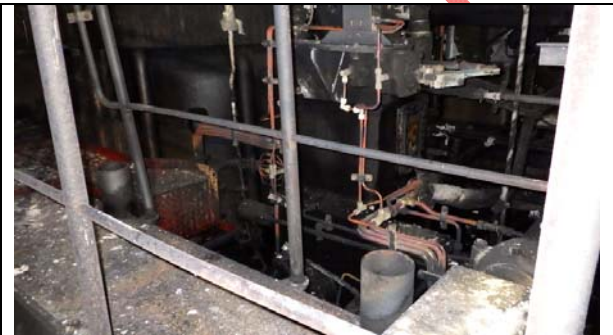
Damaged copper tubing cylinder unit #7

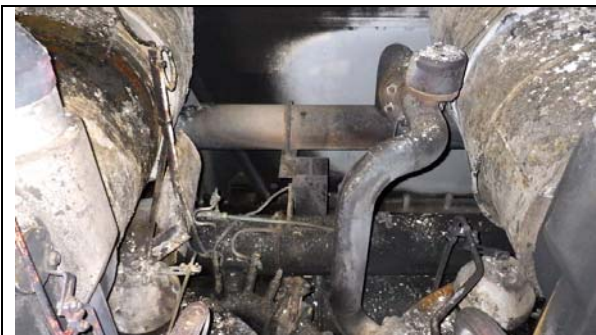
Start air pipe for start air valve and start air header pipe exposed to extreme heat

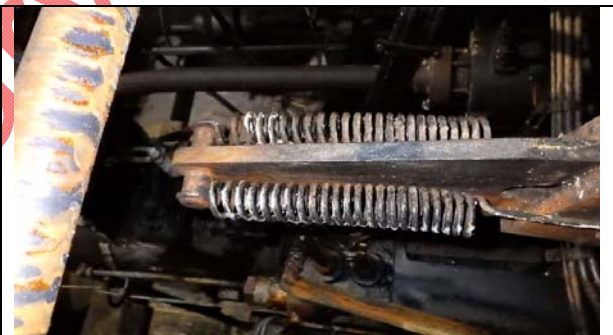
Fuel rack lever and springs exposed to extreme heat

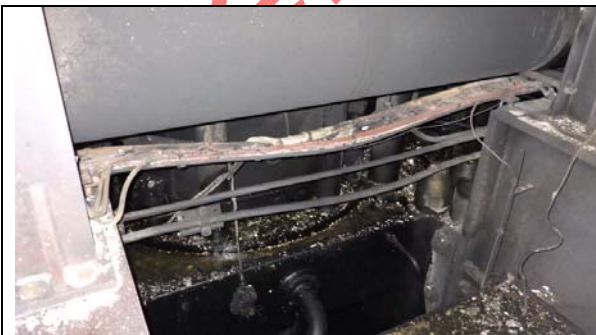
Cables and wiring on exhaust side damaged.

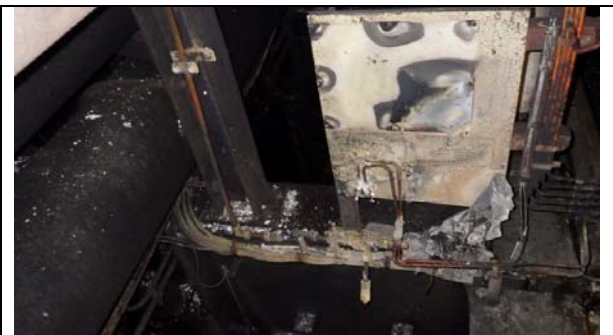
Cables and wiring on exhaust side damaged

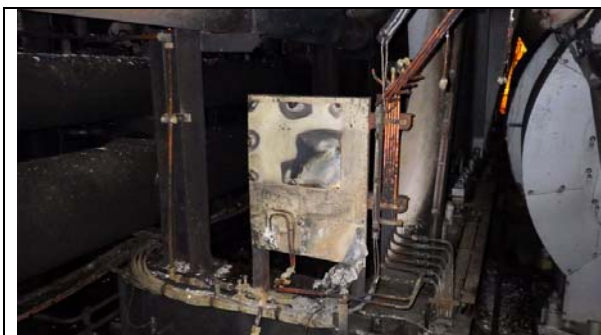
Entire control panel for turbo charger cut out missing (melted)

- To dismantle and inspect turbocharger #2 and #3, at least.
- Replace control panel, cables, copper tubing and actuators for #2 turbo charger cut out device.

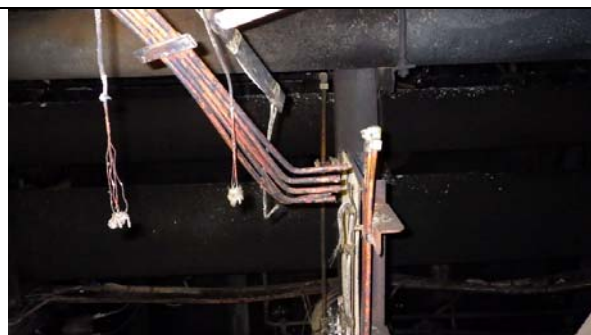
Damaged copper tubing and electrical wiring for turbo charger cut out.

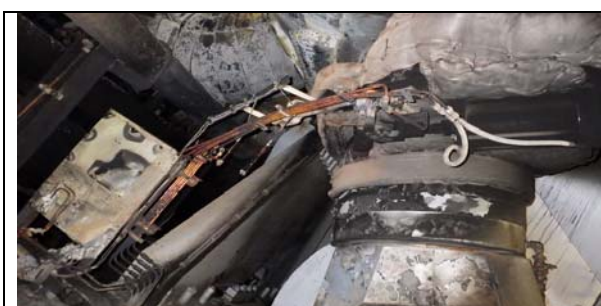
Damaged air cylinder and insulation for TCCO gas inlet. Turbocharger #2

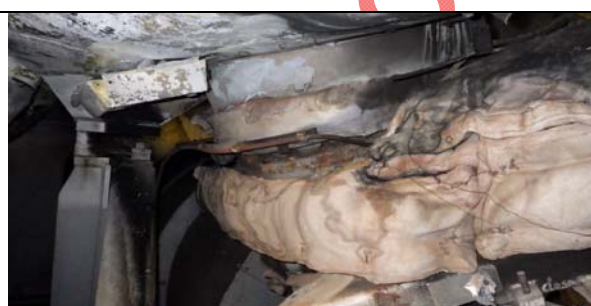
Turbocharger #2: Damaged insulation for gas inlet.

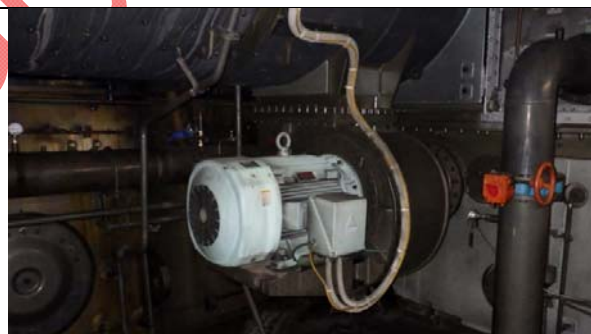
Example of electrical motors exposed to hot smoke an fumes.

- Clean and inspect condition of electrical motors and electrical components that was exposed to hot smoke and fumes.

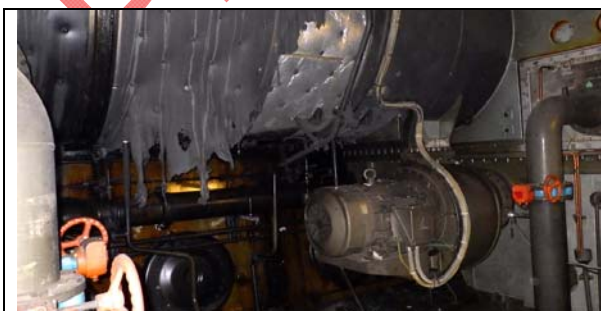
Damaged insulation for scavenge air receiver
Damaged insulation on power cables for aux. blower

- Replace insulation on scavenge air receiver between air cooler #2 and #3.
- Overhaul auxiliary blower #2
- Replace power cables for auxiliary blower #2.
- Clean and inspect external/internal condition of oil mist detectors.

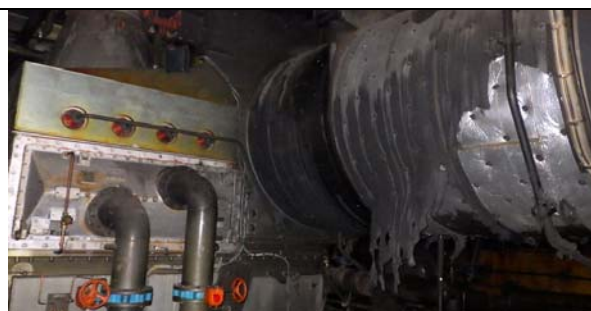
Damaged insulation for scavenge air receiver between air cooler #2 and #3

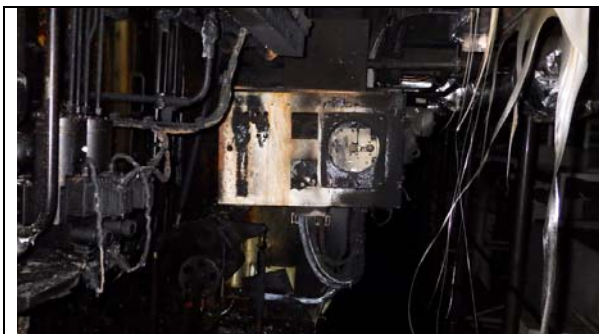
Damaged Emergency/Engine side stand and control panel instruments missing/melted

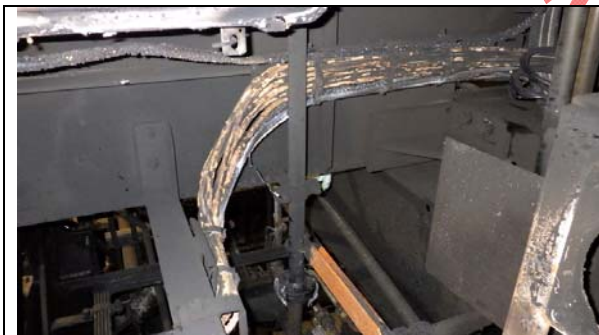
Damaged insulation on cables for engine control and monitoring.

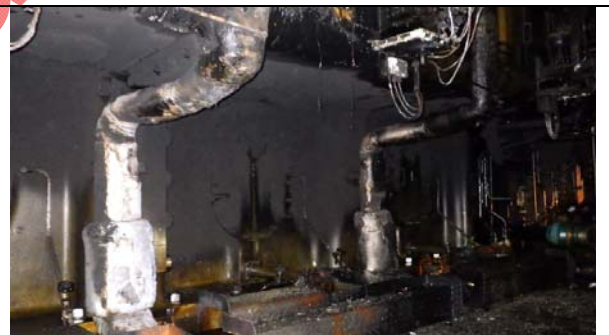
Cylinder frame cam side and underside of cam shaft housing exposed to heat from the fire. Damaged pipe insulation

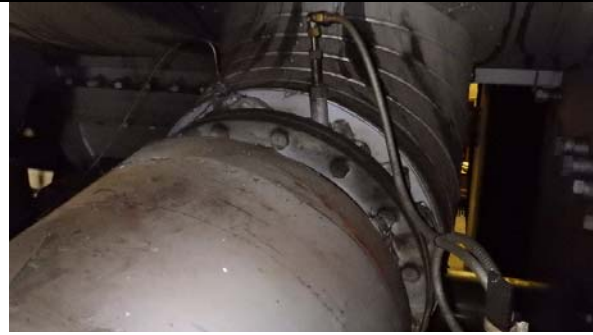
- Insulation for exhaust compensator/bellow flanges, for all cylinder units, was found insufficient and sheet metal not covering the flanges.
- As the fuel return from the high-pressure fuel pump is connected to the same pipe as the return pipe from the fuel valves, gas oil under pressure of 8 bars was led backwards in the return line feeding the fire, until the fuel supply was shut down.

Sheet metal and insulation missing for exhaust valve compensator flange, exposing hot surface

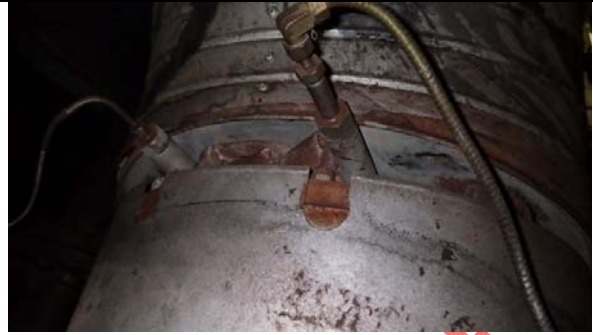
Sheet metal for exhaust valve compensator flange not seated correctly, exposing hot surface

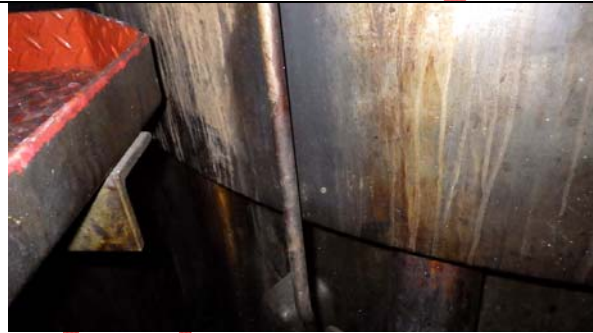
Return pipe for fuel valves incorrectly mounted, pipe hanger missing.

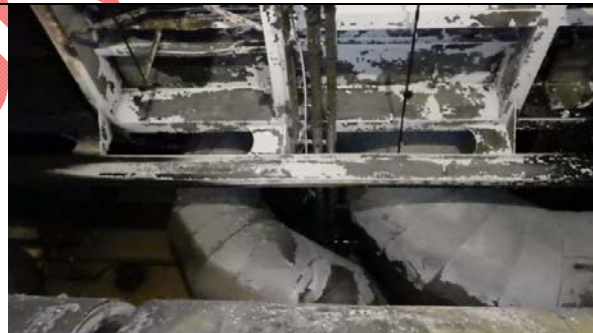
The heat from the fire damaged/deformed the starboard rail for the engine room cranes as well.

Deck above main engine and rail for engine room cranes damaged and deformed due to extreme heat exposure
