Dufour, Laskay & Strouse, Inc.

Condition & Valuation
As of
September 24, 2015

M/V "PROASSIST III"

FILE NO. 1269-03N15-7

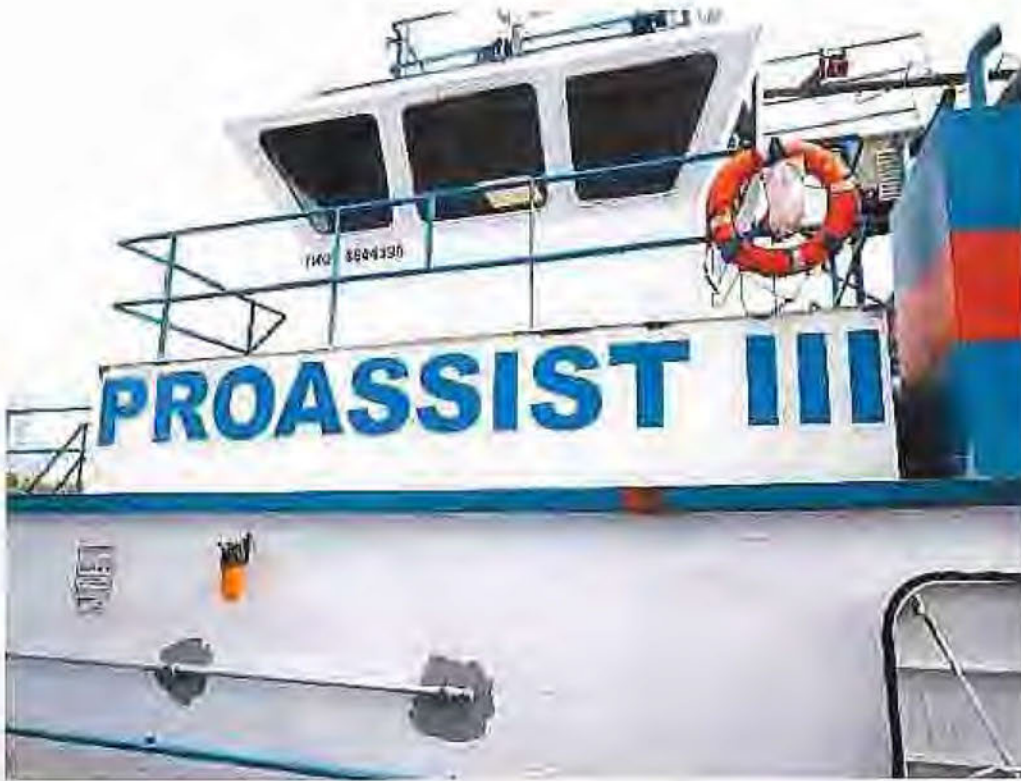
The visible hull was in generally poor to fair condition. The flat bar fender around the perimeter of the main deck was completely wasted away in several locations. Rust and scale were noted below or bleeding through poor to fair coatings. A very sharp inset was noted in way of the port hull side shell plating immediately below the main deck. The corresponding internals were located within a fuel tank and, therefore, not accessible at time of survey. From what could be viewed at time of survey, due to mooring arrangements, the undersigned could not discern the full depth and width of the inset, or if the steel was compromised in any way.

3. PORT SIDE SHELL

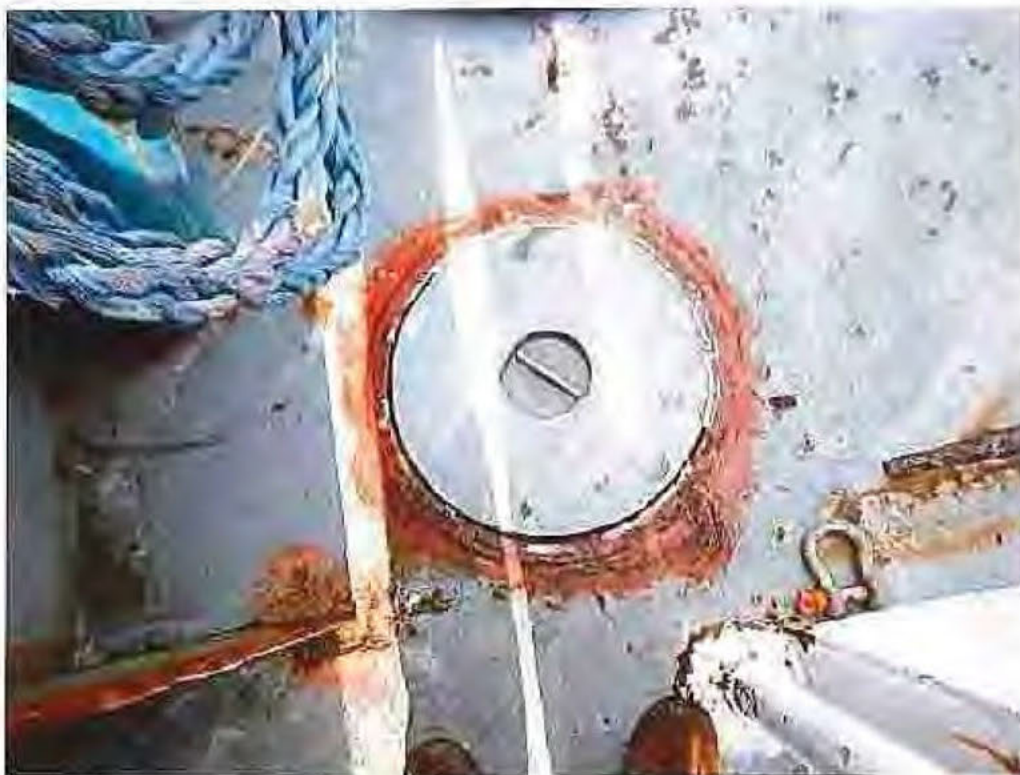
The main deck was in fair condition with fair coatings. Moderate rust and scale were noted throughout the main deck particularly around bulwark frames and hatch covers. The superstructure and upper weather decks were in very good condition with very good coatings. Newer aluminum framed windows were installed in way of the pilothouse, however, the sealant was not applied with a crowned bead, which could allow water intrusion over time. Inboard bulwark surfaces were protected with good coatings.

7. TYPICAL HATCH CONDITION

2. Adjust port side aft quick-acting watertight door to achieve complete watertight integrity
3. Renew deck hatches to achieve watertight integrity
4. Service float lights

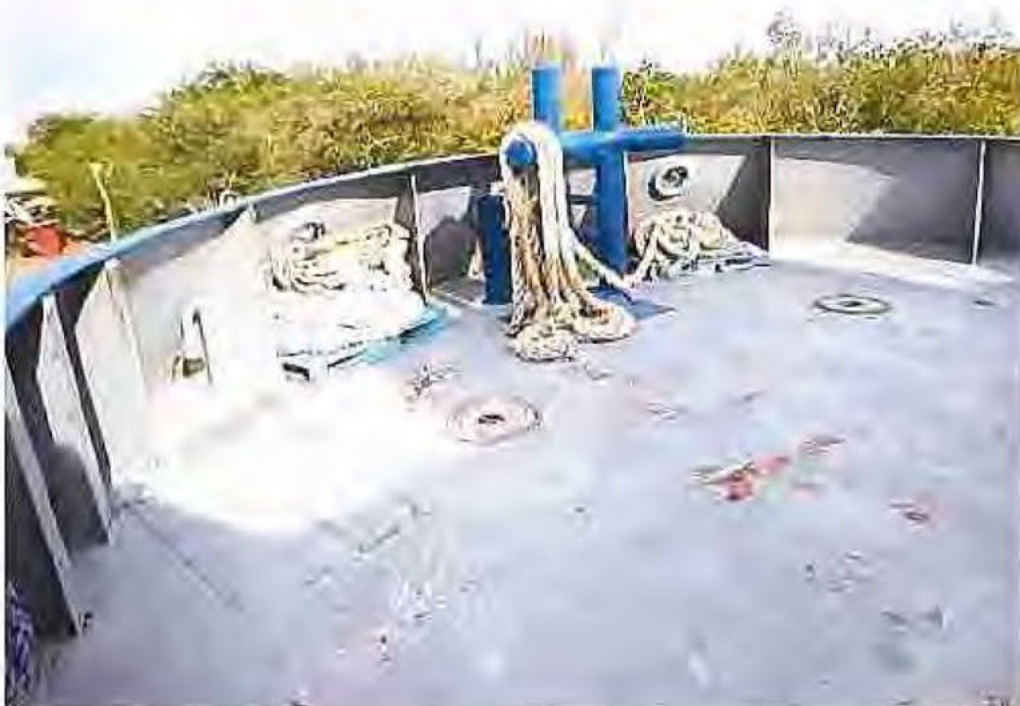
8. FORWARD DECK

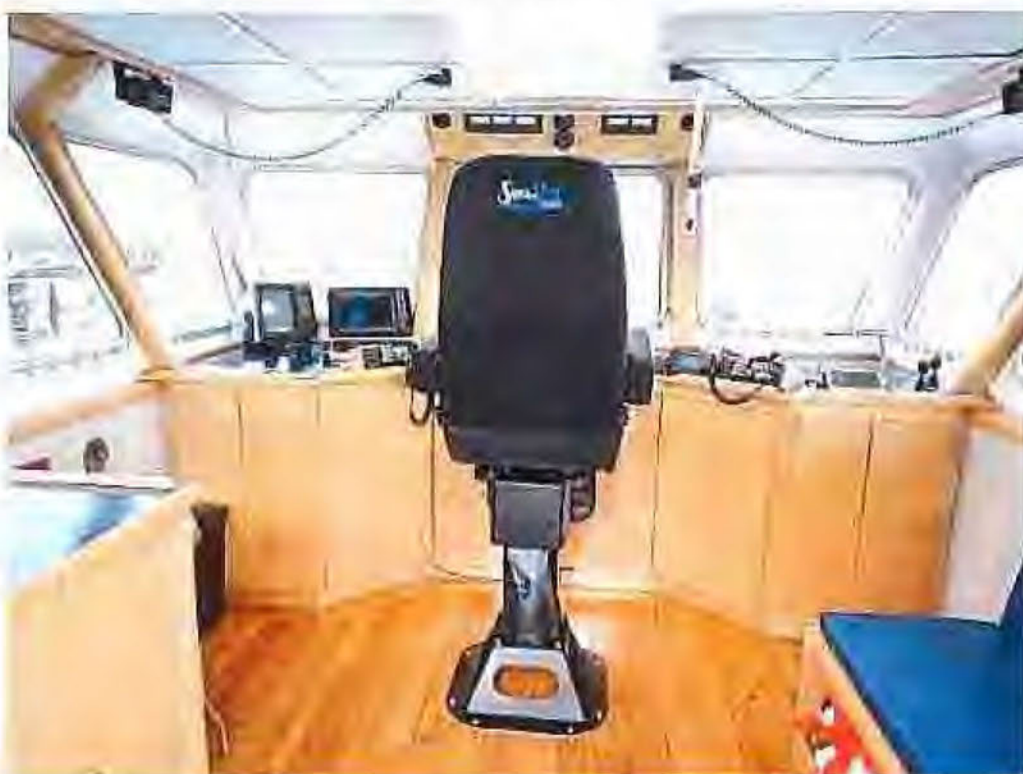
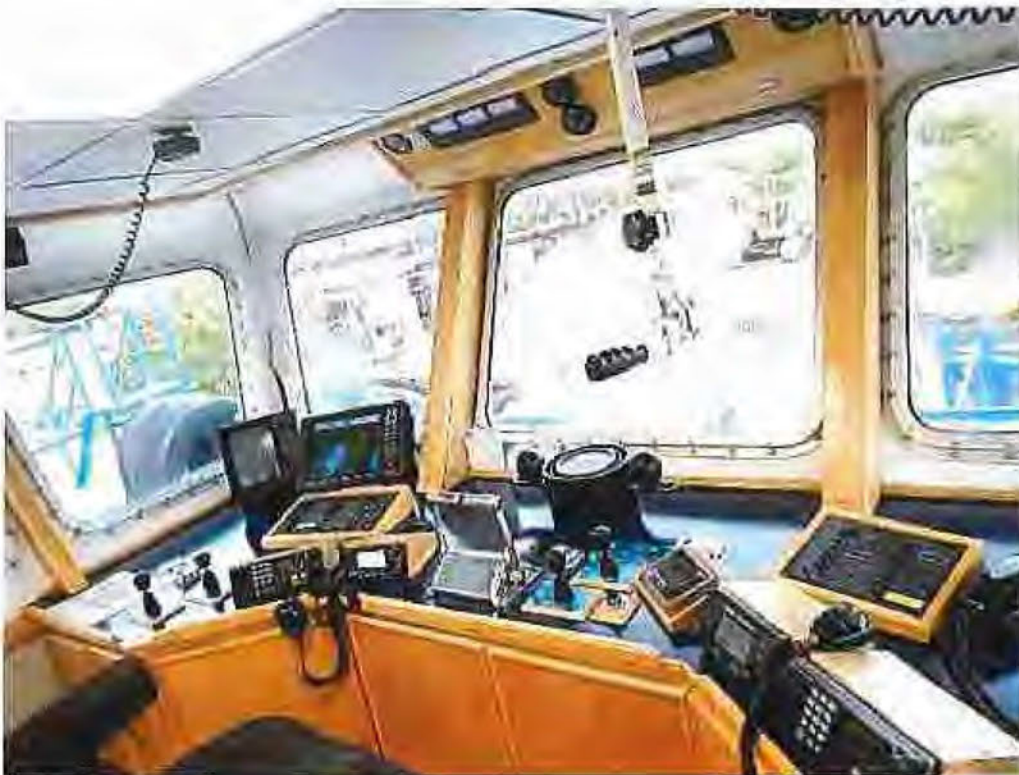
The pilothouse was found in very good condition and reportedly, was recently refurbished with high quality wood joinery and hardwood decks. The electronics were of recent manufacture and considered adequate for a vessel of this size and intended service.

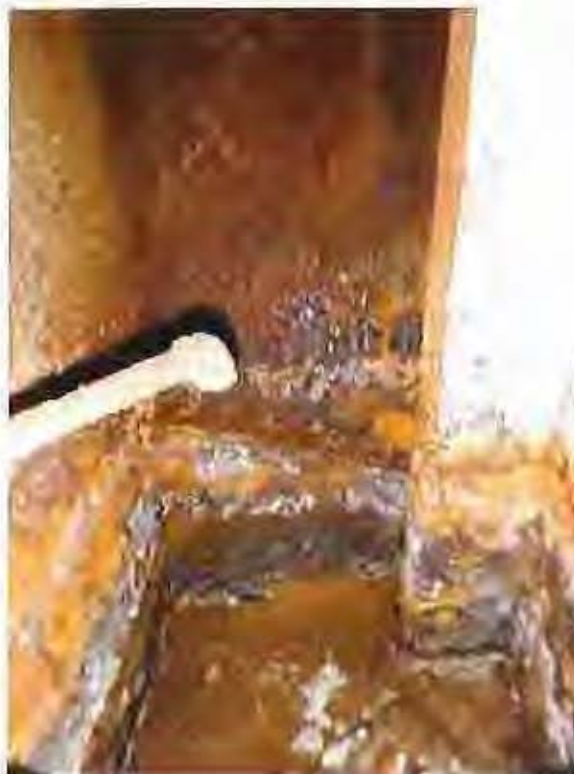
The engine room was in generally good condition. The scantlings and bottom plating in way of the engine room bilge had moderate to heavy rust, scale, and wastage in many locations. The rest of the surfaces were in good condition with good coatings. The main engines and generator engines were in generally good condition.

20. ENGINE ROOM BILGE

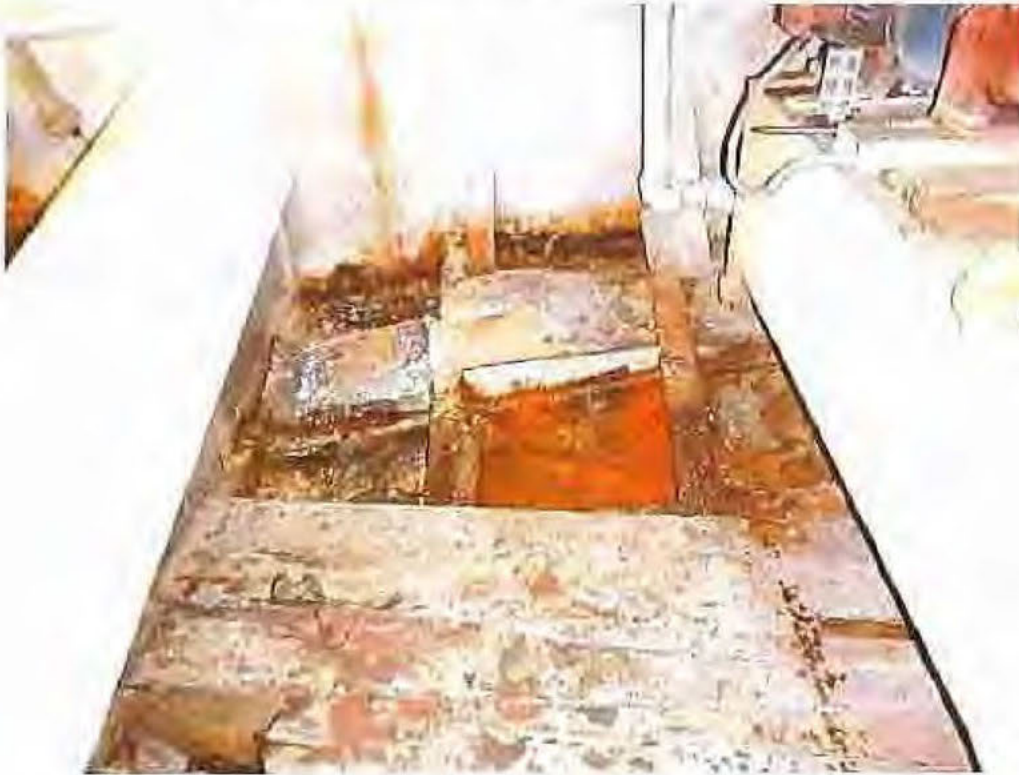
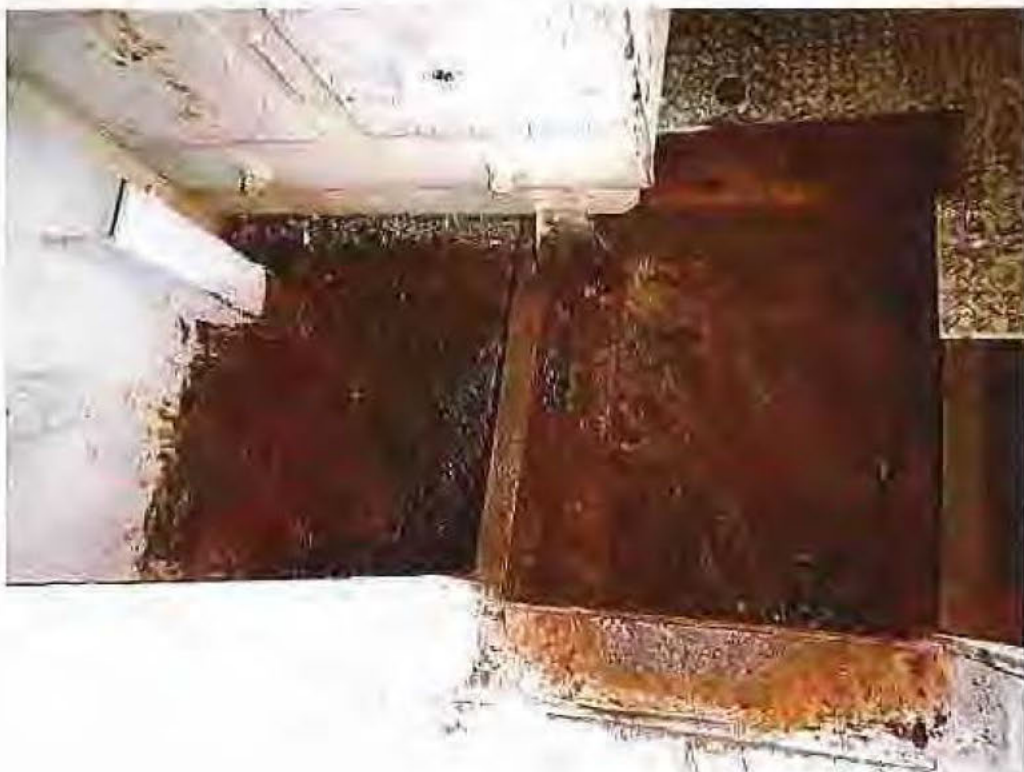
The steering system hydraulics were in generally fair condition. The lower scantlings and bottom plating in way of the steering compartment showed moderate to heavy rust and scale.

23. STEERING COMPARTMENT BILGE

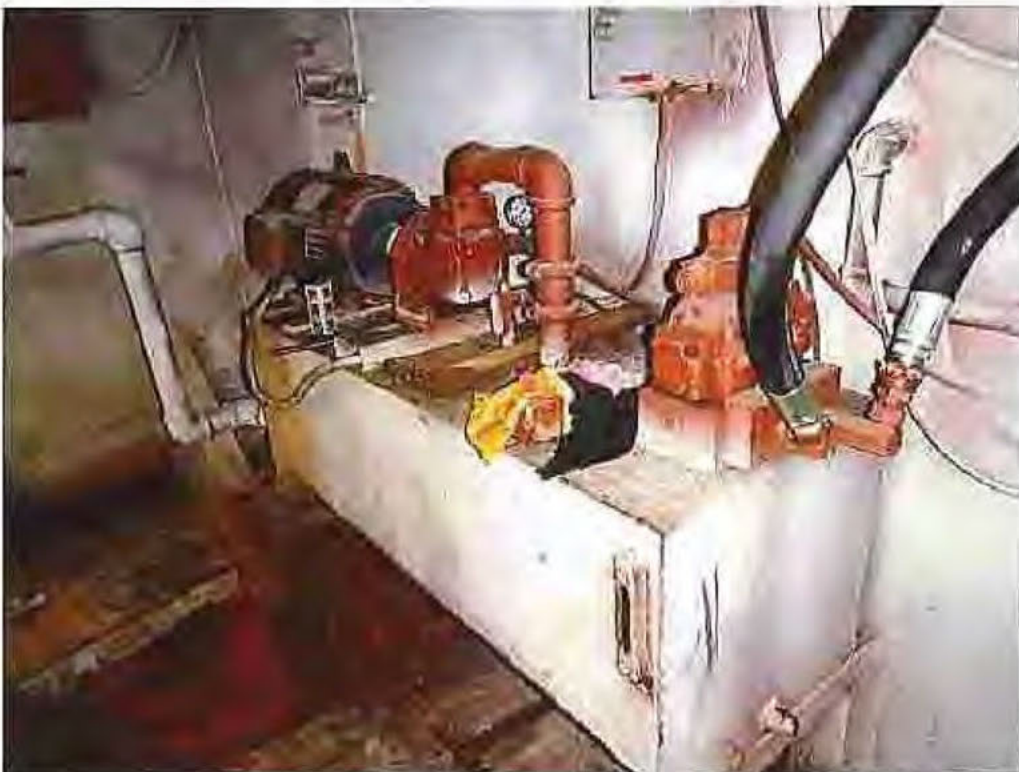
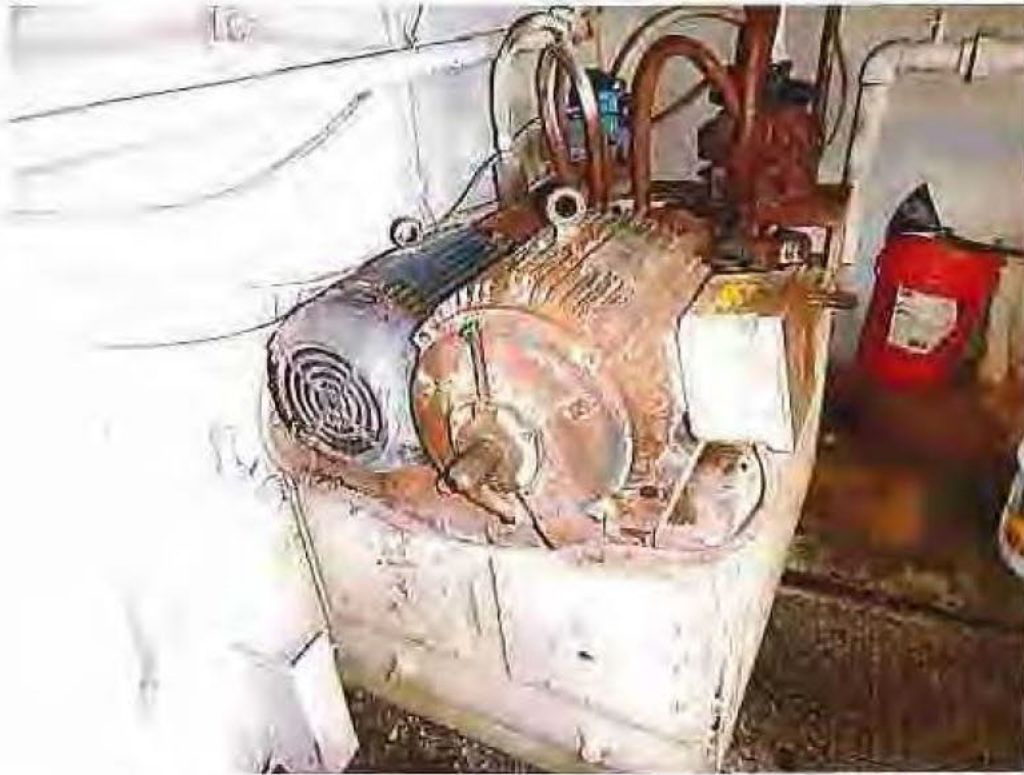
24. STEERING HYDRAULICS
