National
Transportation
Safety Board

Bus Roadway Departure and Rollover

Pala Mesa, California
February 22, 2020

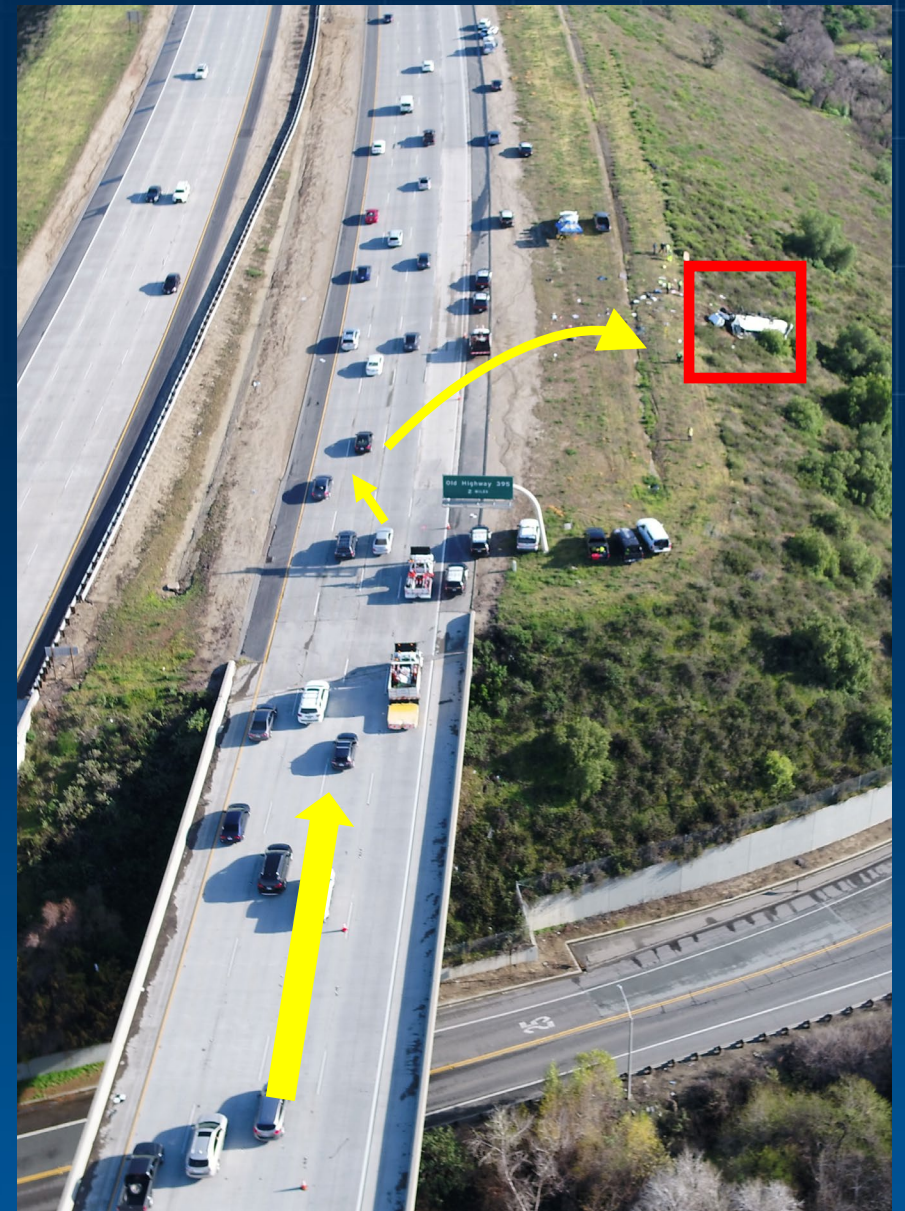
- Driver and 20 passengers on bus after Temecula stop
- About 10:23 a.m.
- Driver lost control
- Bus departed roadway to the right, rolled 1.5 times, came to rest on roof
- Data shows about 74 mph, sustained braking, sharp steering to the right
- Reports of moderate rain and wet roadway at the time

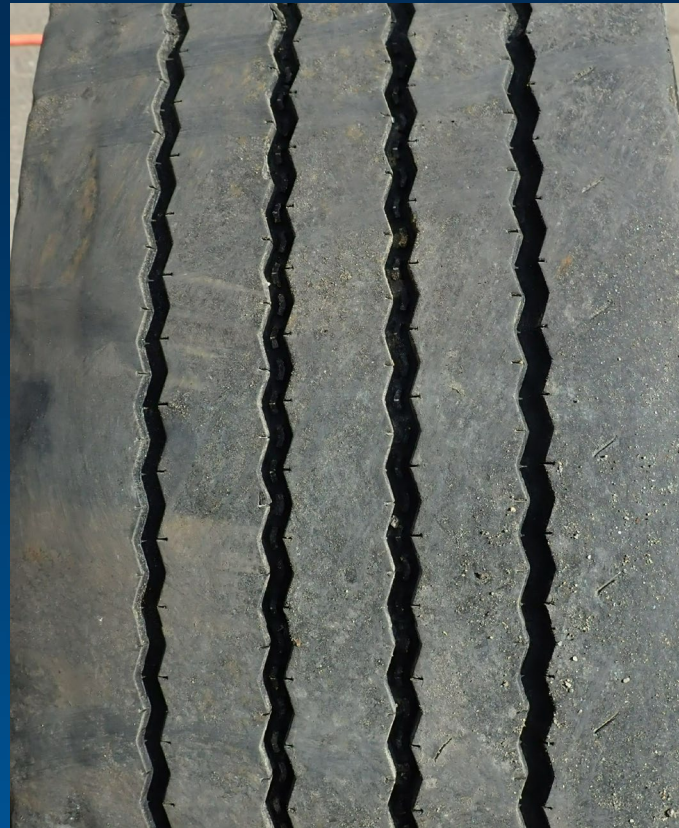
Steer Tire

Axle	Postcrash Bus Tread (Left)	Postcrash Bus Tread (Right)
Steer	10/32 nd inch	11/32 nd inch
Rear/Drive	1/32 nd inch (inside dual)	1/32 nd inch (inside dual)

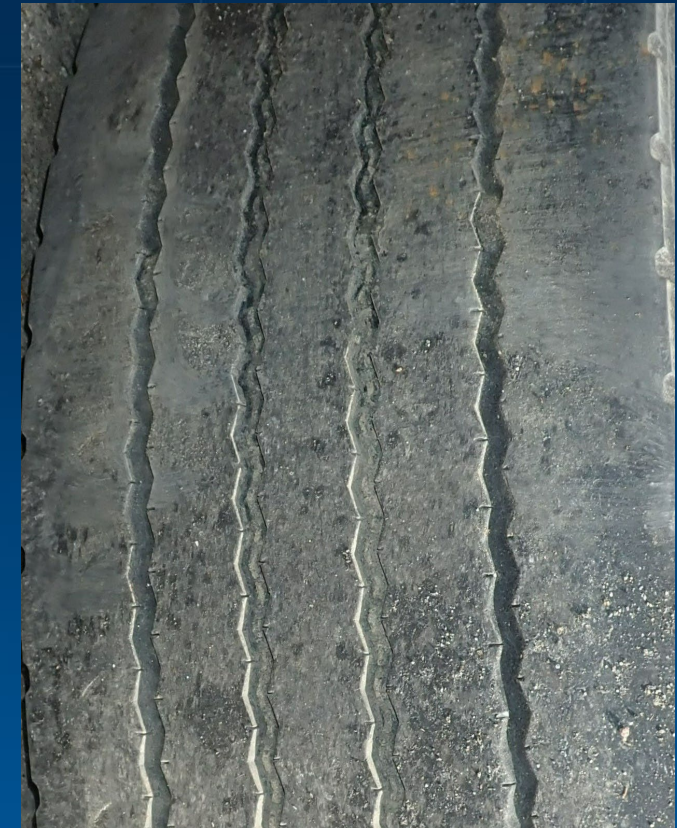
Inside Dual Tire

- Driver performed pretrip inspection of bus and indicated tires were OK on inspection form
- Carrier maintenance records show tires on rear axle had been repeatedly replaced with used tires in months before crash

- Executive Lines' deficiencies in tire replacement and rotation practice allowed bus to operate with tires with less than required tread depth
- Practice of replacing rear axle tires with used tires from steer axle can result in non-uniform tread depths, leading to loss of traction
- What we propose:
 - One recommendation to the United Motorcoach Association and the American Bus Association

- Current minimum tread depth requirements may be insufficient to ensure adequate traction
 - Particularly for passenger-carrying vehicles such as buses
 - Do not address tread depth disparity between tires
- What we propose:
 - Two recommendations to NHTSA
 - One recommendation to FMCSA

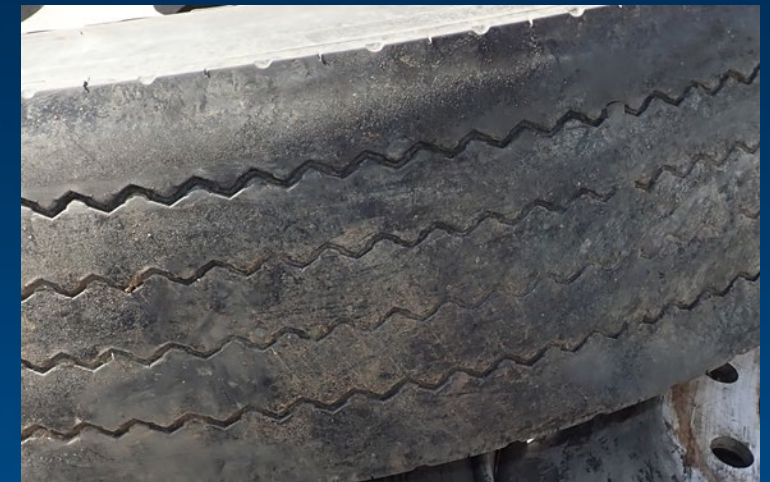
Axle	Regulatory Minimum Tread	Postcrash Bus Tread (Left)	Postcrash Bus Tread (Right)
Steer	4/32 nd inch	10/32 nd inch	11/32 nd inch
Rear/Drive	2/32 nd inch	1/32 nd inch (inside dual)	1/32 nd inch (inside dual)

- Tire tread depth out-of-service criteria
 - Both dual tires must have less than 1/32 inches tread
 - Measured at two adjacent major tread grooves
 - Three separate locations
- Bus would have been in violation of both federal and state regulations
 - Would not have been placed out of service if inspected roadside
 - Tires would need to be replaced before being allowed to make another trip

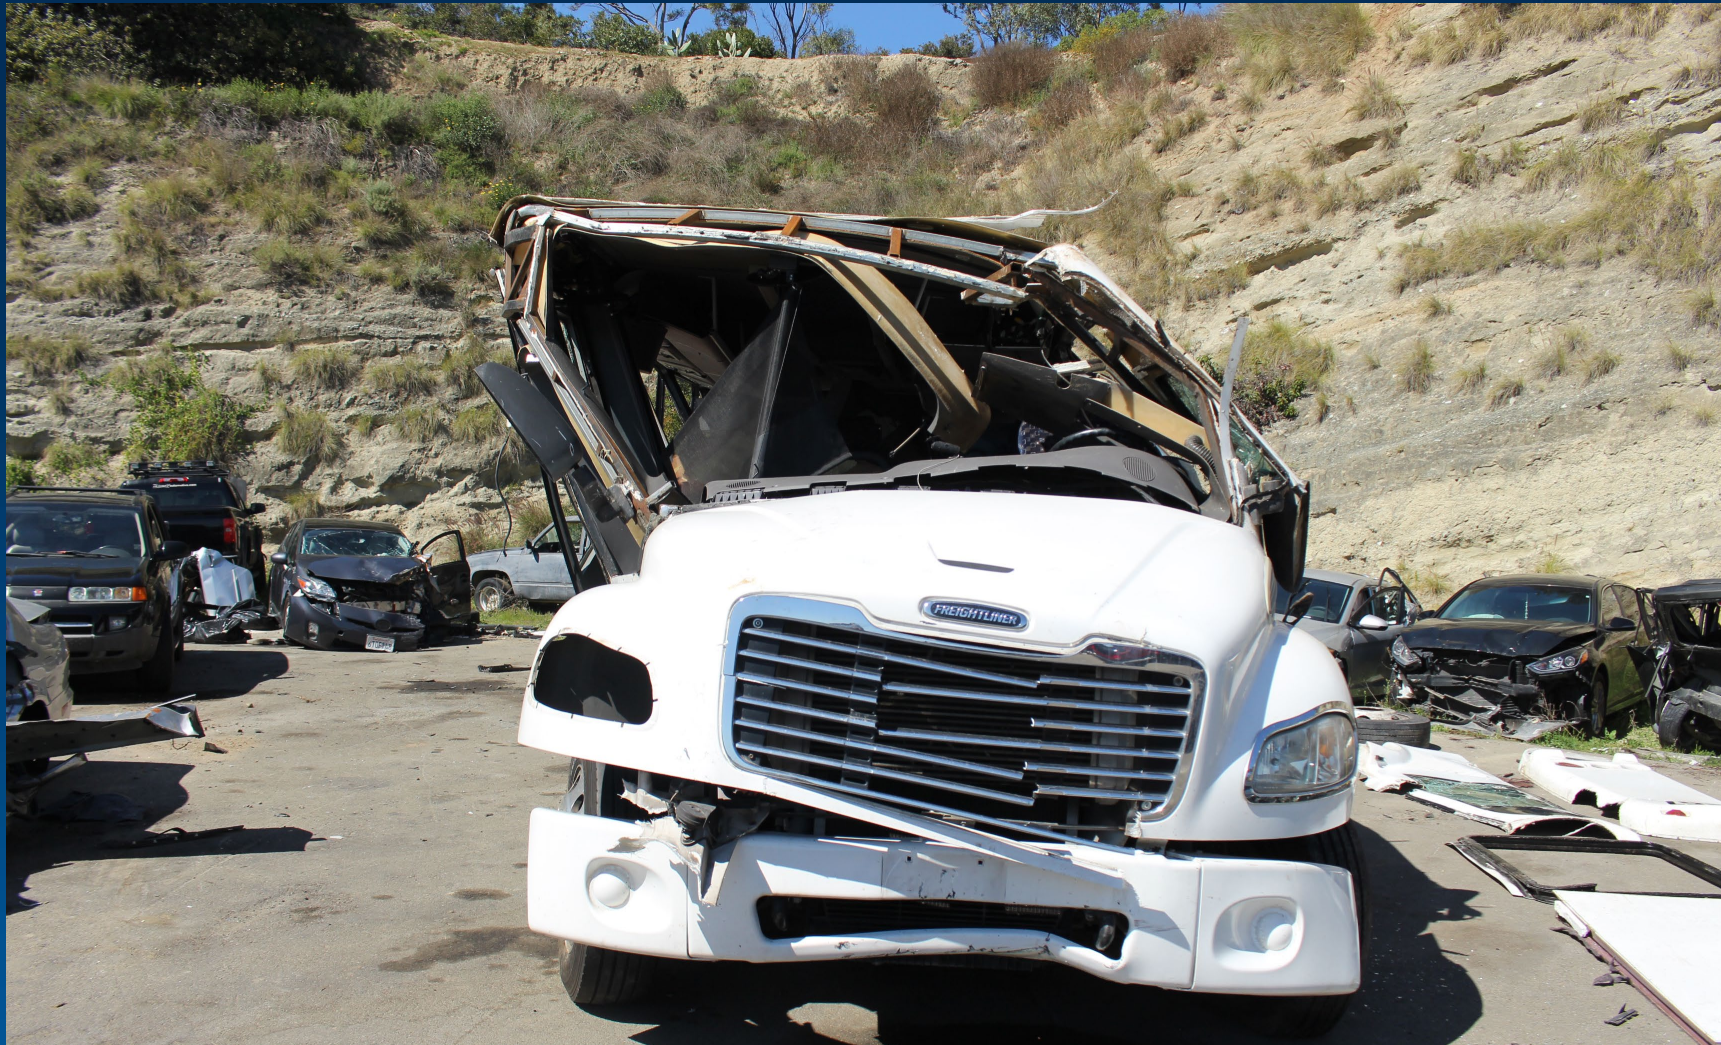
Roof Structural Integrity

- FMVSS standards regarding roof strength not applicable to all passenger-carrying buses
- 2014 Freightliner bus did not meet FMVSS definition and was not required to conform to the standard
- Lack of crashworthiness and failure of roof structural integrity resulted in passenger ejection
- What we propose:
 - One reiterated recommendation (H-21-2) to the National Highway Traffic Safety Administration
