K&S Helicopters, Inc.  
d/b/a Paradise Helicopters  
73-341 U'u St.  
Kailua-Kona, HI 96740

National Transportation Safety Board  
490 L'Enfant Plaza, SW  
Washington, DC 20594  
Attn: Aaron Sauer – Lead Investigator

Party Submission: 49 CFR 831.14  
Accident Number: ANC22FA041

### **K&S Helicopters, Inc. – N402SH Accident**

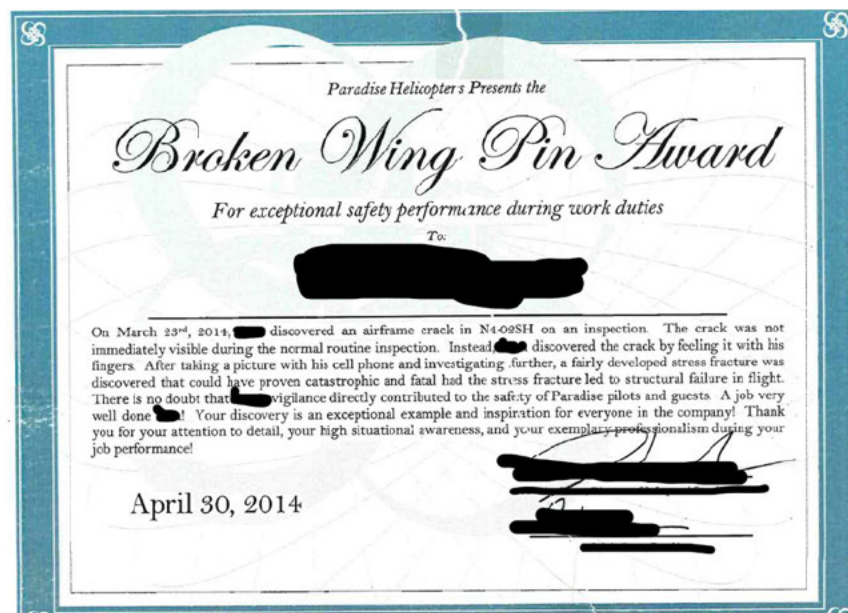
Figure 1

N402SH tailboom at the time of the accident was installed at 5,780 airframe hours. The aft bulkhead and upper left longeron was repaired IAW TB 407-12-96 following discovery of a stress fracture in 2014.

On March 23, 2014, one of the operator's maintenance managers found a stress fracture during an inspection. It could not be seen during a visible inspection but instead was found through feeling the affected area. The employee was presented with a safety award for his finding. (see **Figure 1**)

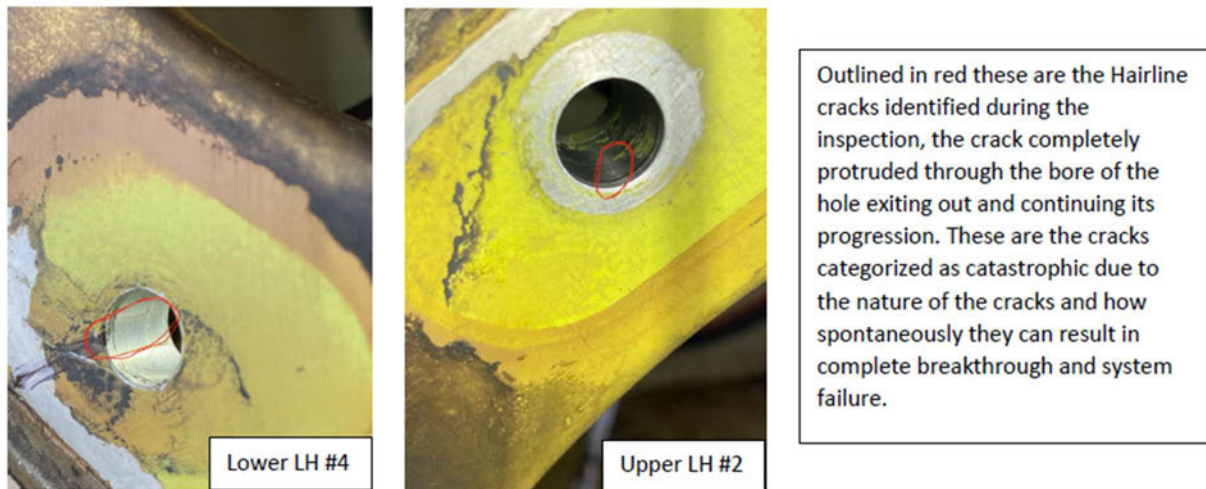
Figure 6

After the accident occurred, the operator conducted eddy-current non-destructive inspection (NDI) on the aft fuselage longerons of their remaining Bell 407 helicopter fleet. On N807PH, NDI found cracking indications on the aft faying surface of the lower-left longeron bolt hole and within the bolt hole of the upper-left longeron. (See **Figure 6**)

At the request of the NTSB, the Bell FI Lab conducted an examination of the two longerons, and concluded that the cracks were the result of fatigue.

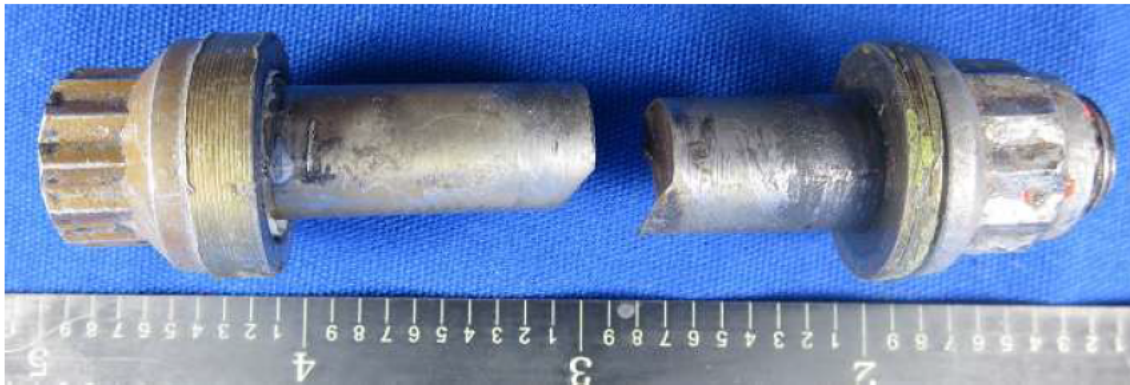
*The second report covered a fractured bolt at the upper-left location with no coinciding cracks in the lower-left fitting (FI Report: 40719M-071). This occurrence indicated that a bolt fracture at the upper-left location can occur without a crack having formed in the lower-left fitting.*

*The Airworthiness Group Chair’s Factual Report for this investigation, dated October 24, 2022 and found in the docket for this investigation, discussed a past occurrence involving a Bell 407 in which the operator found a fractured upper-left attachment bolt during a scheduled 300-hour recurring torque check. Metallography of the fractured bolt found multiple-origin fatigue cracking through about 2/3 of the fracture cross-section, with the remainder of the fracture cross-section in overload. The location of the fracture on the bolt was estimated to be co-located with the aft face of the aft fuselage bulkhead.*

The fractured bolt found on Bell 407 S/N 53563. (Image courtesy of Bell)
