NATIONAL TRANSPORTATION SAFETY BOARD

Personal Electronic Devices

Specialist's Factual Report By W. Deven Chen

Location: Calabasas, California
Date: January 26, 2020
Aircraft: Sikorsky S76-B
Registration: N72EX
Operator: Island Express Holding Corp.
NTSB Number: DCA20MA059

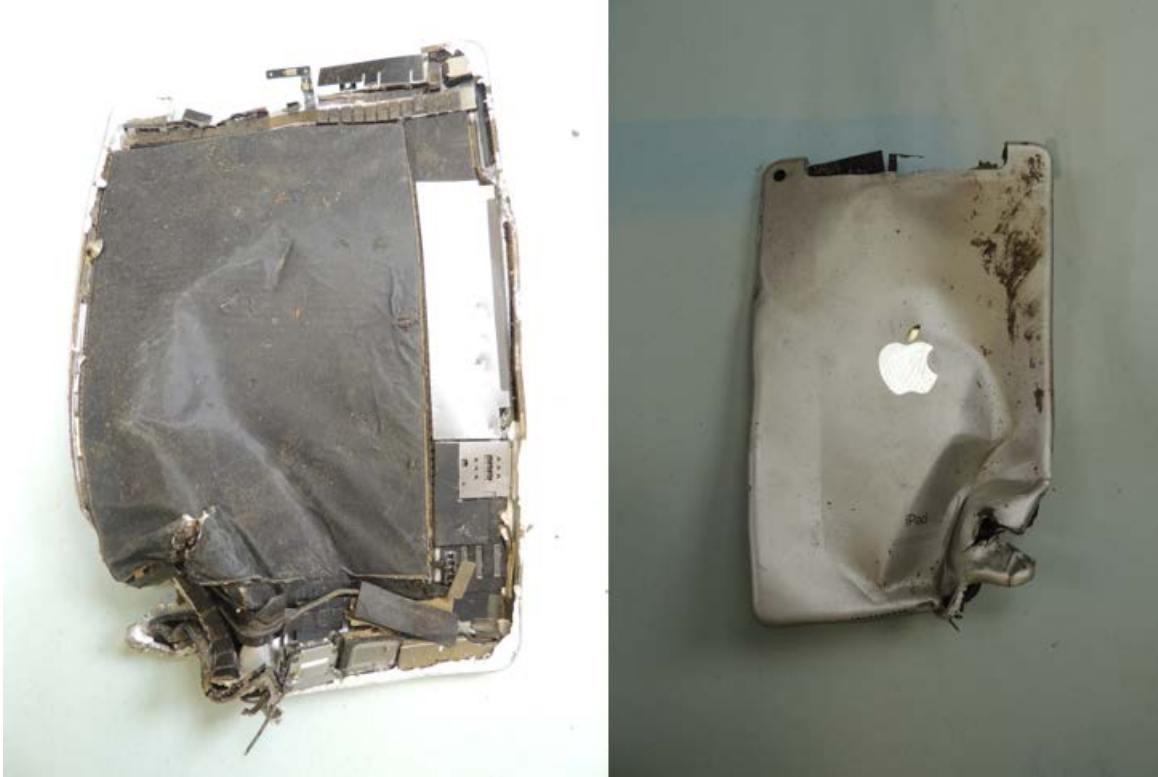
Upon arrival at the Vehicle Recorder Division, an exterior examination revealed the device had severe damage, as shown in Figure 1. The device's motherboard was removed and examined revealing that the NVM was missing from the motherboard, as shown in Figure 2. The extent of the damage and missing NVM precluded recovery procedures. Thus, no data were recovered from this device.

Figure 1: Front and back of Apple iPad Mini 5 as received.

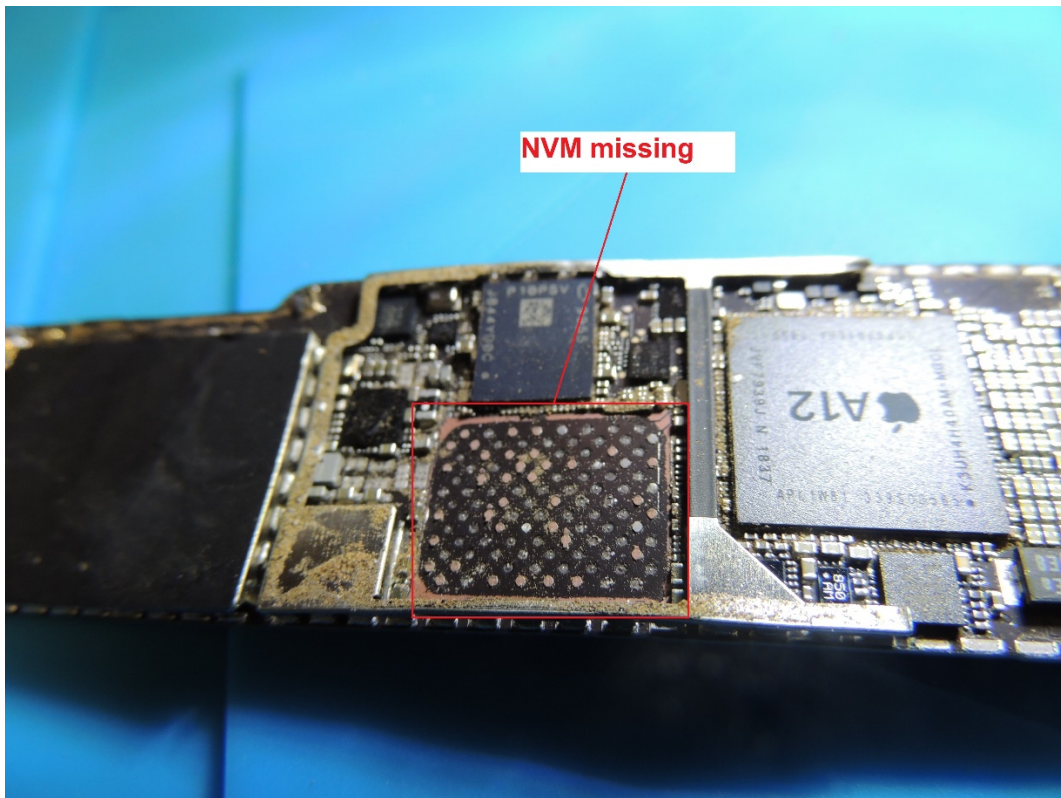
Figure 2: Location of the missing NVM on the motherboard of Apple iPad Mini 5.

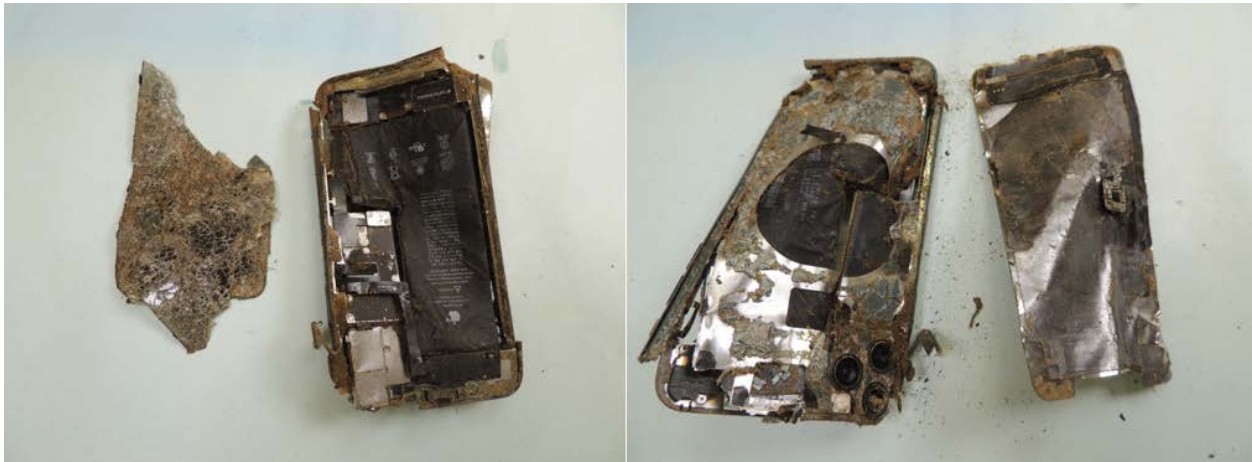
Upon arrival at the Vehicle Recorder Division, an exterior examination revealed the device had severe damage, as shown in Figure 3. The device's motherboard was removed and a crack was found on the printed circuit board (PCB), as shown in Figure 4. The motherboard was installed in a surrogate device and it did not power up. The extent of the damage precluded normal and advanced recovery procedures at the lab. Thus, no data were recovered from this device.

Figure 3: Front and back of Apple iPhone 11 Pro Max as received.

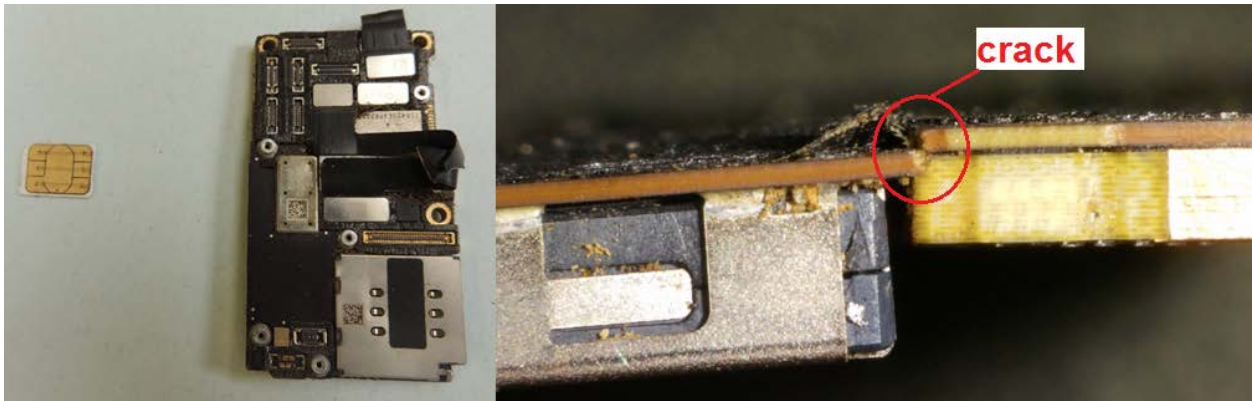
Figure 4: Motherboard of Apple iPhone 11 Pro Max with a crack on the PCB.

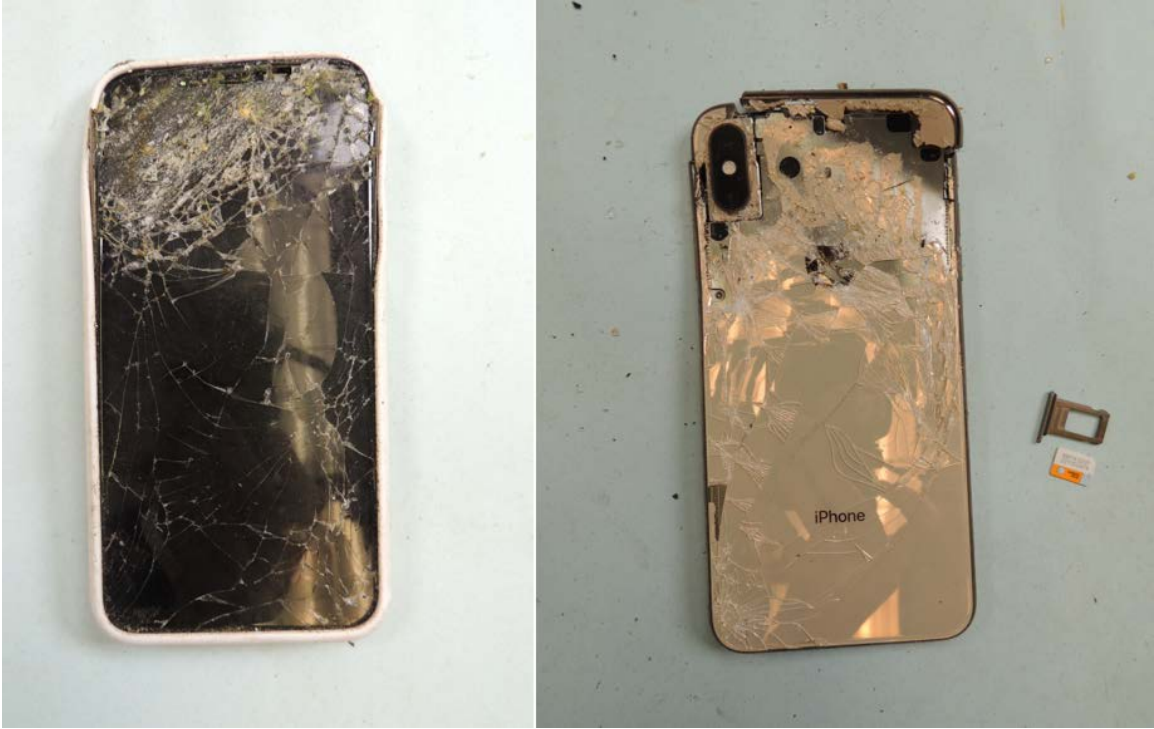
Upon arrival at the Vehicle Recorder Division, an exterior examination revealed the device had severe impact damage, as shown in Figure 5. The device's motherboard was removed and was bent, as shown in Figure 6. The motherboard was tested revealing short circuits and open circuits at various locations. The extent of the damage precluded normal and advanced recovery procedures at the lab. Thus, no data were recovered from this device.

Figure 5: Front and back of Apple iPhone XS Max as received.

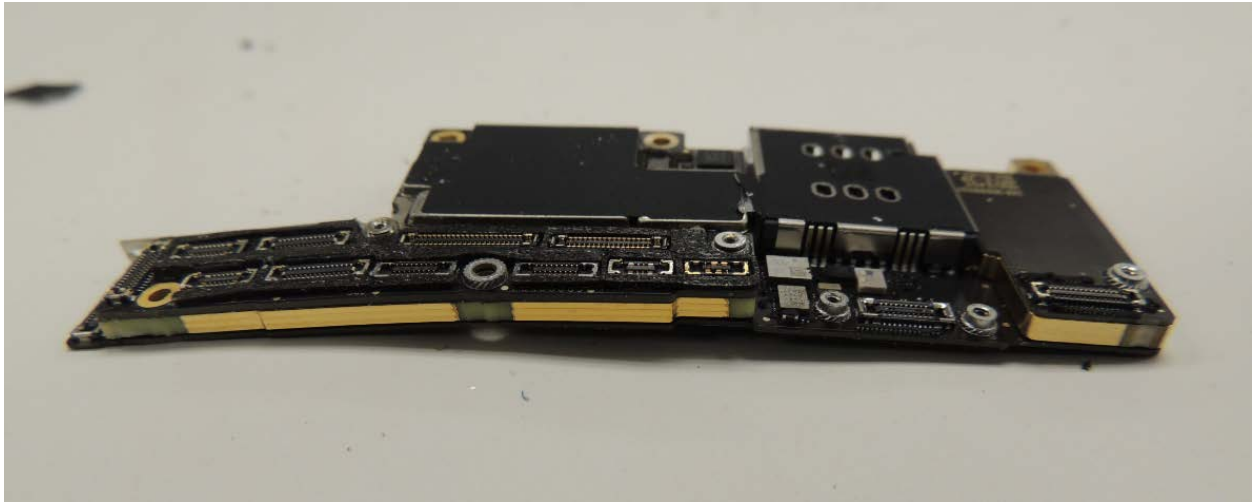
Figure 6: Bent motherboard of Apple iPhone XS Max.

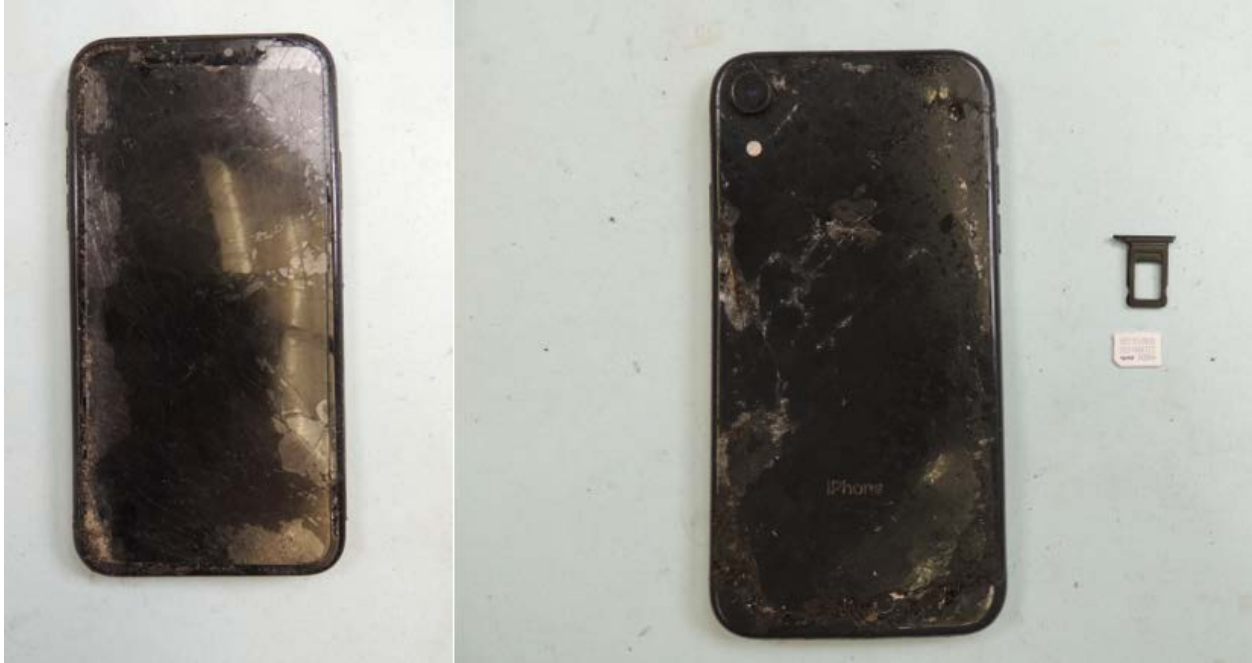
Upon arrival at the Vehicle Recorder Division, an exterior examination revealed the device had impact damage, as shown in Figure 7. The device's motherboard was removed and installed in a surrogate device. The device powered up and was locked with a 6-digit passcode, as shown in Figure 8. In a discussion with the investigator in charge (IIC), attempts to obtain the passcode to unlock the phone were not pursued. Thus, no data were recovered from this device.

Figure 7: Front and back of Apple iPhone XR as received.

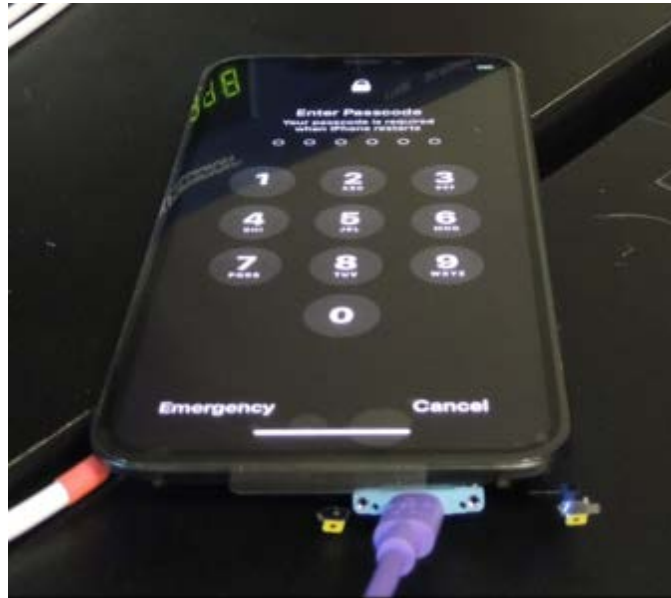
Figure 8: Motherboard of Apple iPhone XR powered up in a surrogate device.

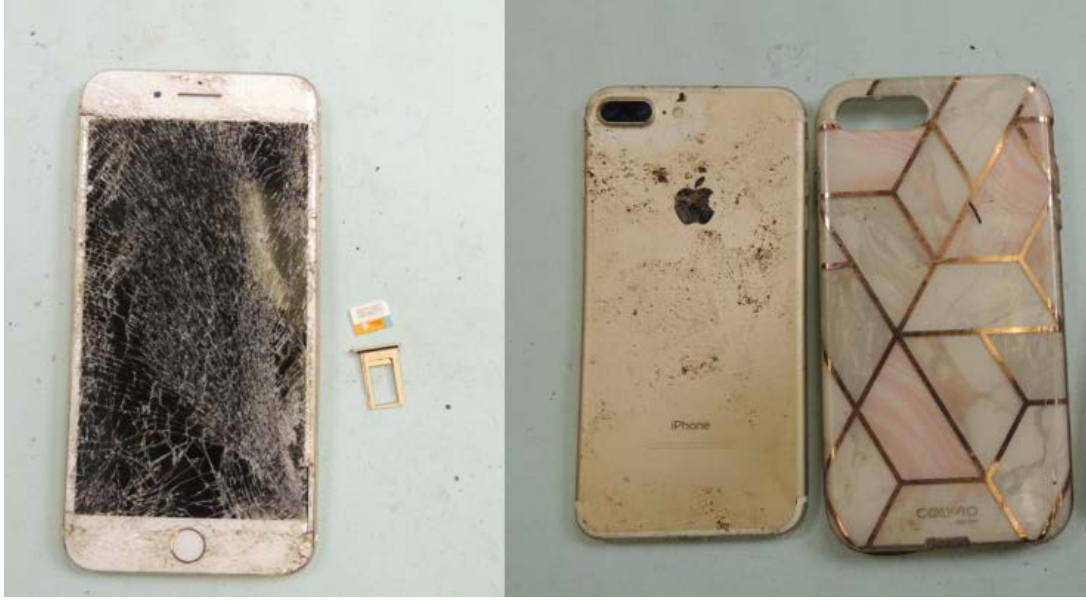
Upon arrival at the Vehicle Recorder Division, an exterior examination revealed the device had impact damage, as shown in Figure 9. The device's motherboard was removed and installed in a surrogate device. The device powered up normally, and was read out using forensic evidence recovery software for PEDs. The reading indicated that the phone was last used in the day before the accident date. Thus, no accident related data were recovered from this device.

Figure 9: Front and back of Apple iPhone 7 Plus as received.

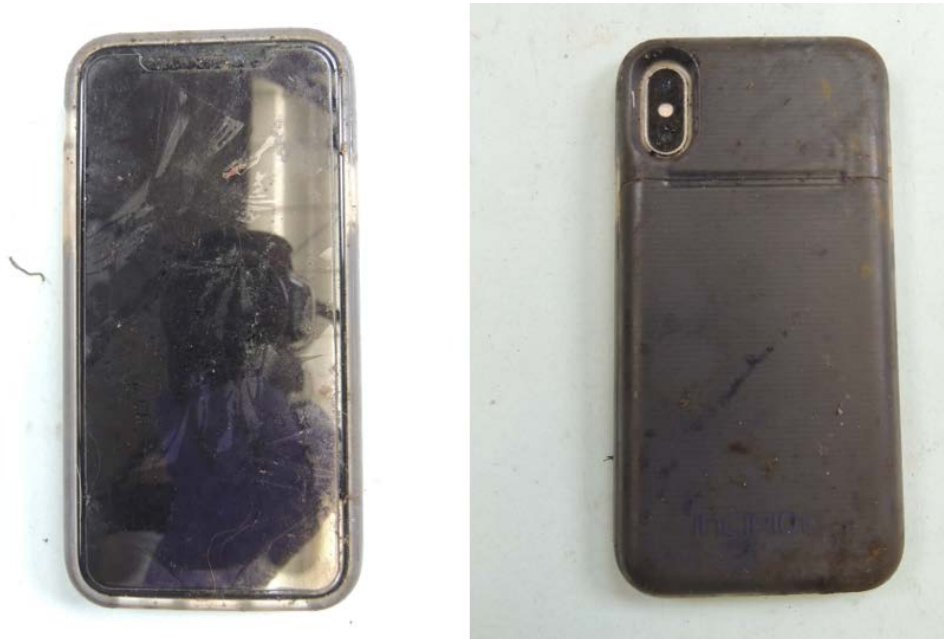
Upon arrival at the Vehicle Recorder Division, an exterior examination revealed the device had minor damage, as shown in Figure 10. The device was slightly bent. An internal examination showed no obvious damage. The device powered up normally in a Faraday box and was found being locked with a 6-digit passcode. In a discussion with the IIC, attempts to obtain the passcode to unlock the phone were not pursued. Thus, no data were recovered from this device.

Figure 10: Front and back of Apple iPhone XS as received.

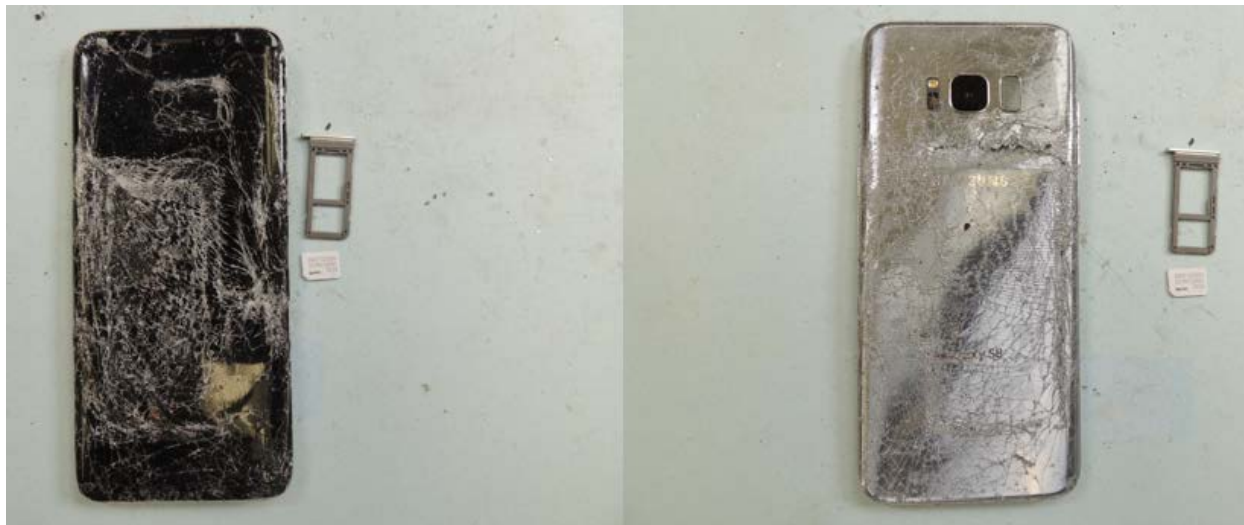
Upon arrival at the Vehicle Recorder Division, an exterior examination revealed the device had severe impact damage, as shown in Figure 11. The motherboard was removed from the device. The motherboard was bent, was missing a component, and had a crack on the printed circuit board, as shown in Figure 12. The motherboard was installed in a surrogate device and it did not power up. The extent of the damage precluded normal and advanced recovery procedures at the lab. Thus, no data were recovered from this device.

Figure 11: Front and back of Samsung Galaxy S8 as received.

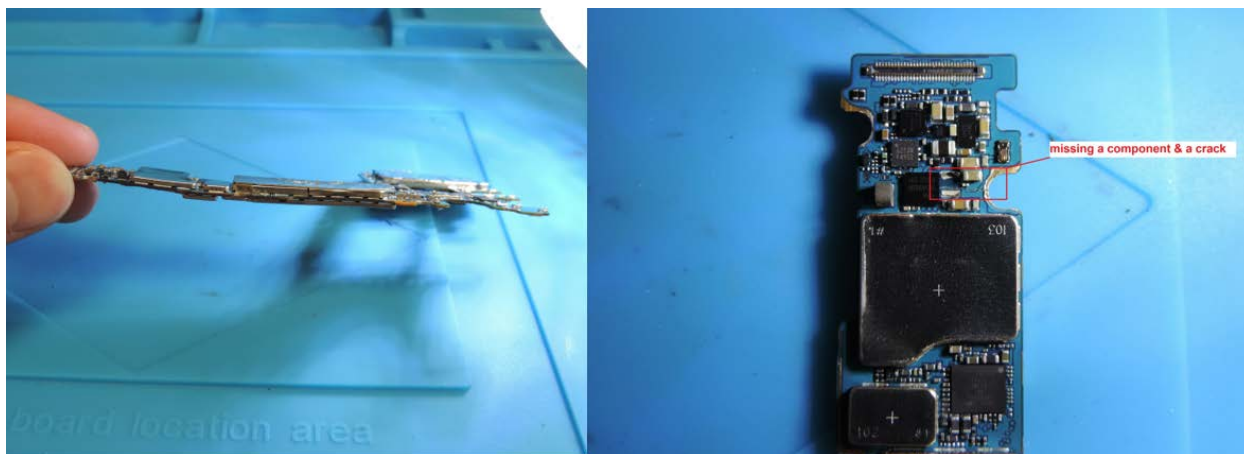
Figure 12: Motherboard of Samsung Galaxy S8 was in bent condition, missing a component and with a crack on the PCB.

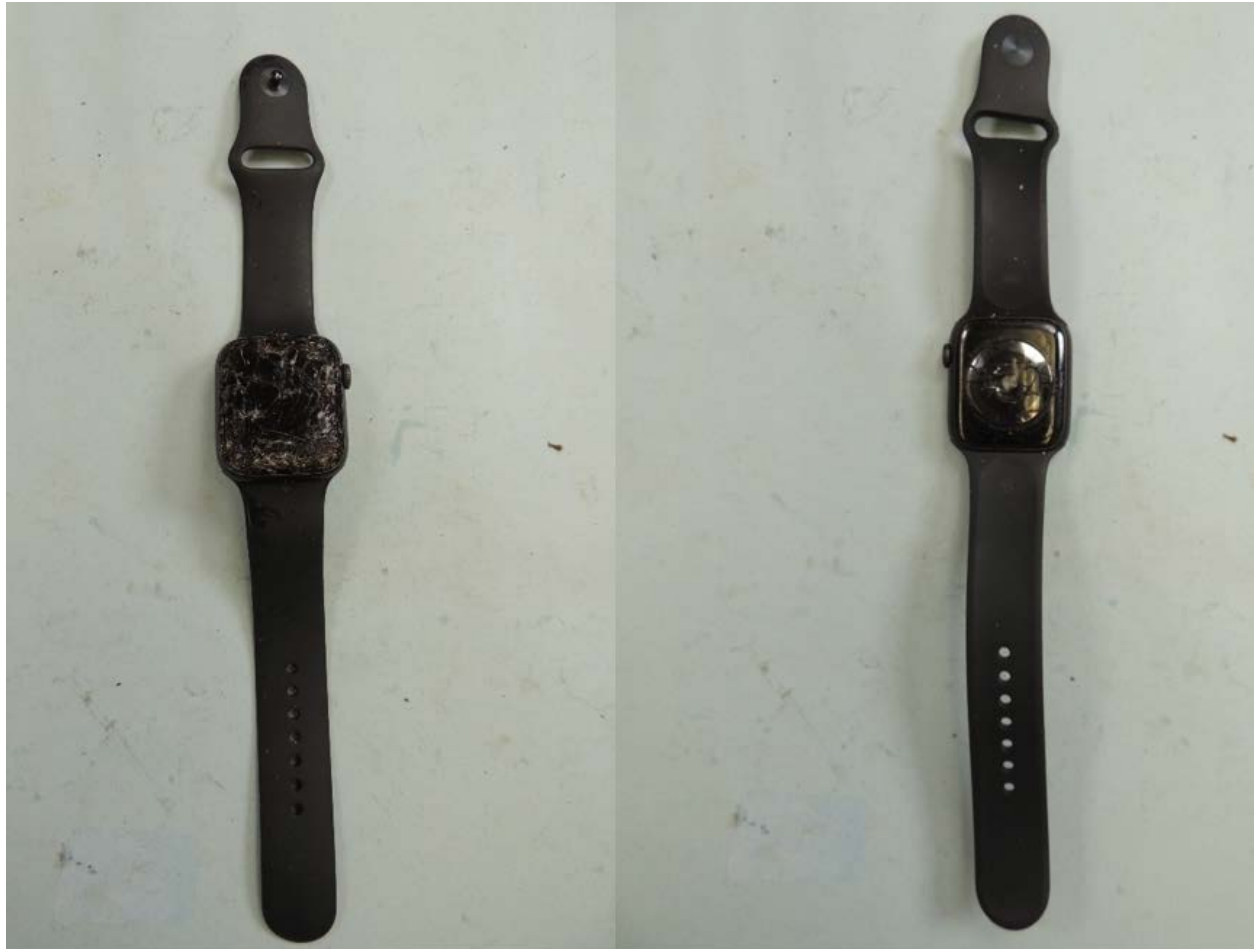
Upon arrival at the Vehicle Recorder Division, an exterior examination revealed the device had impact damage, as shown in Figure 13. The device did not power up. This device and the Apple iPhone XS from section 3.2.6 belonged to the same passenger on the

Figure 13: Front and back of Apple Watch Series 5 as received.
