NTSB ERA22LA310

Cub Crafters CC11-160 (N55JV)

Investigative Photographs

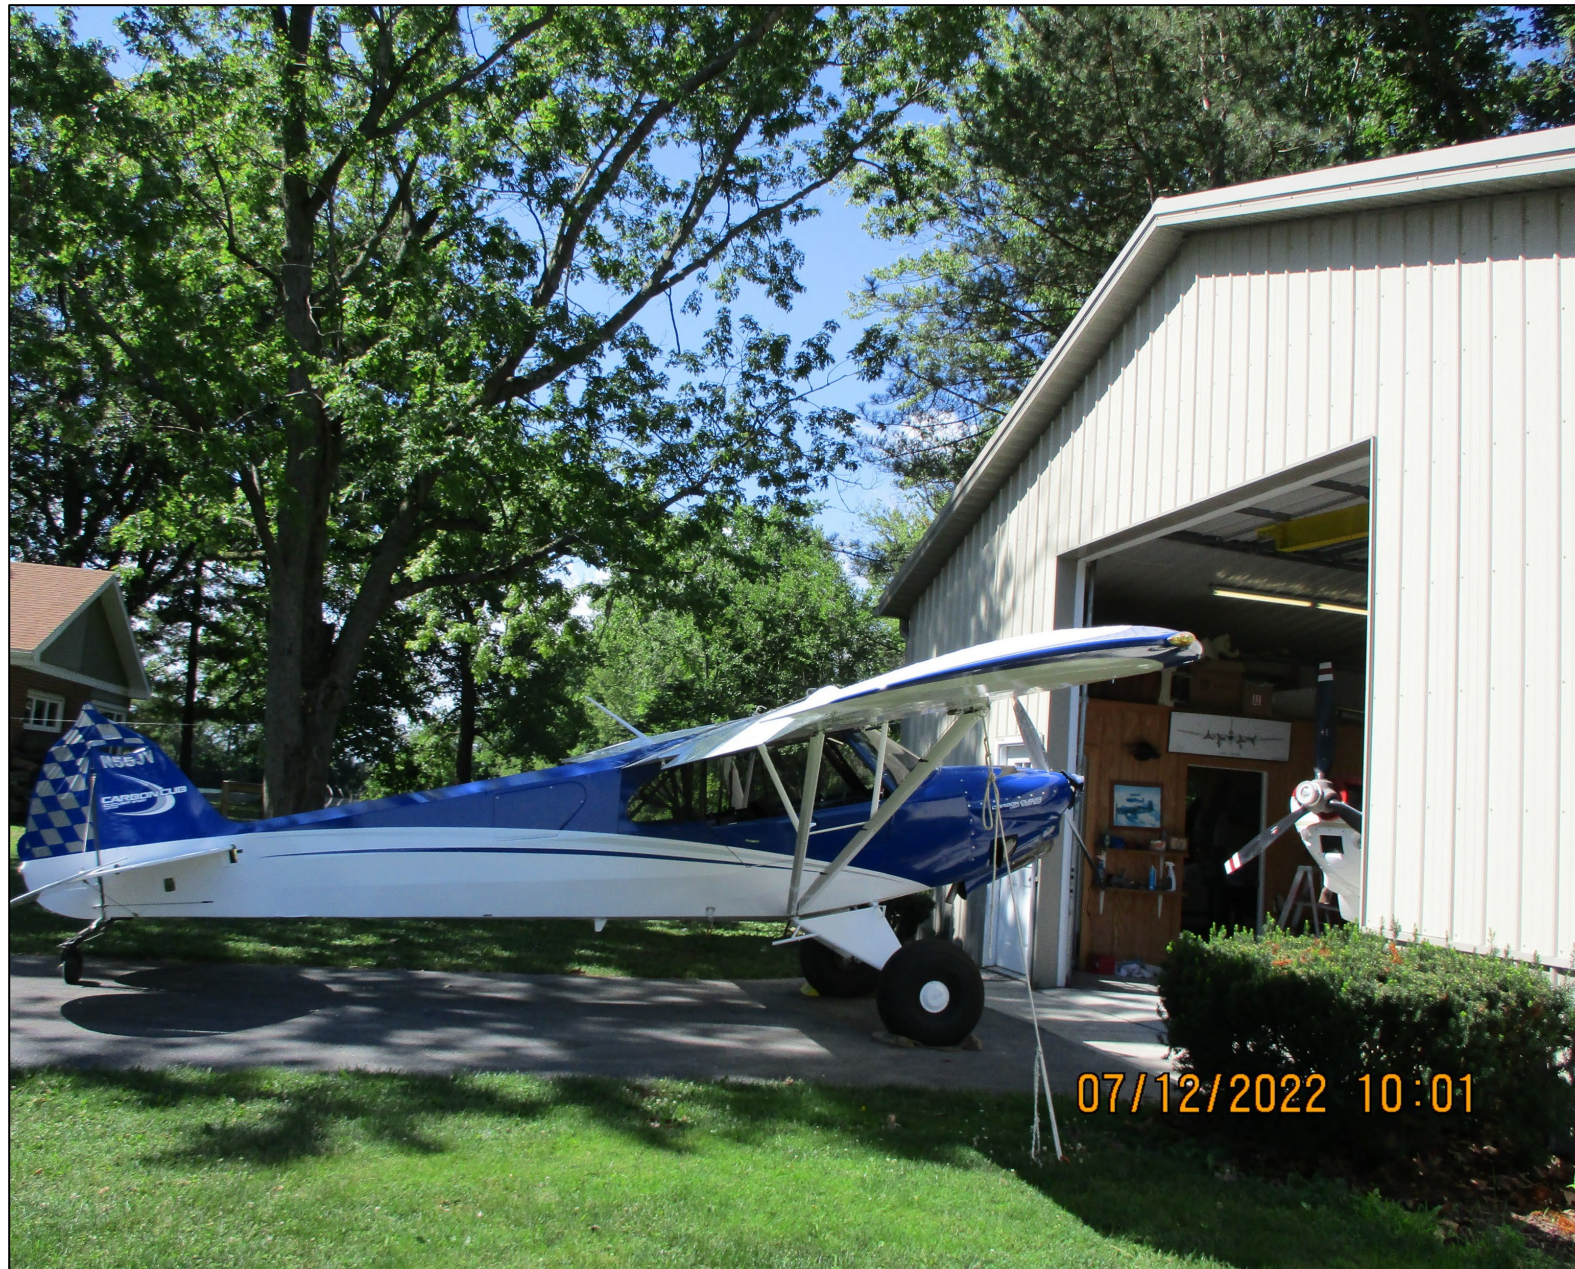
Photo 1: Overview of the airplane after it was recovered from the accident site (Photo Courtesy of FAA)

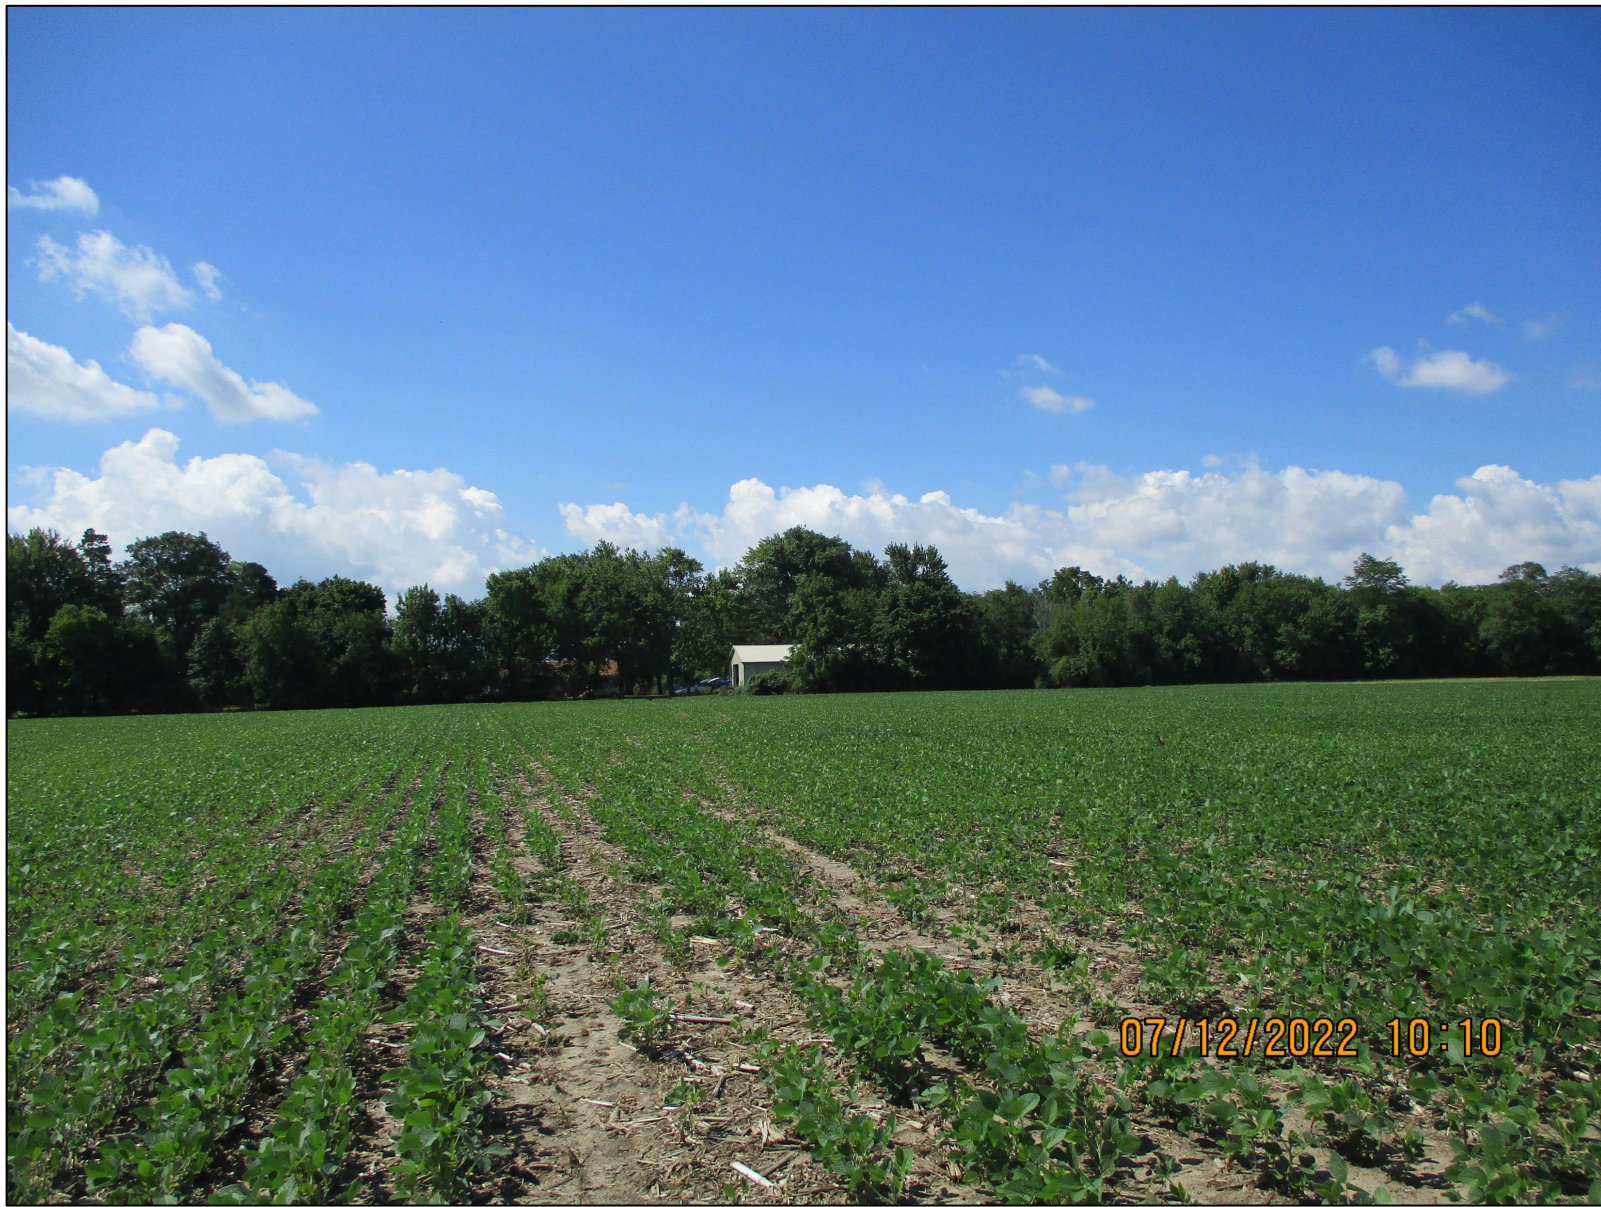
Photo 2: Overview of the farm field that was used for takeoff (Photo Courtesy of FAA)

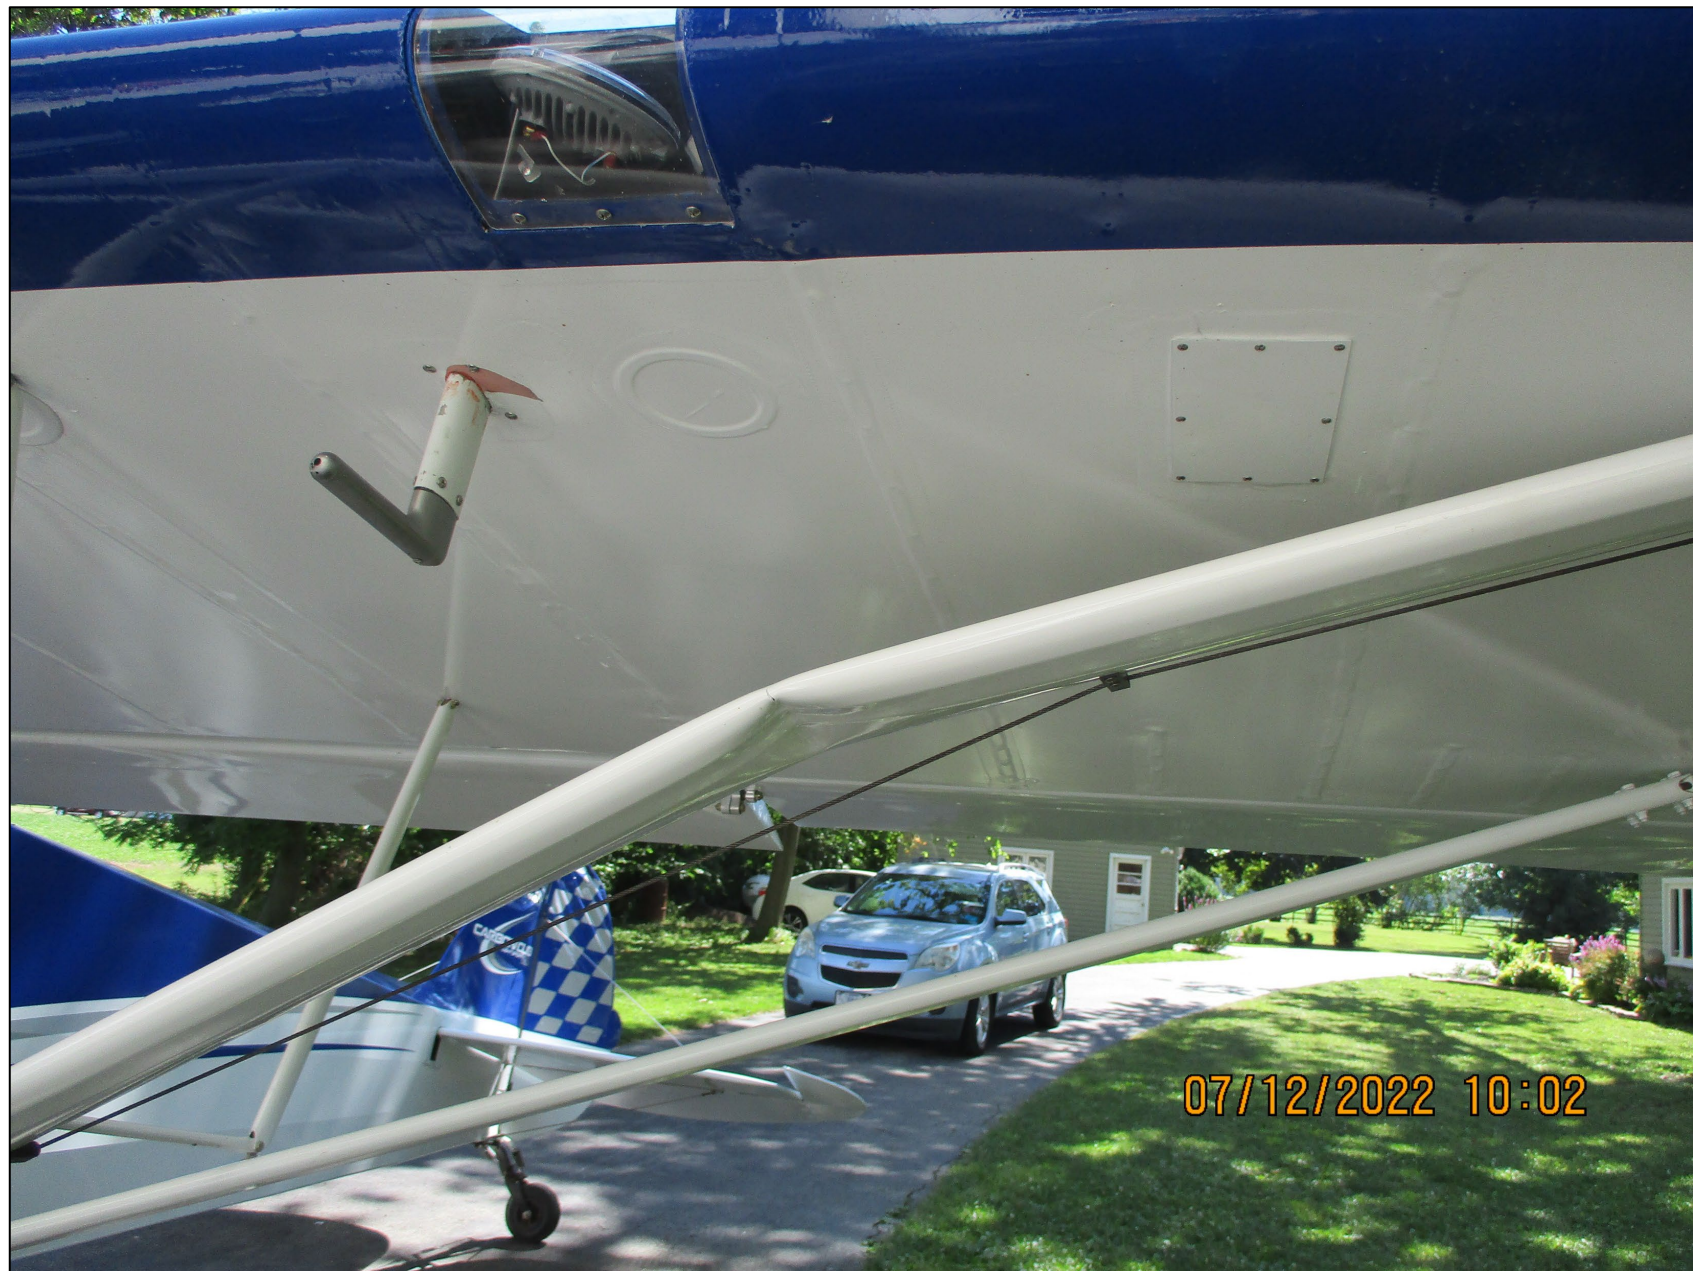
Photo 3: View of the substantial damage sustained to the left wing lift strut (Photo Courtesy of FAA)

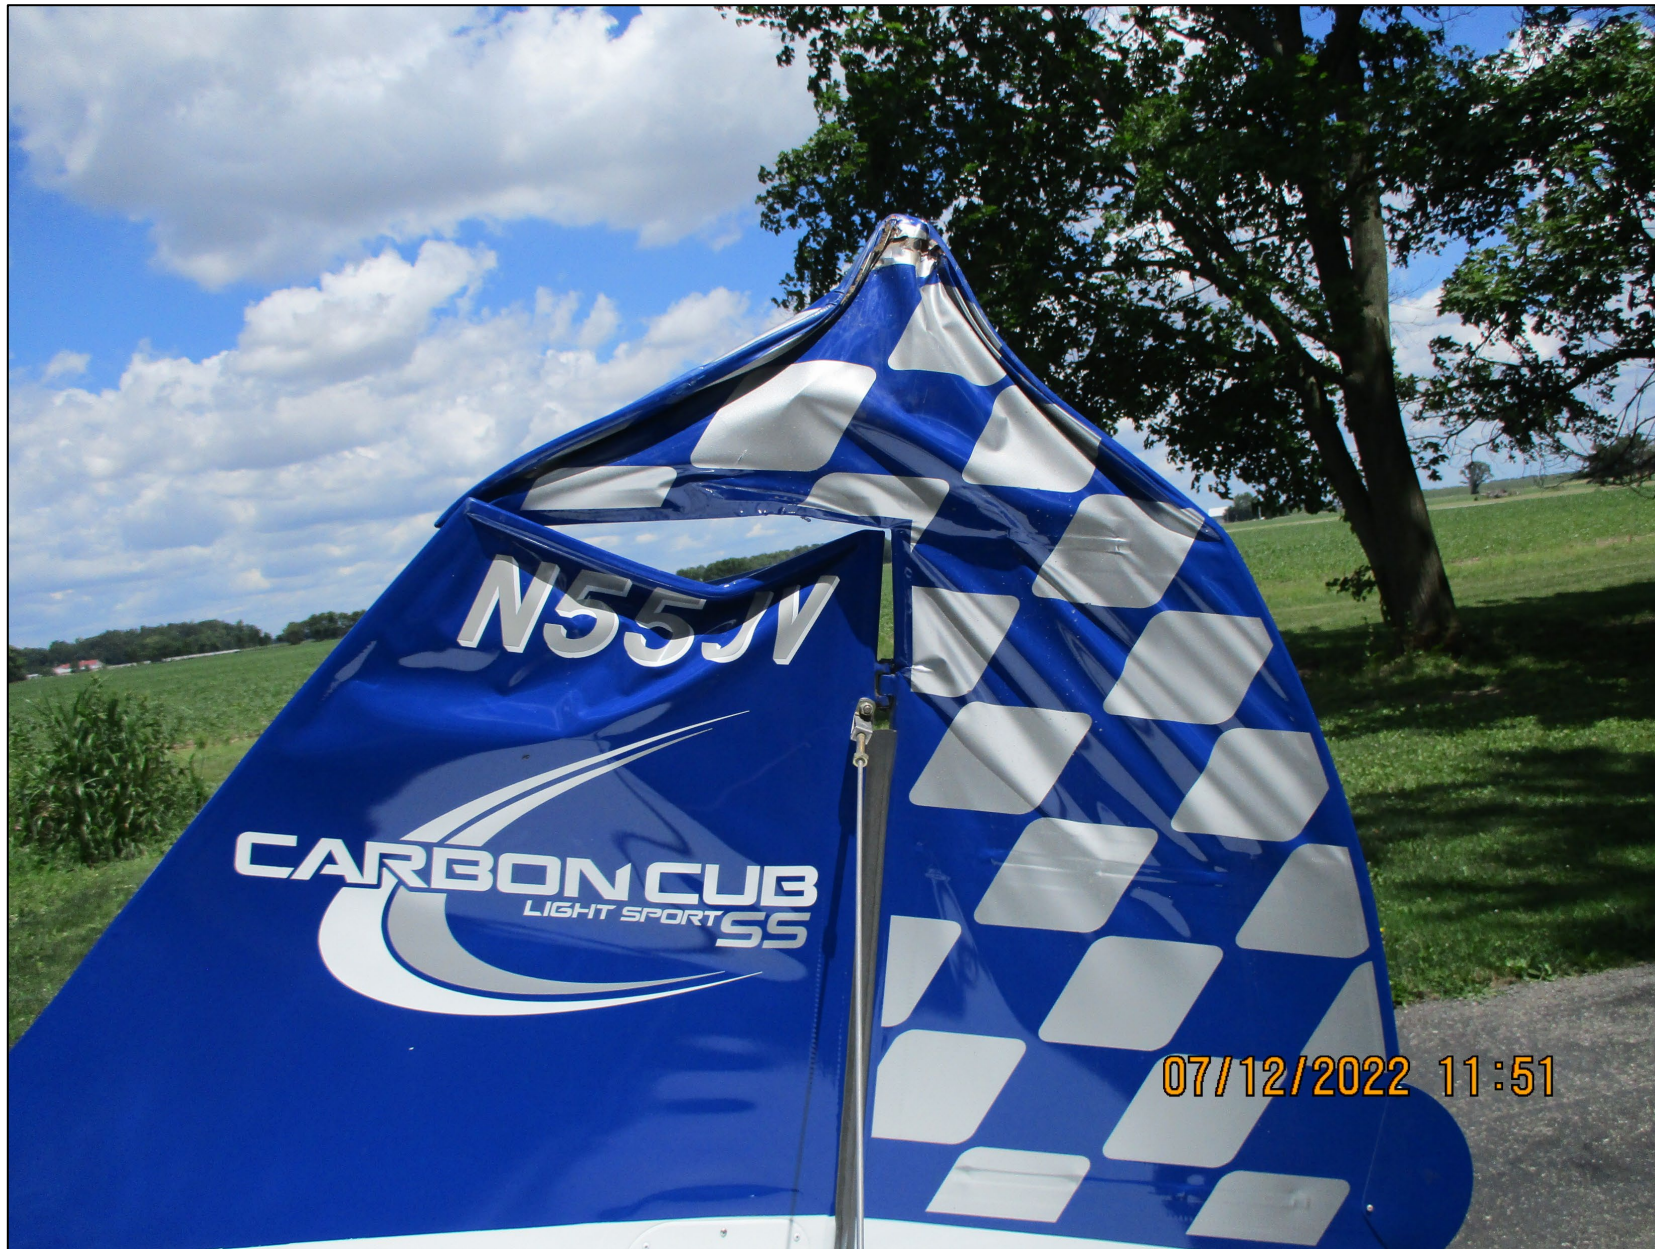
Photo 4: View of the substantial damage sustained to the vertical stabilizer and rudder (Photo Courtesy of FAA)

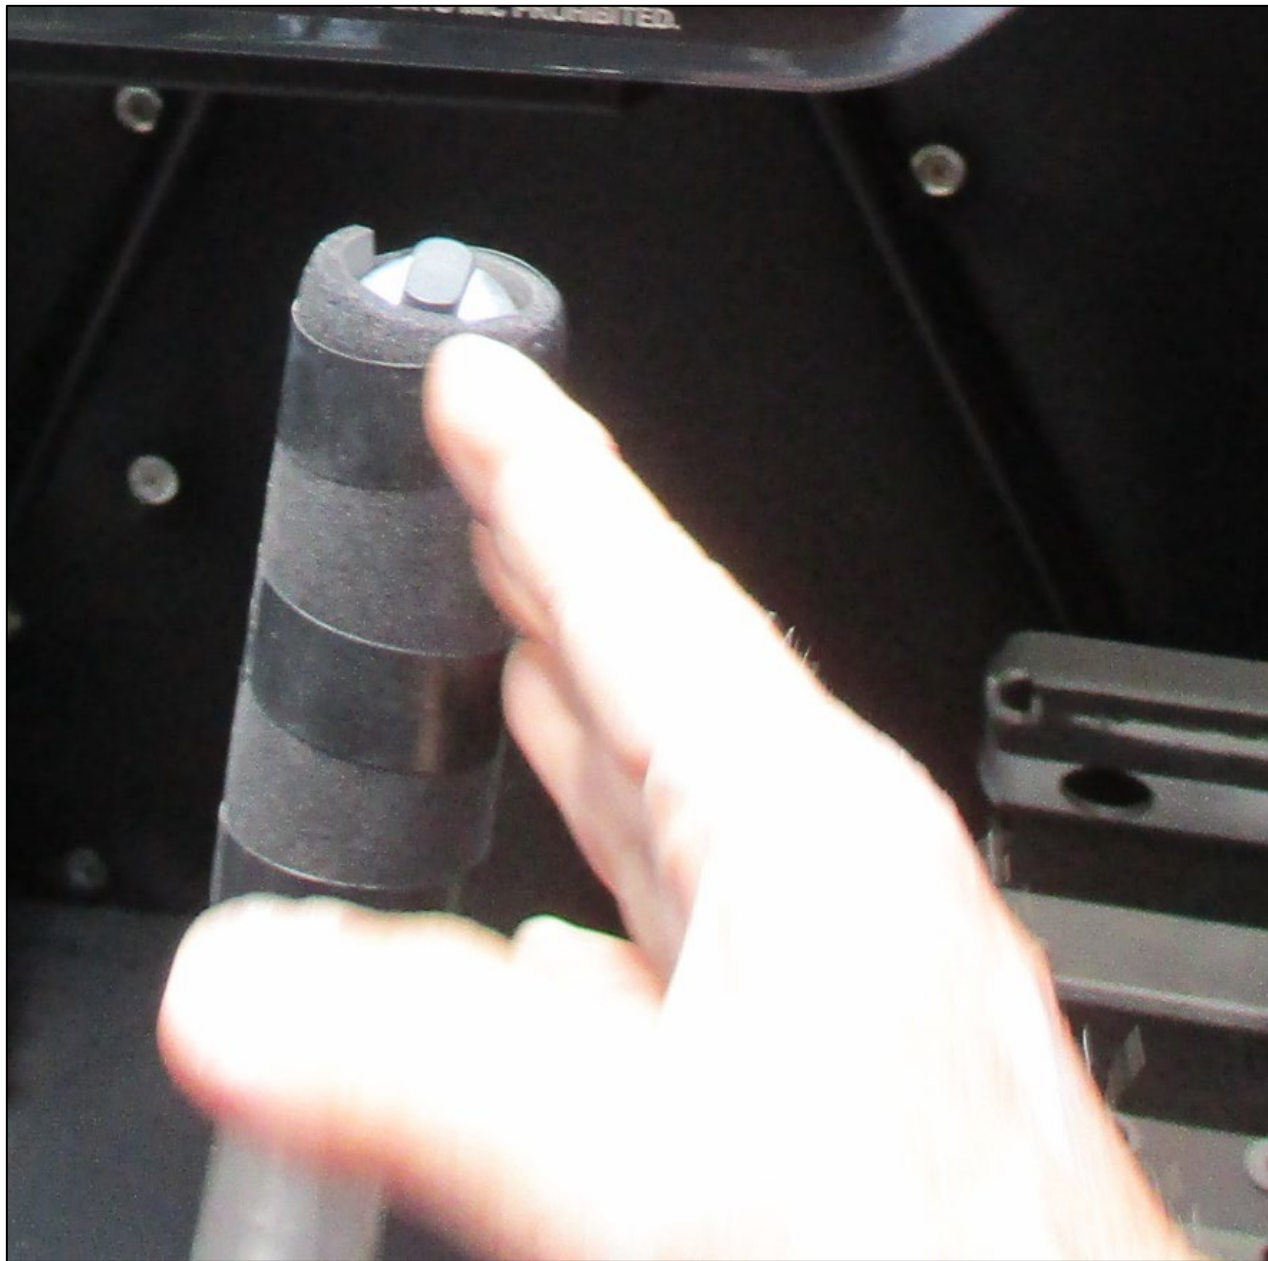
Photo 5: View of the forward seat control stick and rocker trim switch (Photo Courtesy of FAA)

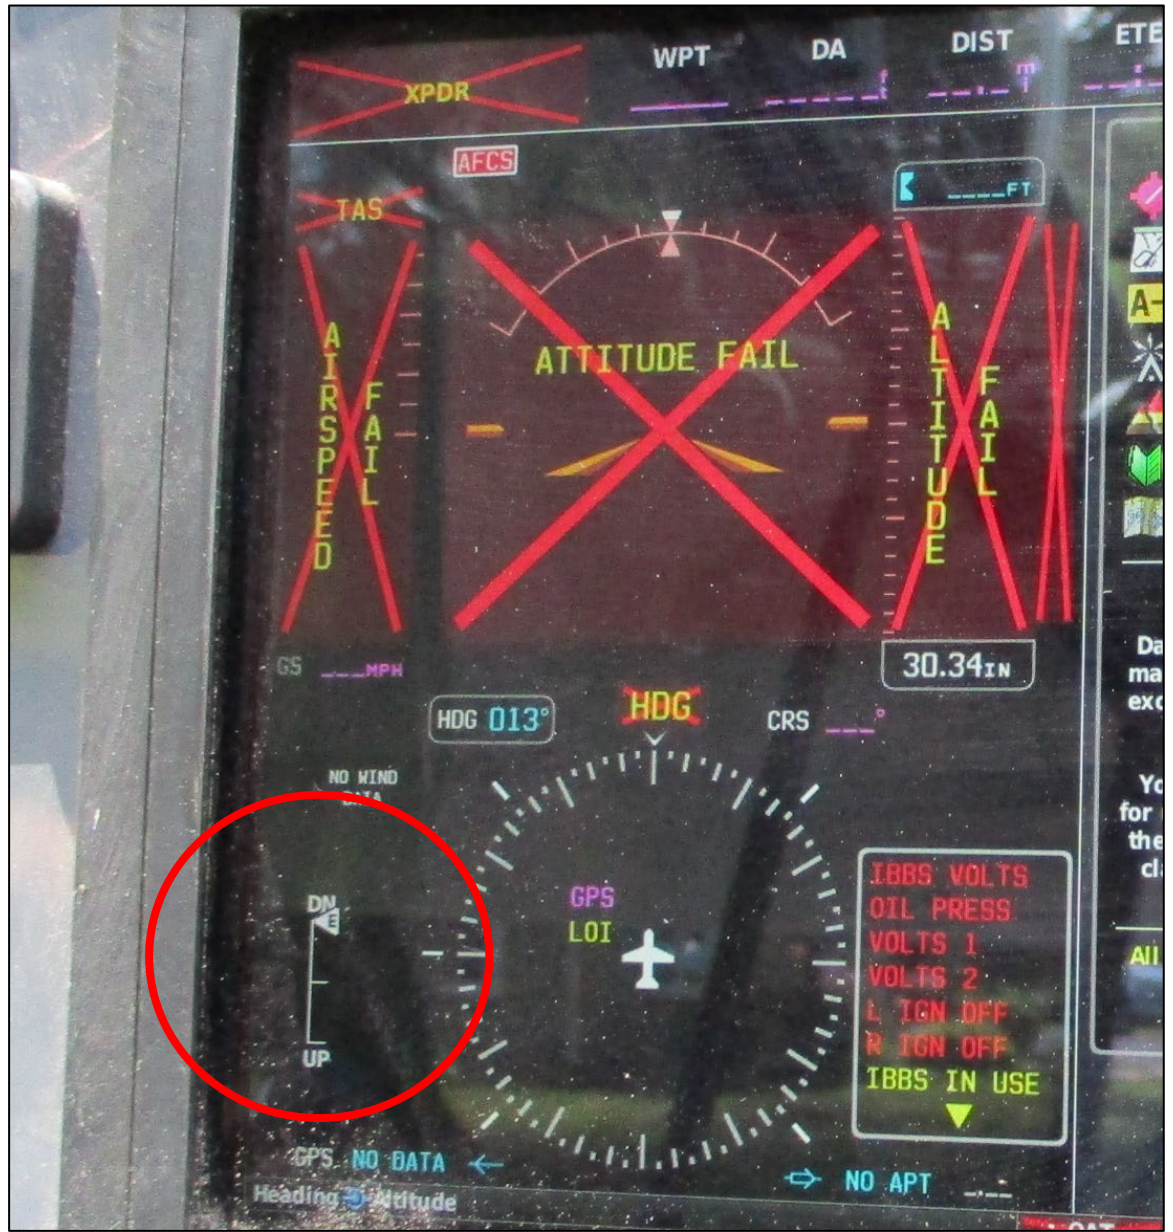
Photo 6: View of the nose UP/DOWN horizontal trim positioned to full nose down (Photo Courtesy of FAA)

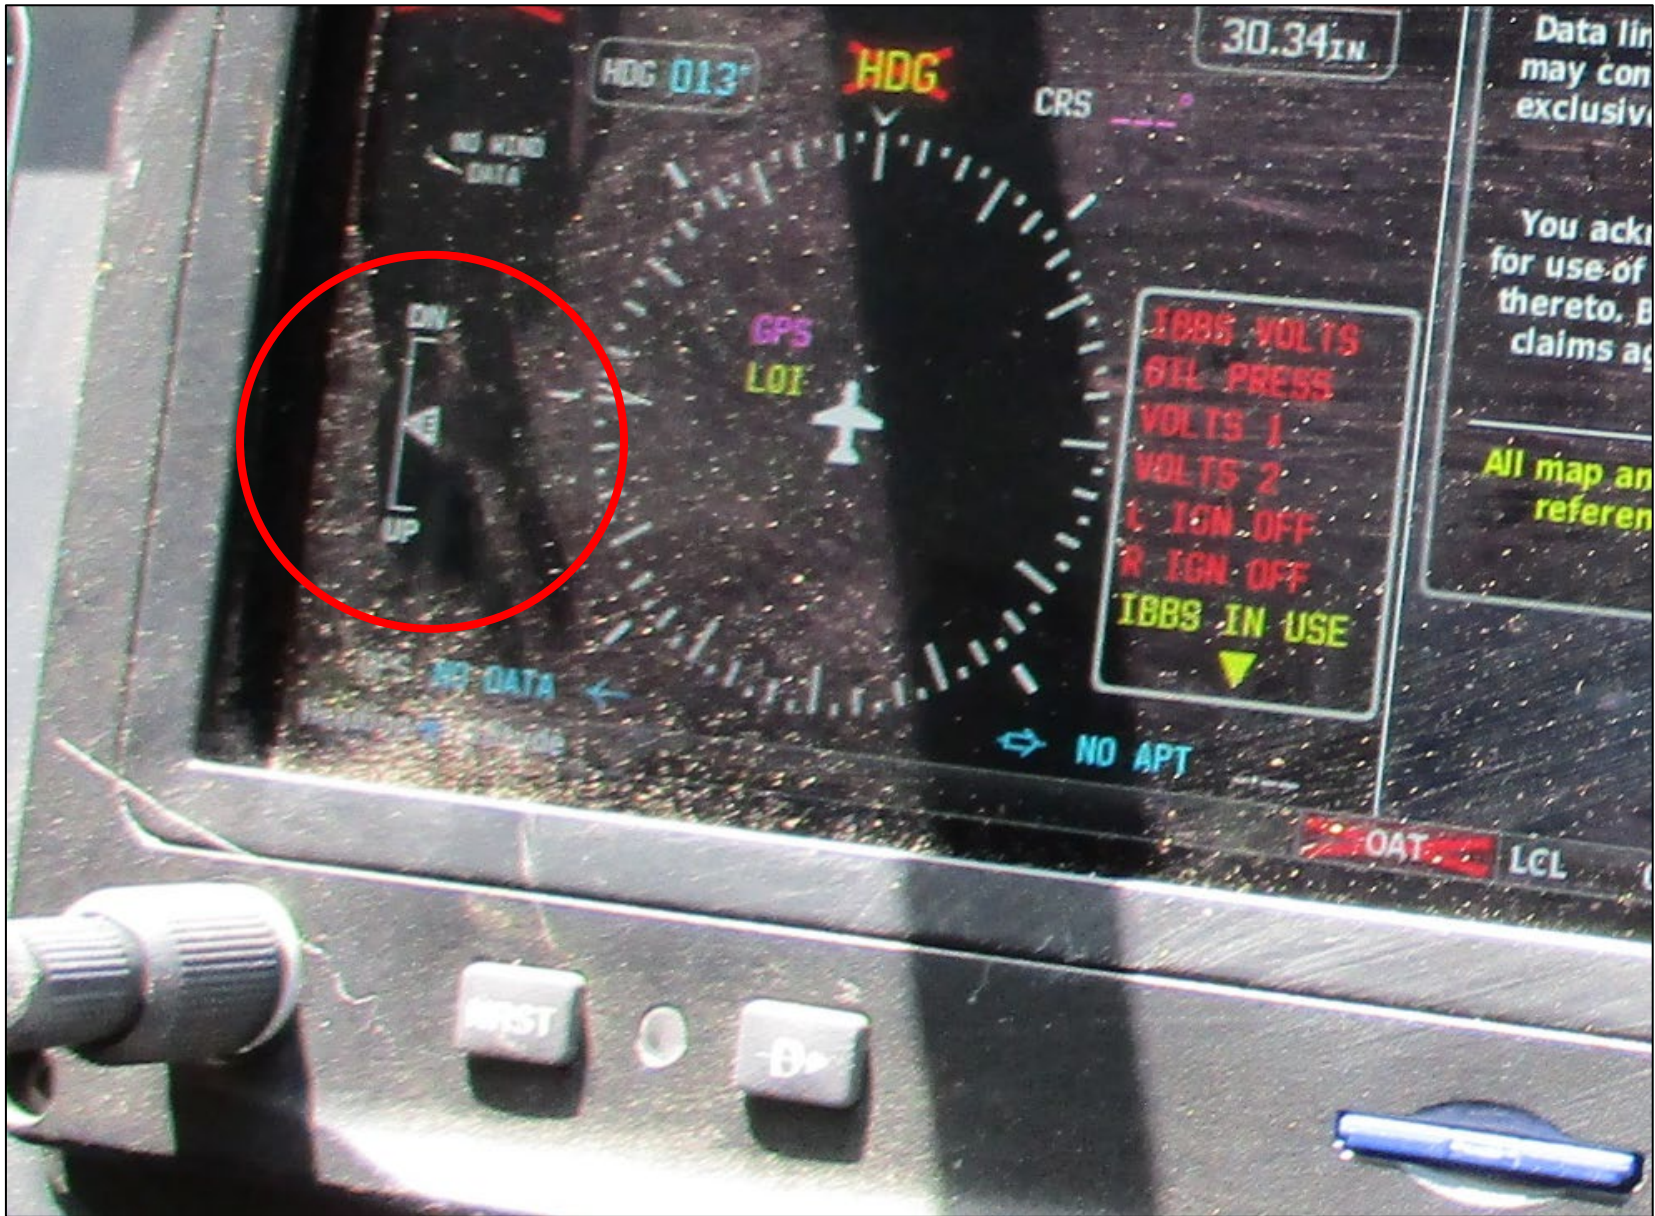
Photo 7: View of the nose UP/DOWN horizontal trim positioned to neutral (Photo Courtesy of FAA)
