NTSB ERA23FA001

N262TA, Cessna 172

Hermantown, Minnesota

Photo Array

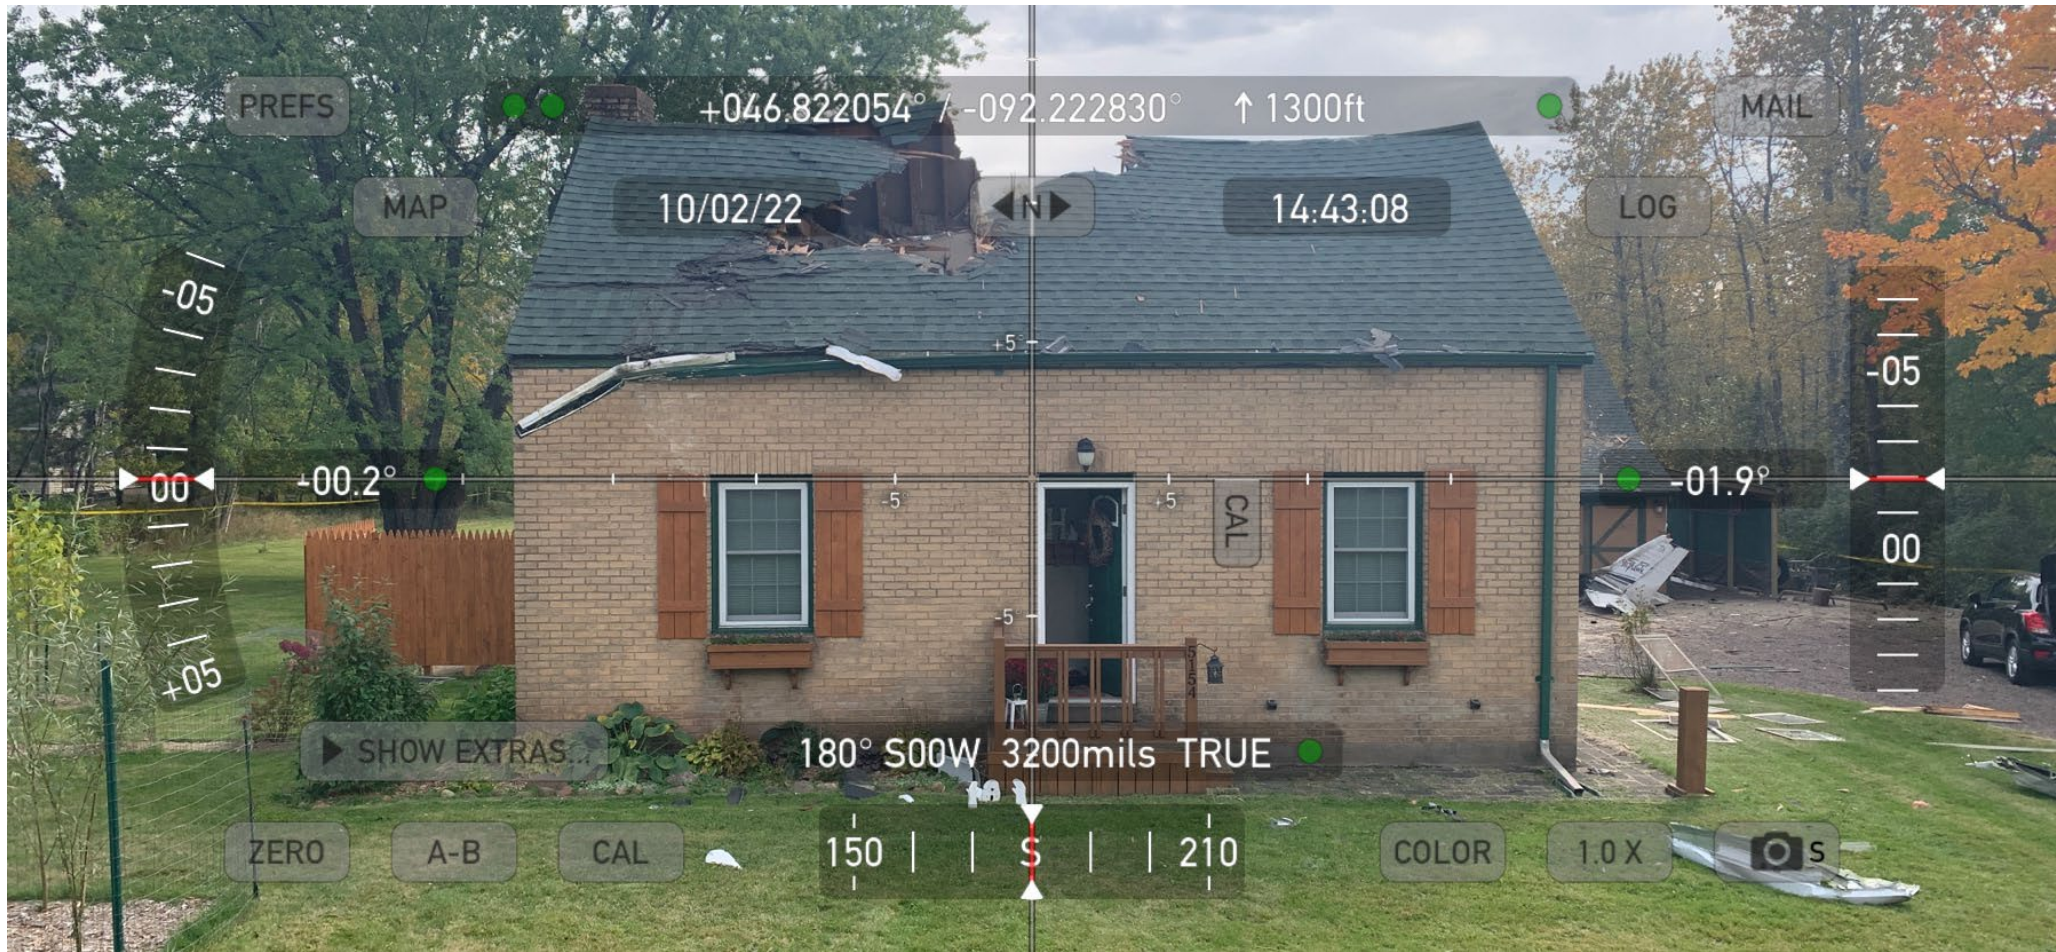
Photo 1: Front view of home where airplane impacted. Note outline of damage to second floor roof.

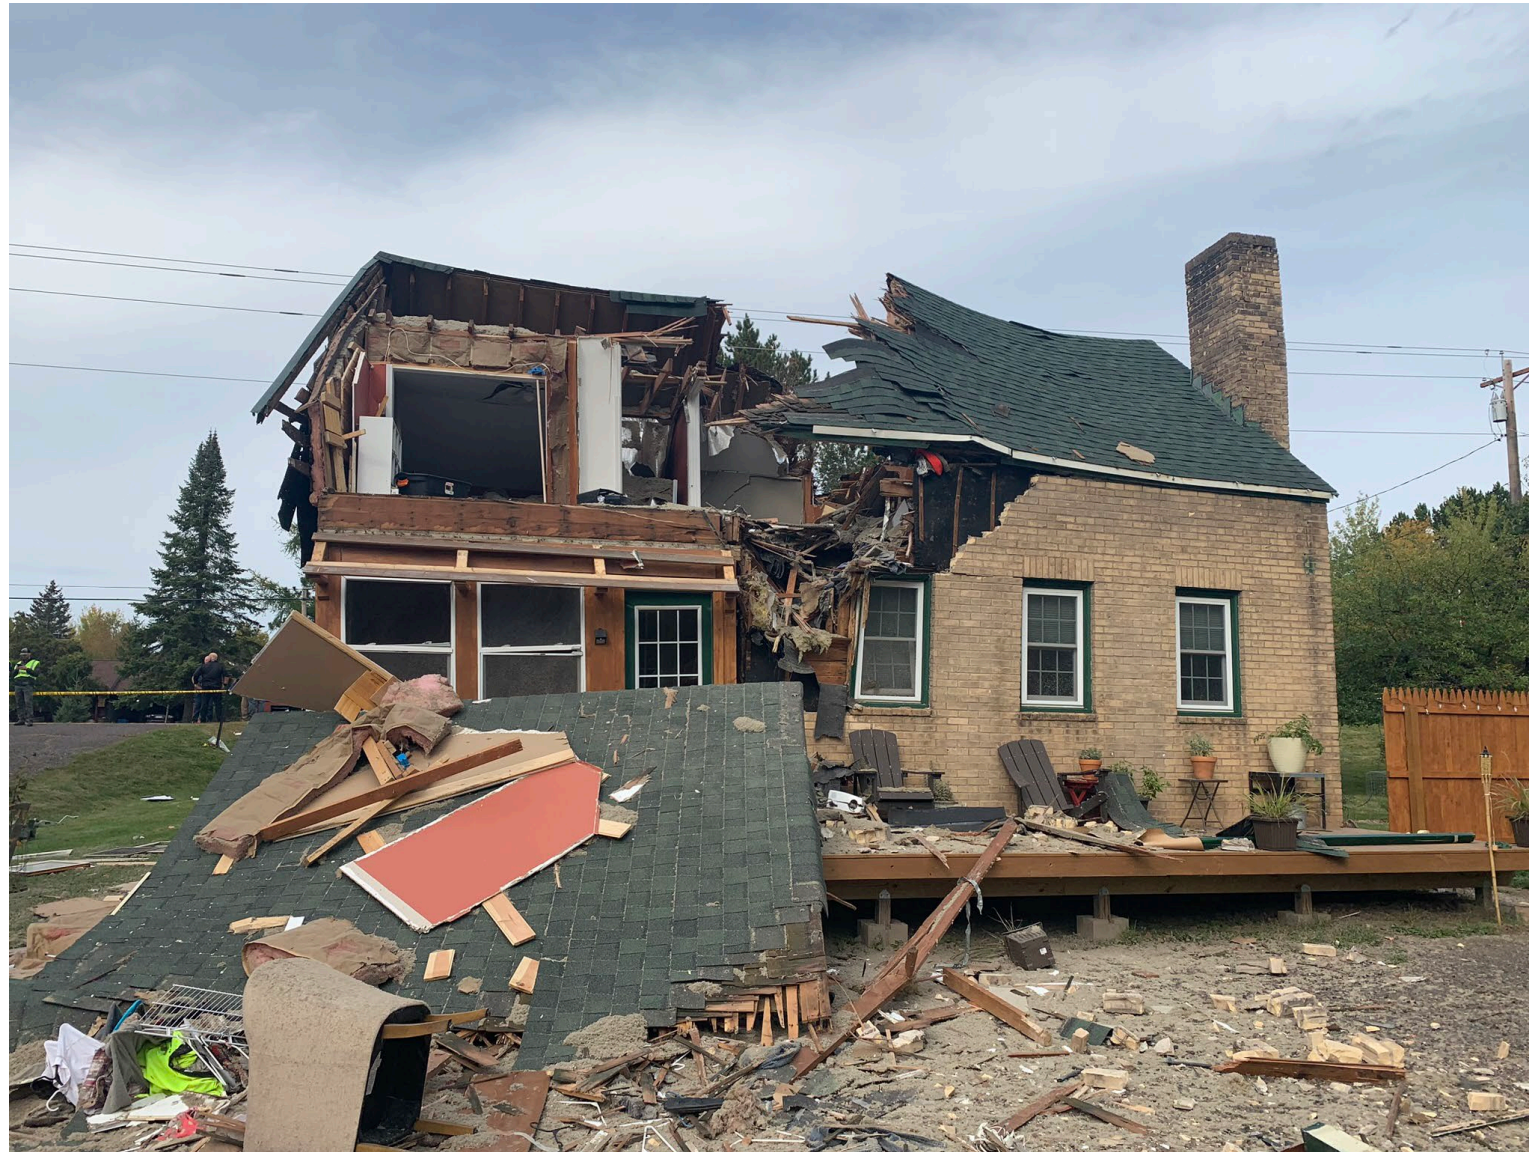
Photo 2: View of backside of damaged home where the airplane exited.

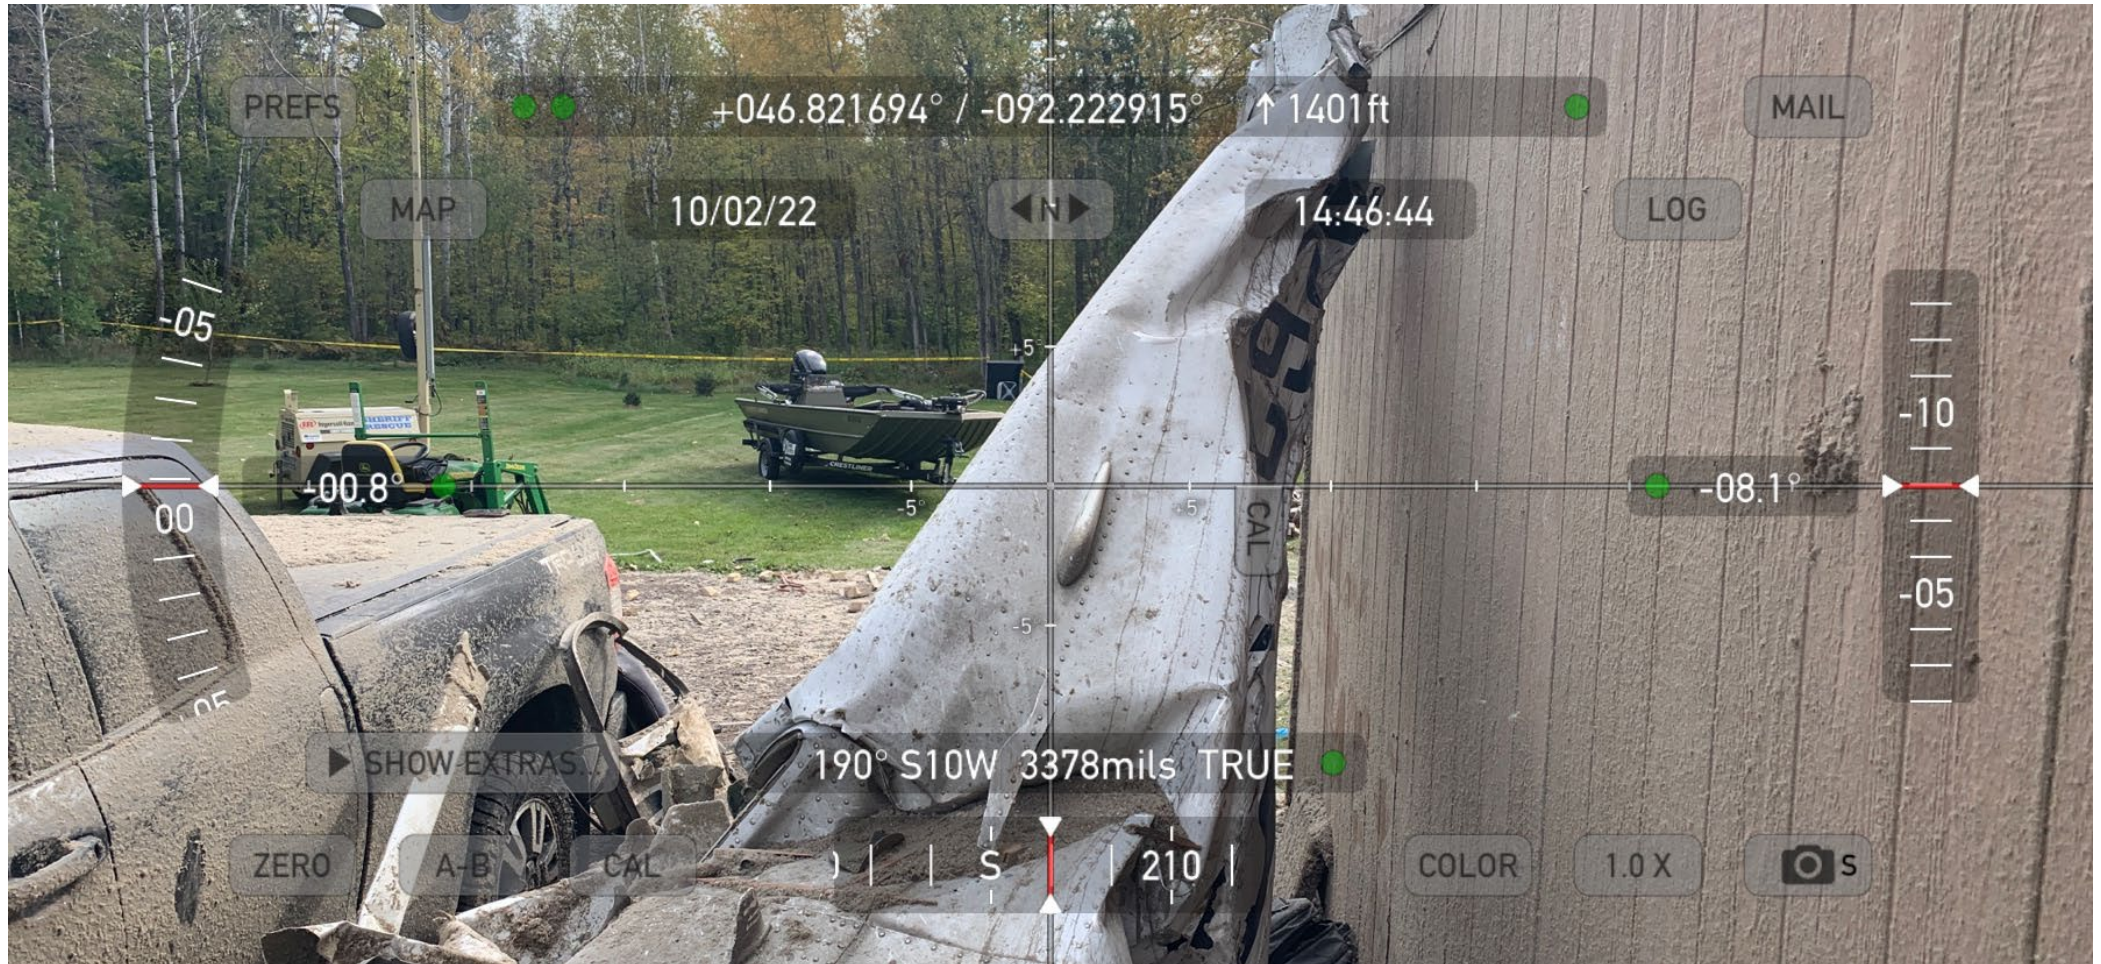
Photo 3: View of main wreckage site detailing latitude, longitude, magnetic heading and elevation.

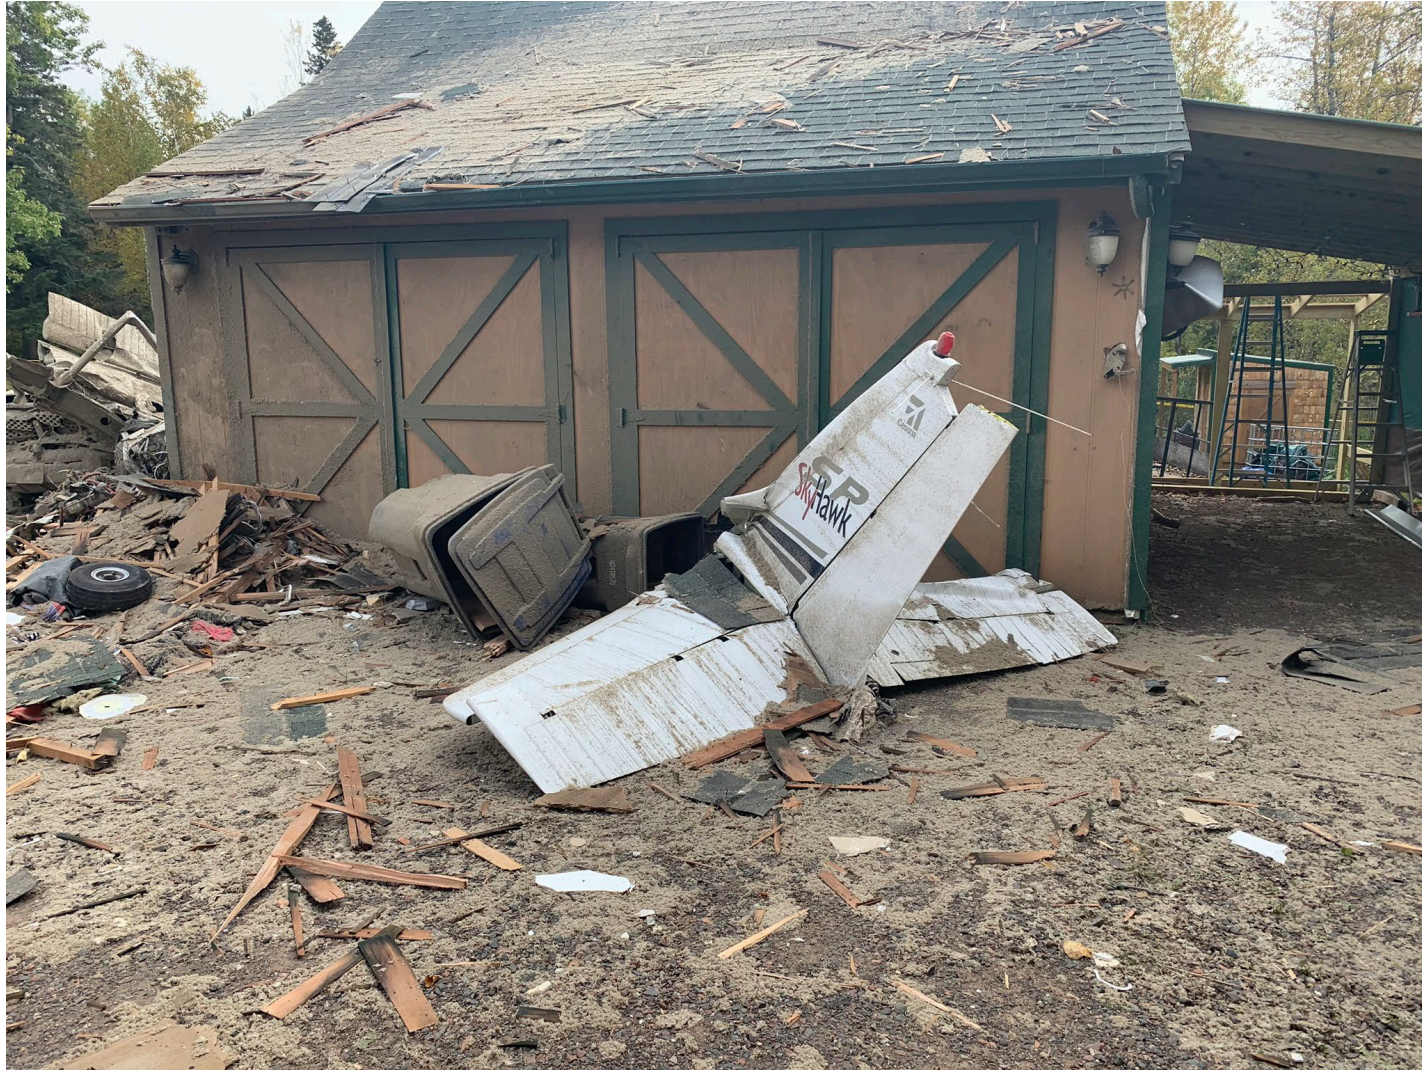
Photo 4: View of horizontal and vertical stabilizer up against garage with their respective control surfaces still in place.

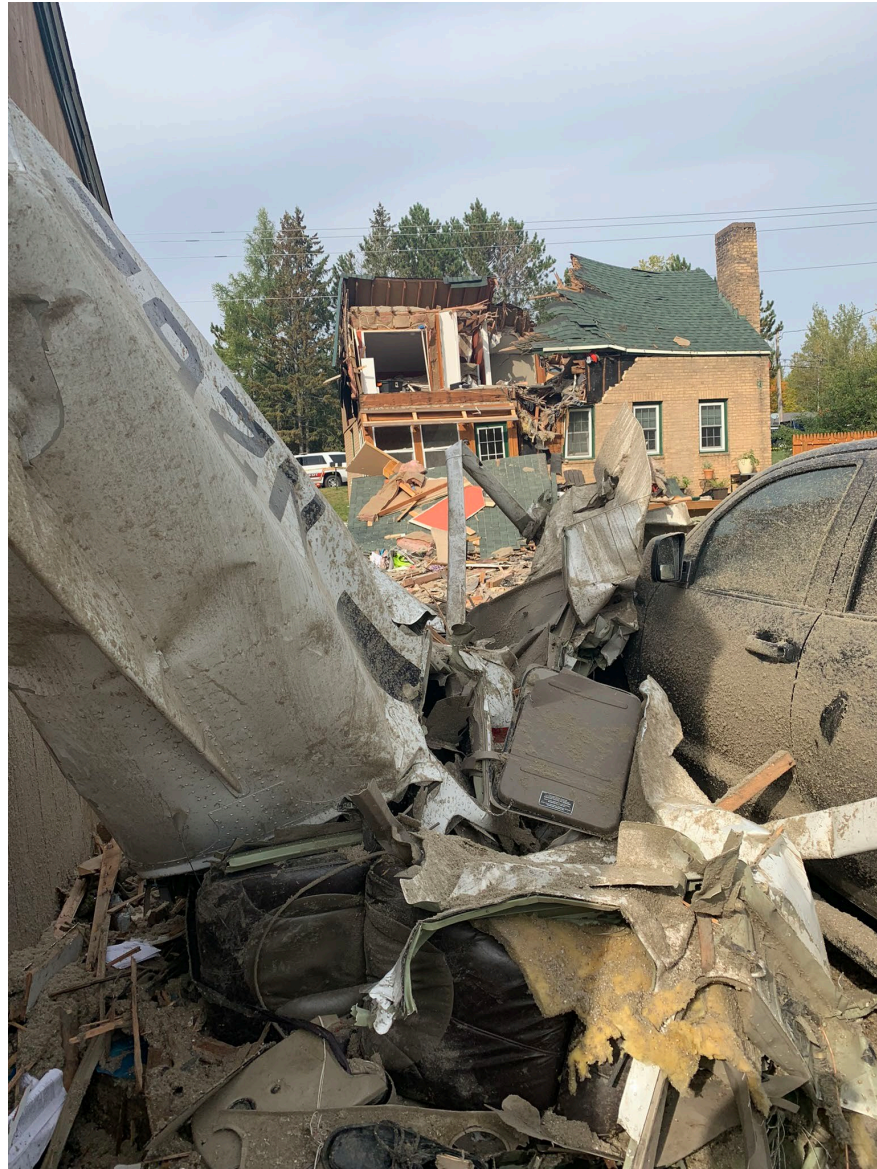
Photo 5: View of main wreckage site looking towards damaged home.

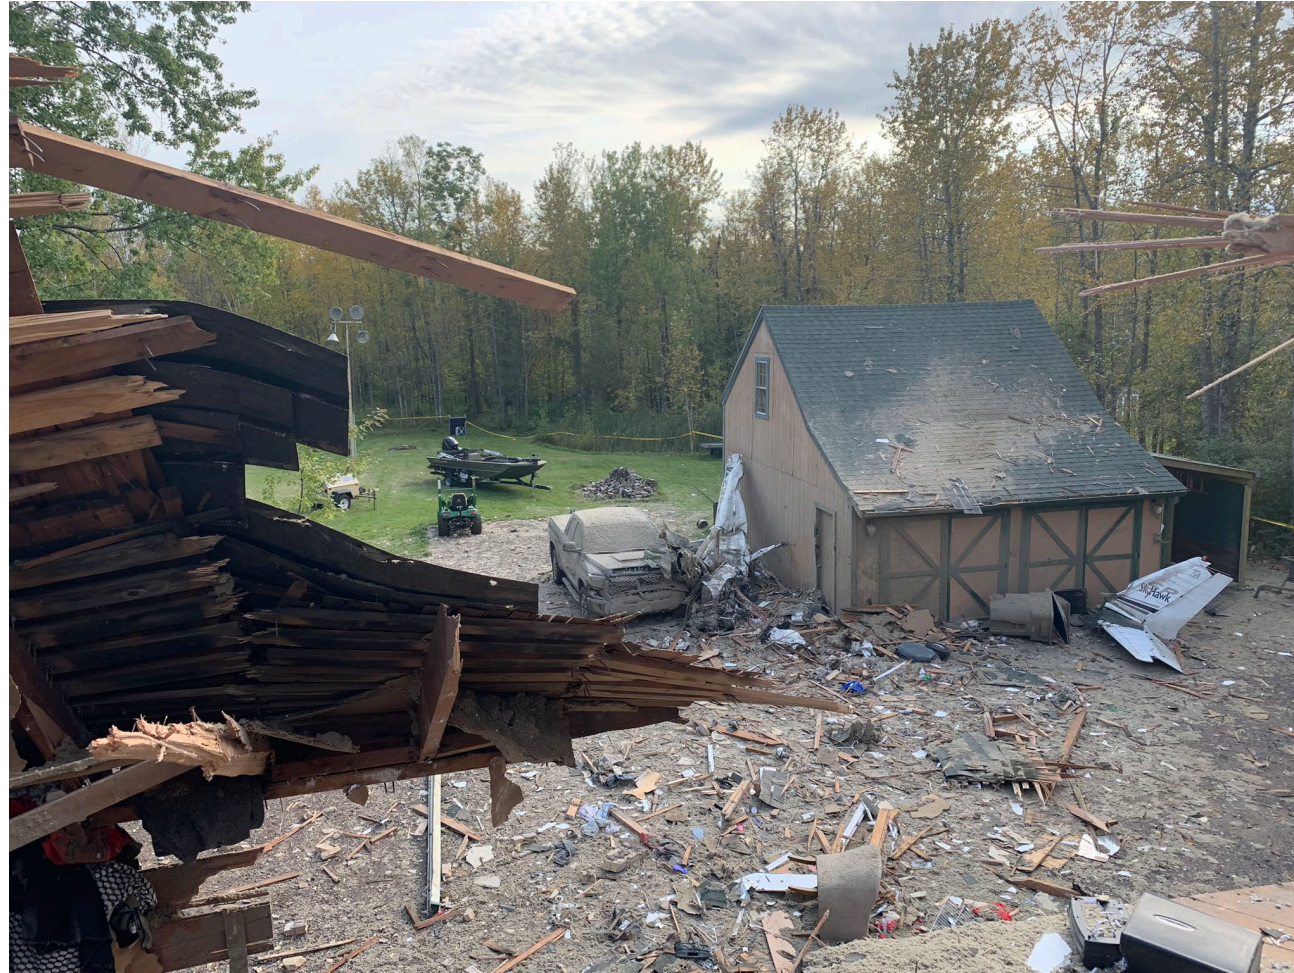
Photo 6: View of main wreckage site taken from second story floor of house.

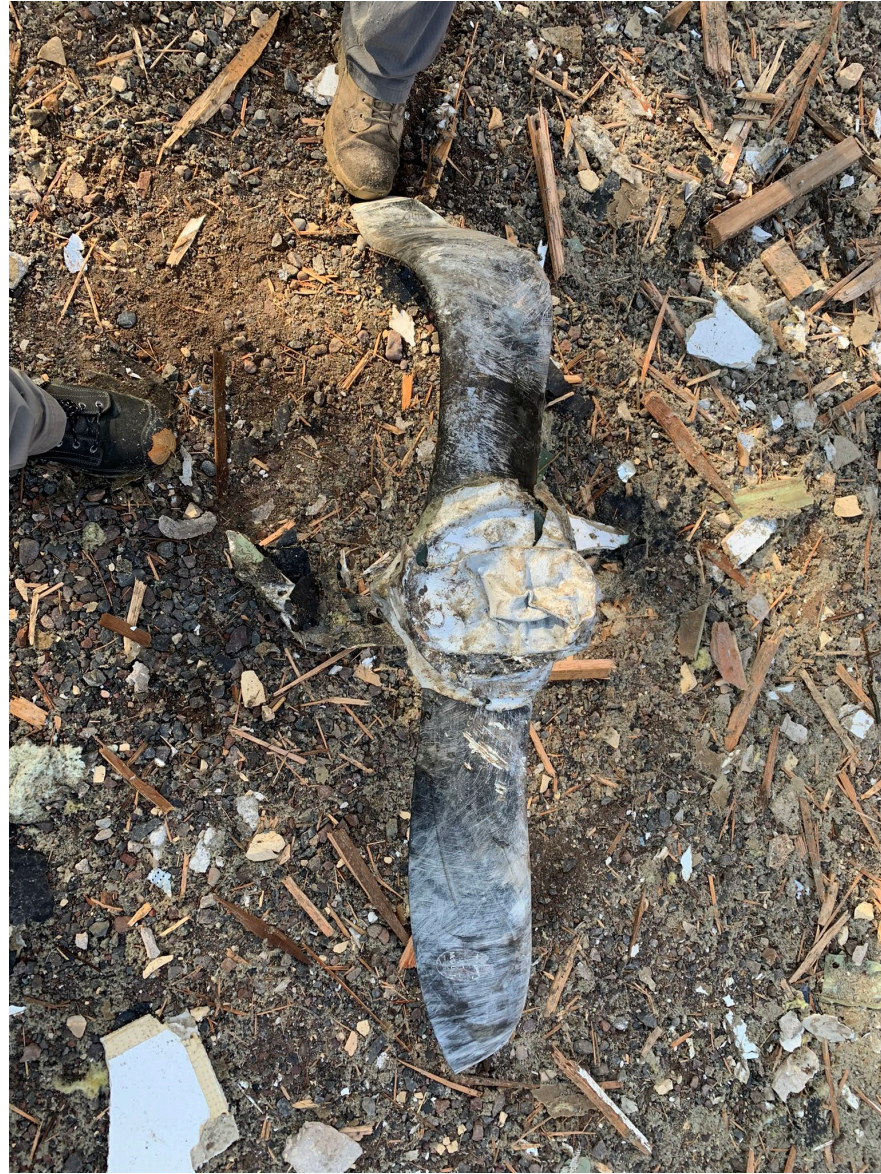
Photo 7: View of propeller assembly showing both blades and crushed spinner. Note the s-bending and chordwise scraping.

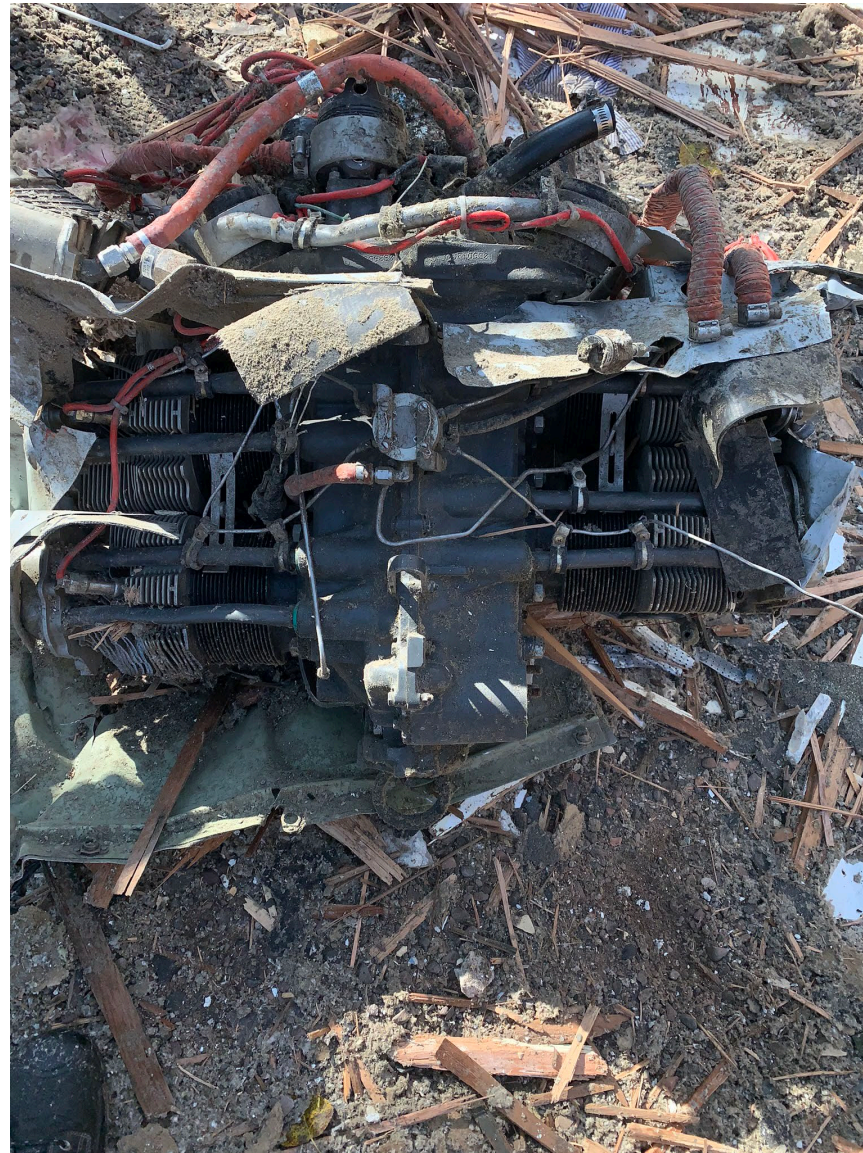
Photo 8: View of engine after removal from debris pile.

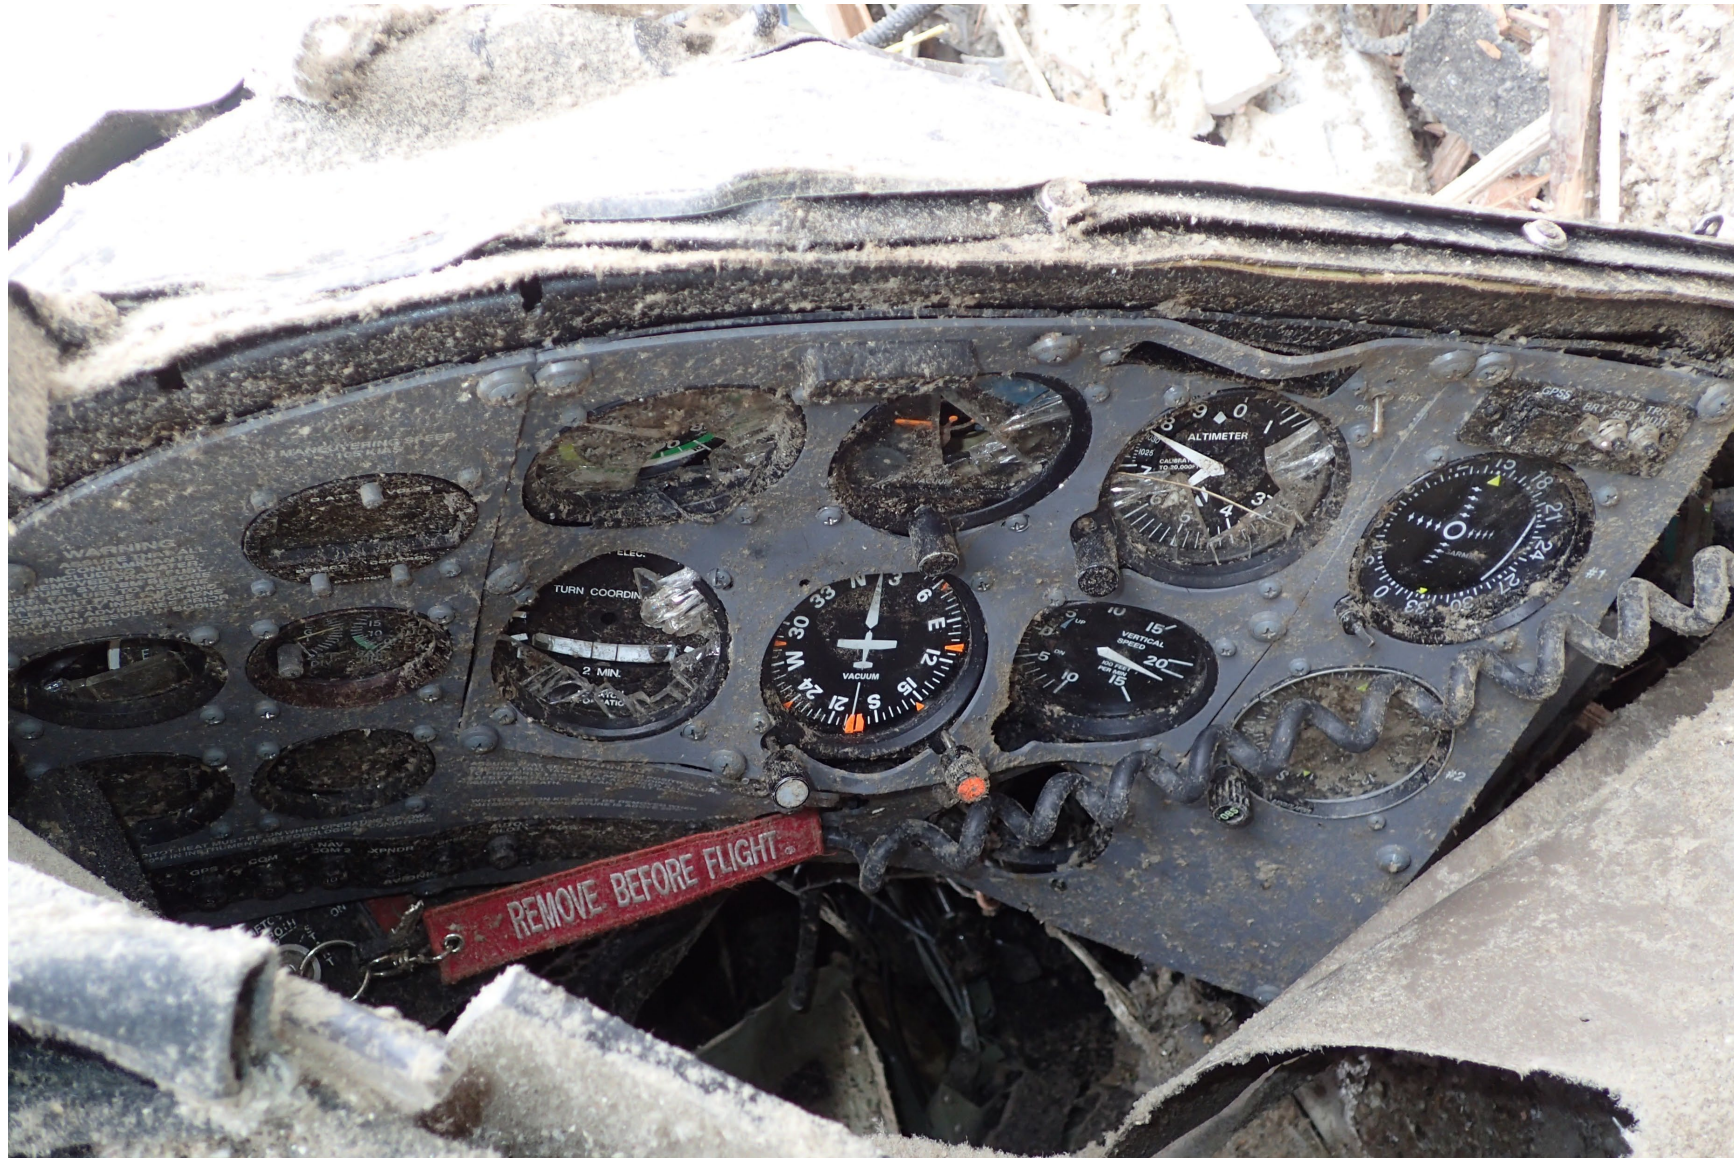
Photo 9: View of cockpit instrument panel at accident site.(Courtesy of Textron)

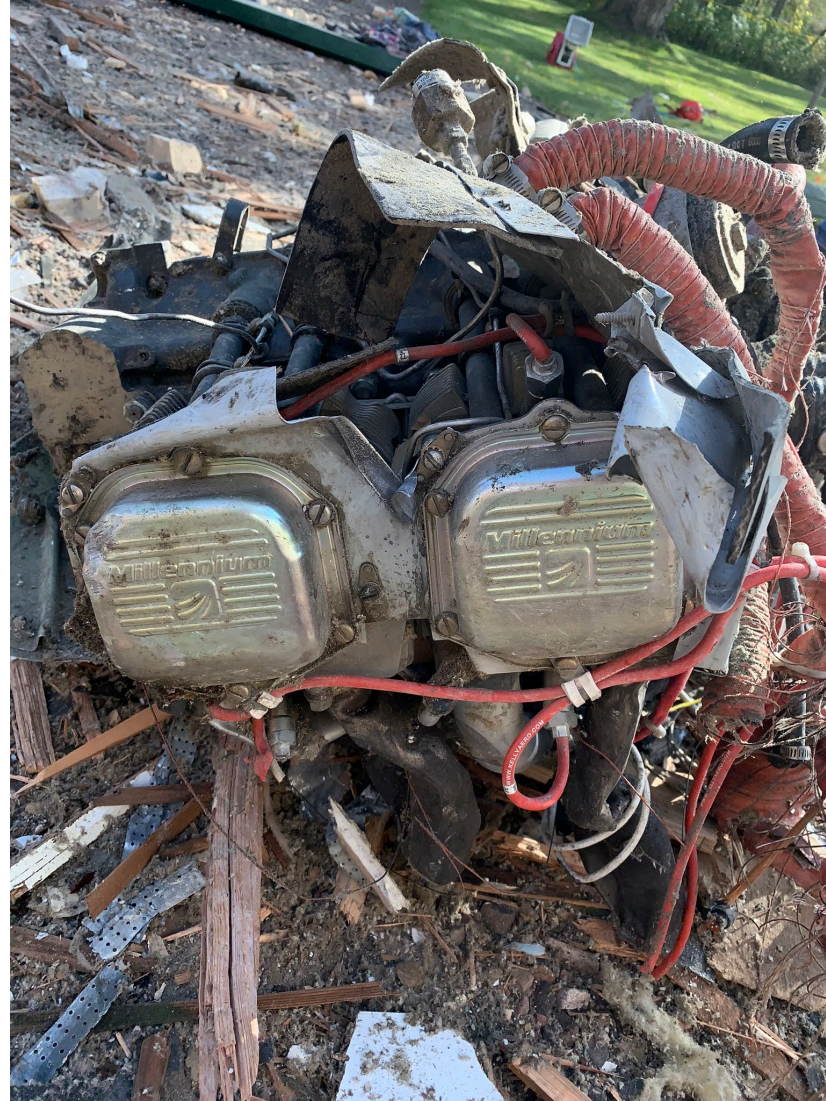
Photo 10: View of left side of engine at wreckage site.

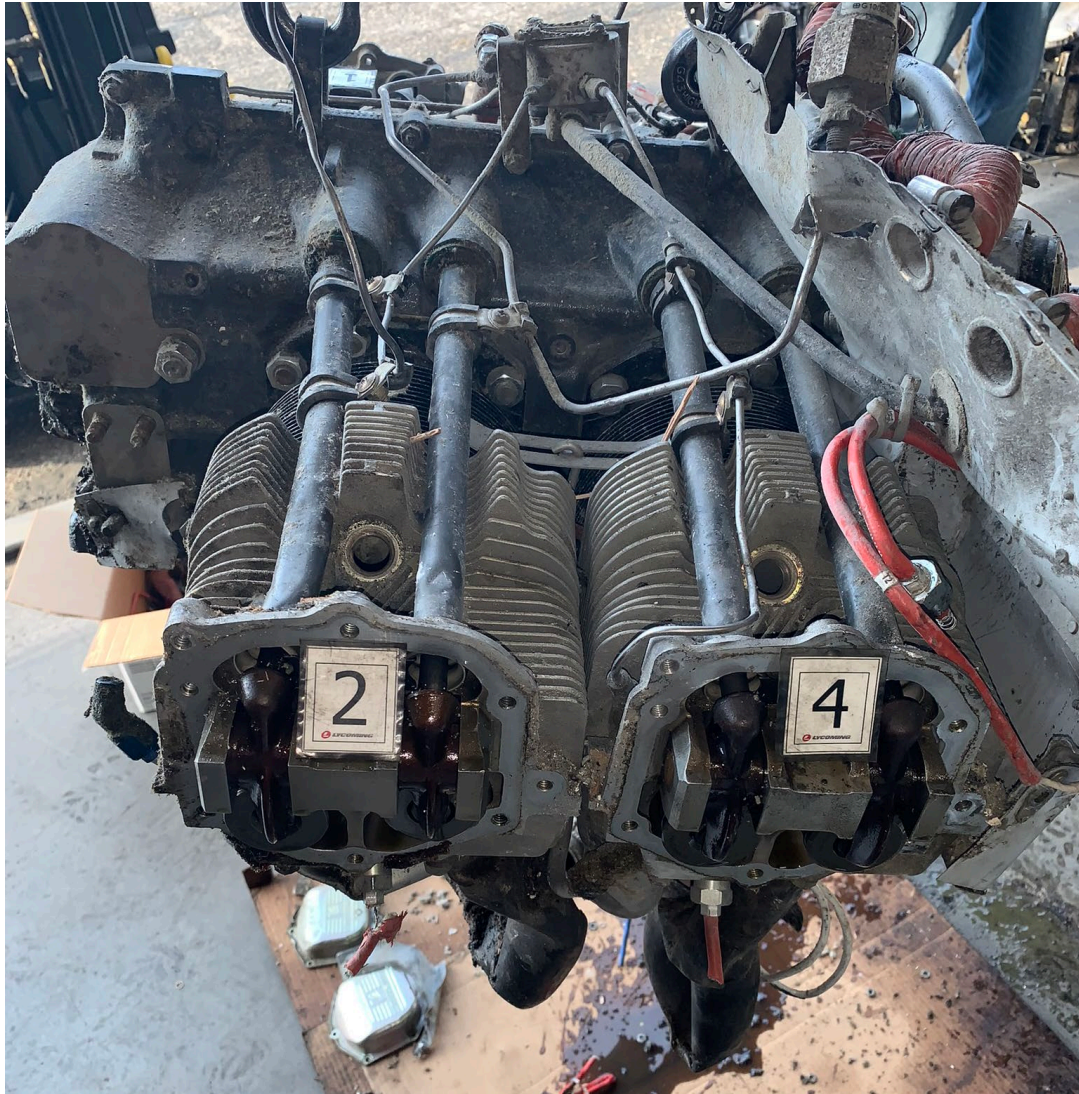
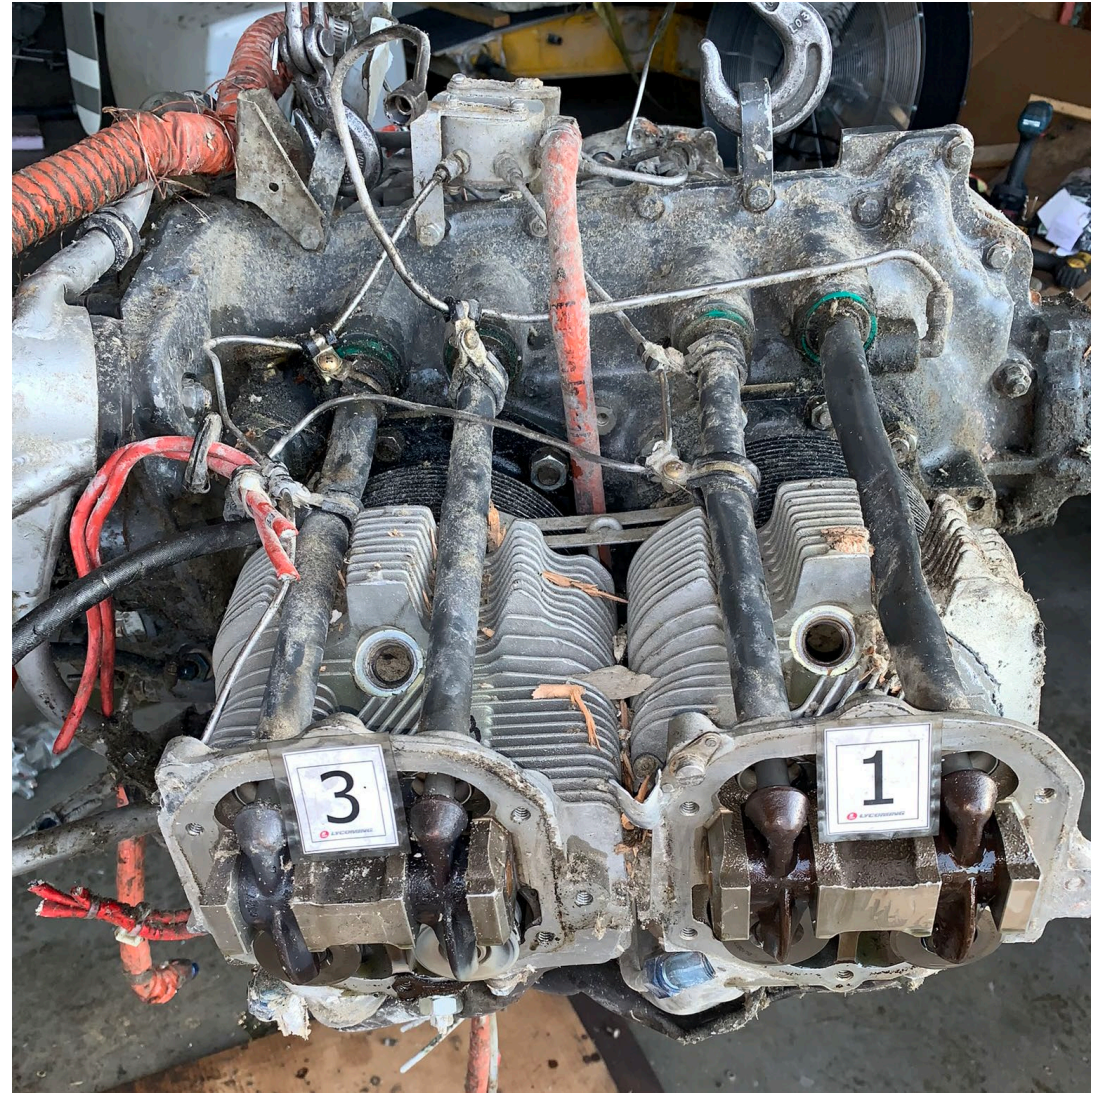
Photo 10: View of engine after removal of valve covers at exam location. (Courtesy of Lycoming)

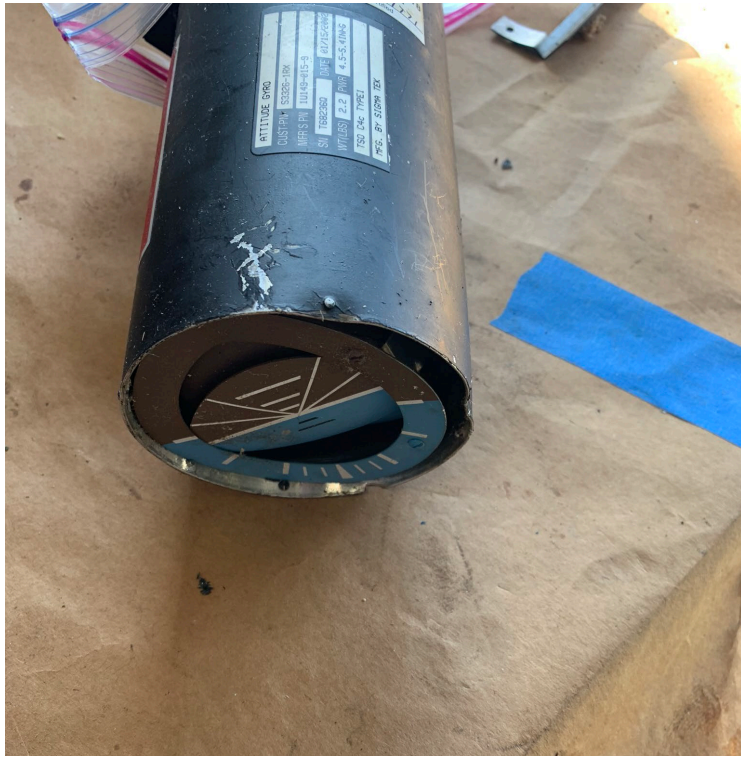
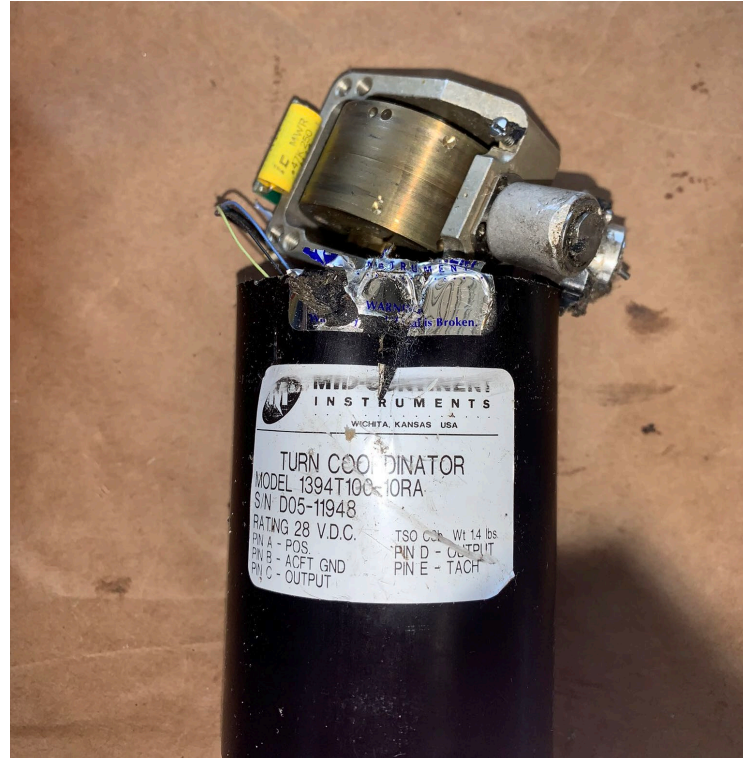
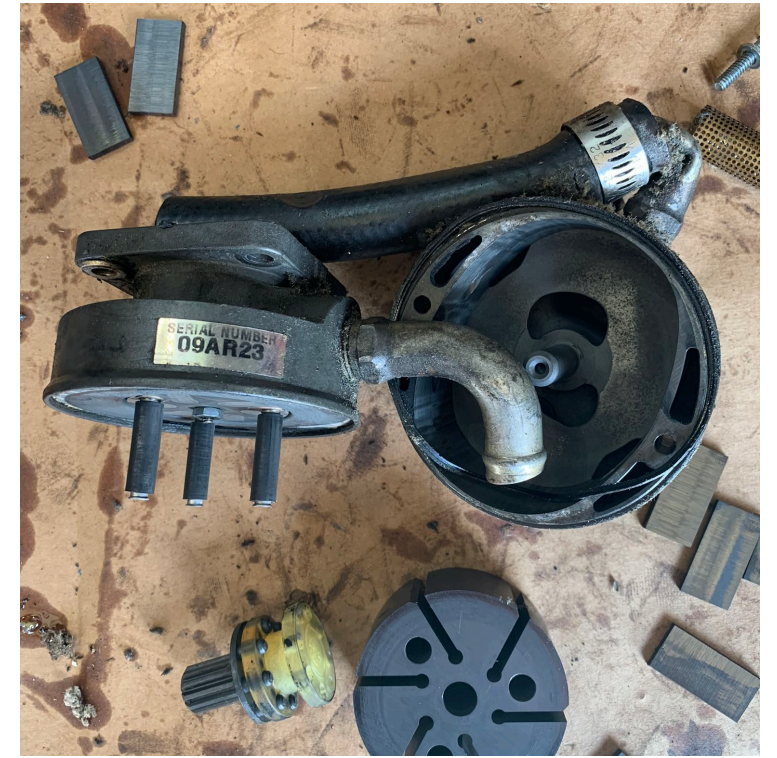
Photos 11, 12, 13: View of attitude indicator, turn coordinator and vacuum system after removal.
