ERA24LA039

INVESTIGATION PHOTOGRAPHS

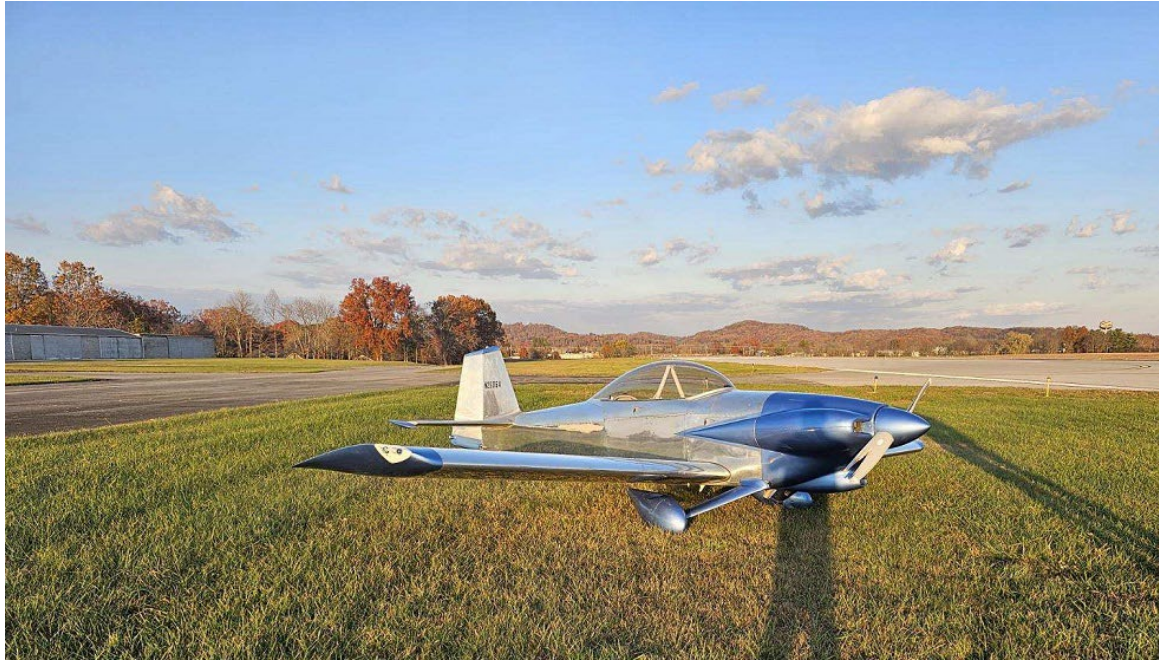
Photograph 1 - Main Wreckage (Courtesy of FAA)

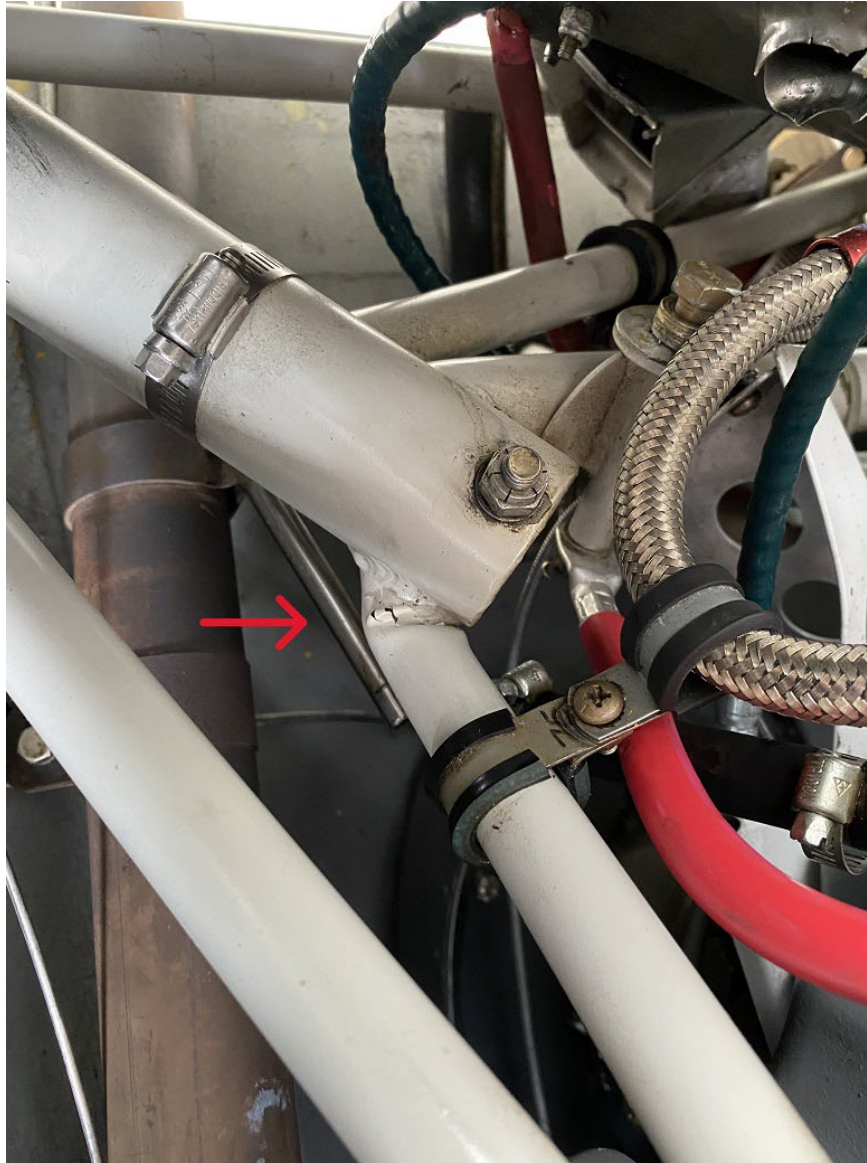
Photograph 2 - Bent Frame Tube (Courtesy of FAA)

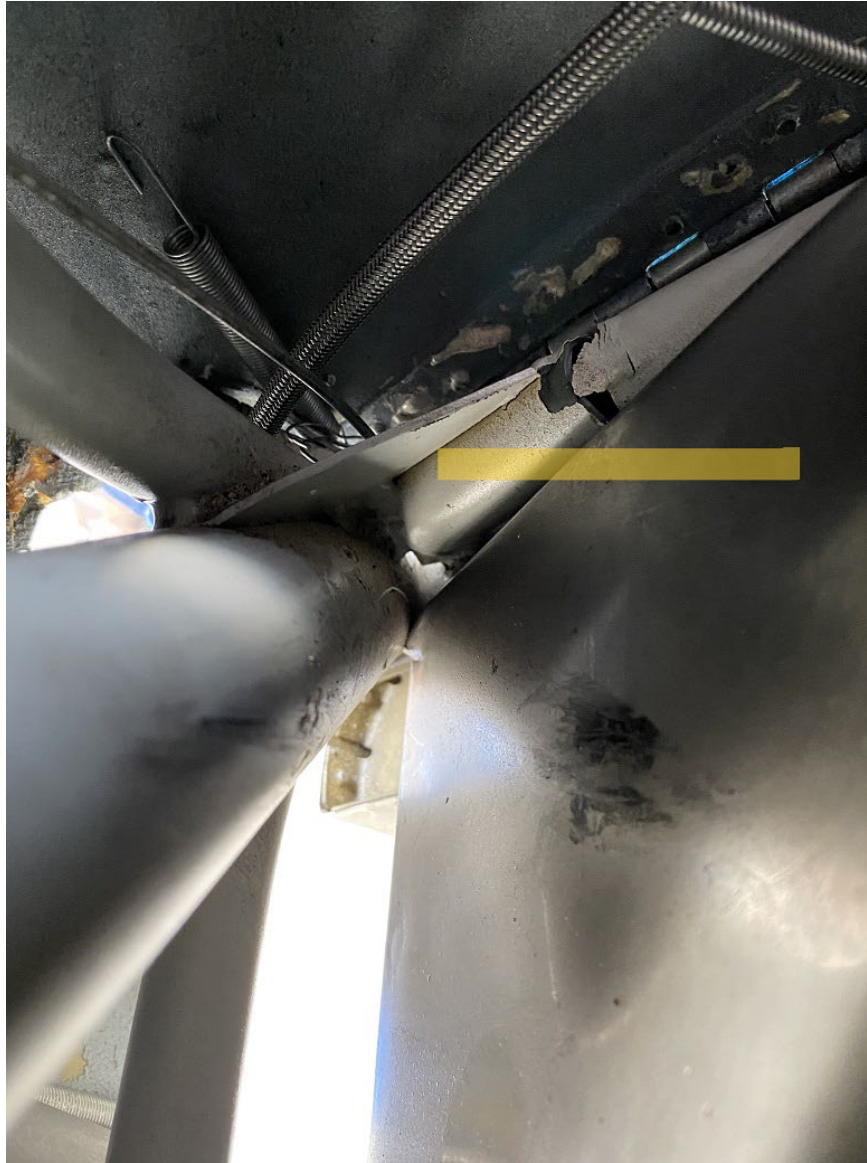
Photograph 3 - Separated Frame Tube (Courtesy of FAA)

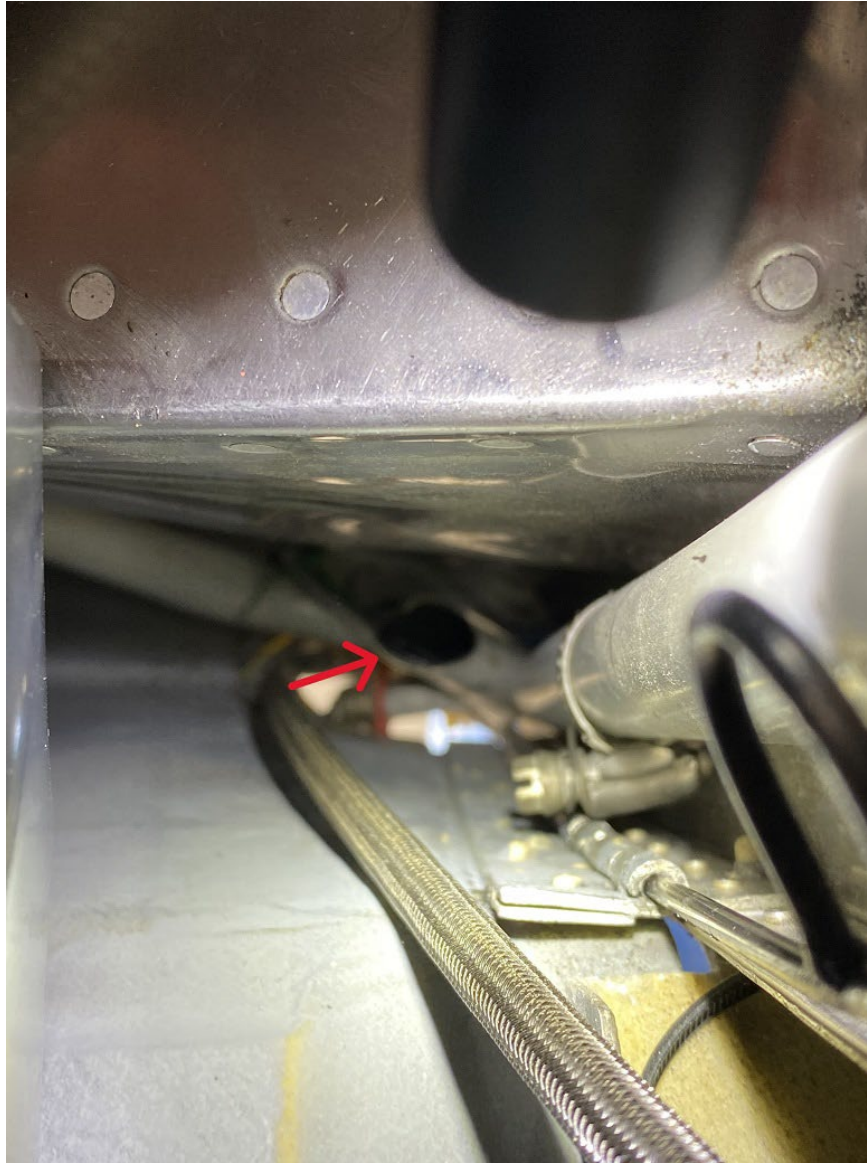
Photograph 4 - Second Separated Frame Tube (Courtesy of FAA)

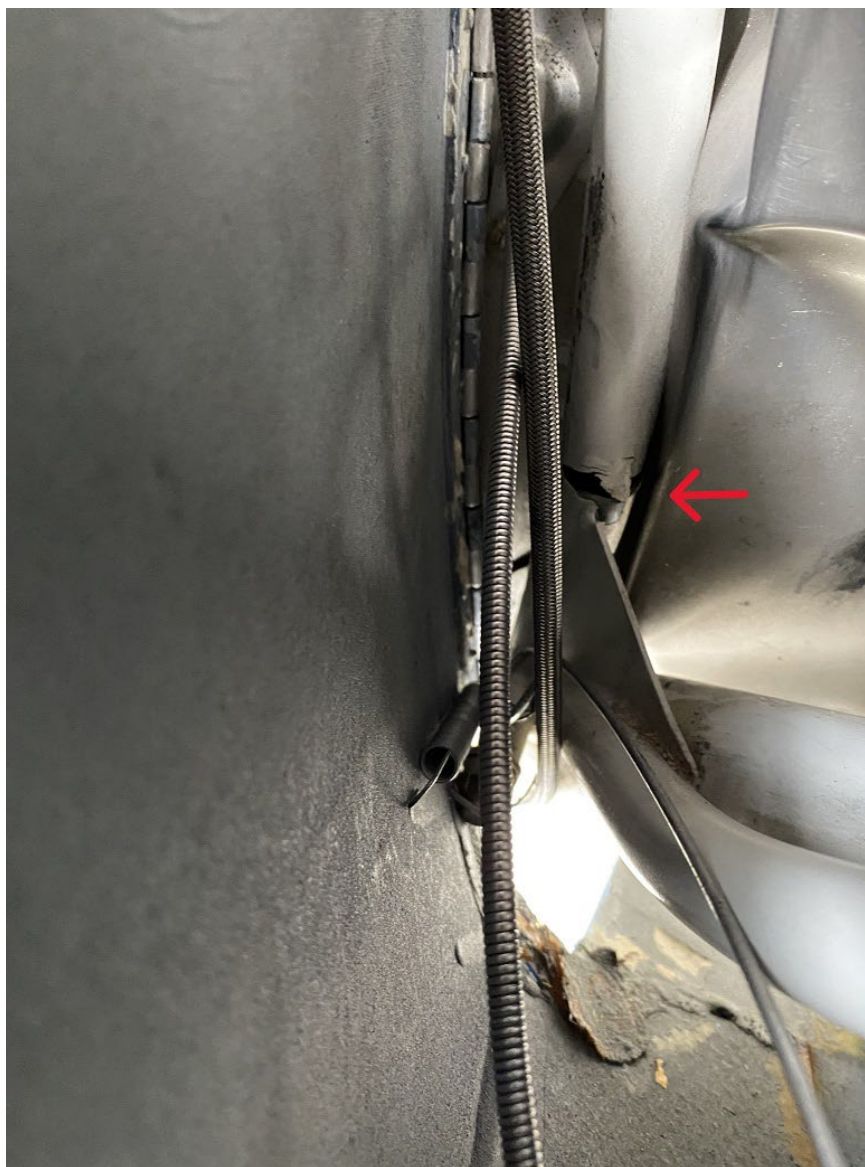
Photograph 5 - Third Separated Frame Tube (Courtesy of FAA)
