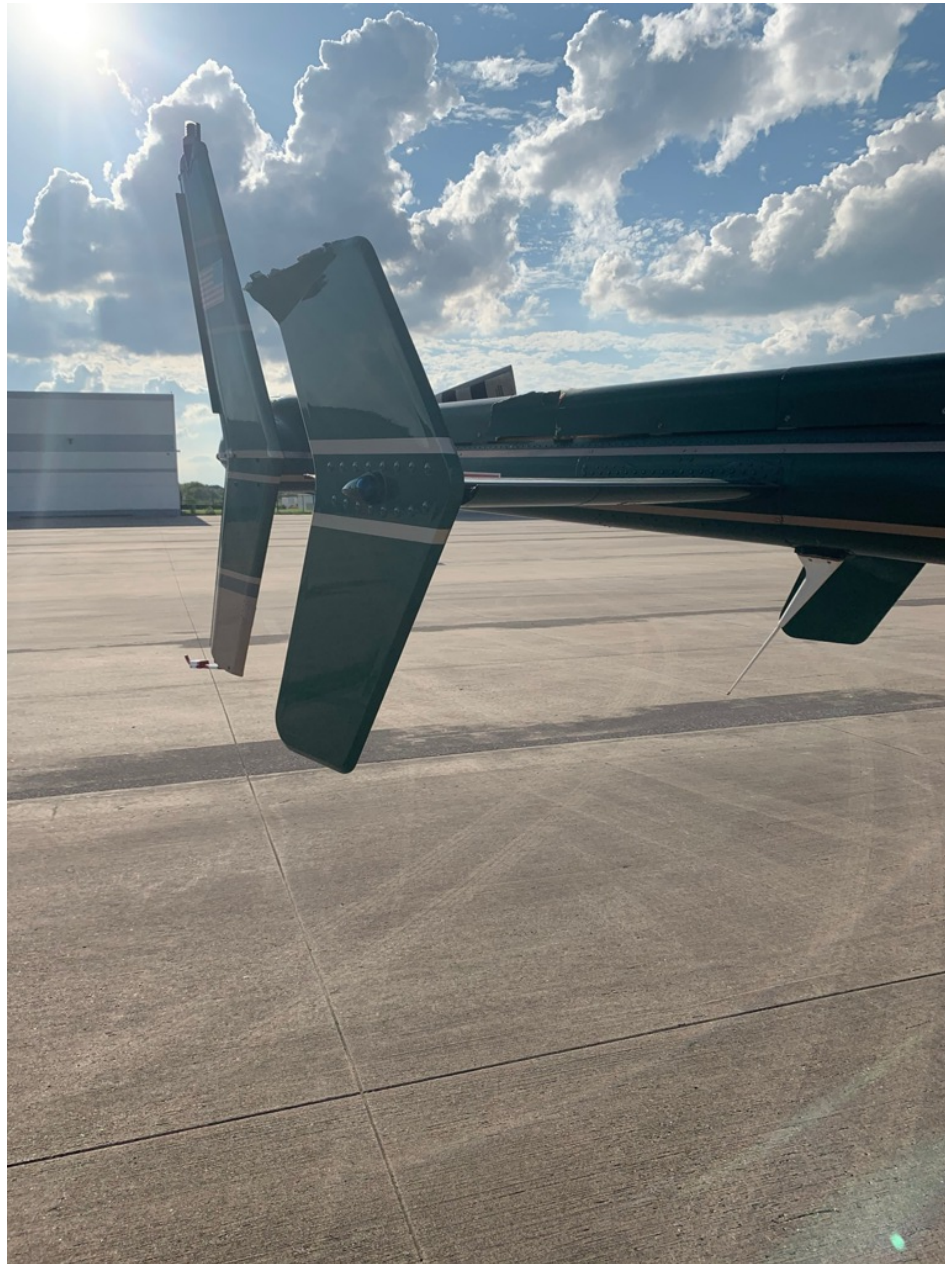
**Photo 1 – Substantial Damage to Tailboom**

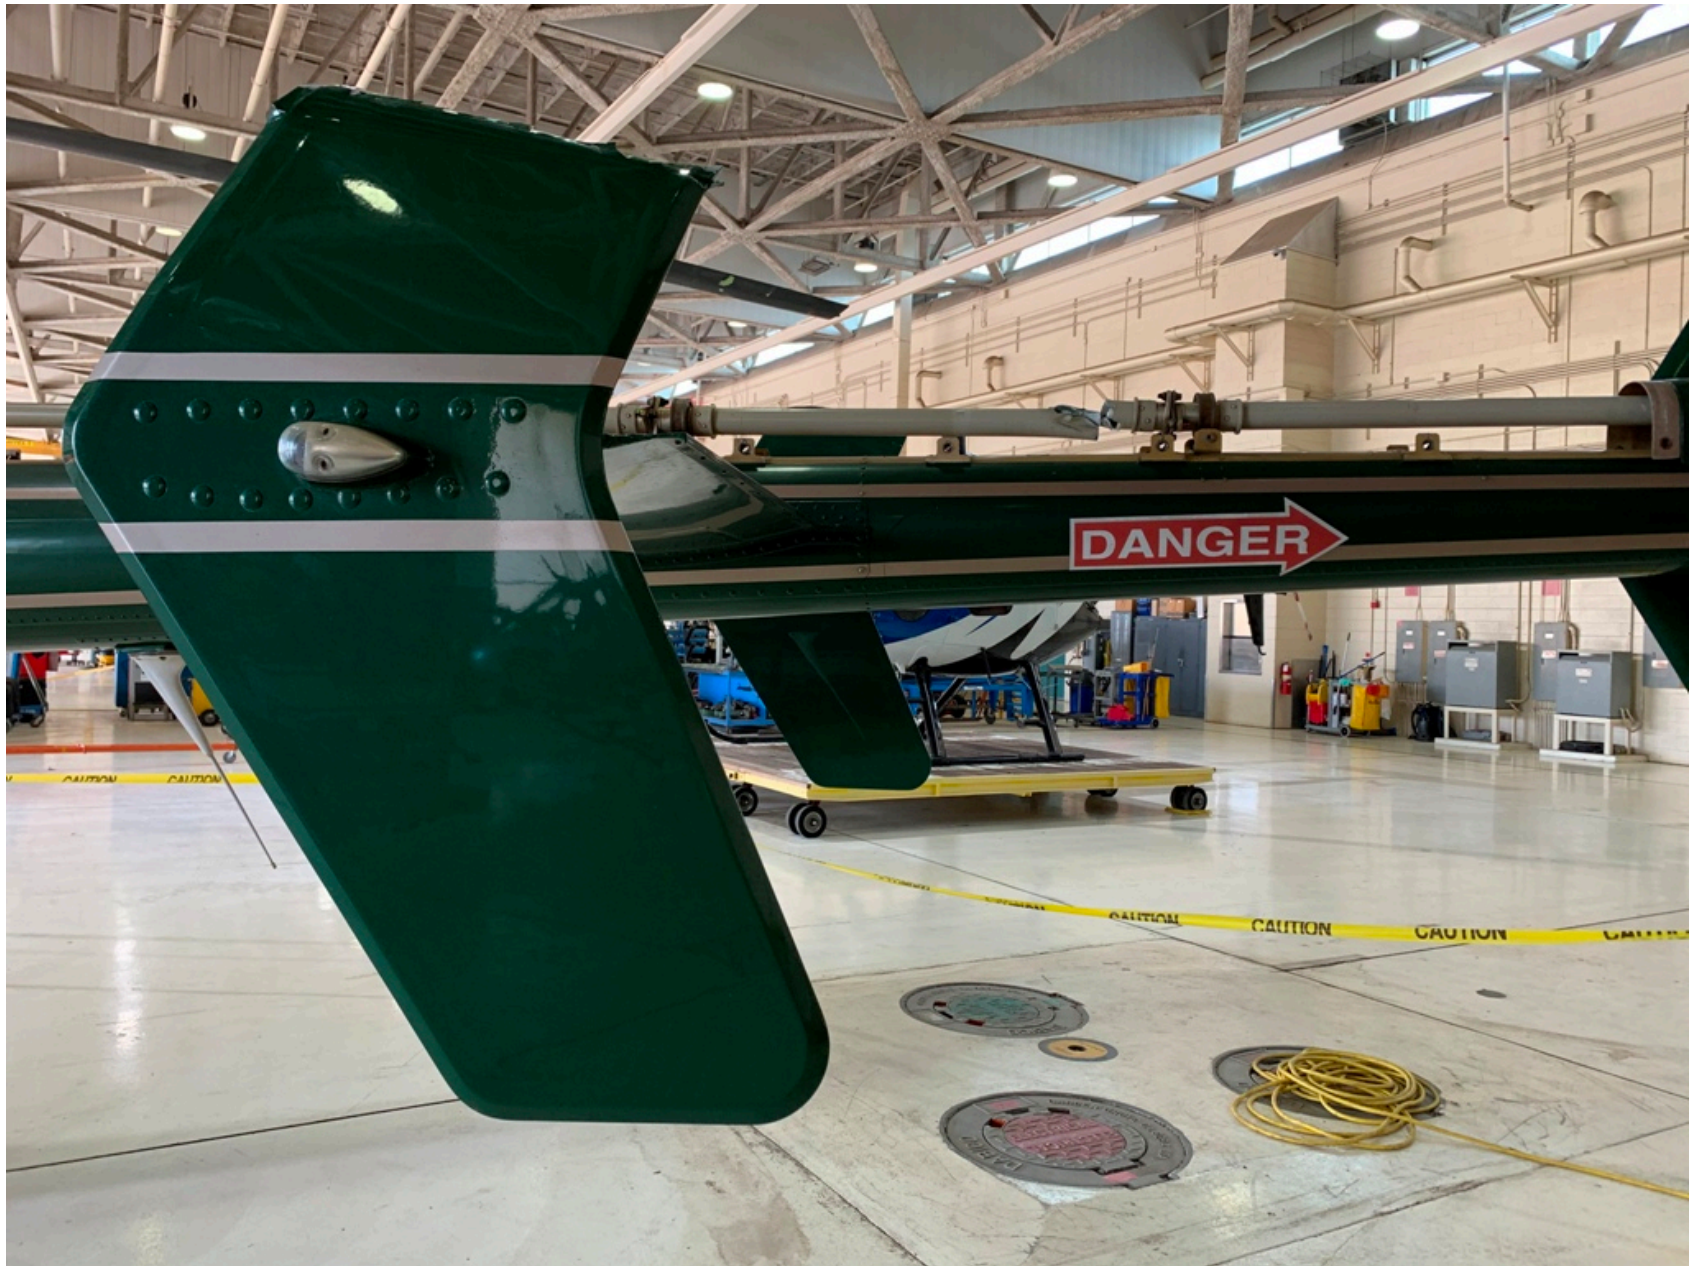
**Photo 2 – Damage to Tailrotor Driveshaft and Vertical Fins**

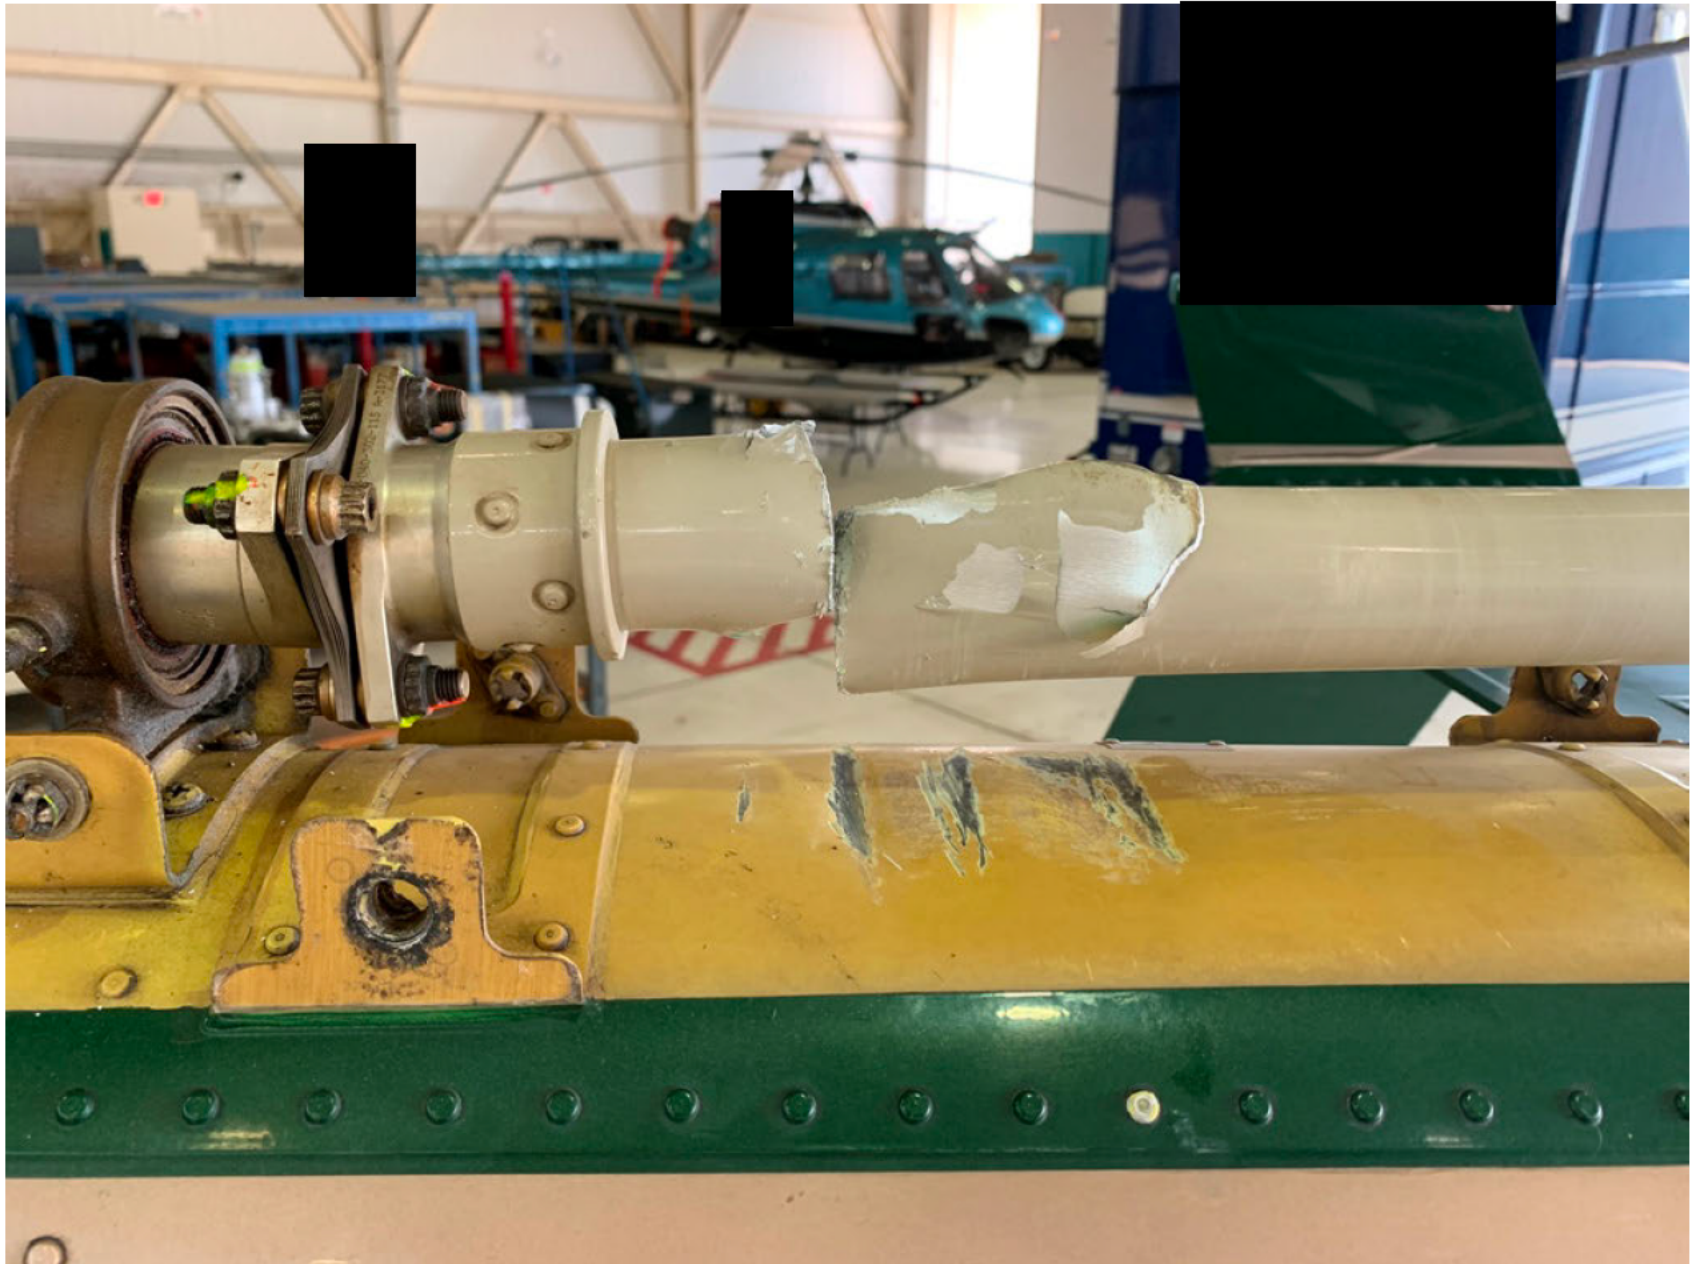
**Photo 3 – Closeup of Damage to Tailrotor Driveshaft**
