ERA23FA006

INVESTIGATION PHOTOGRAPHS

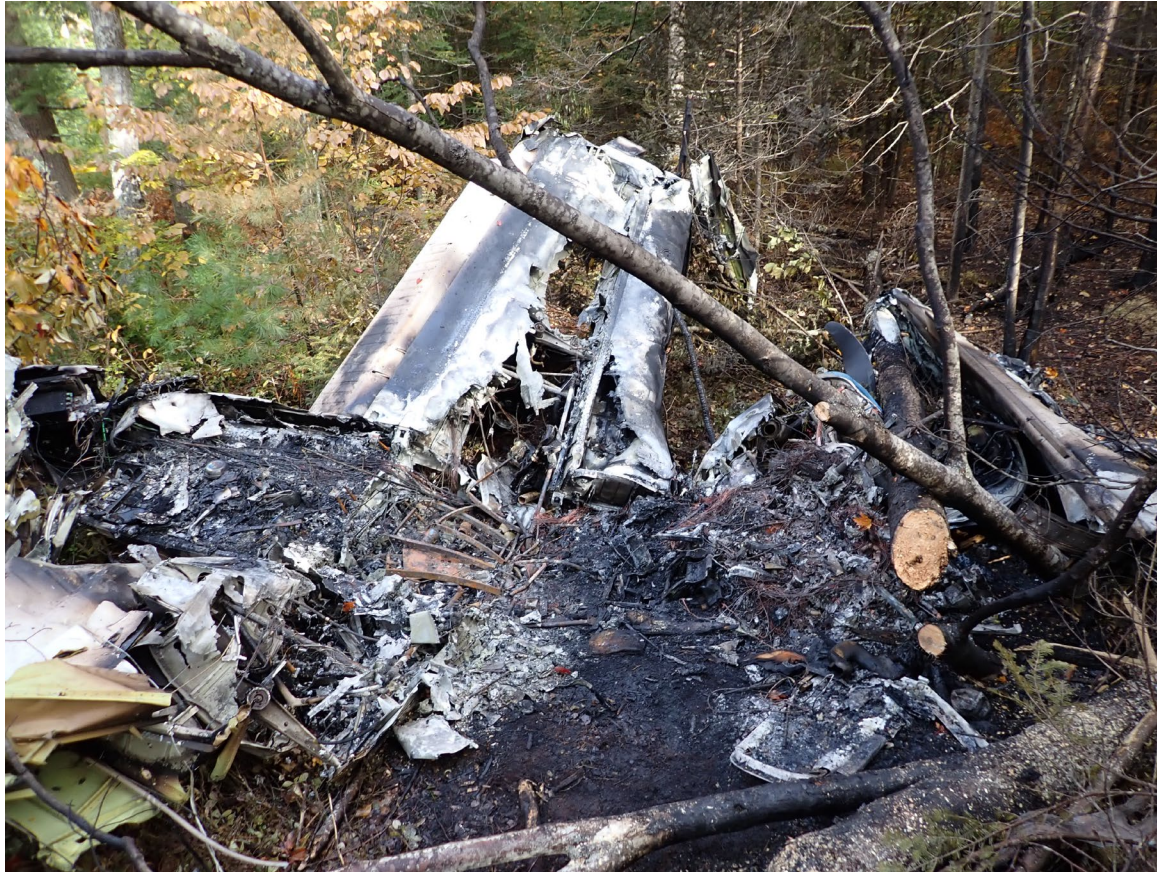
Photograph 1 - View of the fuselage and left wing at the accident site.

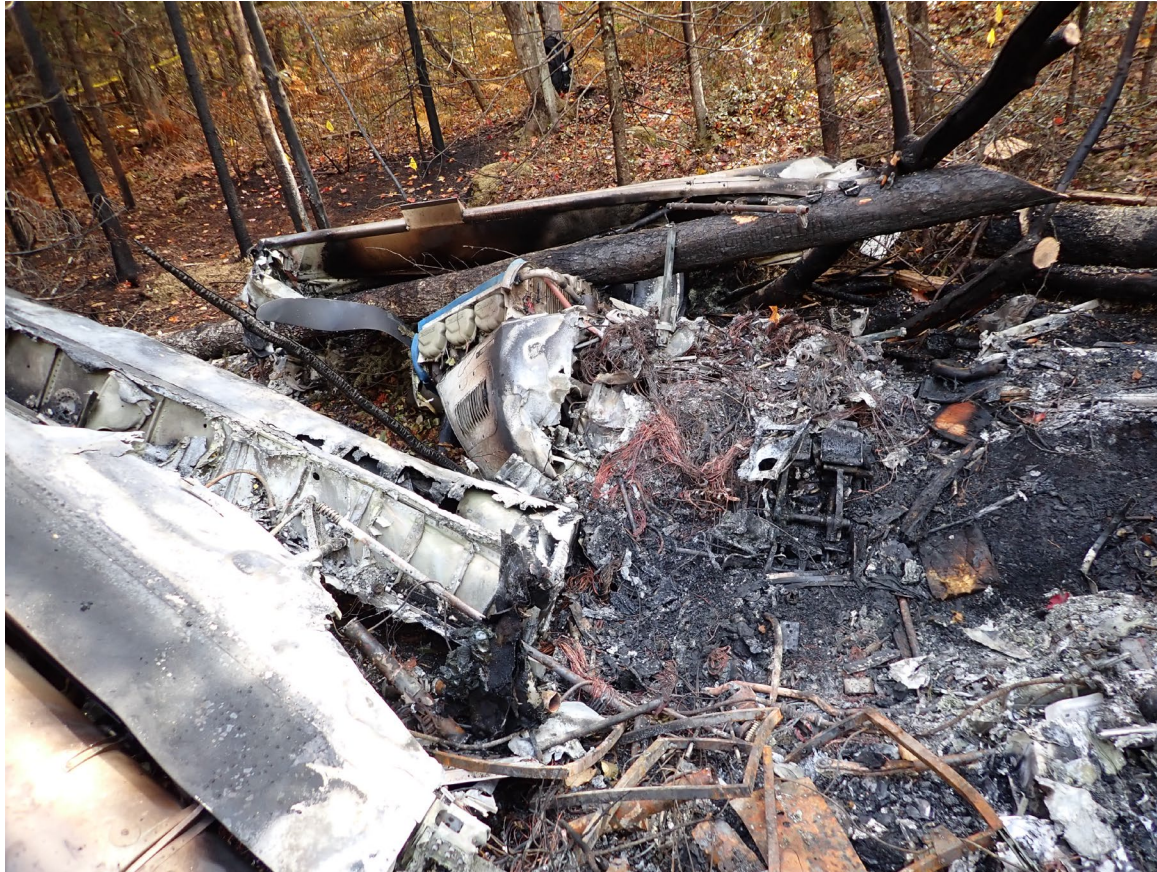
Photograph 2 - View of the cockpit at the accident site.

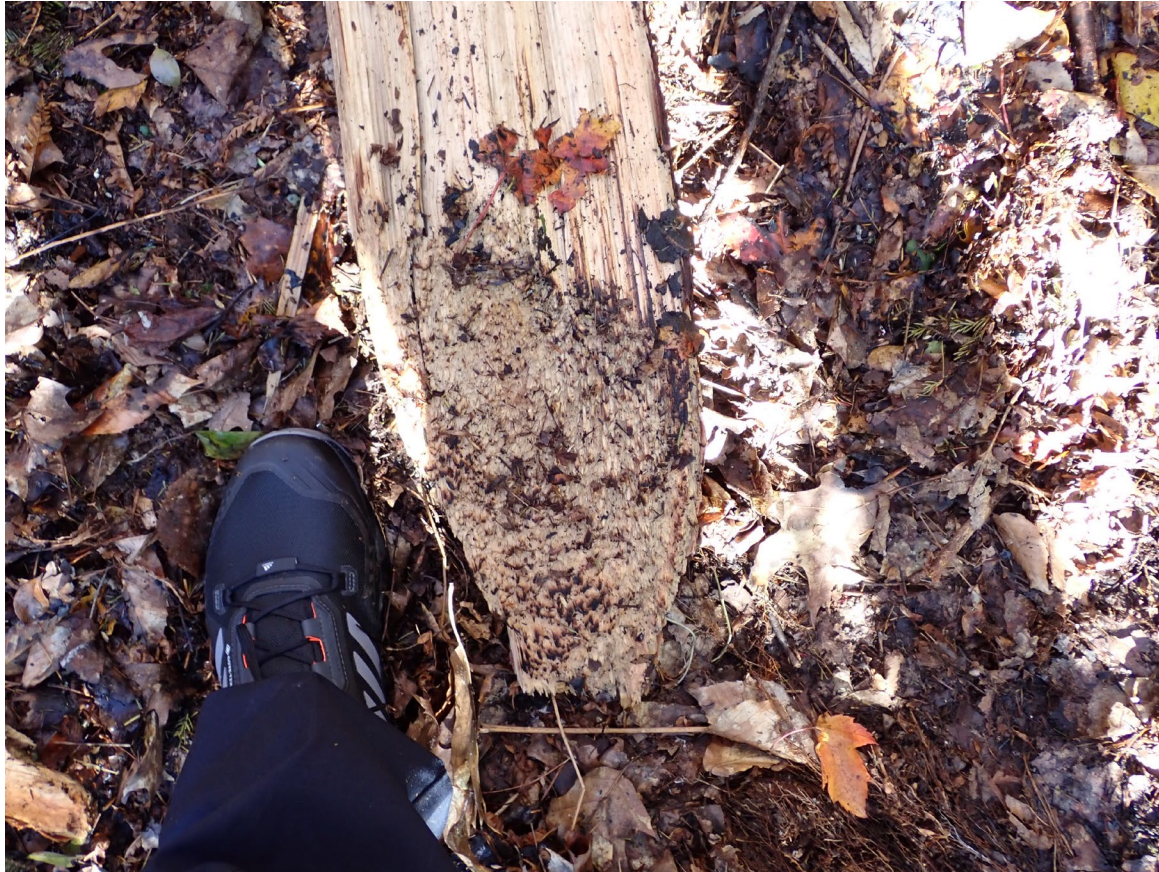
Photograph 3 - View of angular cut wood found near the main wreckage.

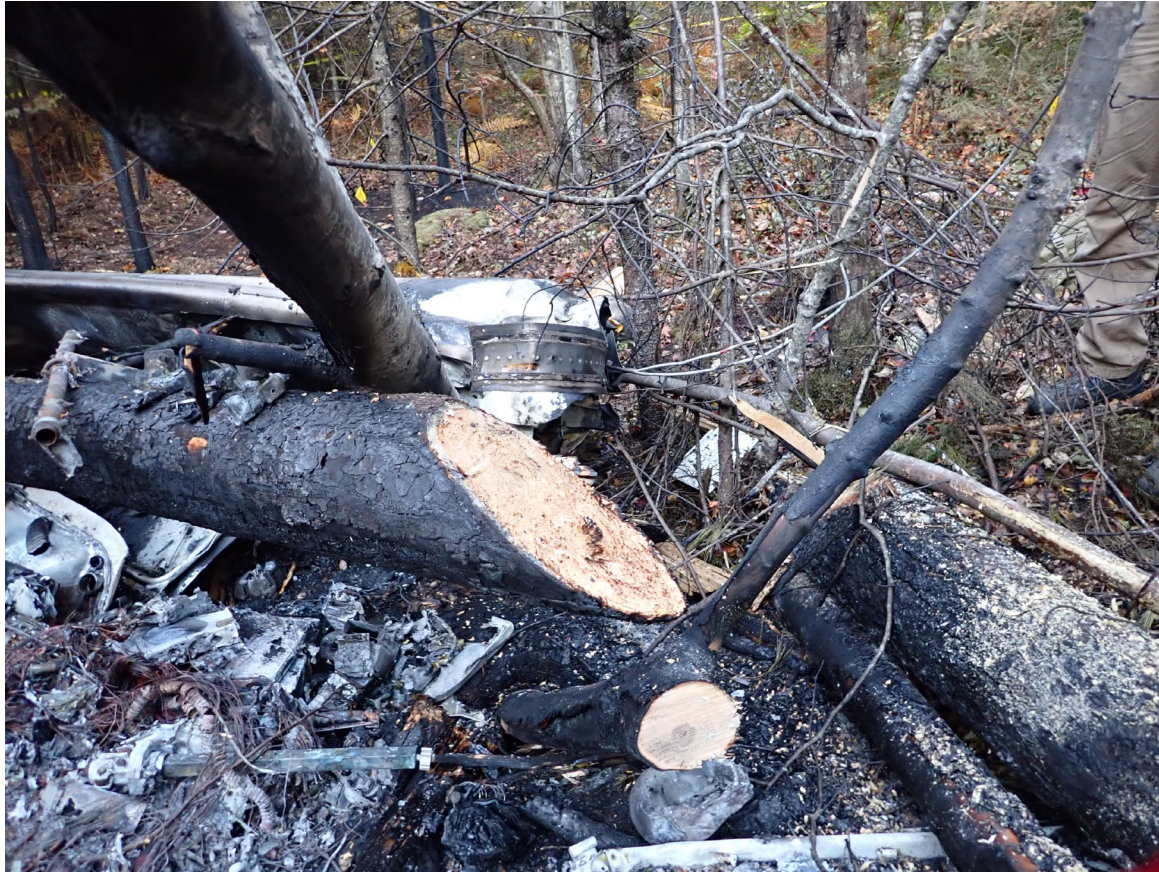
Photograph 4 - View of angular cut wood at the accident site.

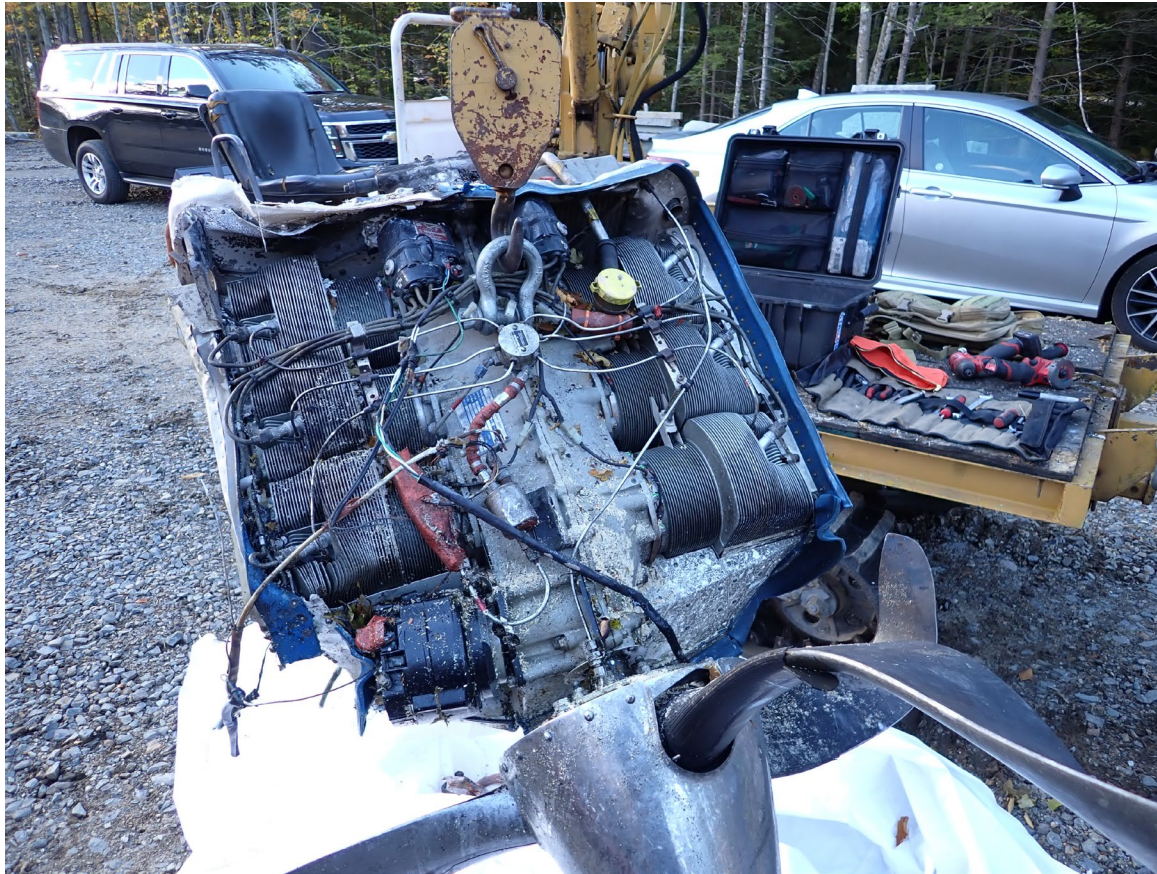
Photograph 5 - View of the top of the engine after recovery from the accident site.

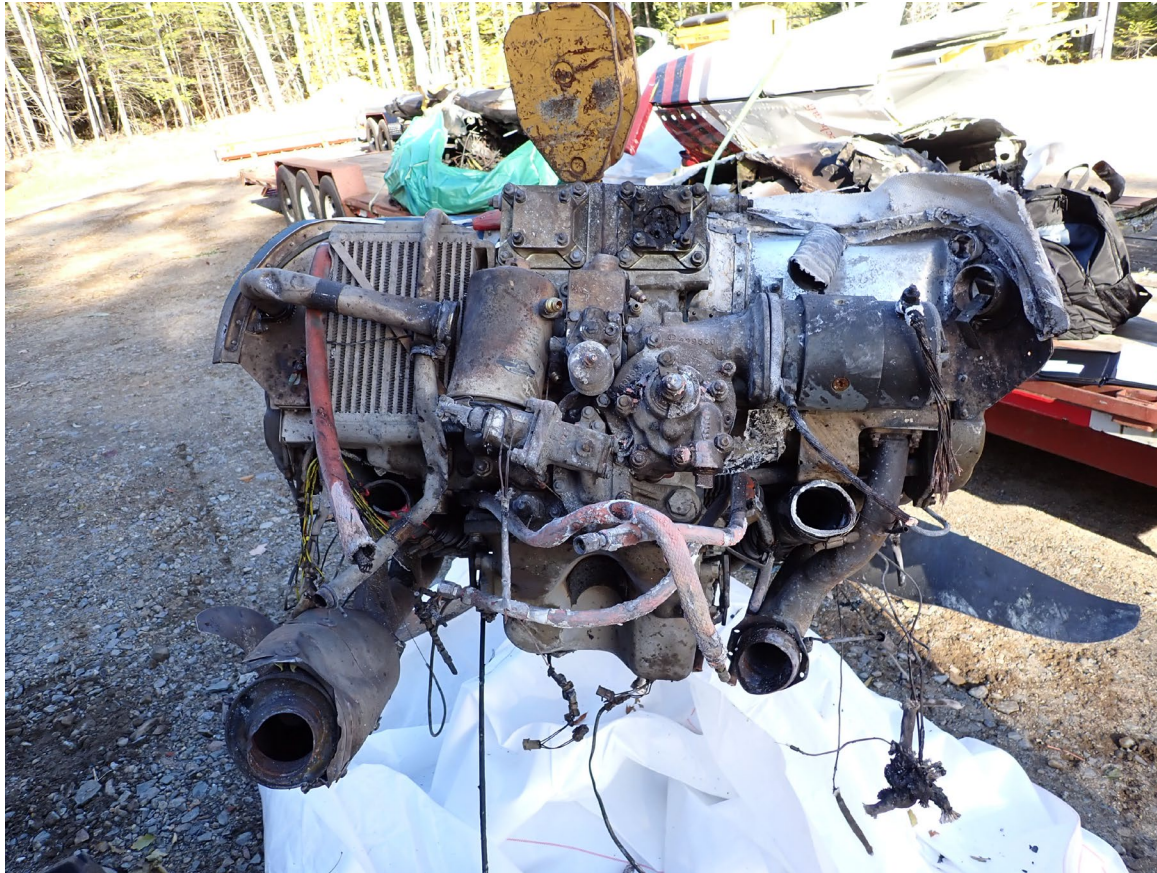
Photograph 6 - View of the rear of the engine after recovery from the accident site.
