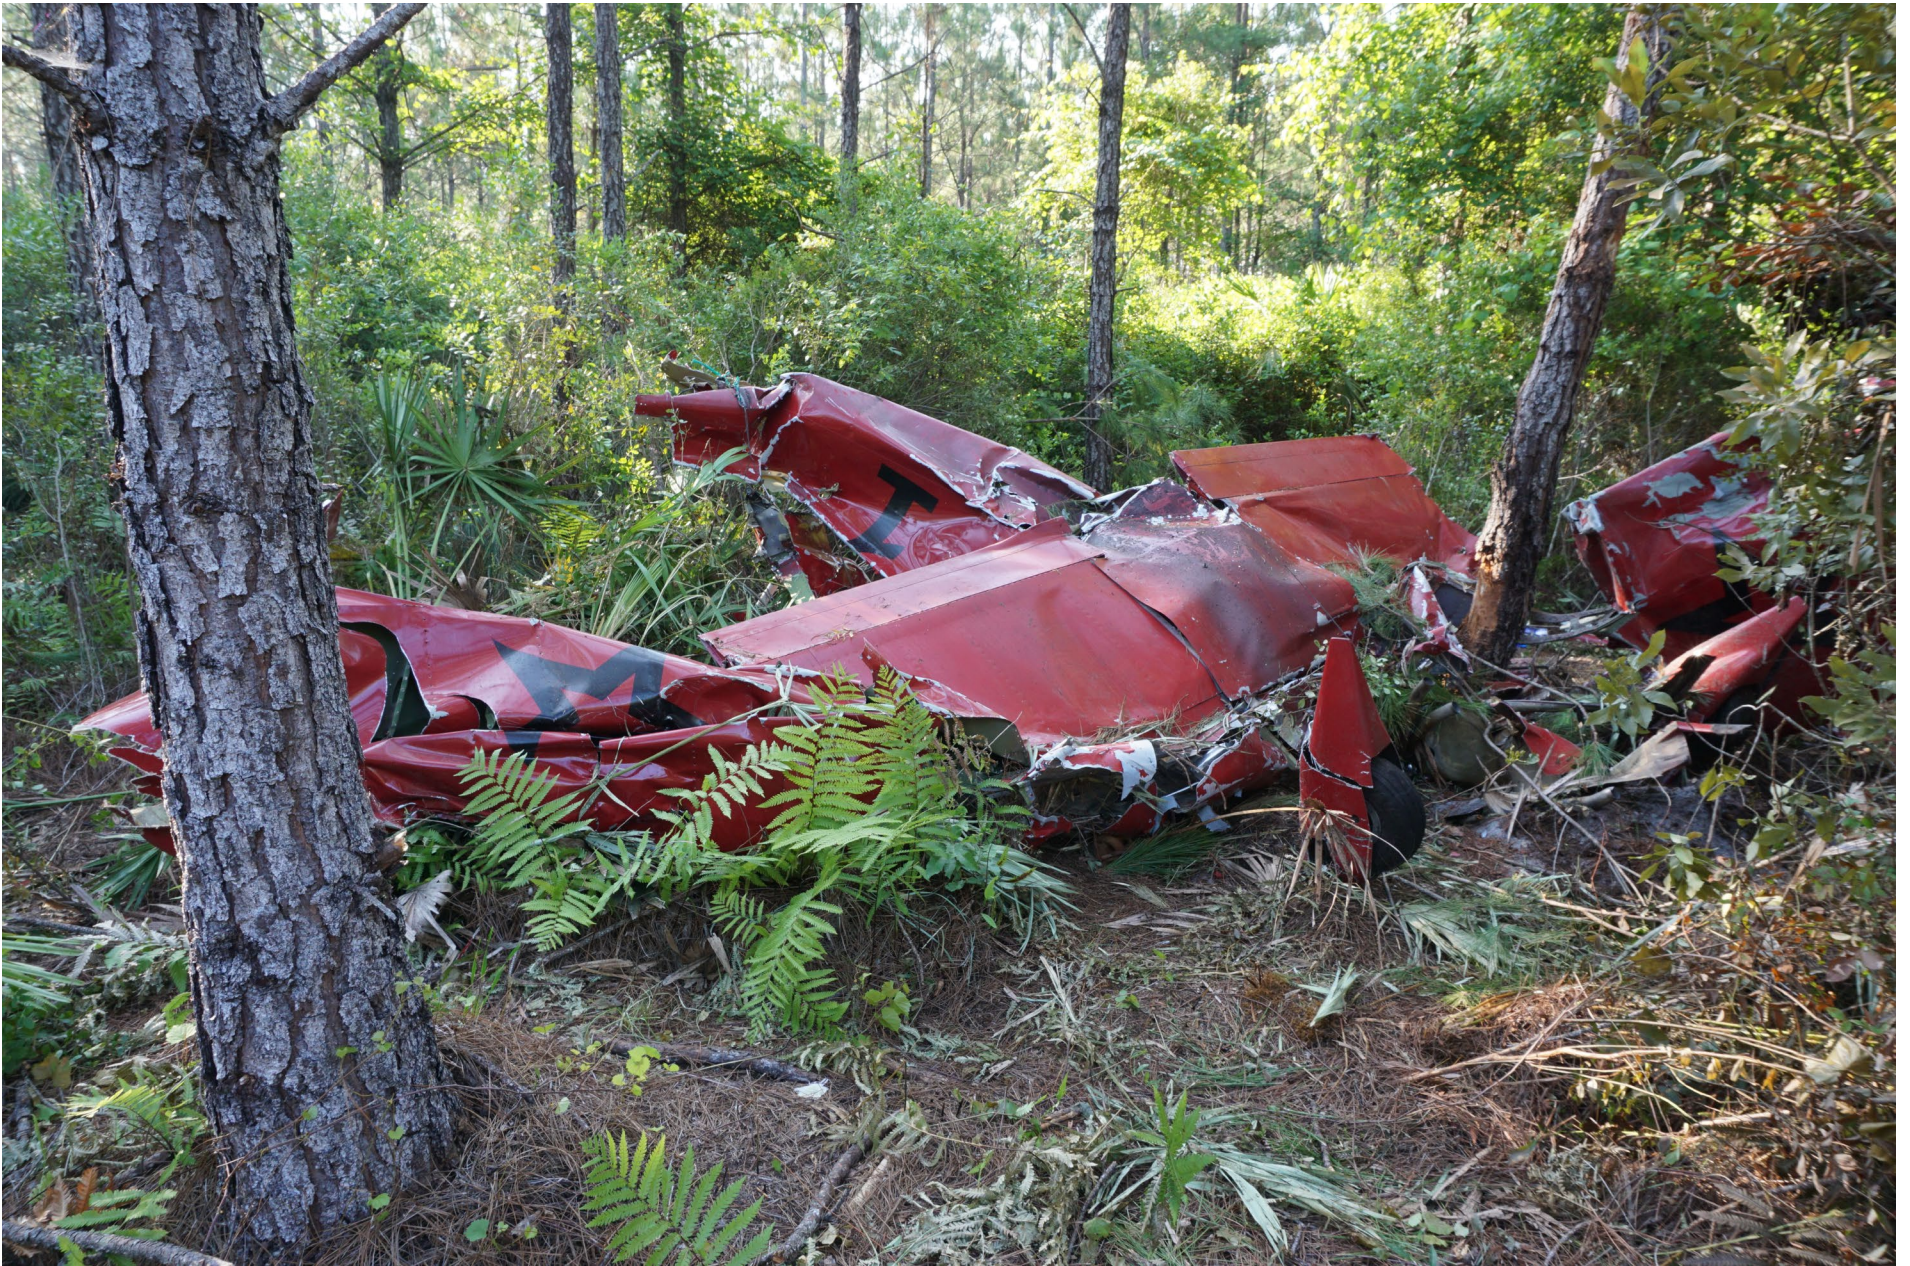
**Photo 1 – View of main wreckage of N319RL showing structural damage of entire aircraft.**

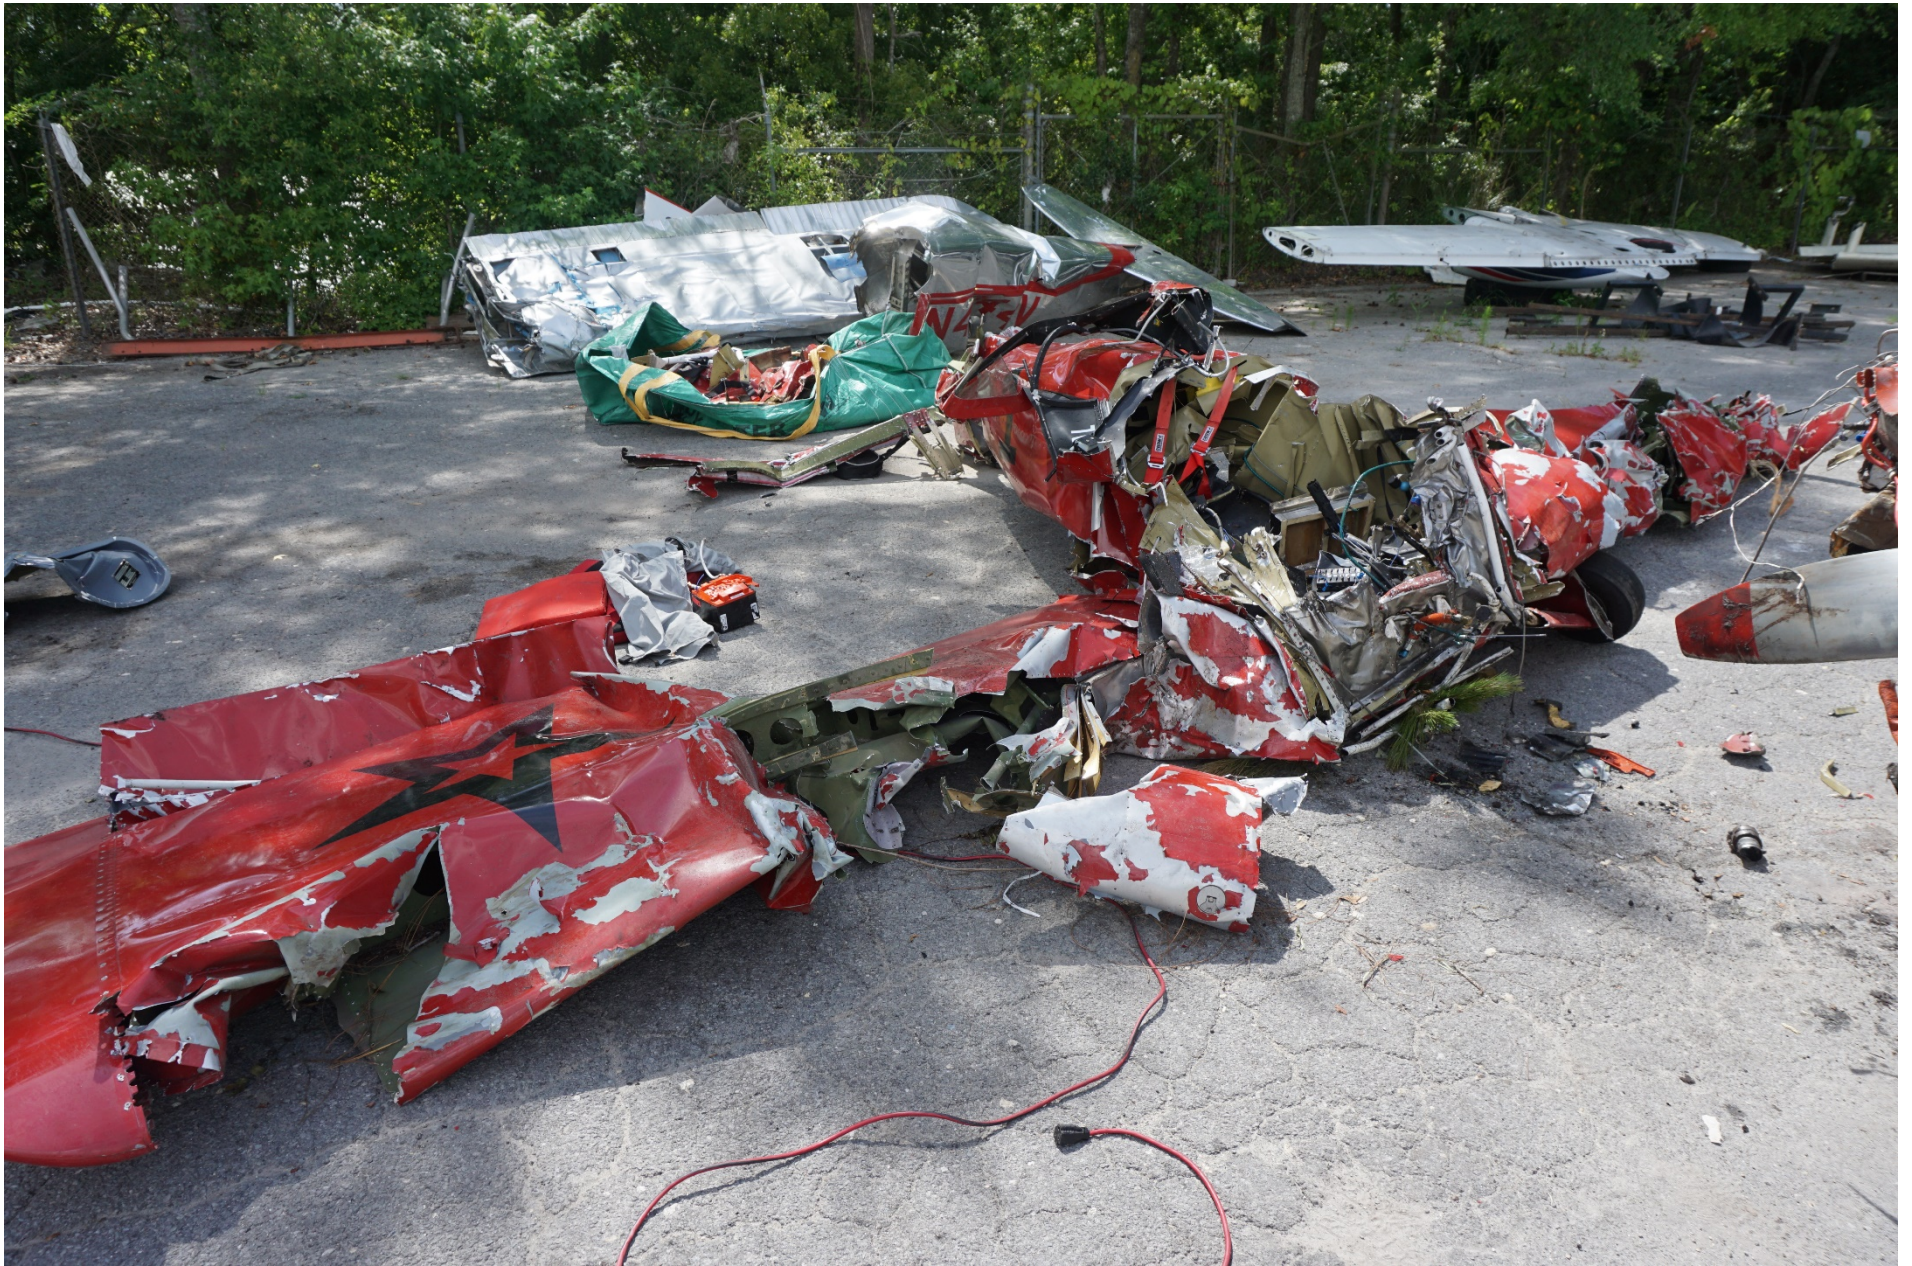
**Photo 2 – View of N319RL after wreckage recovery, showing structural damage.**

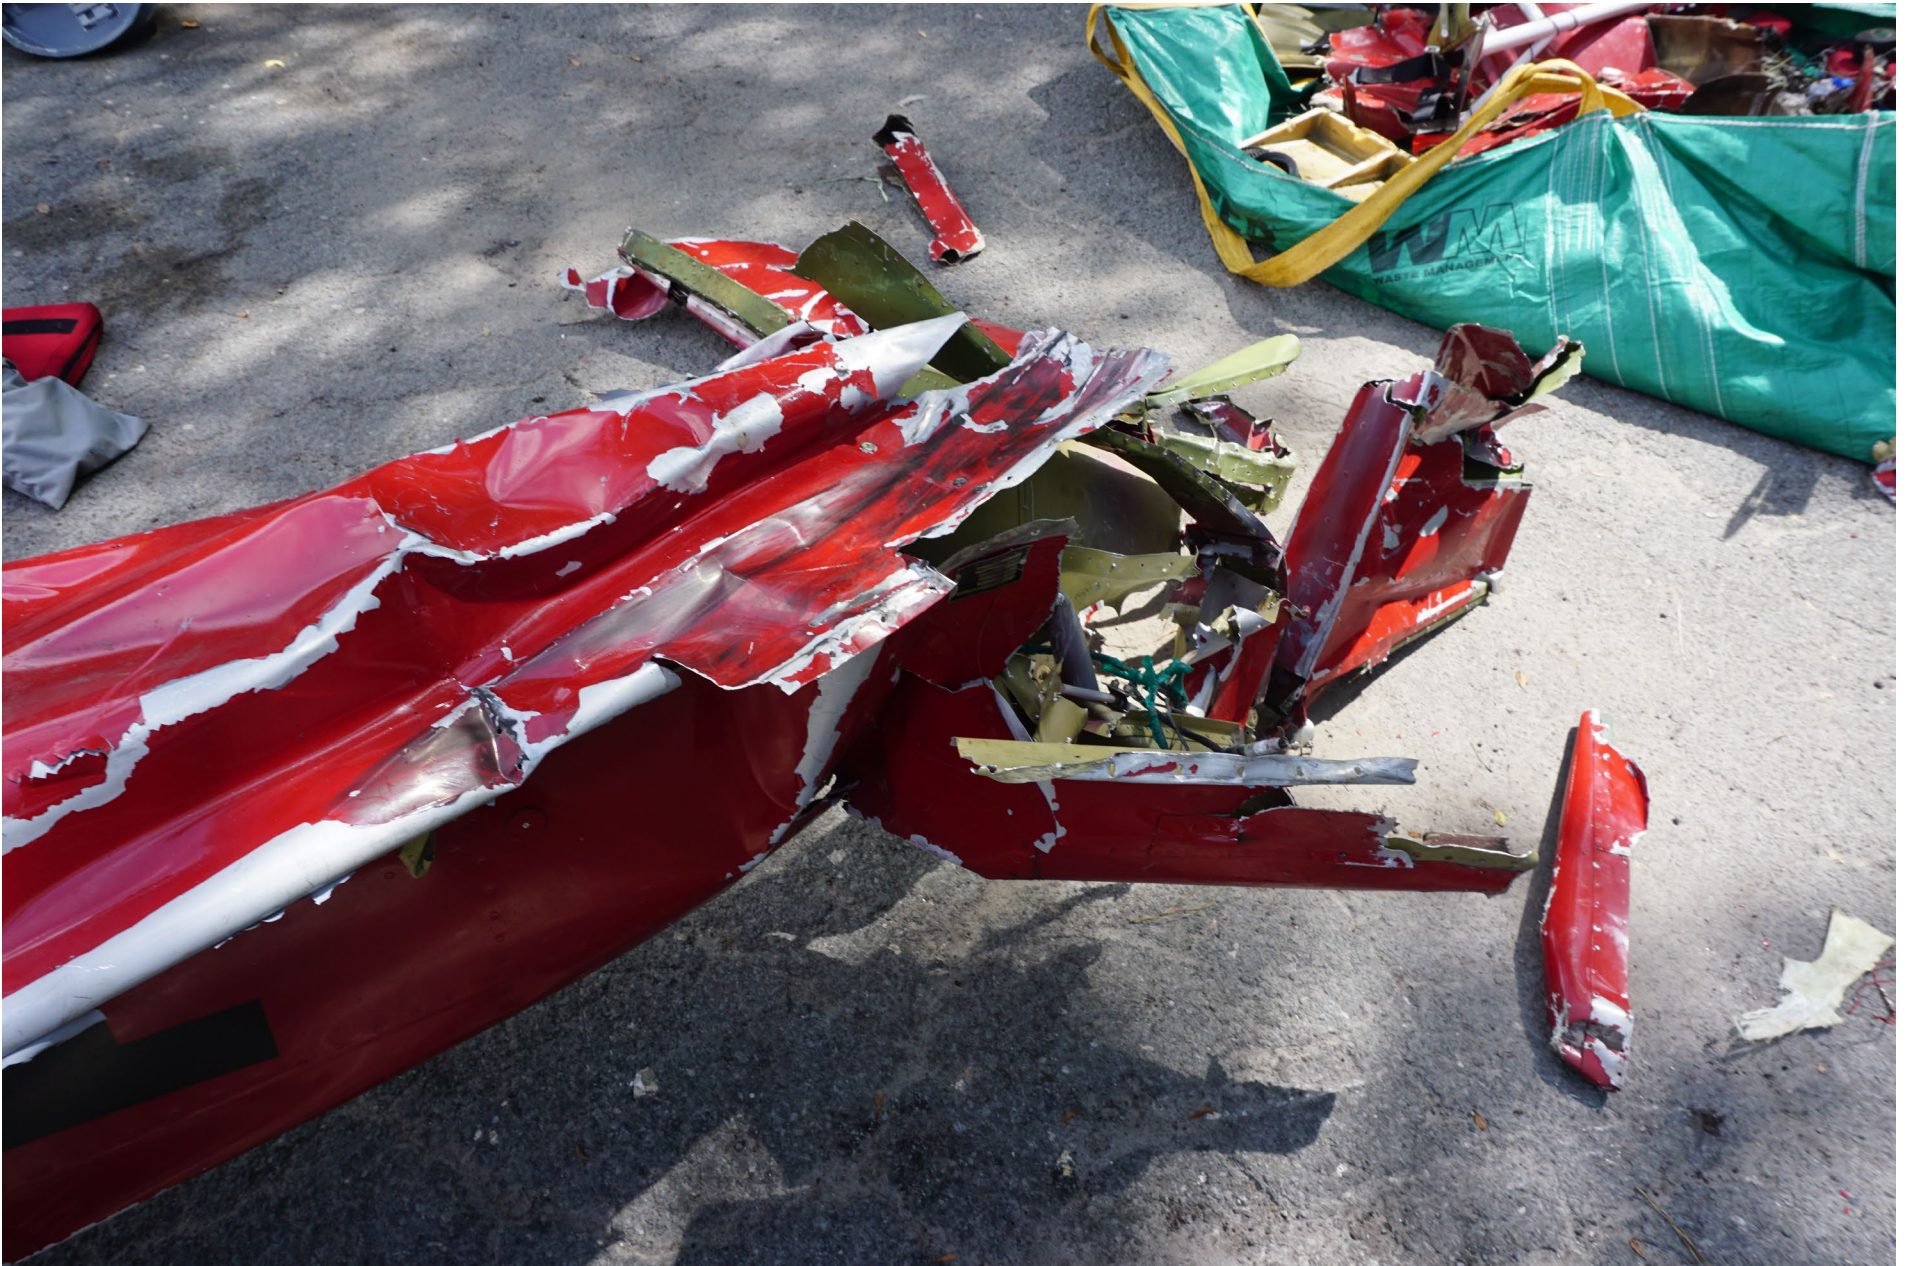
**Photo 3 – View of empennage showing black tire skid mark.**

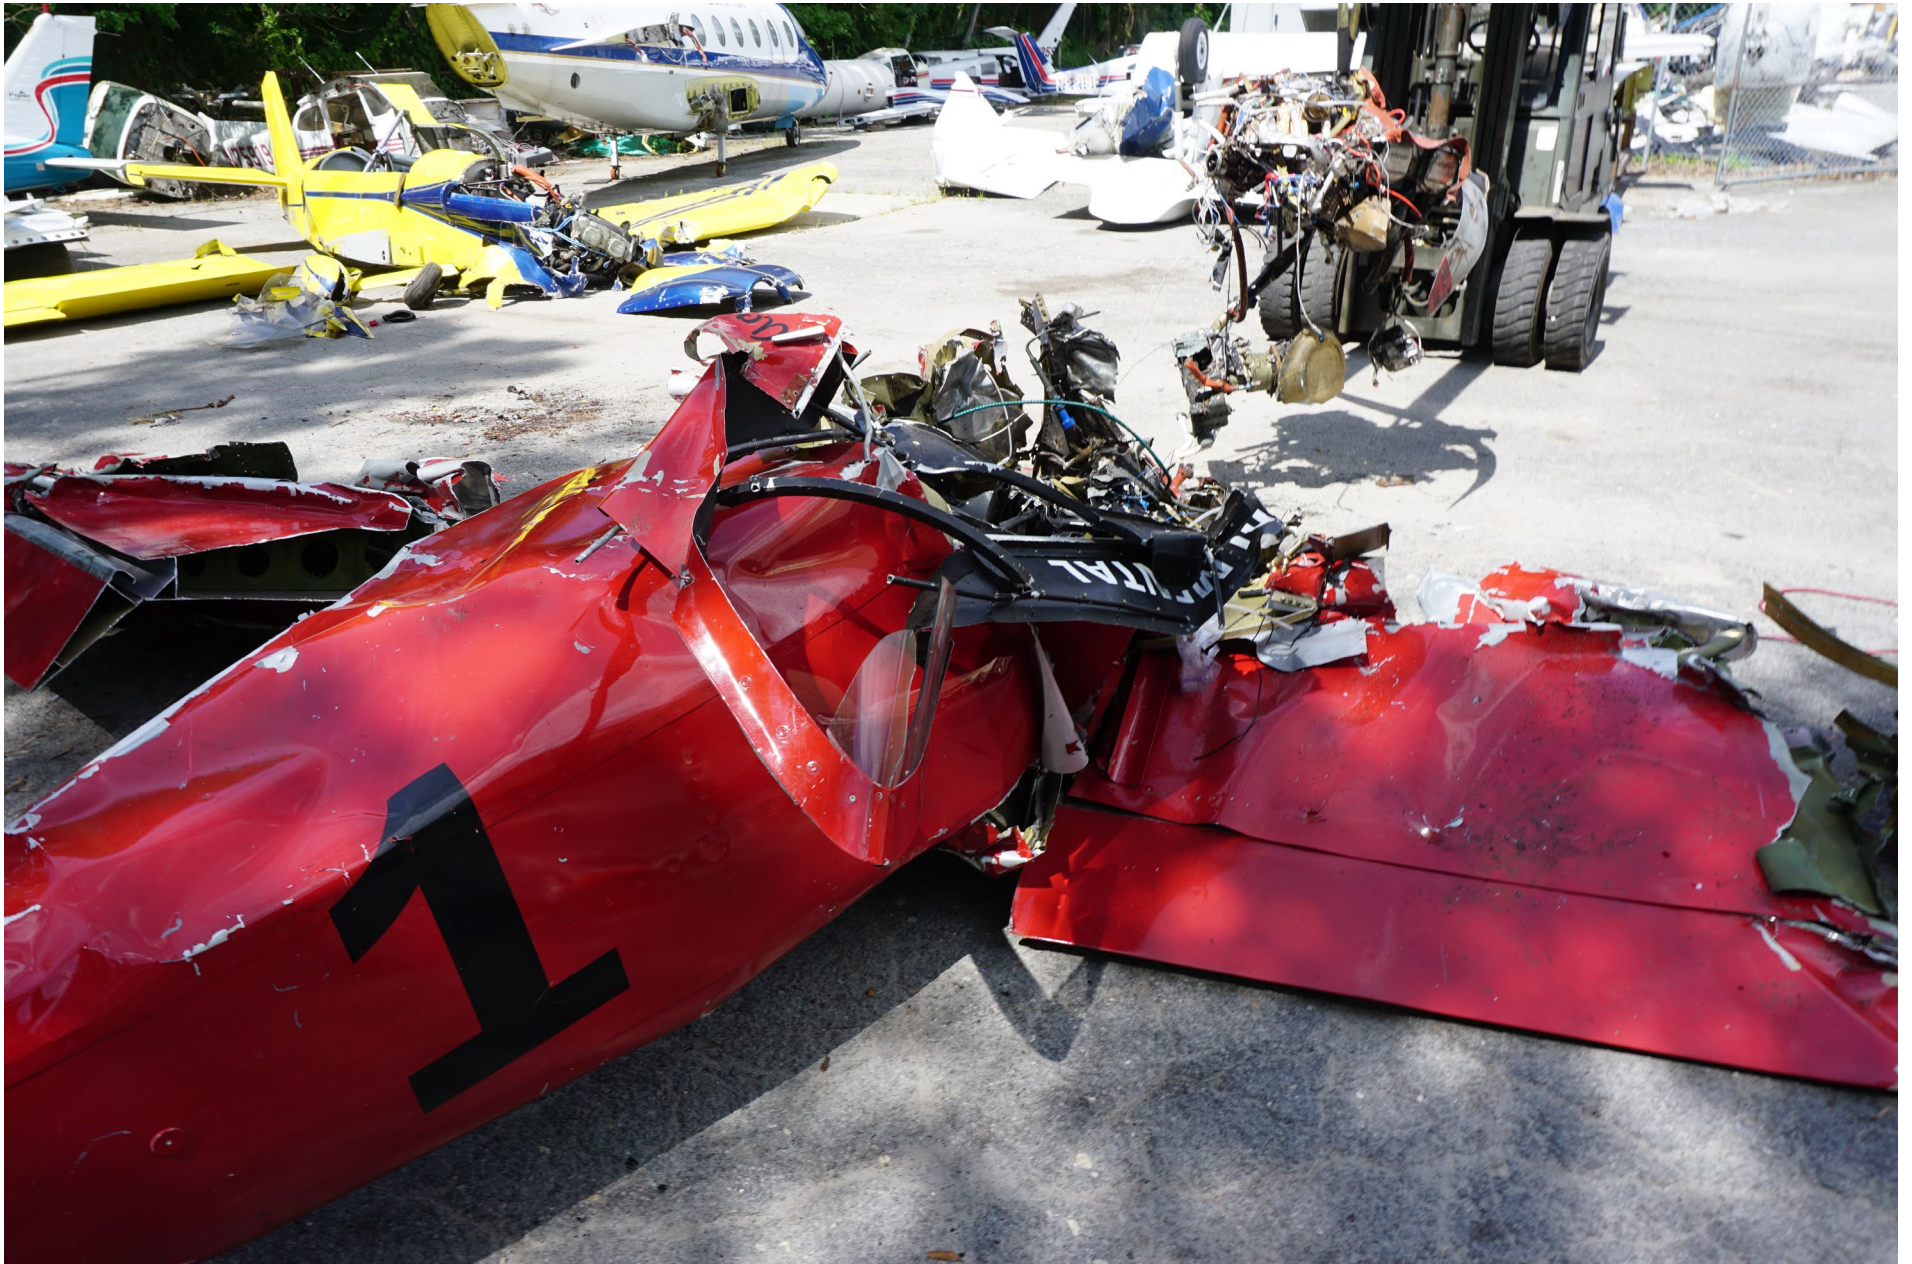
**Photo 4 – View of yellow paint transfer mark on top of fuselage behind canopy.**

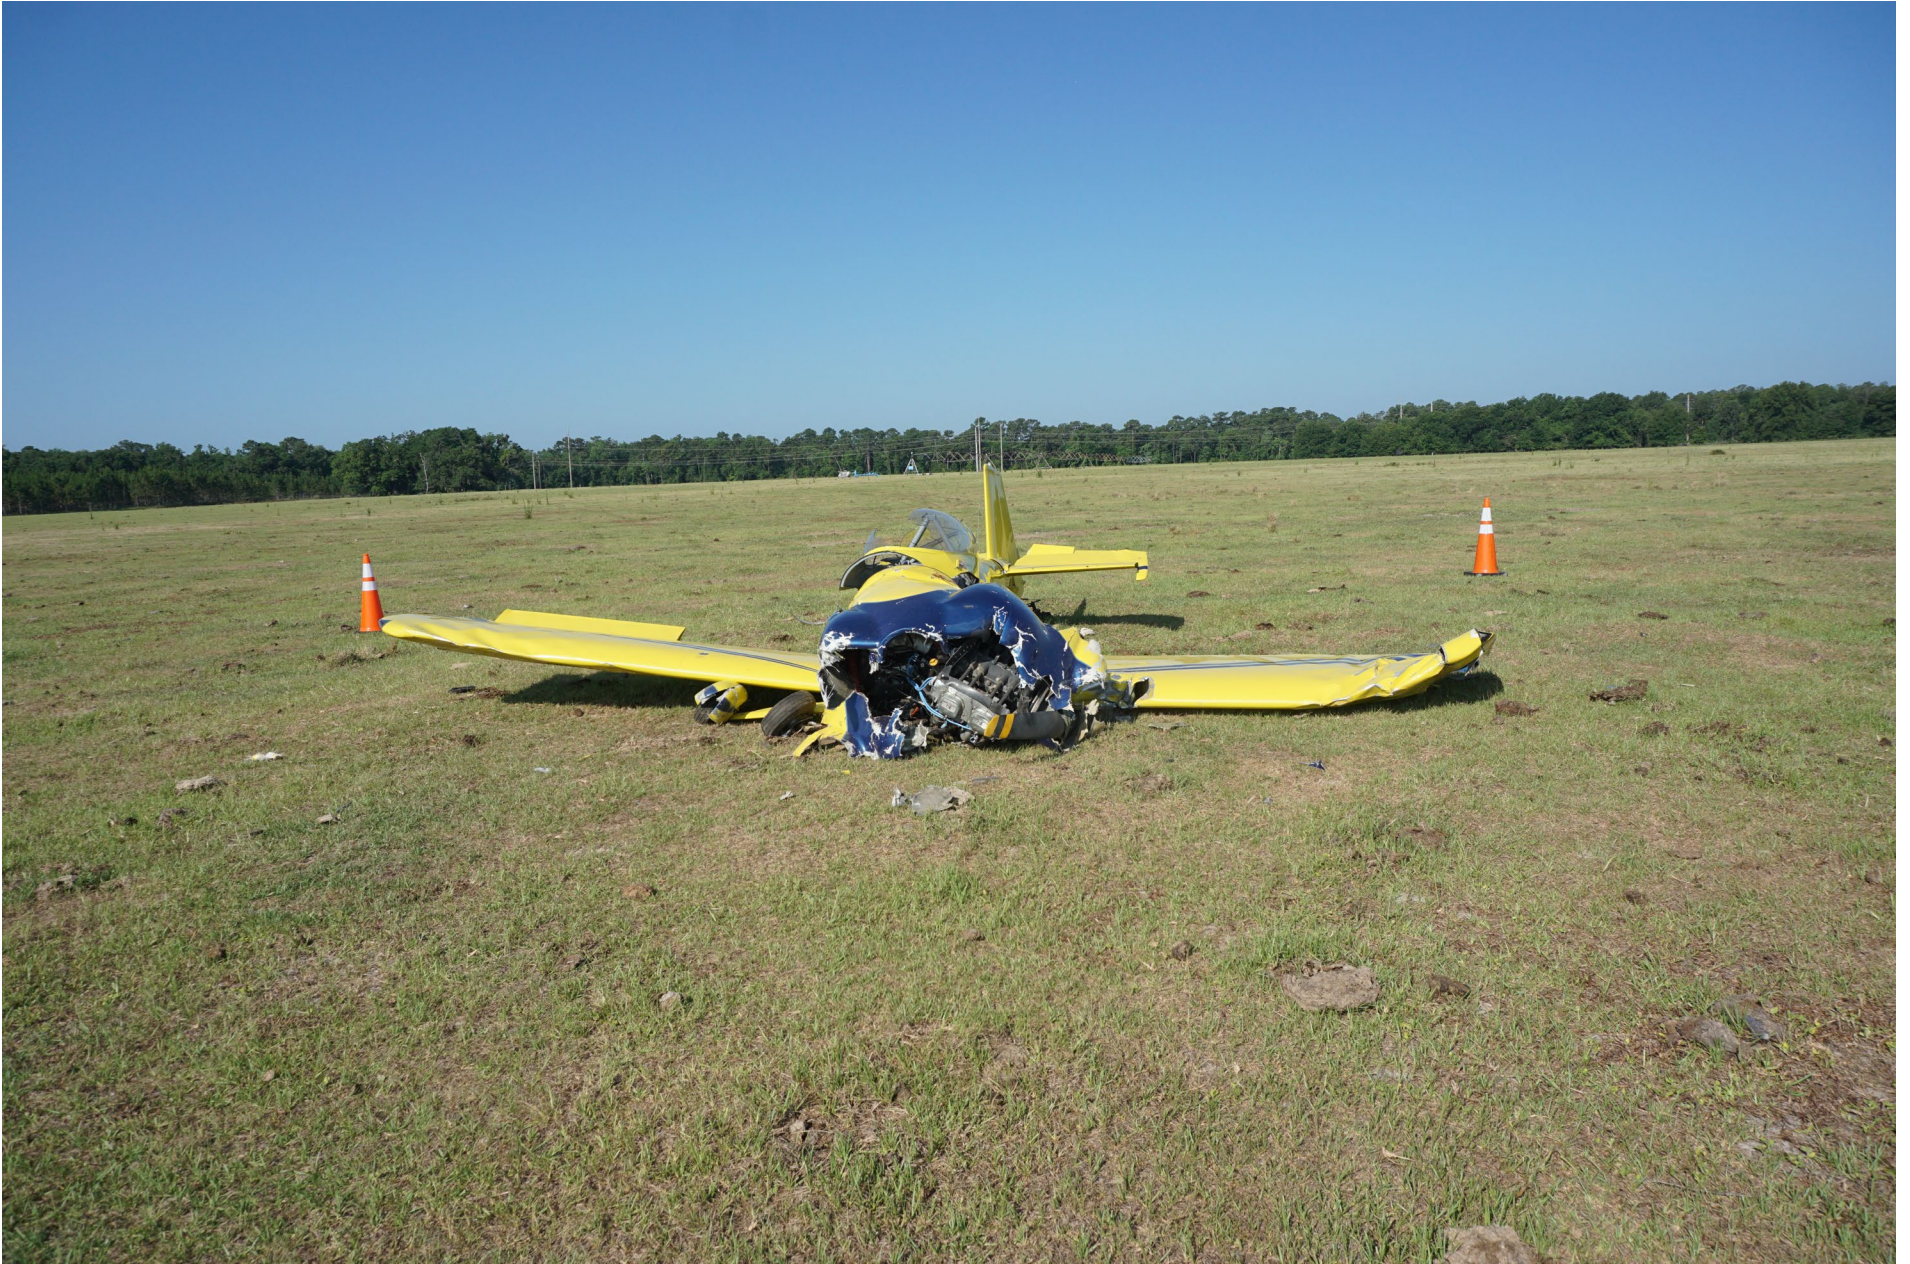
**Photo 5 – View of N203DD in field showing structural damage throughout aircraft.**

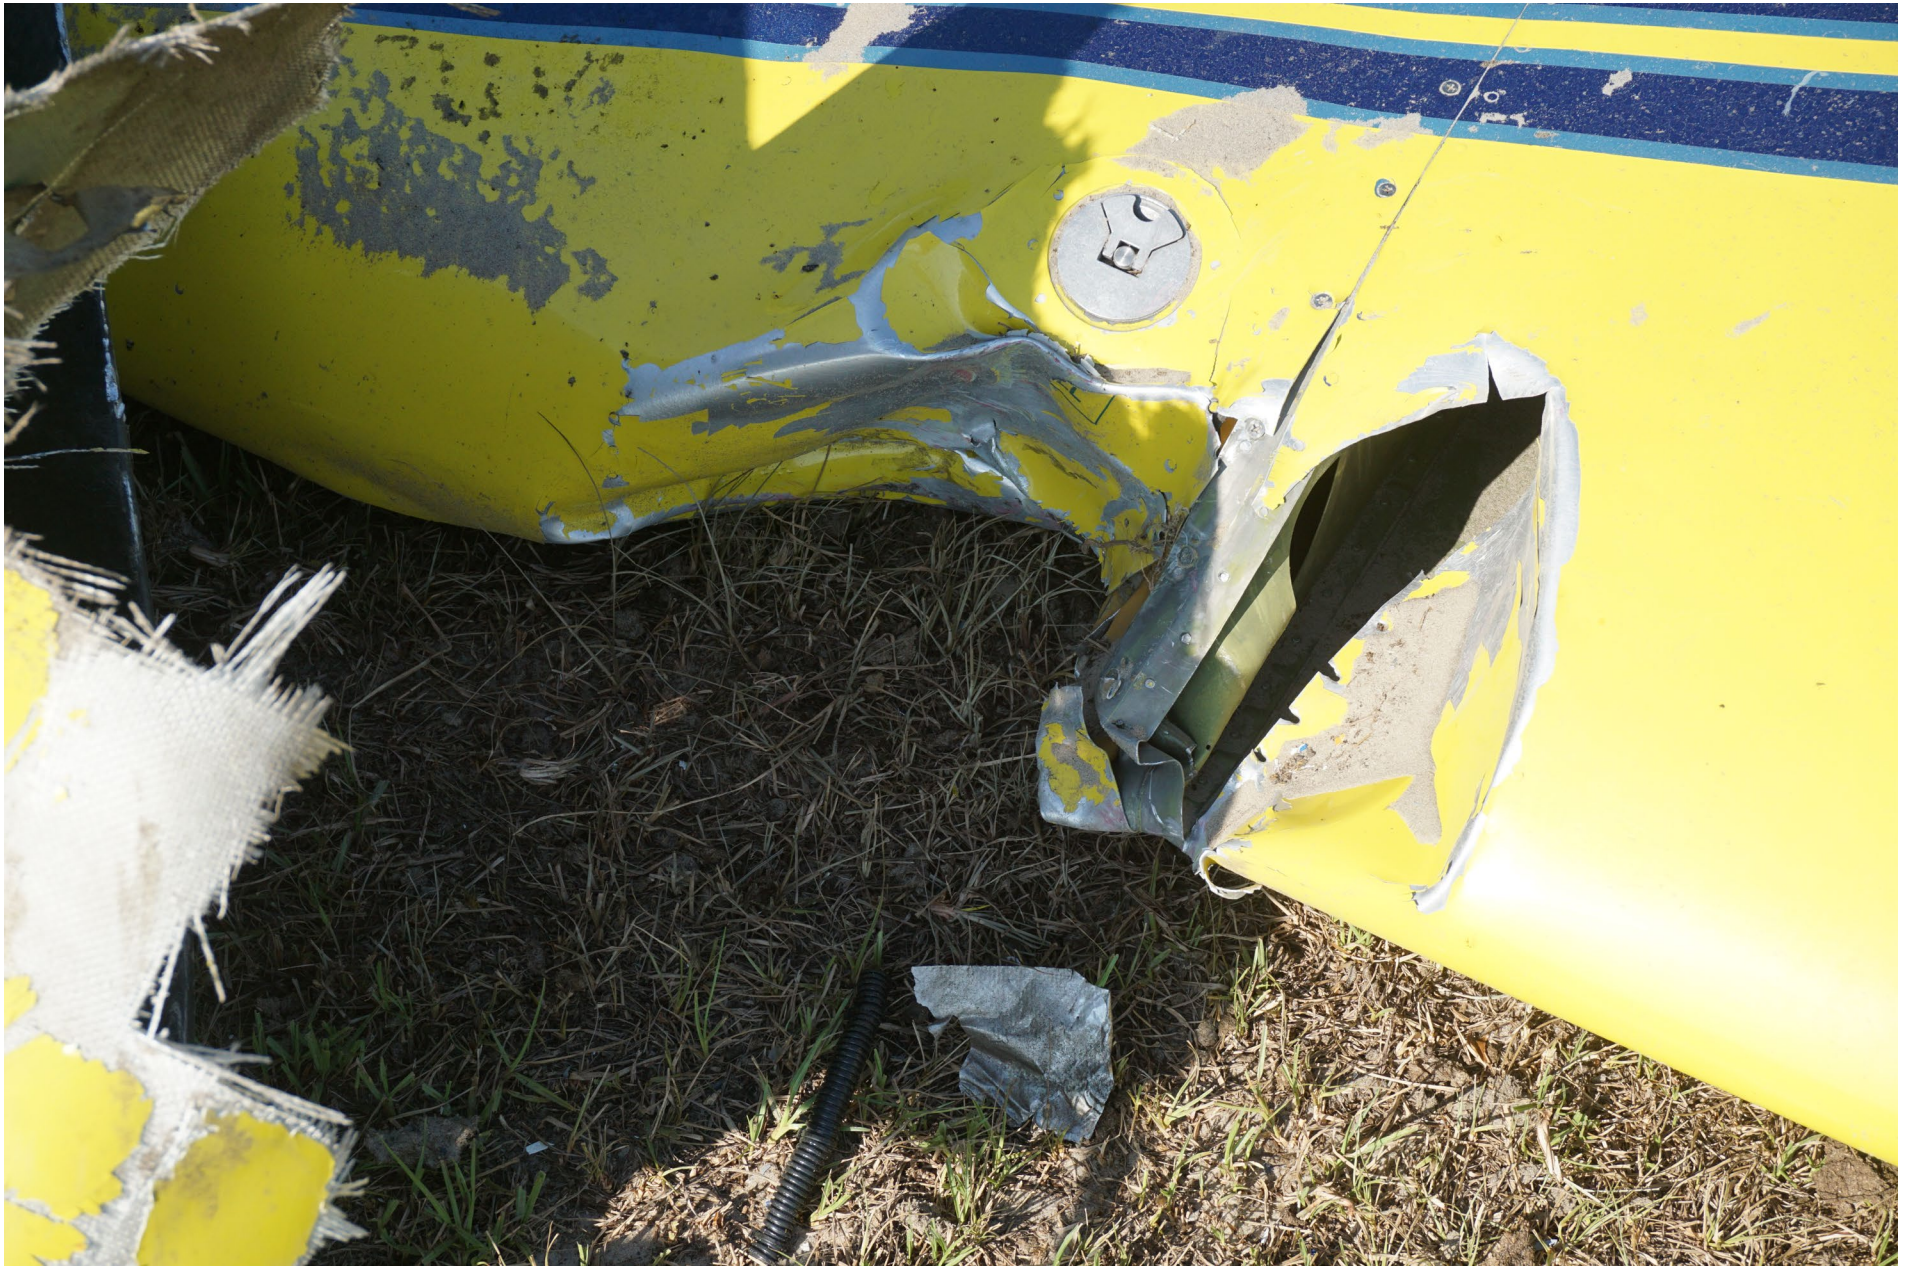
**Photo 6 – View of semicircular damage on leading edge of left inboard wing.**

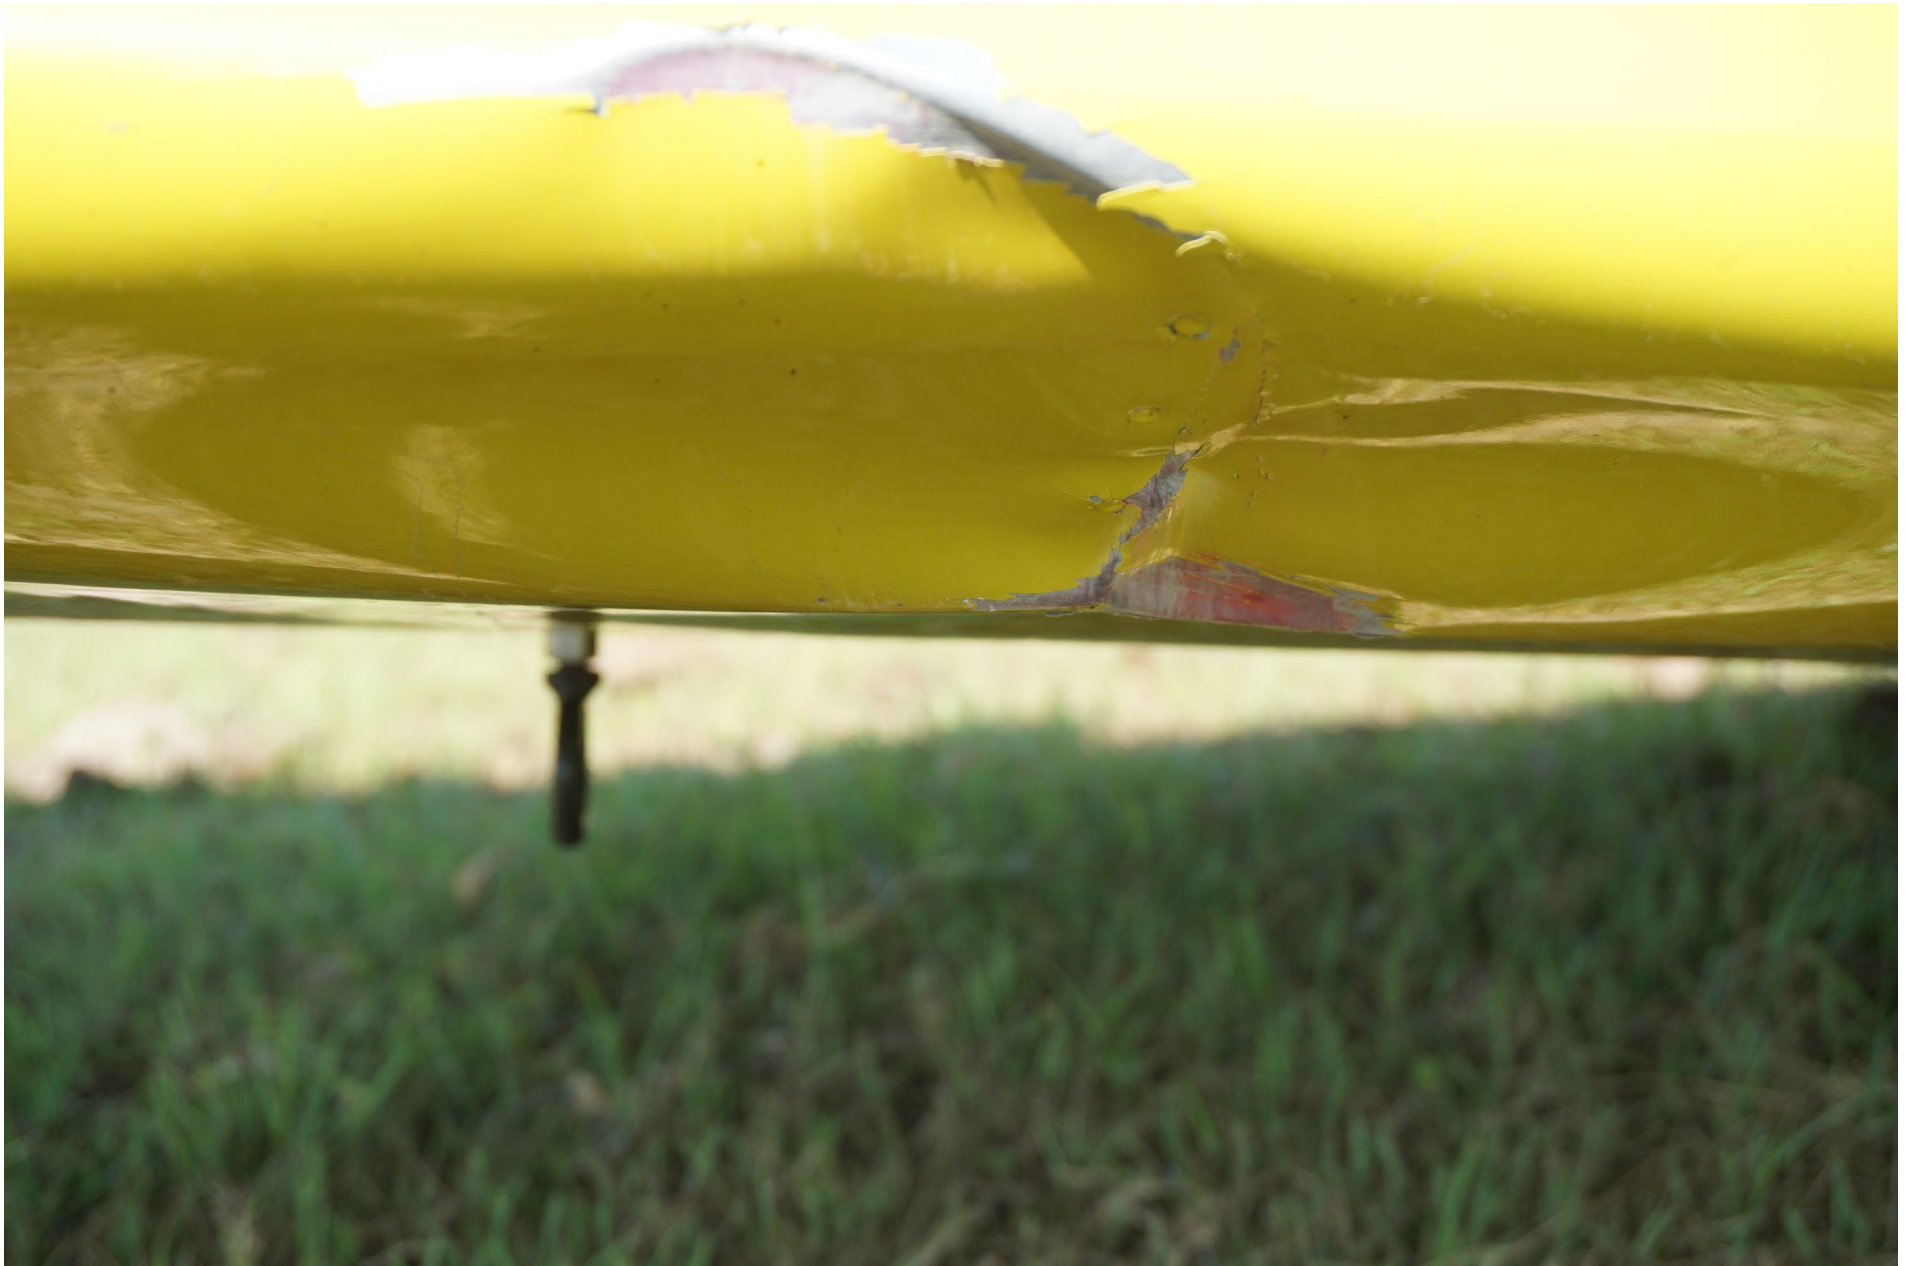
**Photo 7 – View of red paint transfer on leading edge of right wing.**
