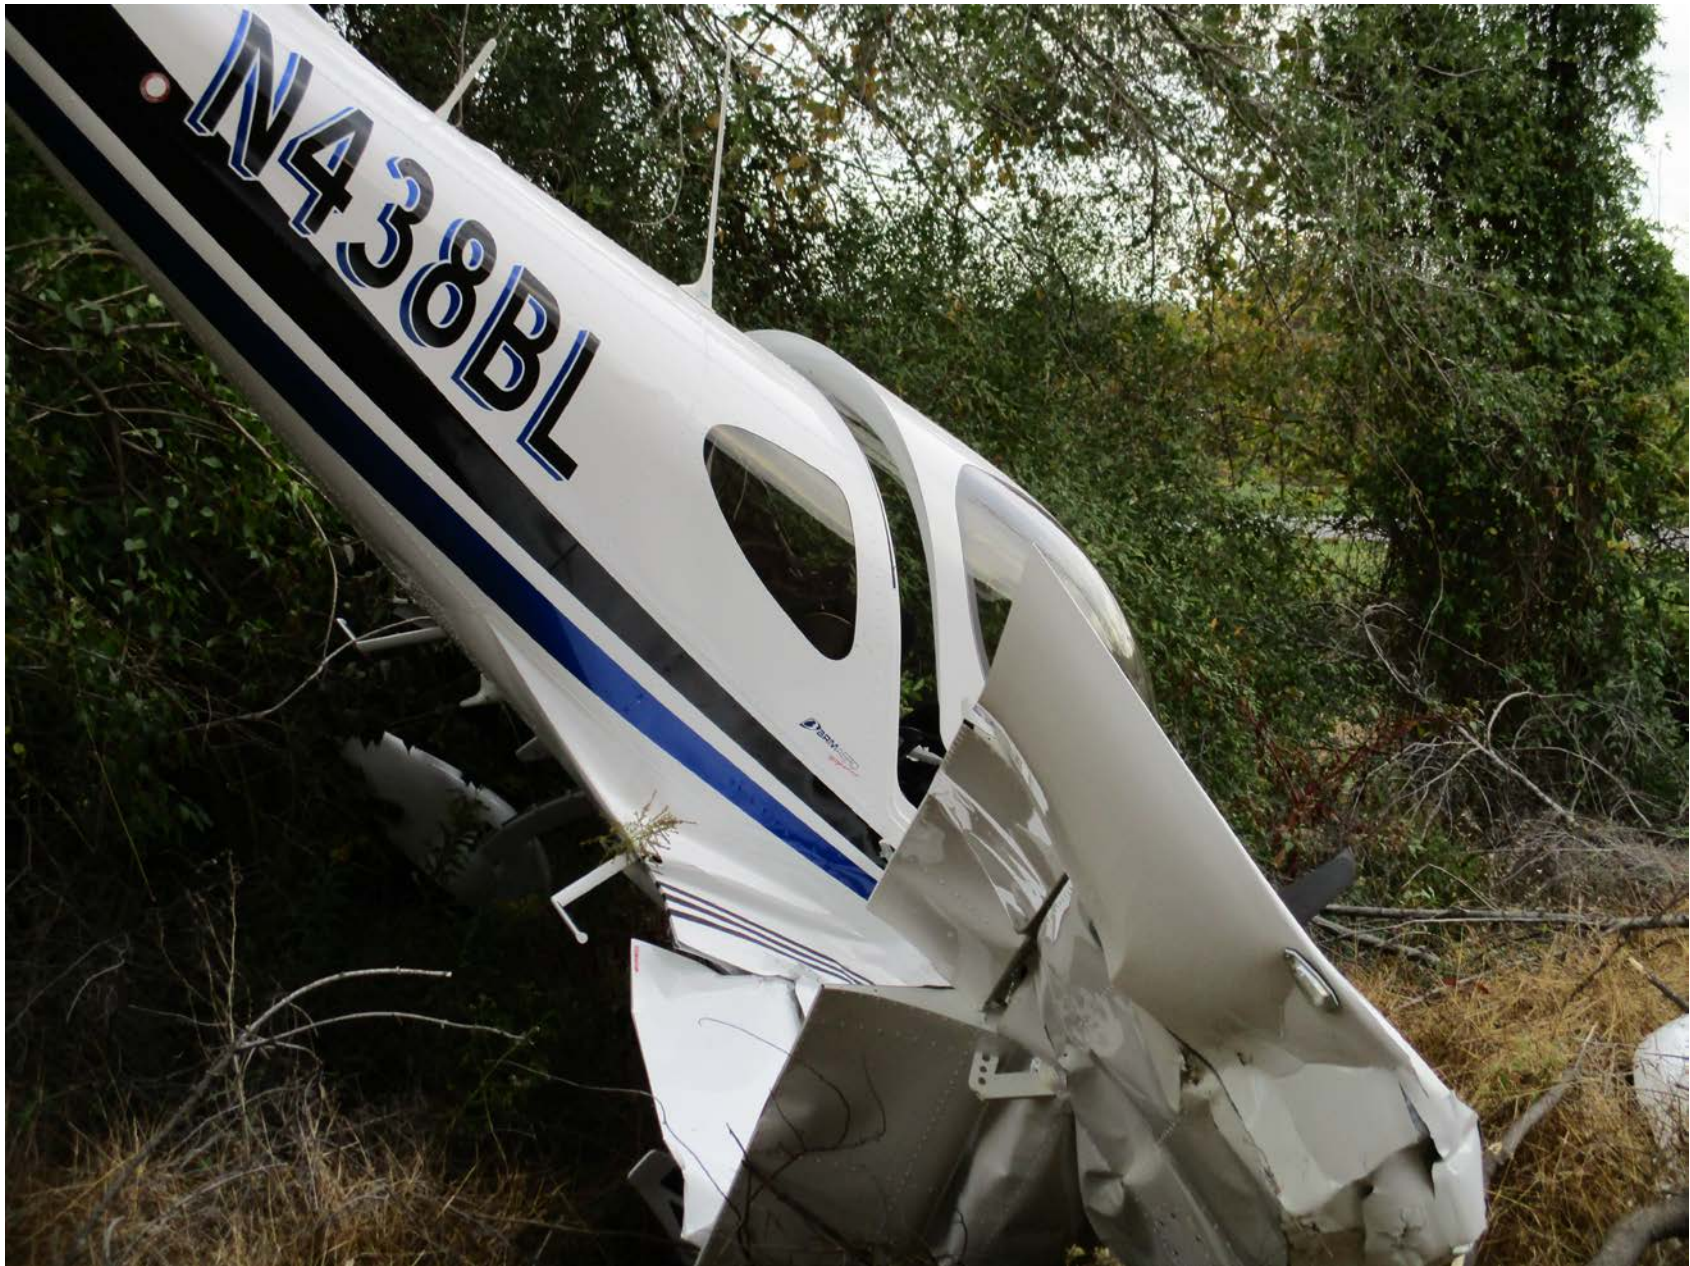
**Photo 1 – View of airplane from the left side showing right wing damage**

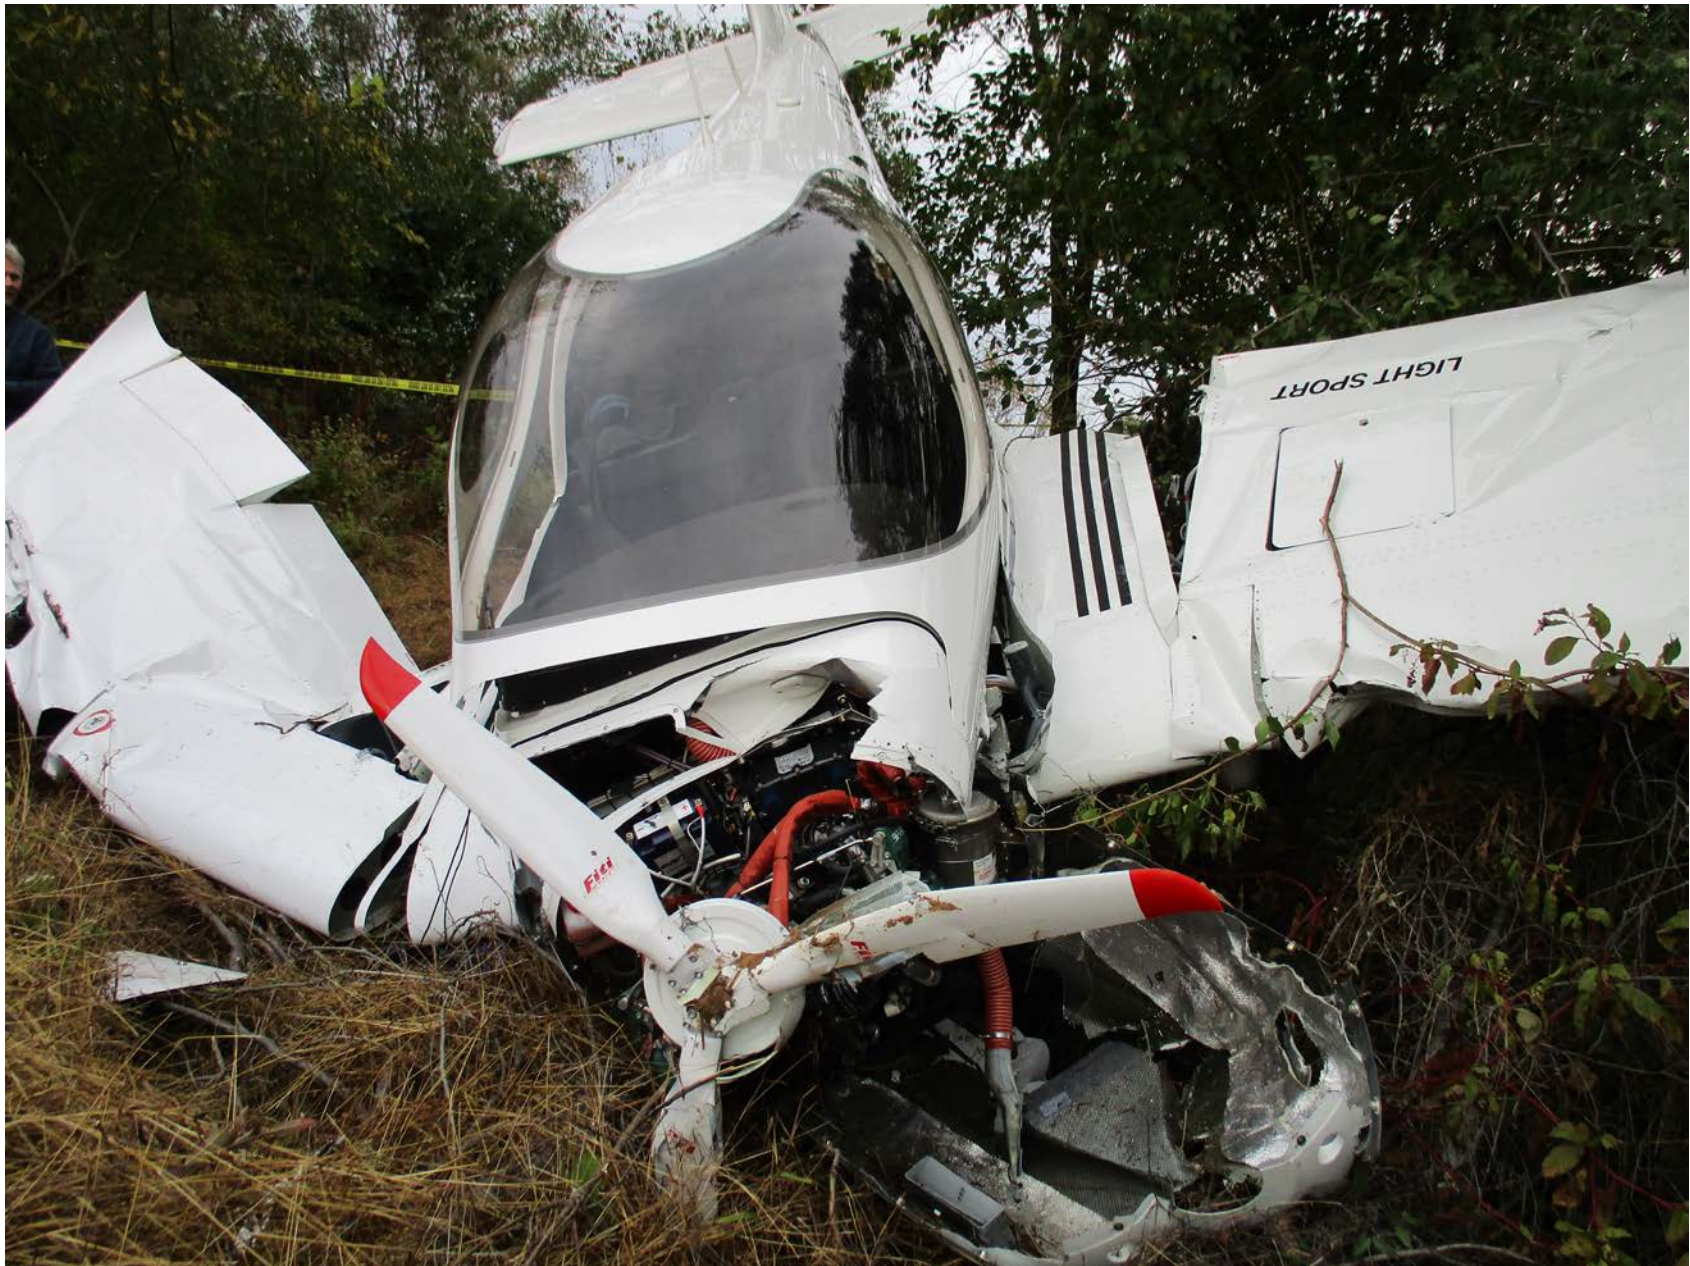
**Photo 2 – View of airplane from the front showing forward crush damage**
