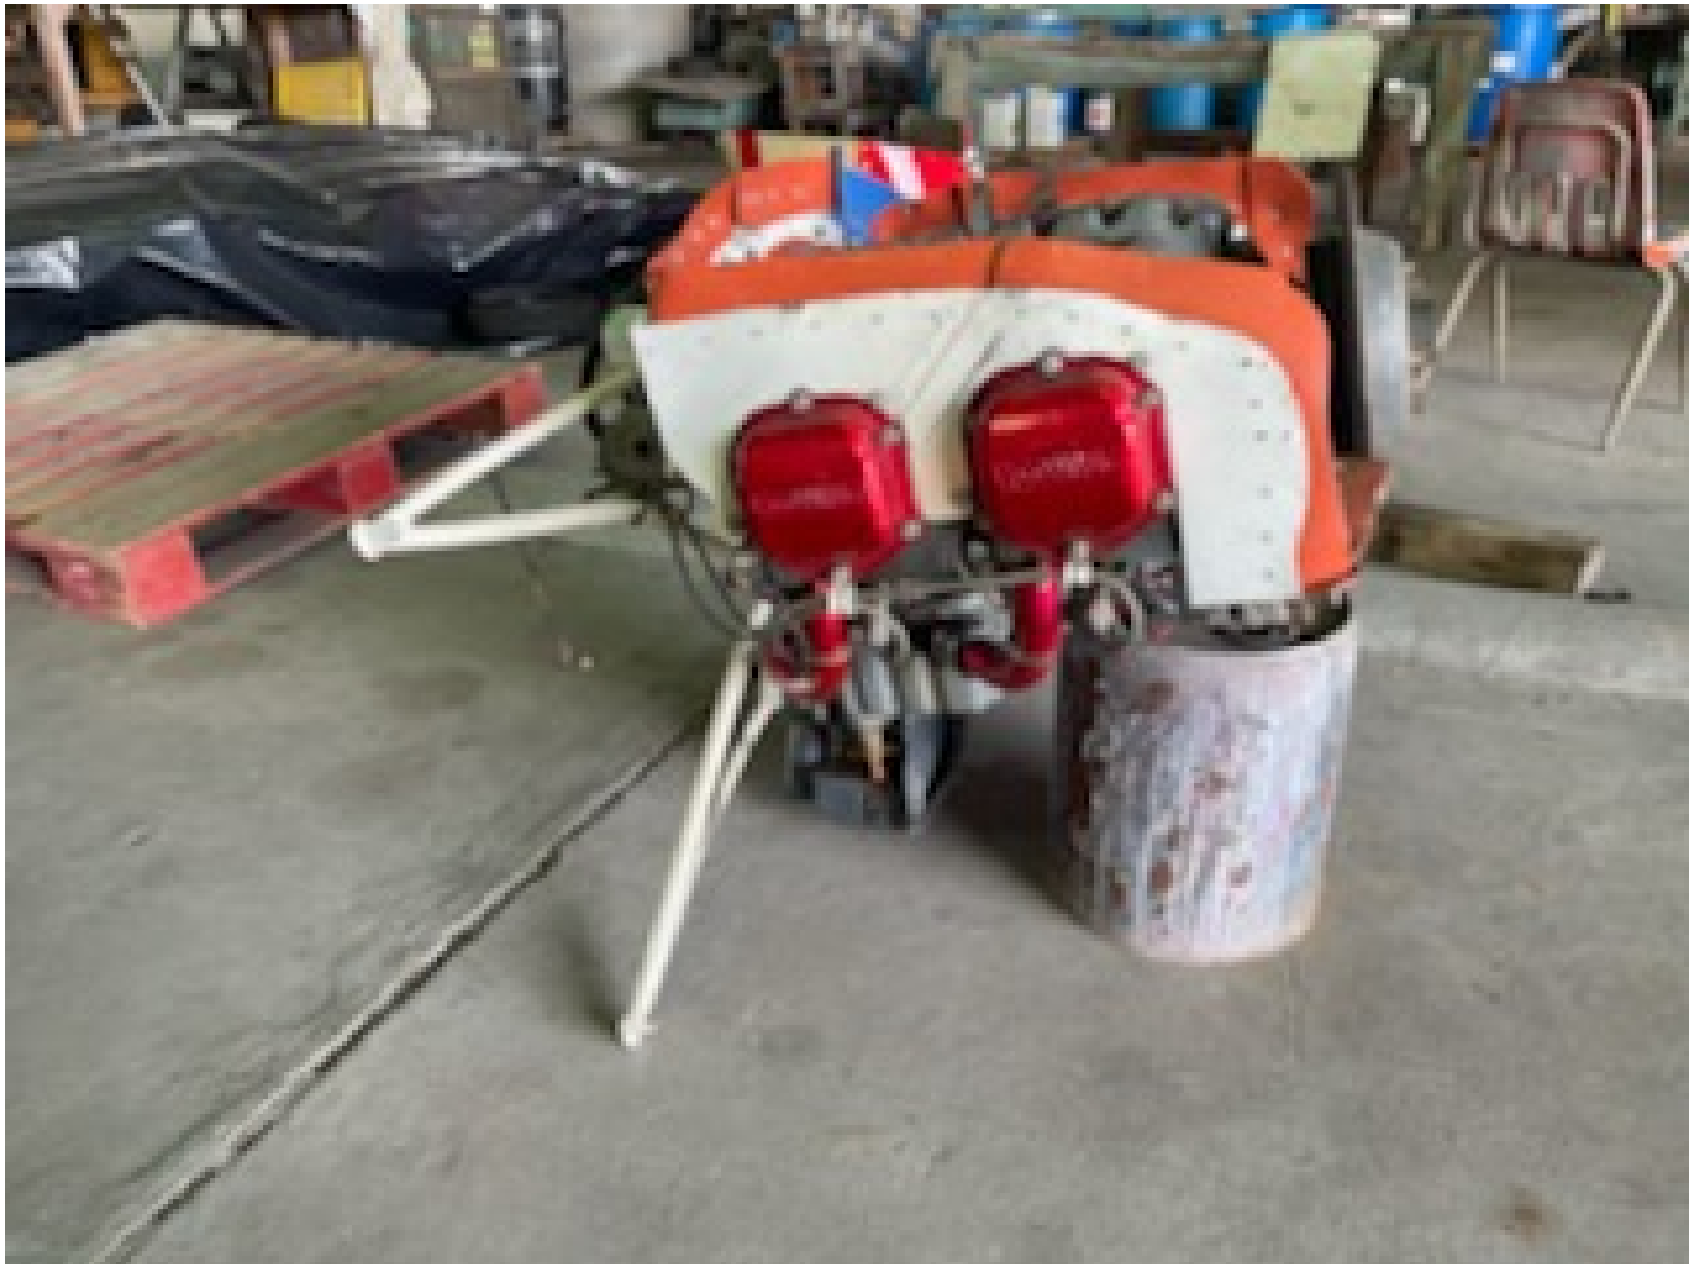
Photo 1 – View of motor mount showing a bend in the lower section.

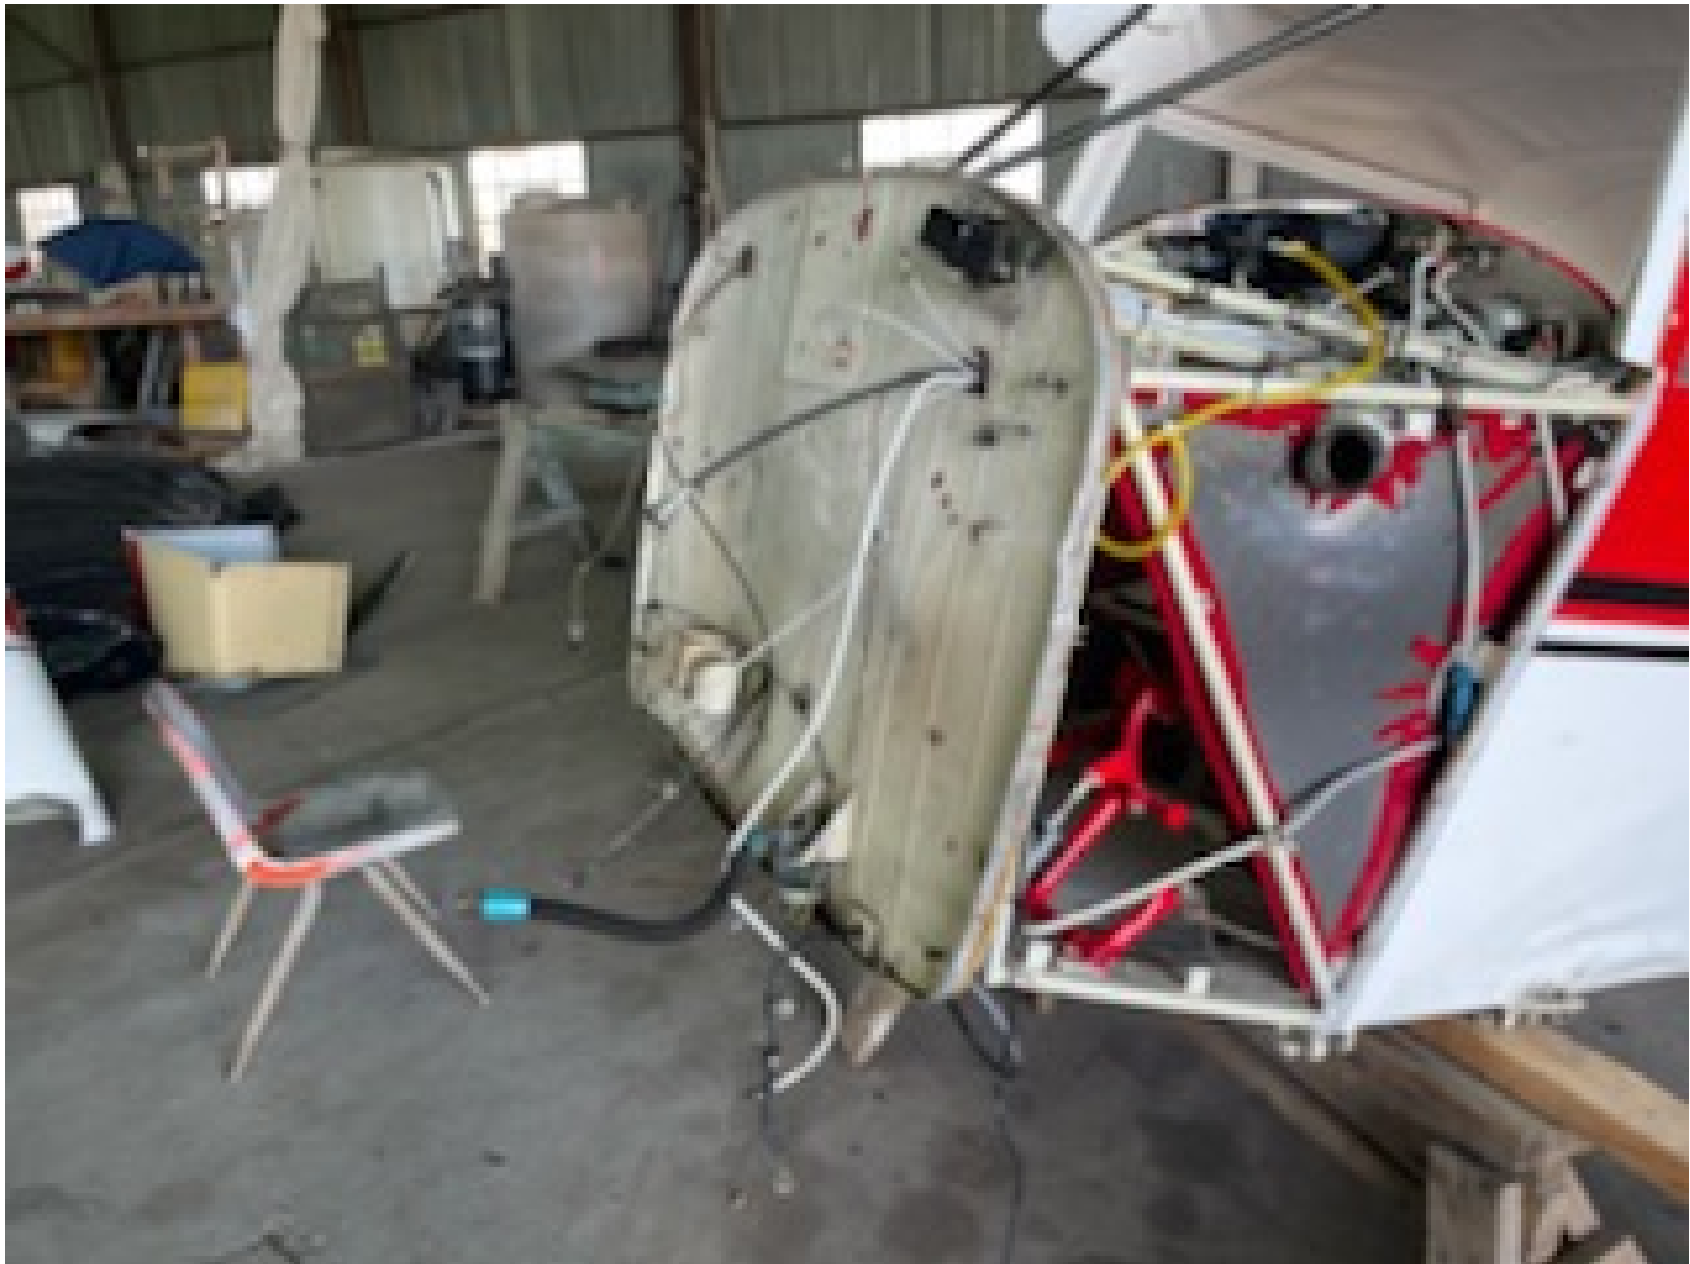
Photo 2 – View of damaged firewall
