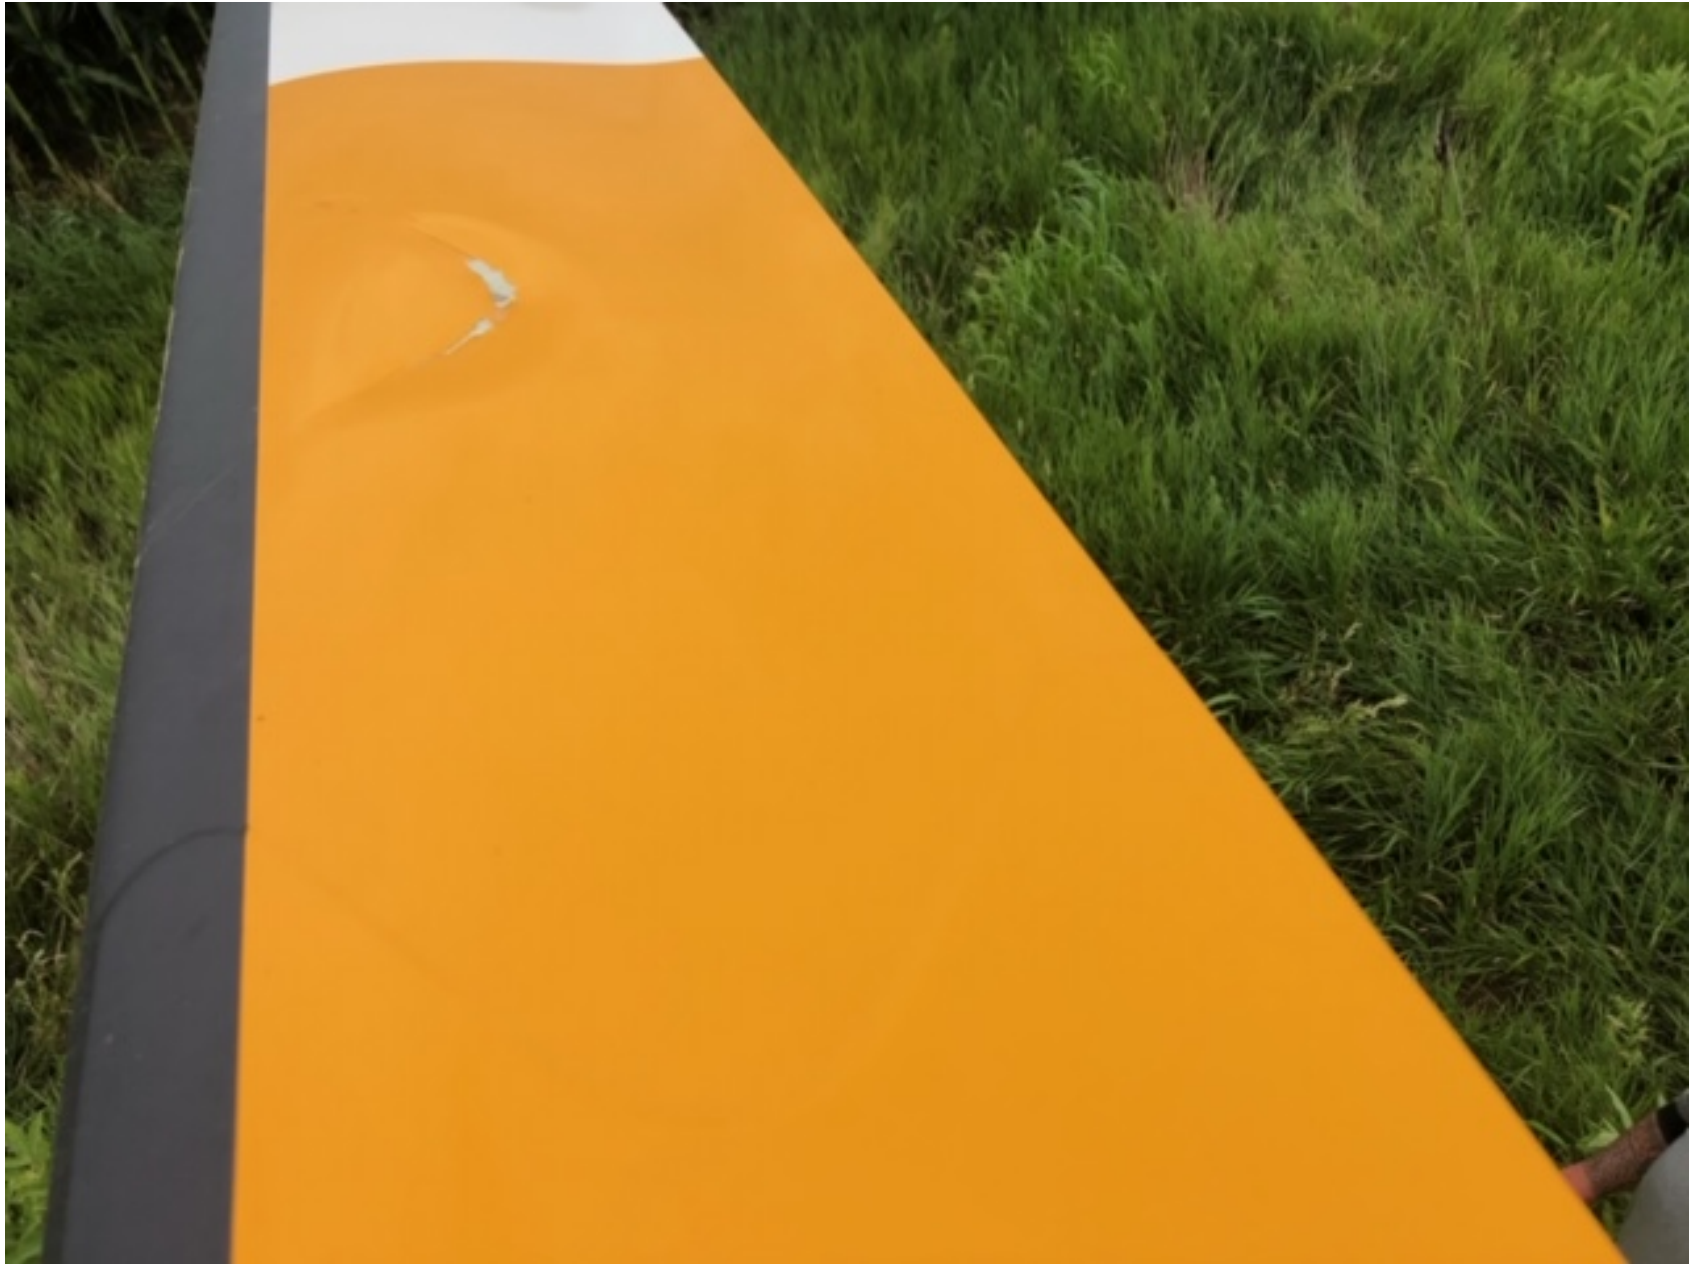
Photo 1 – Damage to main rotor blade
