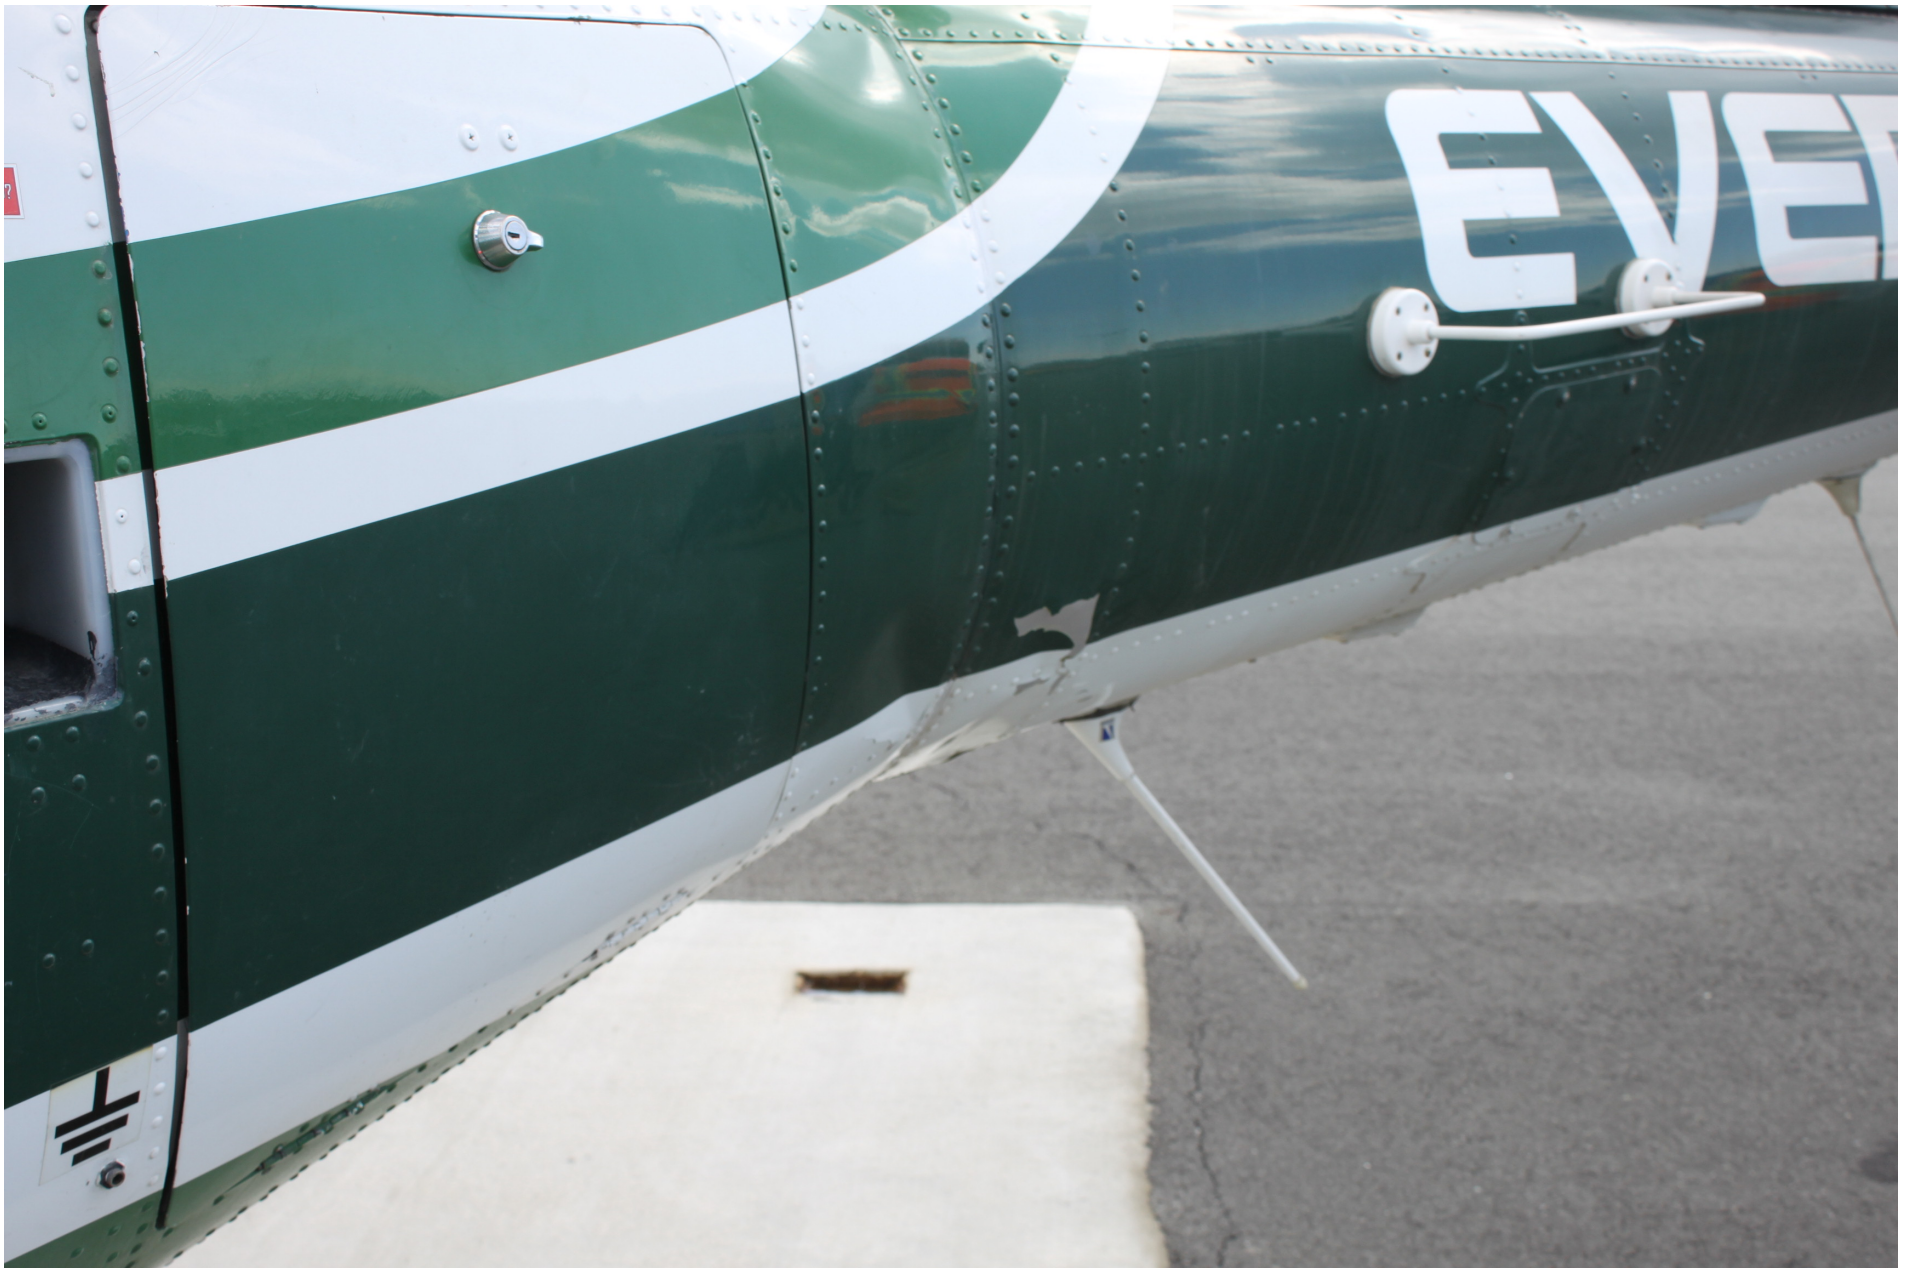
Photo 1 – Damage to Left Tail Boom Assembly

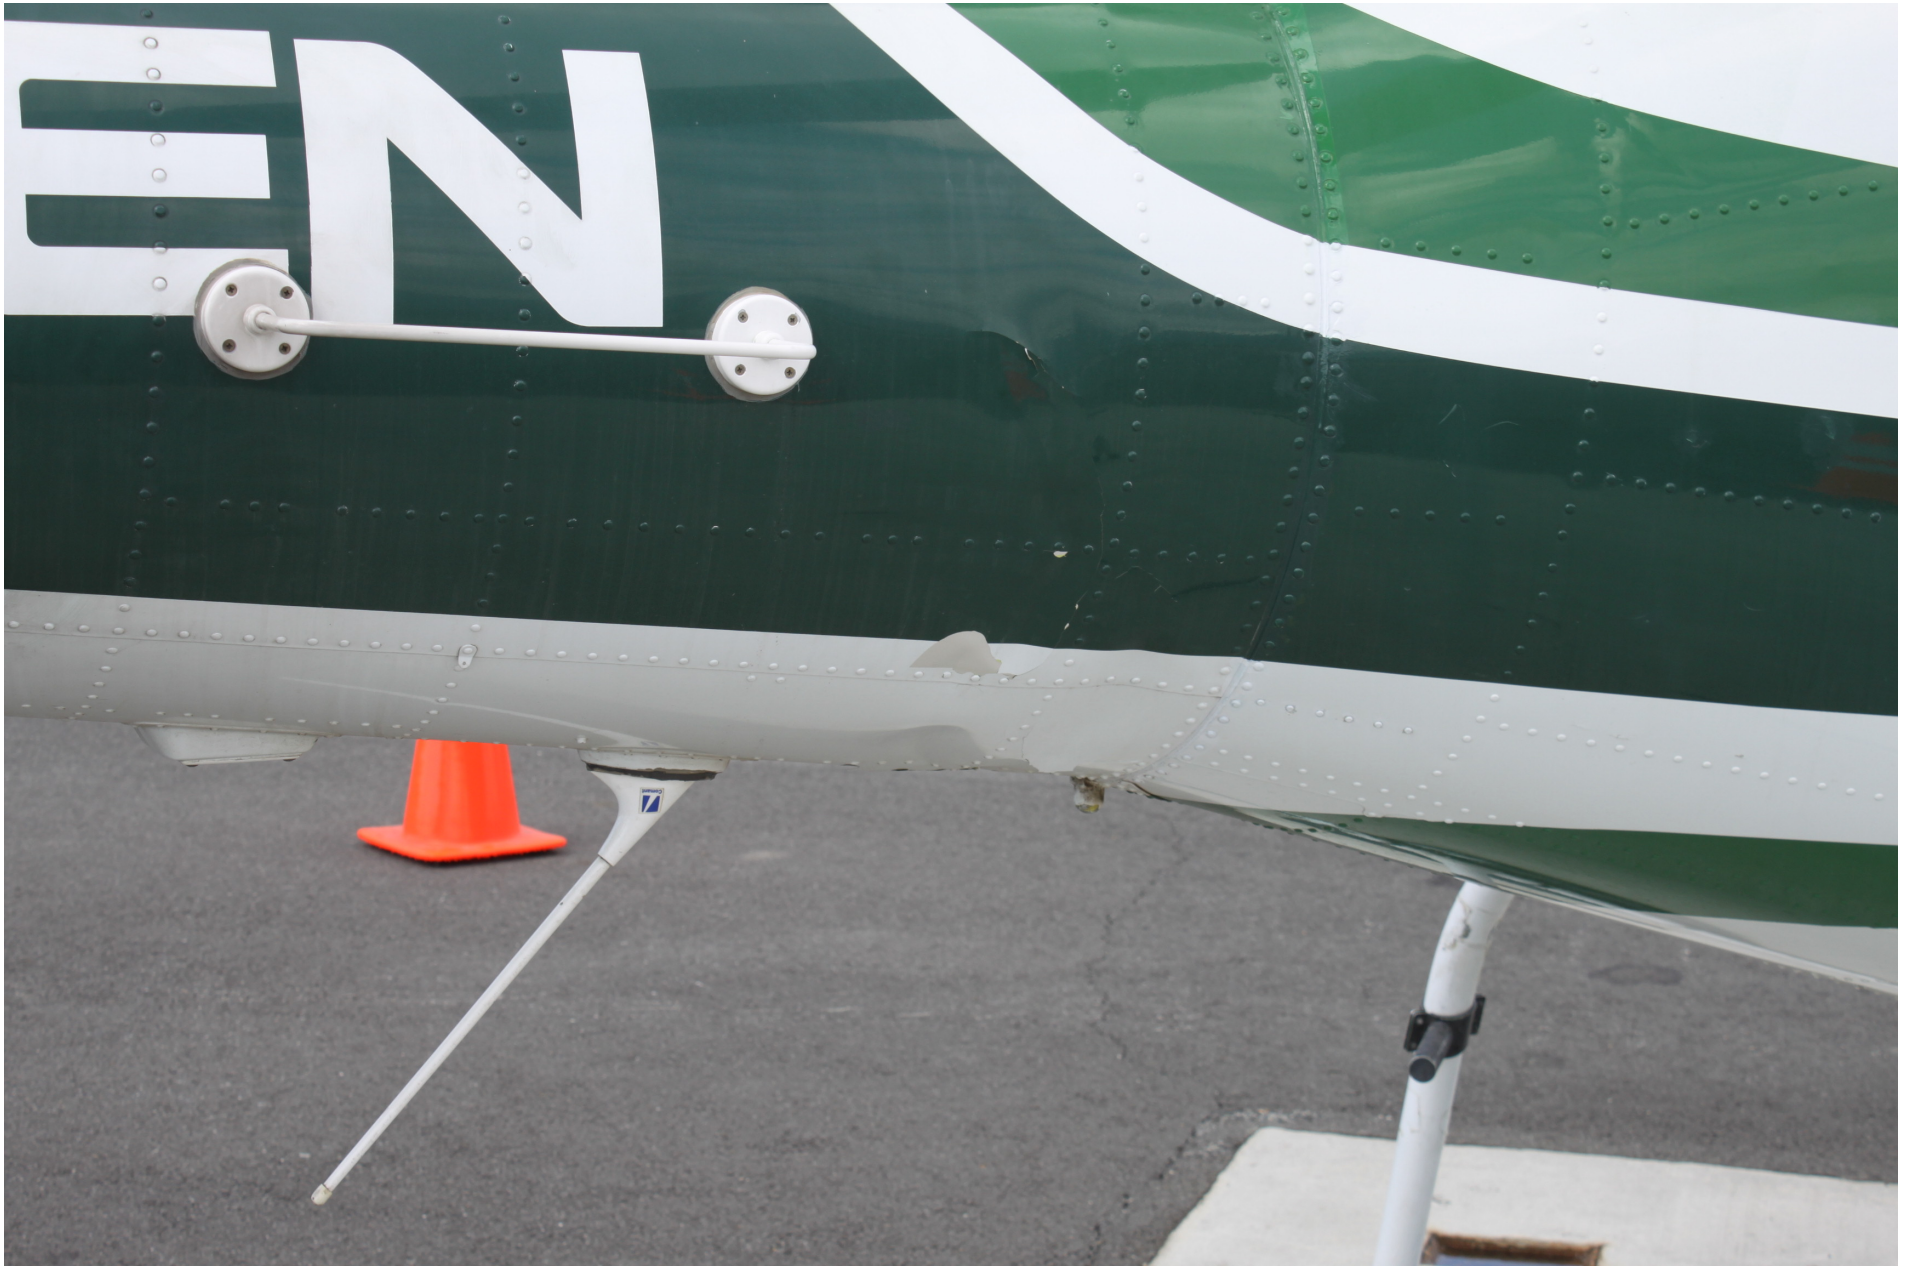
Photo 2 – Damage to Right Tail Boom Assembly

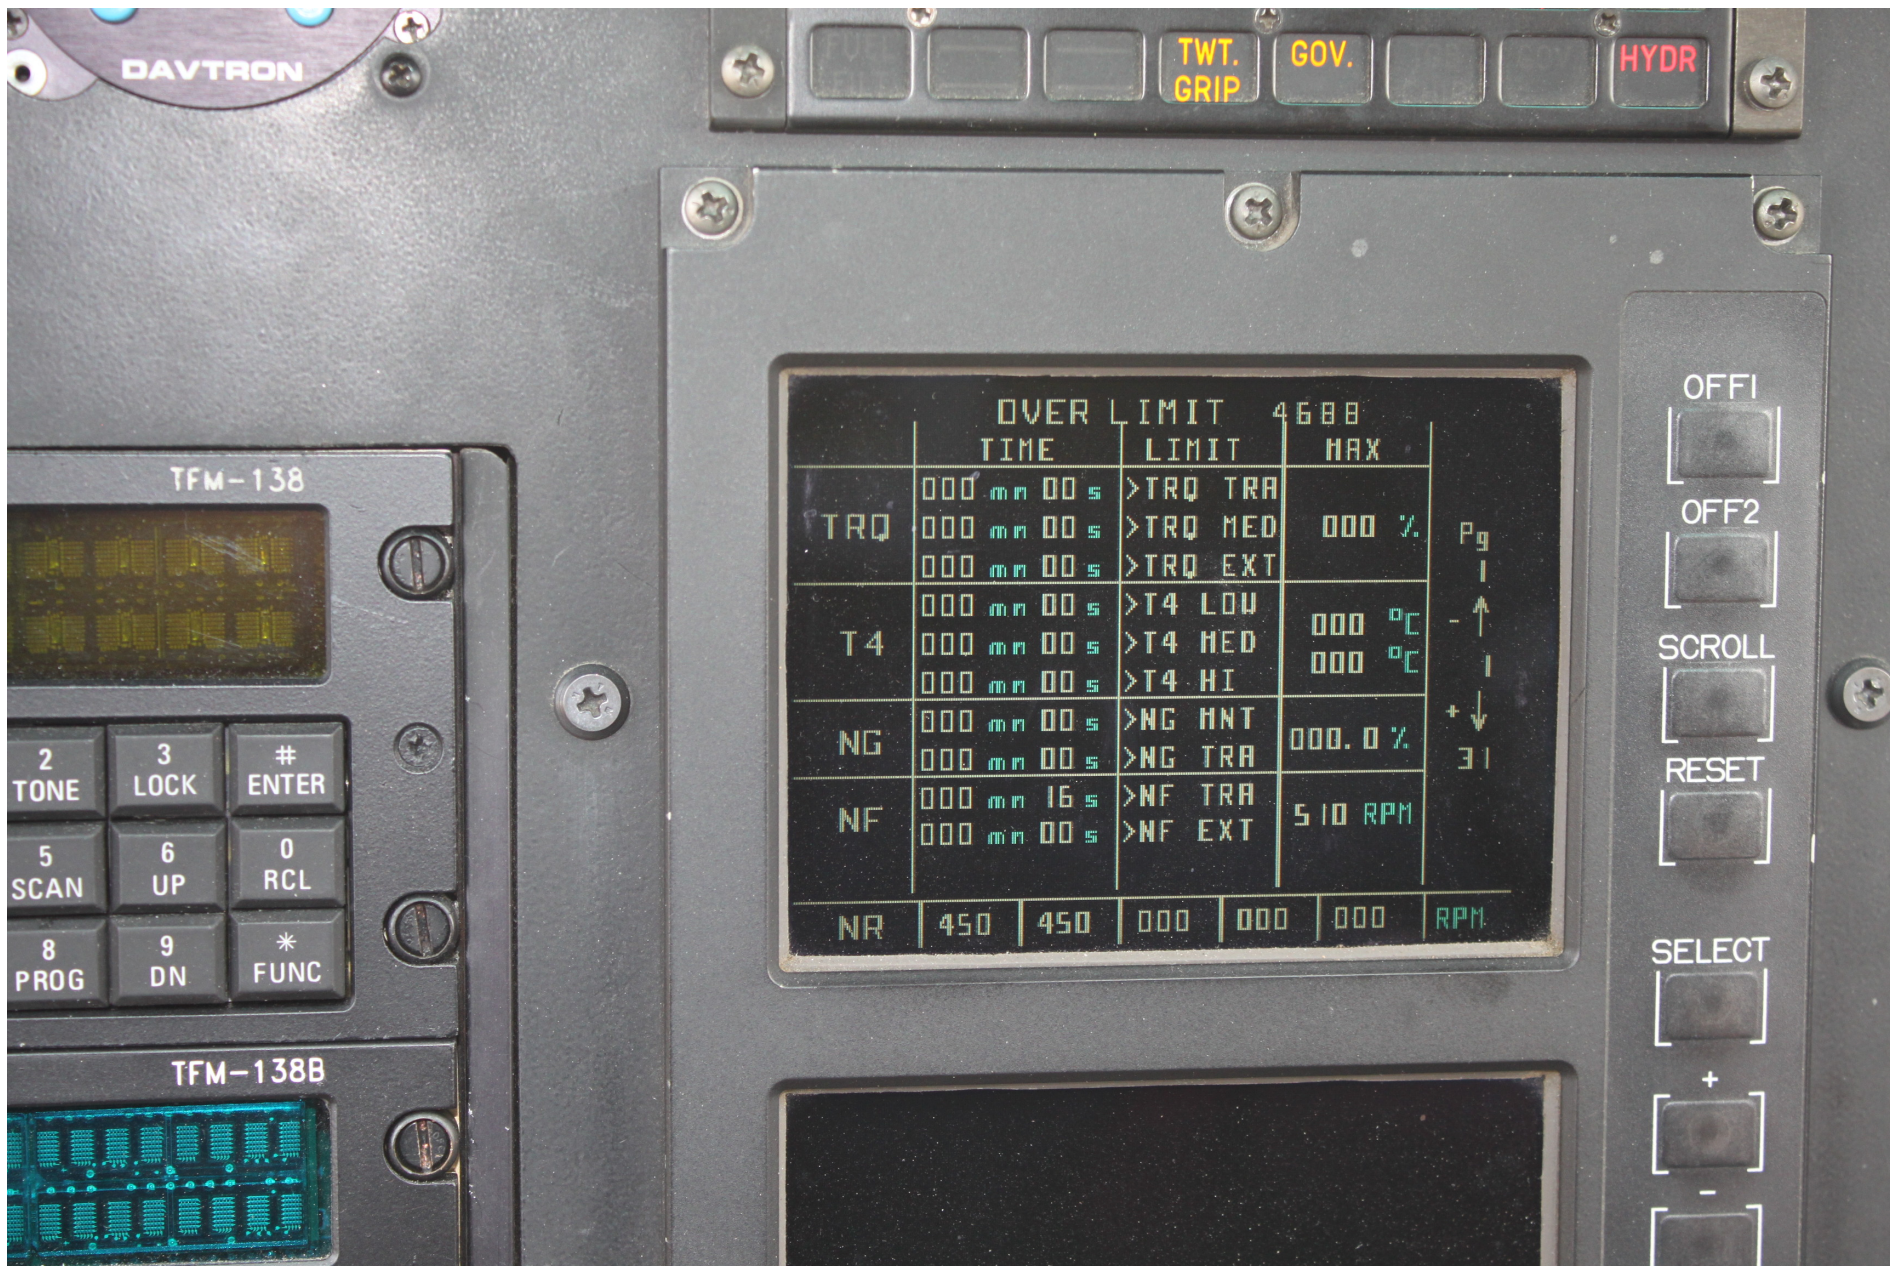
Photo 3 – VEMD Post-Accident

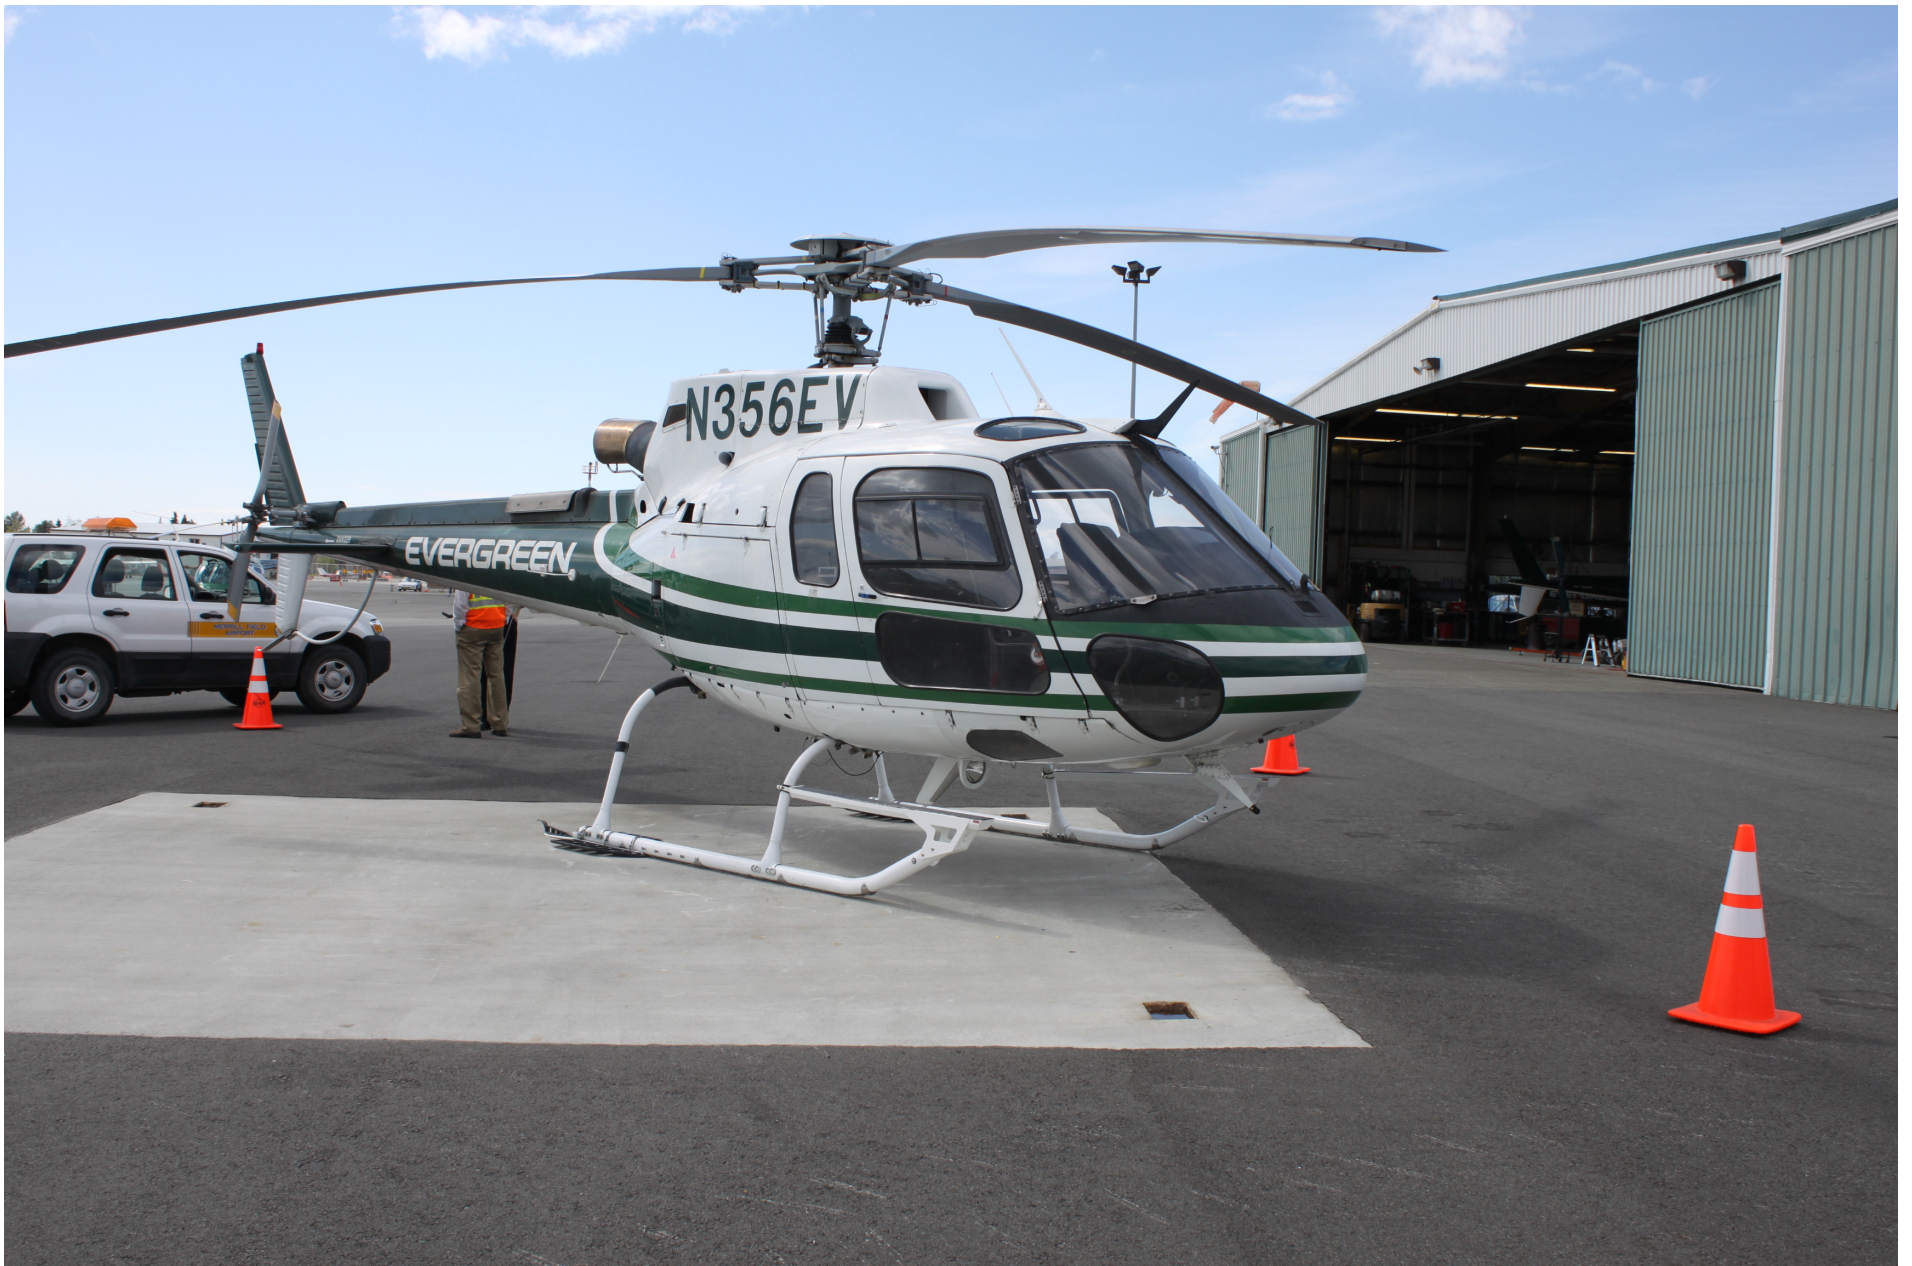
Photo 4 – Helicopter’s Right Side, Next to Hangar, After Accident
