NATIONAL TRANSPORTATION SAFETY BOARD

Photo Array

ERA22LA044

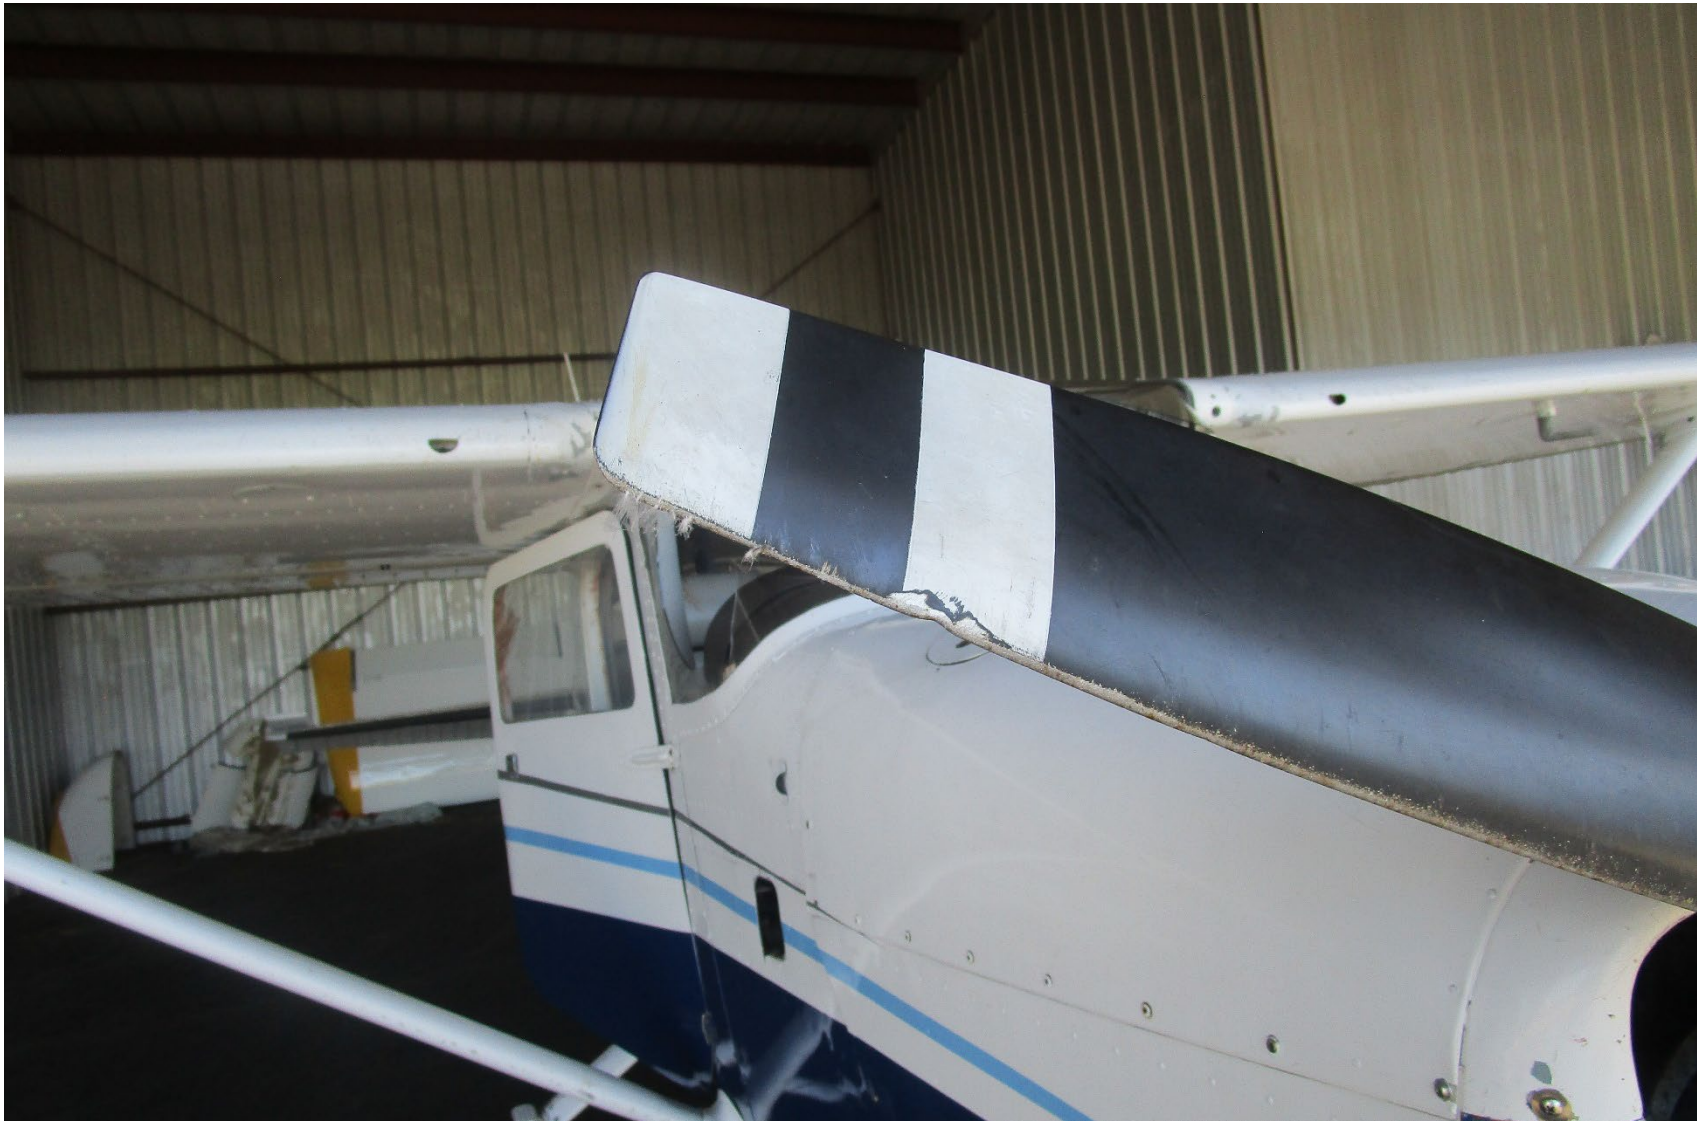
Photo 1 – View of Propeller with Feathers (Photo Courtesy of FAA)

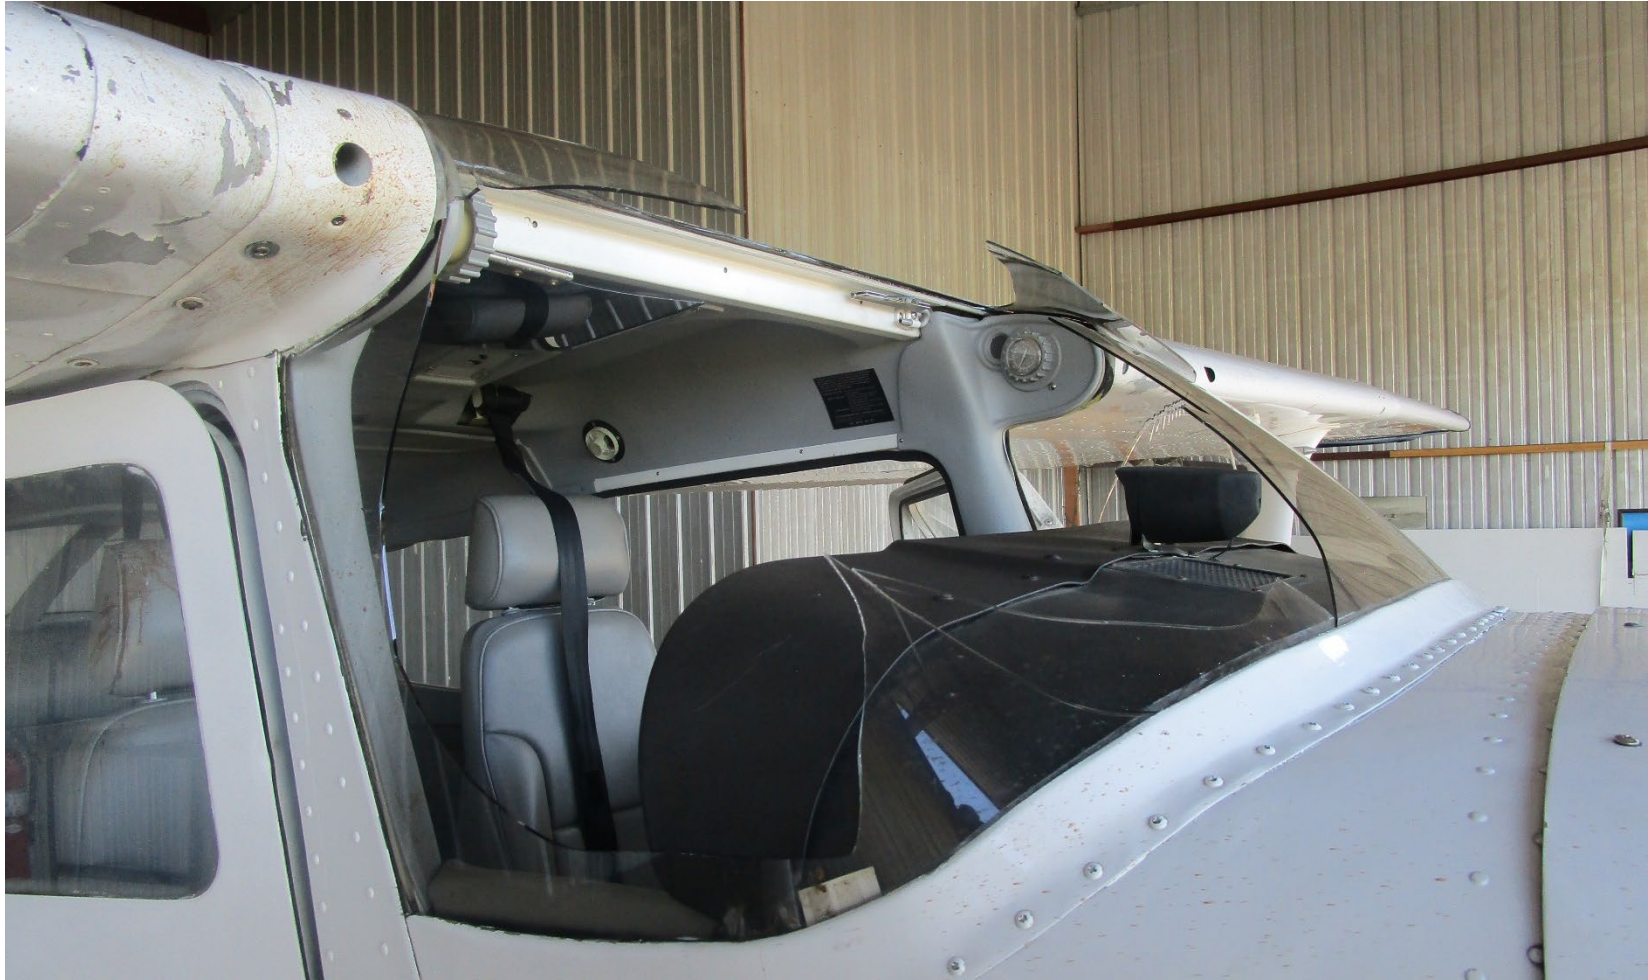
Photo 2 – View of Broken Windscreen (Photo Courtesy of FAA)

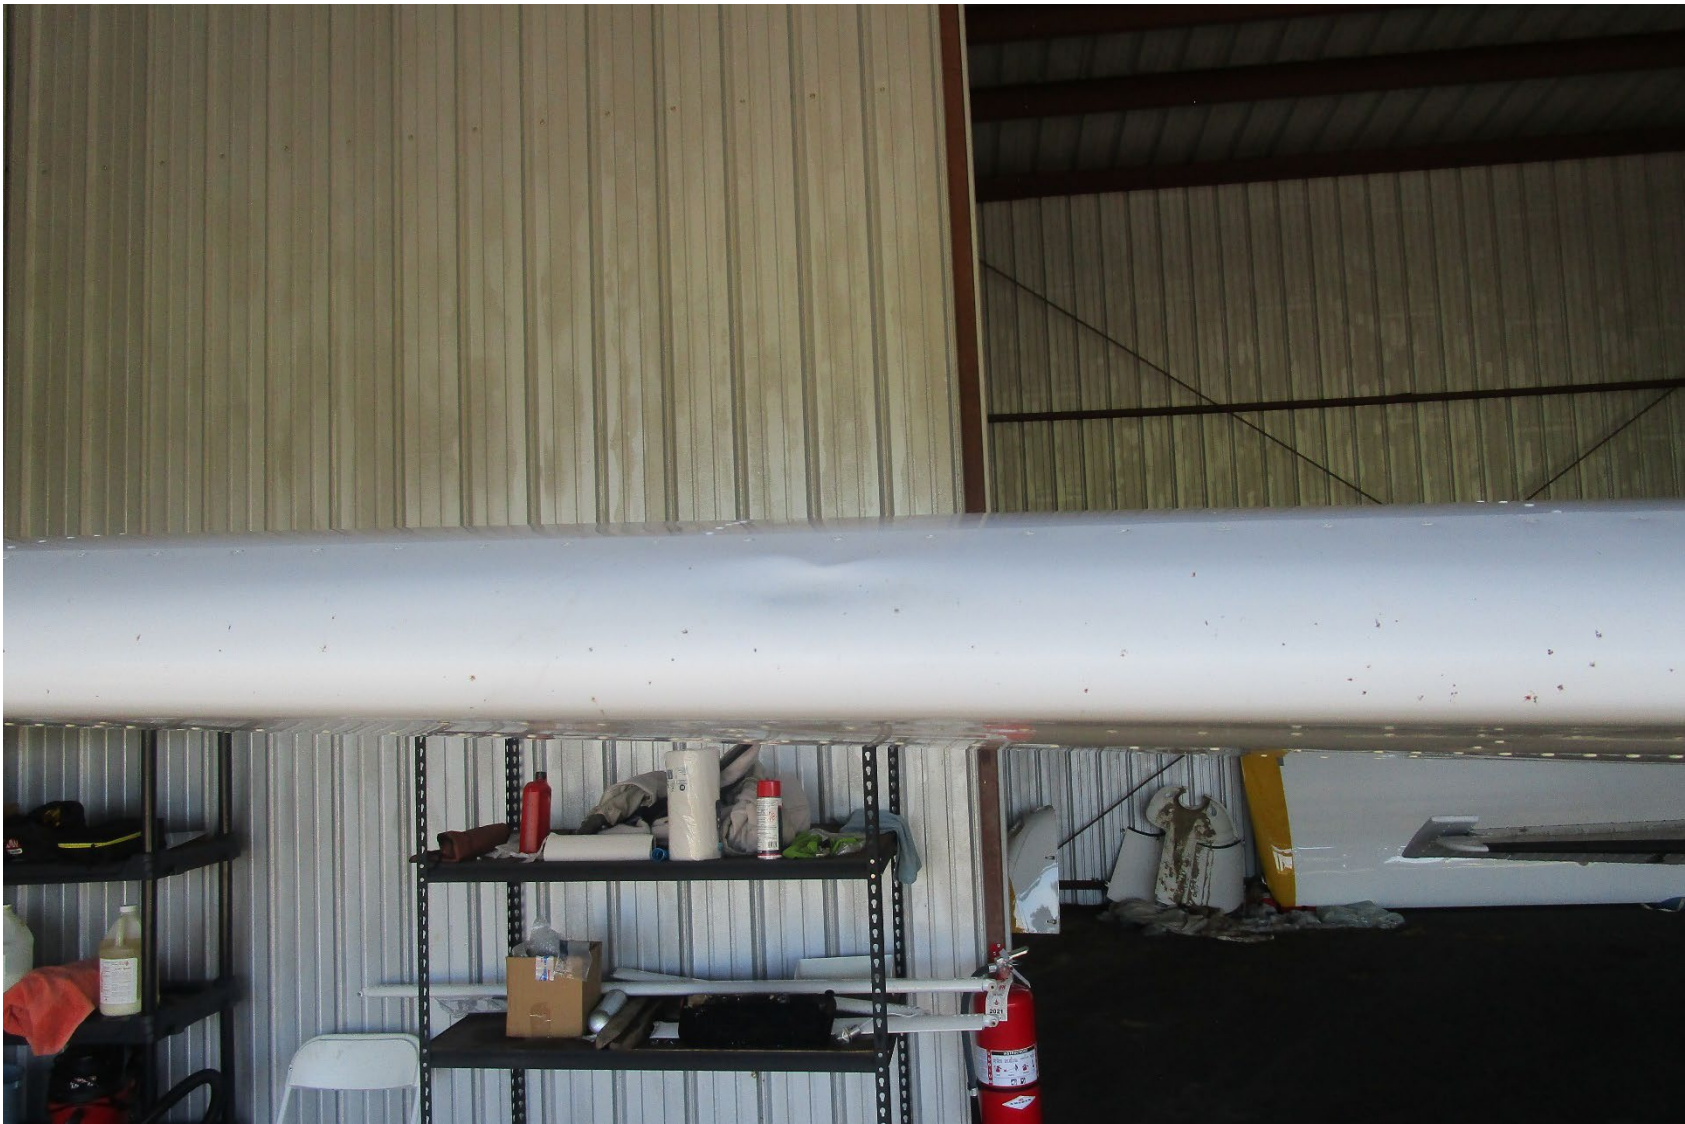
Photo 3 – View of Additional Bird Impact Damage on Right Wing (Photo Courtesy of FAA)
